**GREENSTAR LTD. - KNOCKHARLEY LANDFILL,
CO. MEATH**

ANNUAL ENVIRONMENTAL REPORT:

Report Period: January 2013 – December 2013

WASTE LICENCE REF. NO. W0146-02

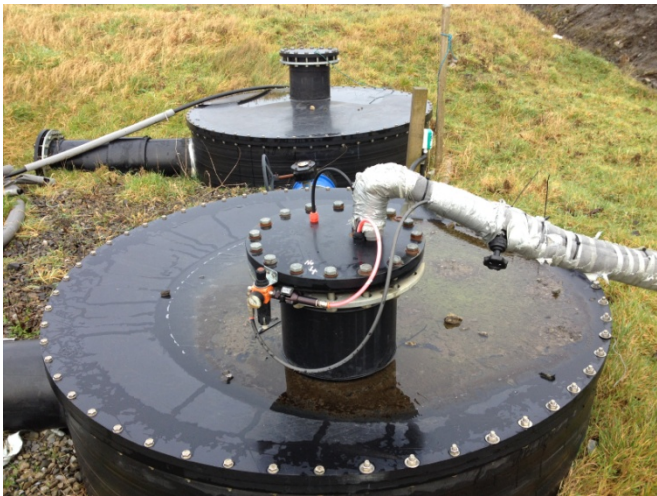
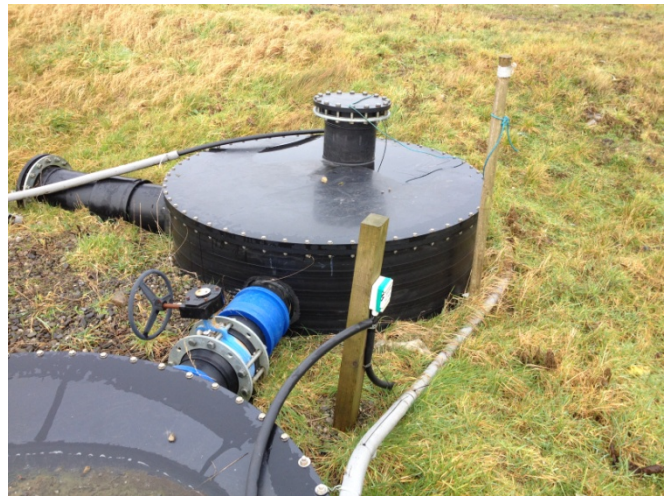
Small-diameter condensate pipes convey condensate from the landfill gas system to the leachate system. All visible pipes were inspected and no leaks were found.

Photograph 20: Insulated condensate pipework

Photograph 21: Insulated condensate pipework

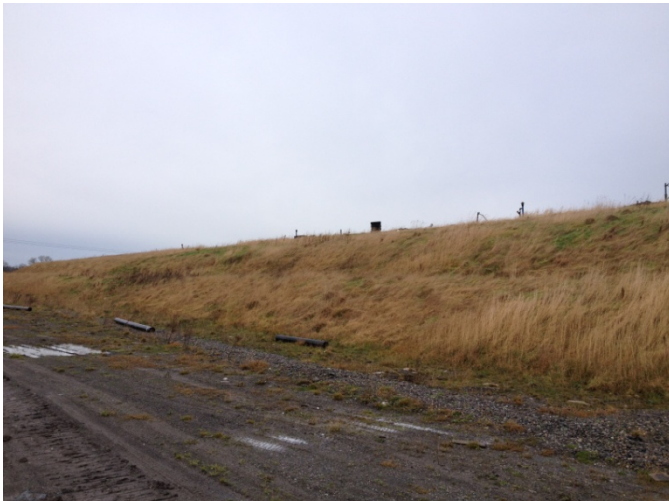
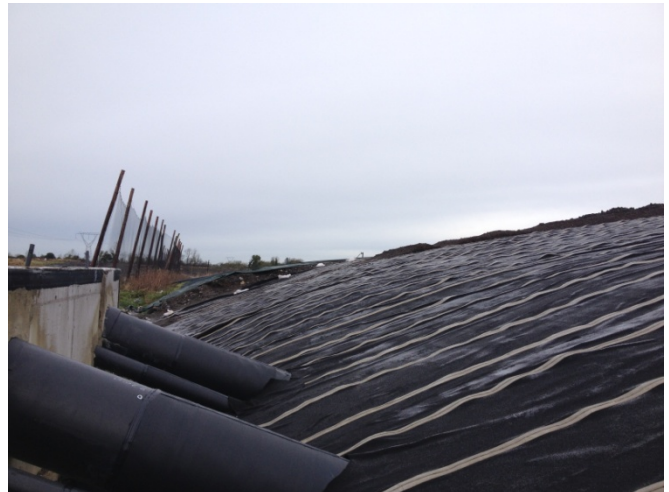
The entirety of Cells 1, 2, 3, 4, 5, 6, 7 and 8 are capped with a combination of geo-textile, LLDPE barrier, drainage geocomposite, subsoil and topsoil. The cap is at a slope of 1:5, well within normal good practice and within its design parameters. There is no evidence of slippage or other deterioration.

Photograph 22: Final Capped Area

Photograph 23: Final Capped Area Awaiting Soils

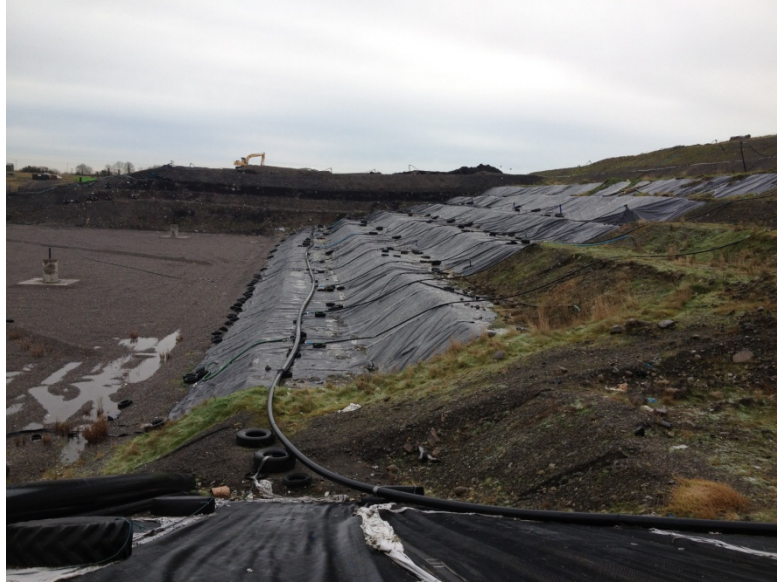
This is an 'operational' slope, constructed as waste is placed and (theoretically) an area that would give rise to concern. In this instance, Greenstar has constructed this slope as a terraced embankment in a manner that can only be described as exemplar. The terracing performs a number of positive functions including safe access to personnel undertaking litter patrols. There is no exposed waste as a layer of black polythene is used to seal the slope and thus contain leachate and gas.

Photograph 24: Northern slope of Cell 9

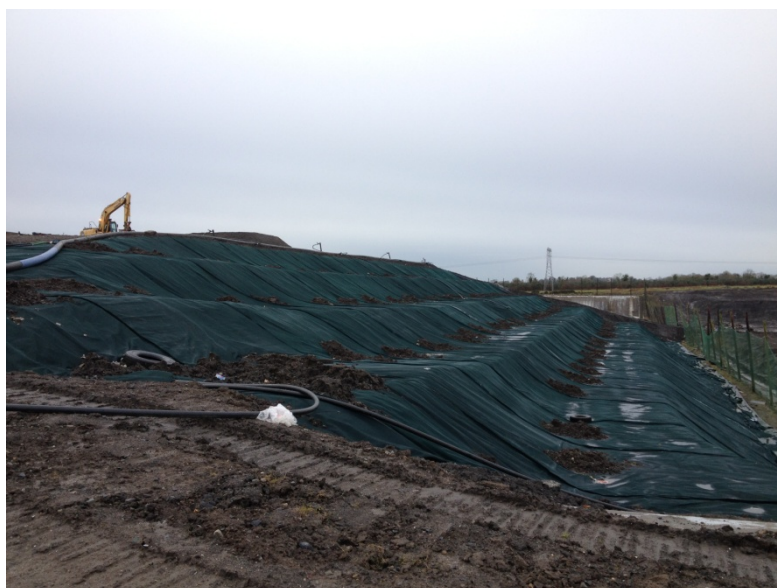
This is an 'operational' slope, constructed as waste is placed and (theoretically) an area that would give rise to concern. In this instance, Greenstar has constructed this slope as a terraced embankment in a manner that can only be described as exemplar. The terracing performs a number of positive functions including safe access to personnel undertaking litter patrols. There is no exposed waste as a layer of green geo-hesh is used to seal the slope and thus contain leachate and gas.

Photograph 25: Northern slope of Cell 12

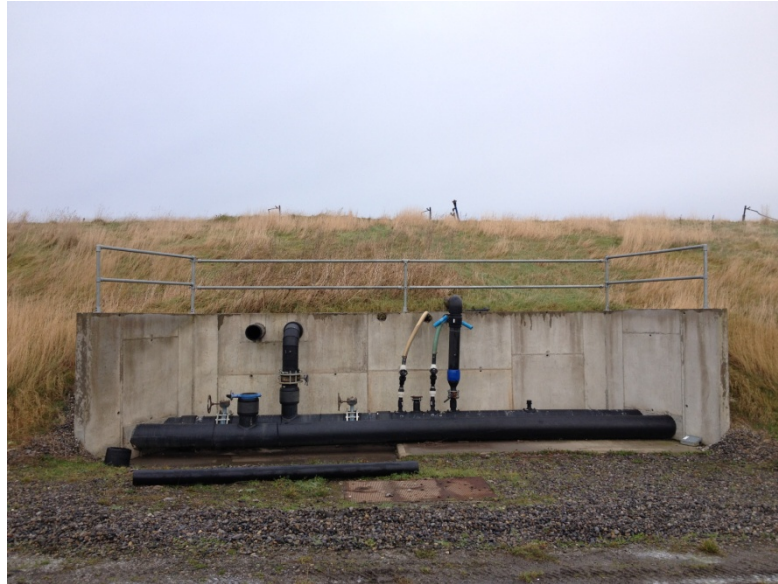
Thirteen reinforced concrete retaining structures retain the landfill and its cap where gas and leachate pipework exit the waste mass. All are in good condition with no evidence of distress.

Photograph 26: Retaining Structures at Cell 1 & 2
