3.9 LANDSCAPE AND VISUAL ASSESSMENT

3.9.1 Introduction

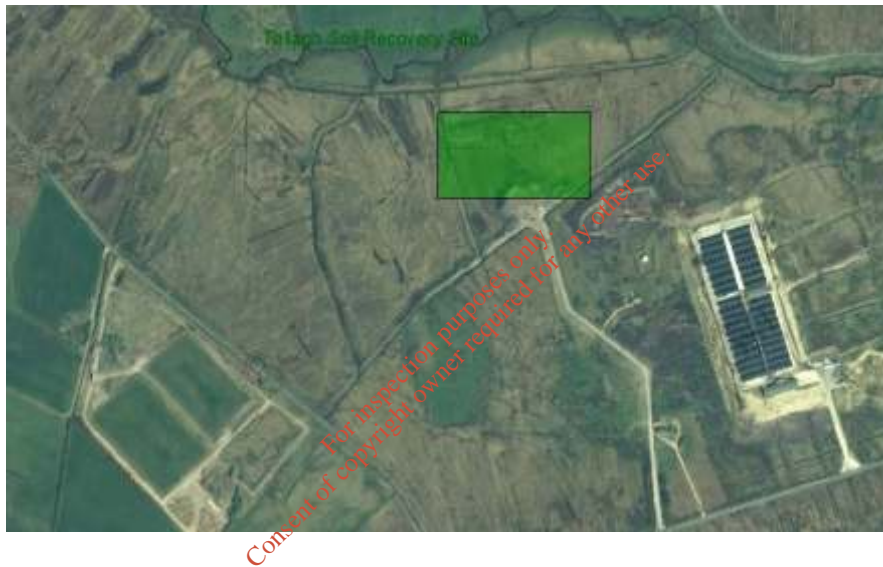
Photo 3.9.2.1: Aerial Photo of Existing Soil Recovery Site at Tallagh

3.9.2 Existing Environment

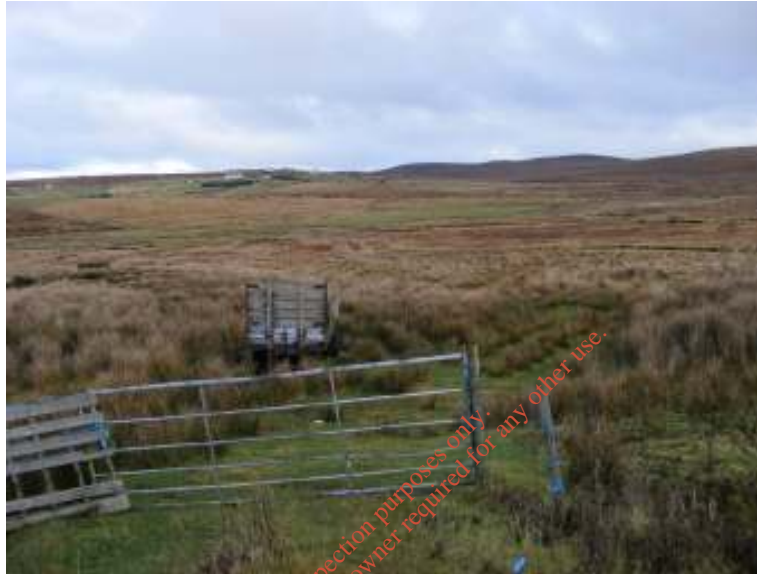
Photo 3.9.2.2: View of Existing Site – Marginal Agricultural Land

Photo 3.9.2.2 is a view into the site looking from the west towards the north and shows that the lands are marginal agricultural grassland used for grazing sheep. The land would be considered poor agricultural land due to the undulating topography, poor drainage and removal of much of the top soil layers due to peat cutting. There is also widescale evidence that the area has been cut-over for peat in the past but that this has ceased.

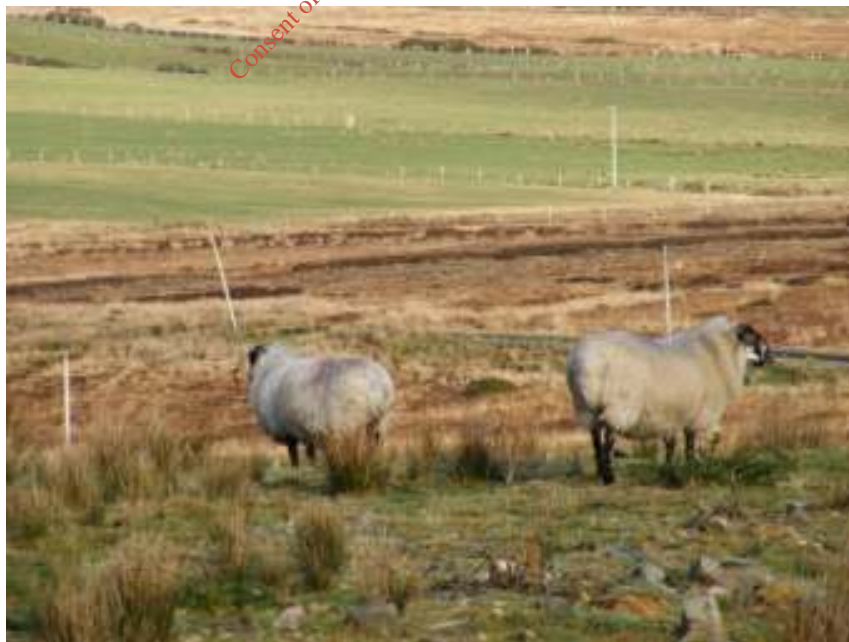
Photo 3.9.2.3: Sheep Grazing on the Existing Soil Recovery Site with Adjacent Reclaimed Land in the Distance

Photo 3.9.2.3 and **Photo 3.9.2.3** show that lands immediately adjacent to the existing land reclamation site have been reclaimed to form productive agricultural land. Therefore there are clearly precedents in the area for land reclamation activities including the local GGA pitches.

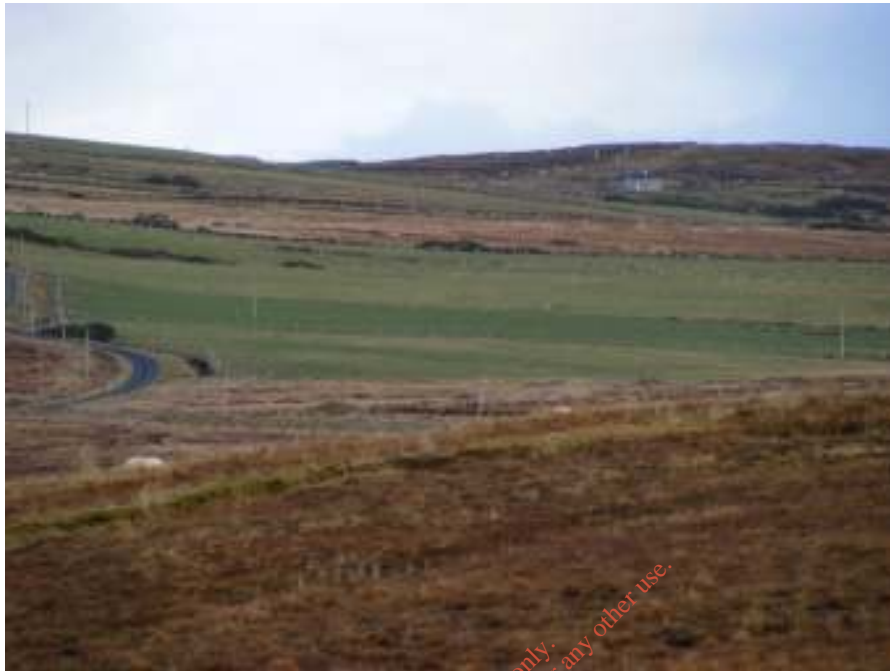
Photo 3.9.2.4: View of Site in Foreground looking towards Adjacent Land in a north-easterly direction which has been reclaimed to Productive Agricultural Land.

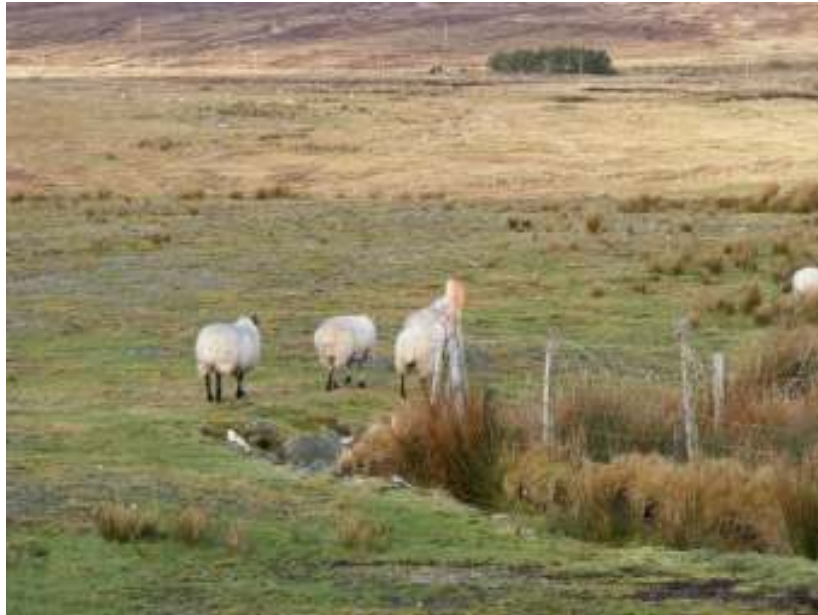
Photo 3.9.2.5: View of Sheep Grazing within the land reclamation site and congregating on the area which has already been reclaimed

Photo 3.9.2.5 and **Photo 3.9.2.6** show the area of the site already reclaimed under. **Photo 3.9.2.5** clearly demonstrates that the land is used for agricultural purposes at present with sheep grazing in the foreground and within the un-reclaimed part of the site in the distance. The site would appear to be being farmed on a continuing basis as the land reclamation works progress.

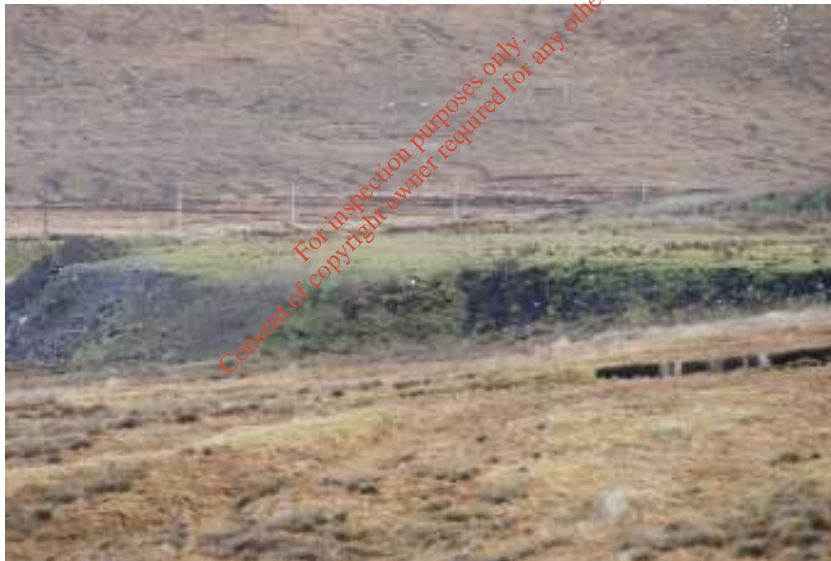
Photo 3.9.2.6: View of the area of the site reclaimed for agricultural purposes

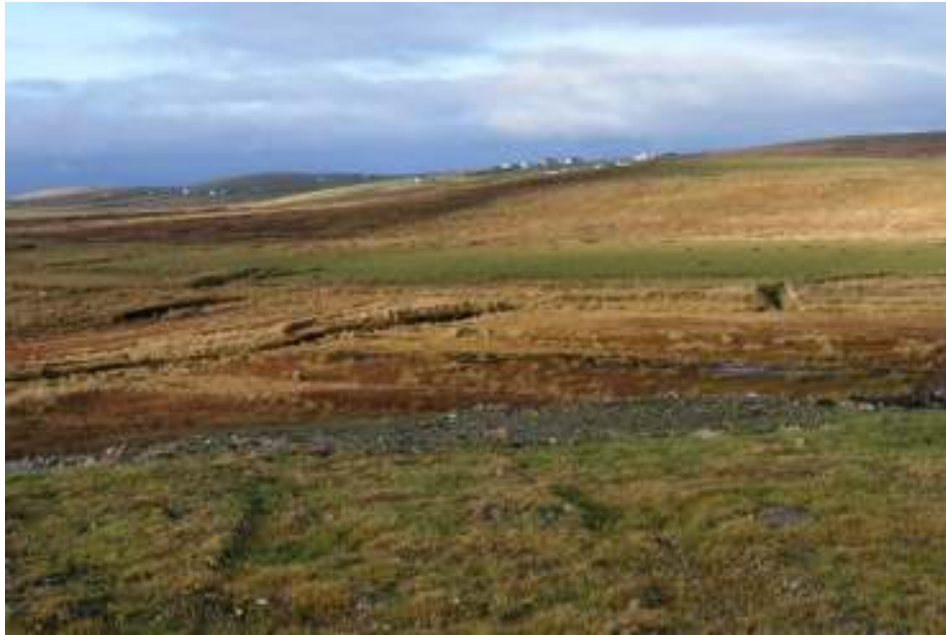
Photo 3.9.2.7: View from the portion of site reclaimed towards the lower portion of the site towards the river (which is excluded from filling). Note the reclaimed land under separate ownership on the far side of the river.

Photo 3.9.2.7 shows the view from the portion of site already reclaimed towards the lower portion of the site towards the river. Note the reclaimed land under separate ownership on the far side of the river.

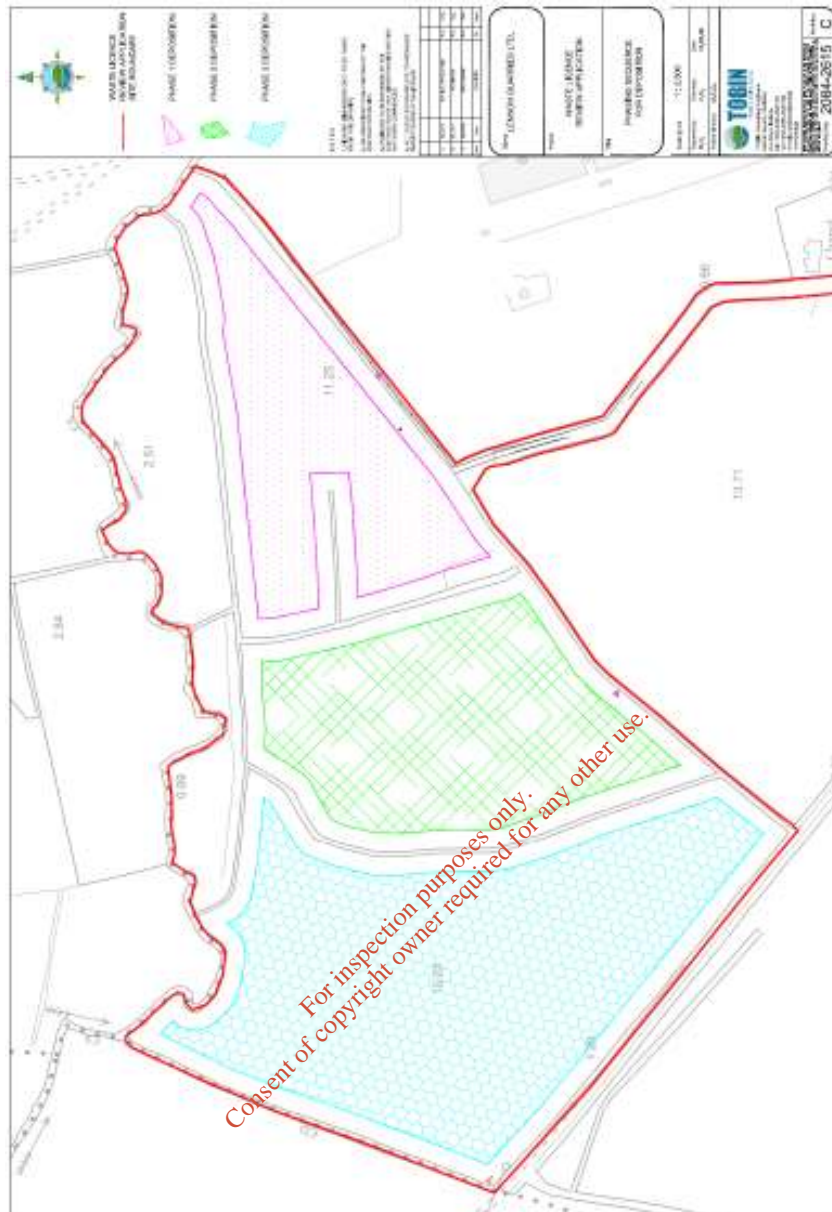
Figure 3.9.3.1: Phasing Plan

The site is currently licensed, per licence W0256-01, for soil recovery and deposition with a 1m Land Raise at the site. The Application for a Licence Review proposes no change to the final topographic level licensed under W0256-01; it is proposed that the same 1m Land Raise, as currently licensed, is maintained. The site will be phased as per the phasing drawing shown as **Figure 3.9.3.1**.
