Cavan County Council

Corranure Landfill

Annual Environmental Report 2013

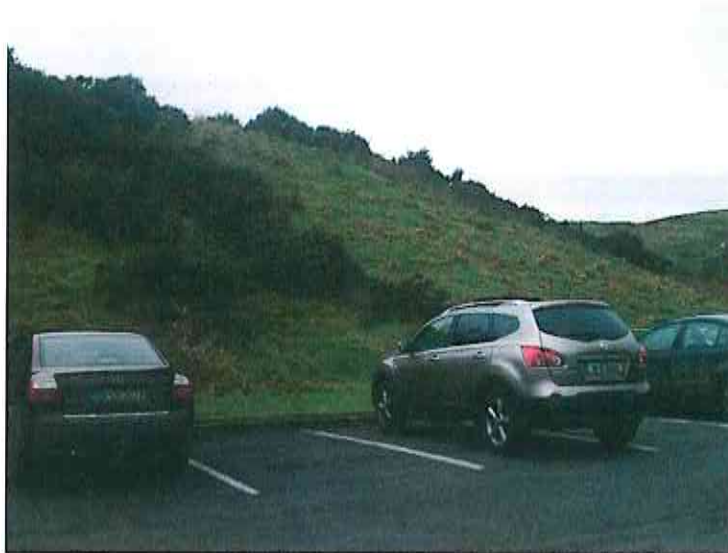
Plate 1 East Slope Cell 0

This slope is at an angle of about 1:2 (**Plate 1**) and is located at the site entrance (ref. **Appendix A**). It is well vegetated with grass, rushes and gorse. A drainage channel at the base of the slope appears to be working well with no signs of ponding. There are no signs of movement or distress on the slope. The slope appears stable.

Some general recommendations would be to continue to ensure that water does not pond near the crest of slopes as this can cause weakening of the soil resulting in failure. Low spots should be re-graded to eliminate ponding and toe drains and ditches should be kept clean to ensure efficiency.

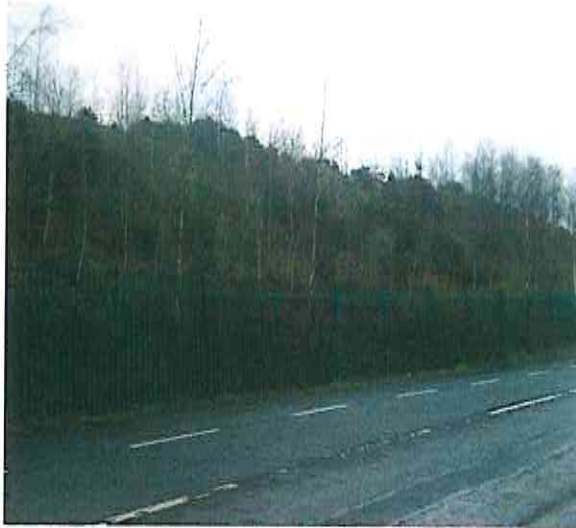
Plate 2 South East Slope – Western End

The South East Slope as shown in **Plate 2** and **Plate 3** is bounded by the R188 (ref **Appendix A**). It is typically graded at an angle of approximately 1:2.5. It is well vegetated with lush grass, rushes and gorse. The drain at the toe of the slope appears to be functioning well with no signs of ponding. There are no signs of distress or movement and the slope appears stable.

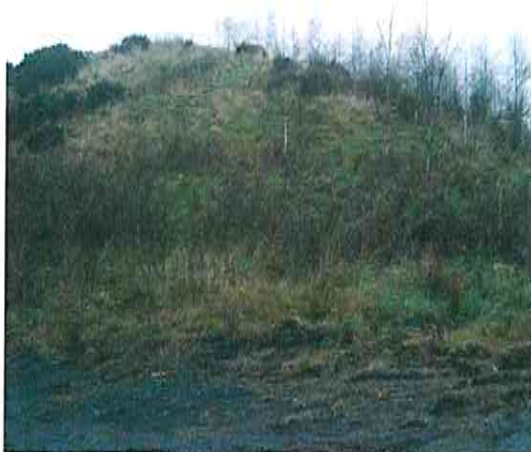
Plate 4 South West Slope (facing NE)

The slope as shown in Plate 4 and Plate 5 (ref. **Appendix A**) is at an angle of about 1:2. It is well vegetated with lush grass and rushes, and is hummocky in places. A haul road is located at the base of this slope. There is a drainage channel between the road and the landfill boundary. There are no signs of distress or movement on the slope and the slope appears stable.

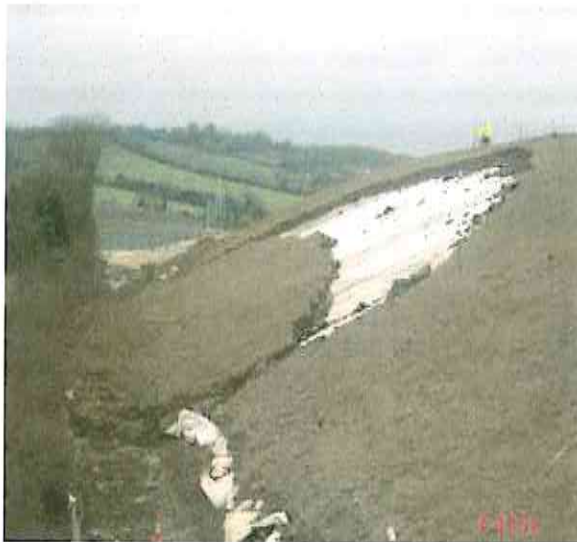
Plate 8 North West Slope Failure 2006

The toe of this slope had been left truncated for a month or more to facilitate the installation of a toe drain. This resulted in tensile loading of the liners which they are not designed for. It was also concluded that leachate streams which flowed from the top of the exposed landfill to the western face were a contributory factor to the failure.

Remediation measures included the installation of a geogrid and a reduction of leachate levels. An overall slope angle of 1:2.5 was attained. During capping works, care was taken to ensure that the toe of the slope would not be truncated or oversteepened. A toe bund was also constructed. The haul road now sits on this bund.

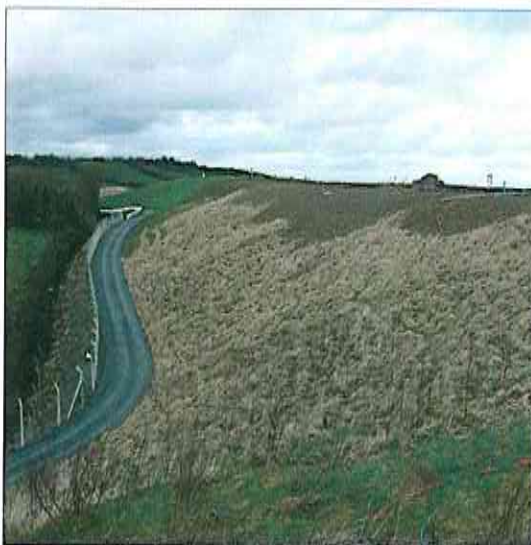
Plate 9 North West Slope (February 2008)

Plate 9 and **Plate 10** show the appearance of the slope in 2008 and December 2013, and illustrates that there is no sign of distress or movement.

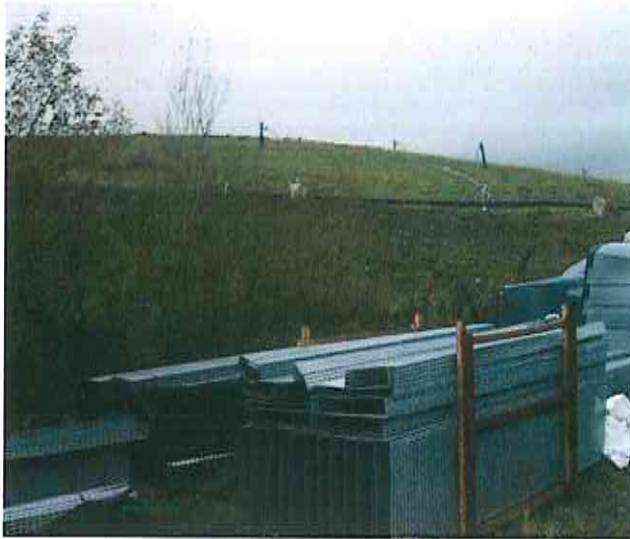
Plate 11 North East Slope

This slope is well vegetated (**Plate 11**), with a gradient of about 1:3. Old farm buildings exist a small distance from the base of the slope and a haul road which serves Cell 3 runs along here also (ref. **Appendix A**). No signs of distress or movement are apparent and the slope appears stable.

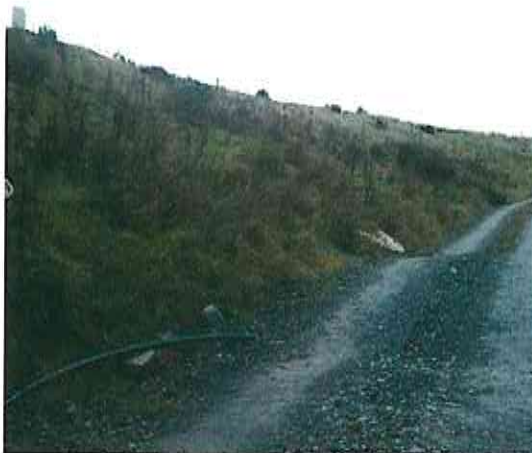
Plate 12 North West Slope – Cell 2

This slope is well vegetated with grass (**Plate 12**). The gradient is at approximately 1:2. Areas at the toe at the northern end of the slope were previously considered to be slightly oversteep during filling, and have therefore been regraded during capping. A haul road exists at the base of the slope and provides a toe bund to the slope. No signs of distress or movement are apparent on the slope and it appears stable.

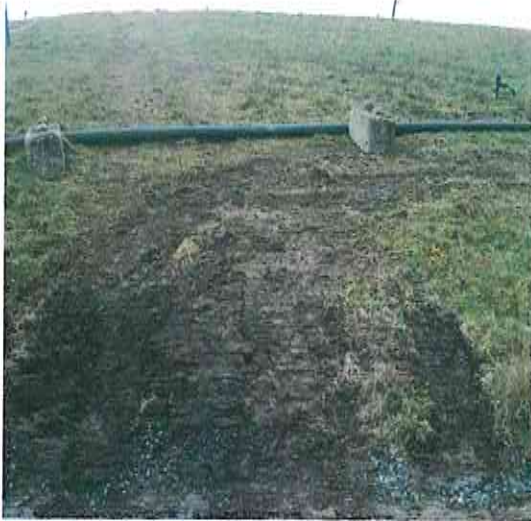
Plate 13 North East Slope

The slope is vegetated with grass and is at an angle of 1:3. A haul road exists at the base of the slope. No signs of distress or movement are apparent on the slope and it appears stable (**Plate 13** and **Plate 14**). This slope was regraded during capping works.

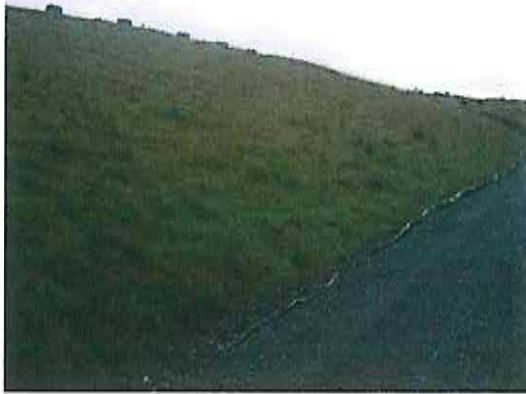
Plate 15 North West Slope facing south

Again this slope is well vegetated with grass and is at an angle of 1:3. There are no signs of distress or movement and the slope appears stable (**Plate 15** and **Plate 16**). The unfilled Cell 4 is visible to the north of Cell 3 in **Plate 16**.

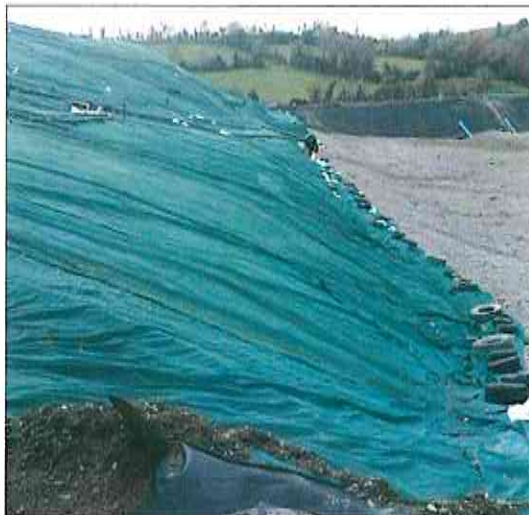
Plate 17 North Slope Cell 3

The surface of the northern end of Cell 3 is lined with a LLDPE landfill liner and a geofabric overliner (Plate 17). It is not permanently capped. A full inspection was therefore not possible.

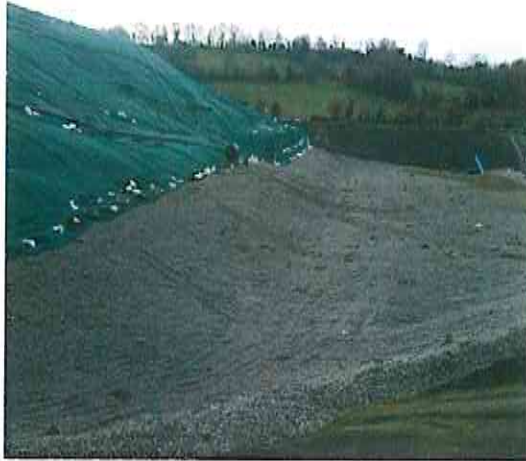
Plate 18 Cell 4 facing west

Cell 4 is located directly to the north of Cell 3 (**Plate 18** and **Plate 19**). Construction of this cell was completed in July 2013. This cell is fully lined and is ready to accept waste.

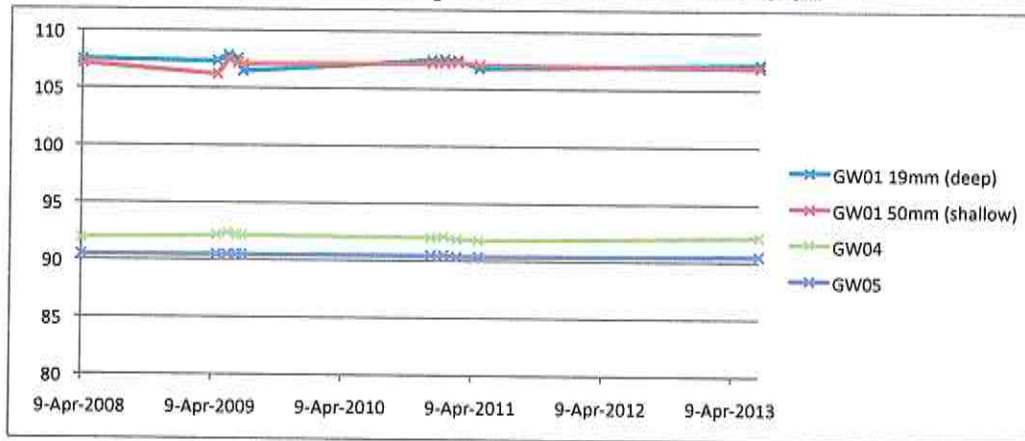
Graph 1 - Historical groundwater levels at Corranure Landfill

Historical data was also referred to in an attempt to identify any seasonal patterns in groundwater levels; collated data is shown in Graph 1. Resolution of available data was low. Of the data available, we can see that groundwater levels are relatively stable, although points appear to be limited to spring months. Data acquired for GW05 showed artesian conditions for all but one measurement, making data from this borehole of limited use. It does again show a gradient from south to north,

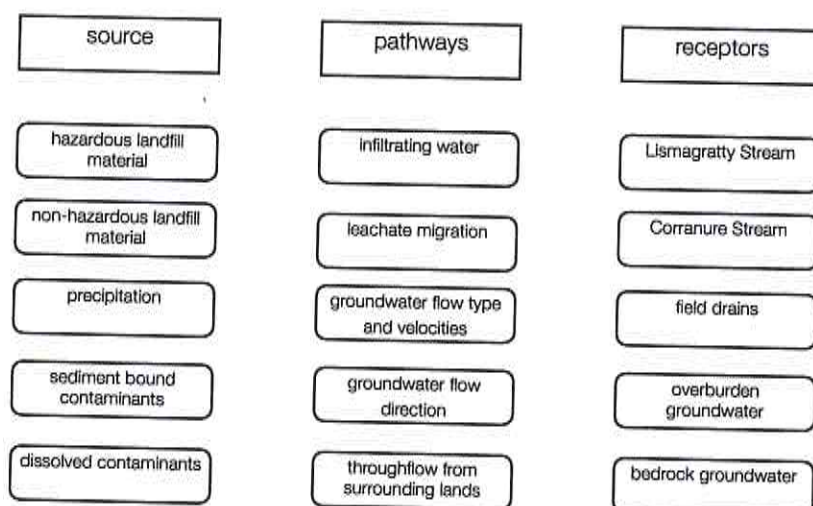
Preliminary S-P-R

Following desk study findings, historical information and the site survey information, the preliminary conceptual source-pathway-receptor model is as follows:

- the overall site is quite large and is located in a northeast tending local topographical depression, tucked between a significant drumlin peak to the south, and a more minor drumlin hills to the northeast and northwest.

- the site contains three capped waste cells, one of which (Cell 0) is unlined, and an excavated area prepared for acceptance of future waste (Cell 4). The unlined cell is the focus of the study as it is the source of a discharge to groundwater.
