Roadstonewood Ltd
Fortunestown,
Tallaght,
Dublin 24,

Re: Annual Environmental Report 2013 for W0269-01, Fassaroe Waste Recovery Facility

The licence holder shall submit to the EPA an Annual Environmental Report before 31st March of the following year.

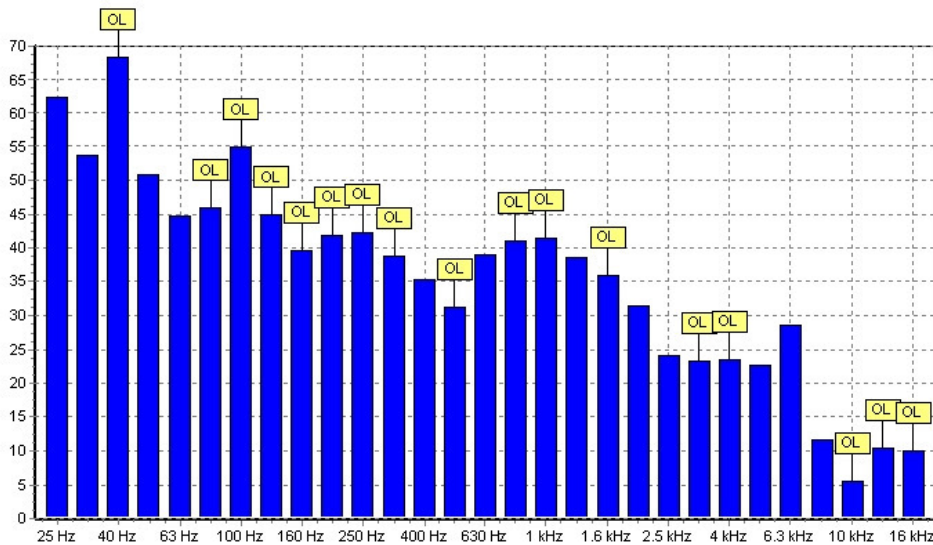
Deaf Defier Measurement Report. Printed on 12/18/2013 at 11:50:09 AM.

Site Observations

- No observed tonal noise.
- Wind is at 3.5m/s gusting 4.5m/s. Wind gust noise is causing problems with the readings creating higher noise in a particular frequency at that moment.
- The garage in the neighbouring facility has an air hose going occasionally.

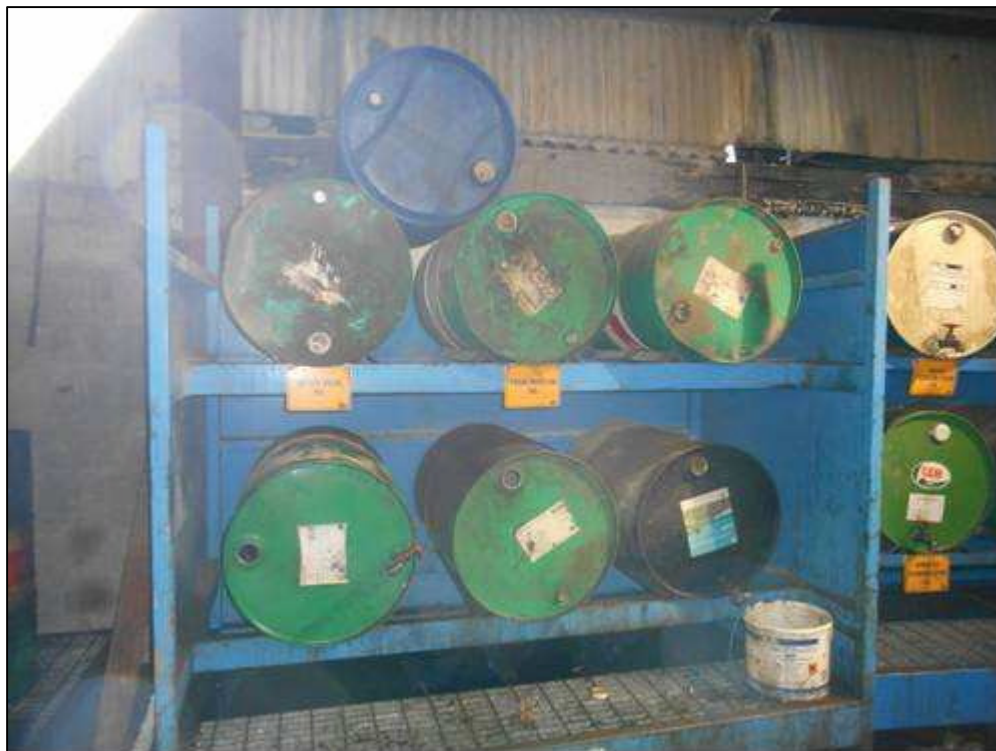
Figure 1 Bund identification

Aspect	Value/Finding	Comment
Date of Assessment	January 2014	
Location	Garage	
Hydrostatic test possible?	No	Sump half full of oil
Bund construction	Steel	
Tank size, m ³	6 off 205L	Designed for 6 off 205L drums
25% total tank size, m ³	0.3	25% of 6 off drums
Bund size, m ³	0.3	Bund volume designed for 6 off drums. Storage capacity exceeded on some racks which reduces effectiveness of bund.
Bund roofed	Yes	Bund under cover
Defects	Yes	Sump half full of oil which reduces effectiveness of bund.

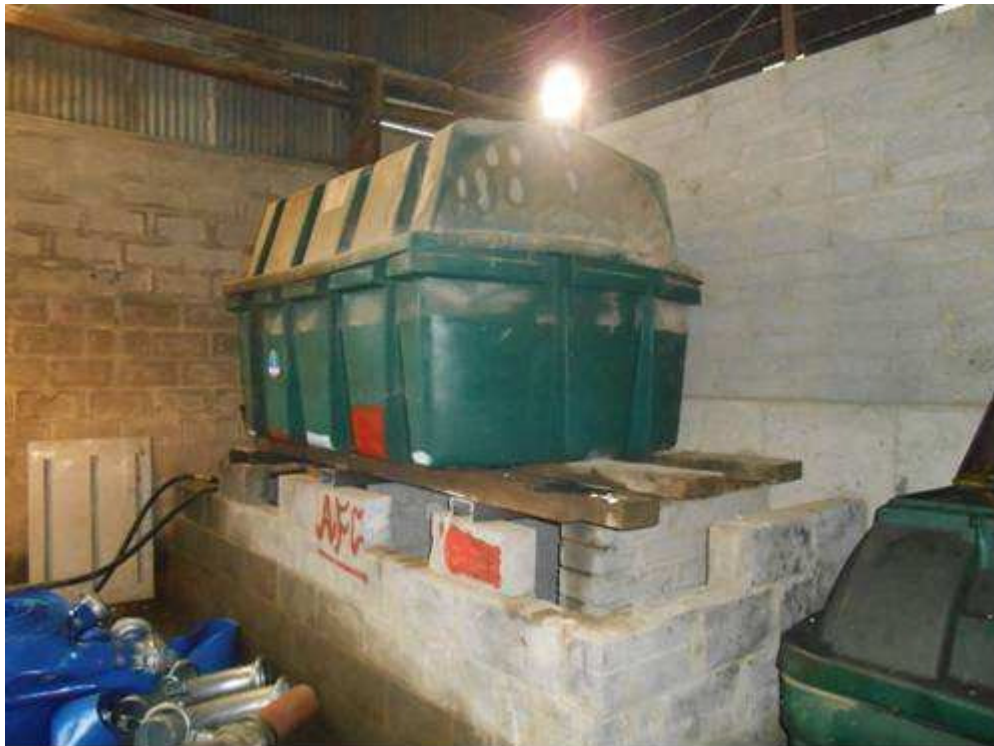
Figure 3 Bund identification

Aspect	Value/Finding	Comment
Date of Assessment	January 2014	
Location	Garage	
Hydrostatic test possible?	No	Self bunded tank
Bund construction	Plastic self bunded	
Tank size, m ³	50.0	Approximately
110% tank size, m ³	55.0	Approximately
Bund size, m ³	55.0	Self bund tank designed for 110% of tank volume
Bund roofed	N/A	
Defects	No self-test facility to check void in self bunded tank	If the inner skin is to puncture, e.g. a corrosion pin hole, the void will fill with oil. This will result in the tank being effectively unbunded.

Associated refueling area?	Yes	
Impermeable ground?	Yes	Concrete floor of garage
Interceptor?	N/A	Interceptor not required as area is undercover.
Defects	No

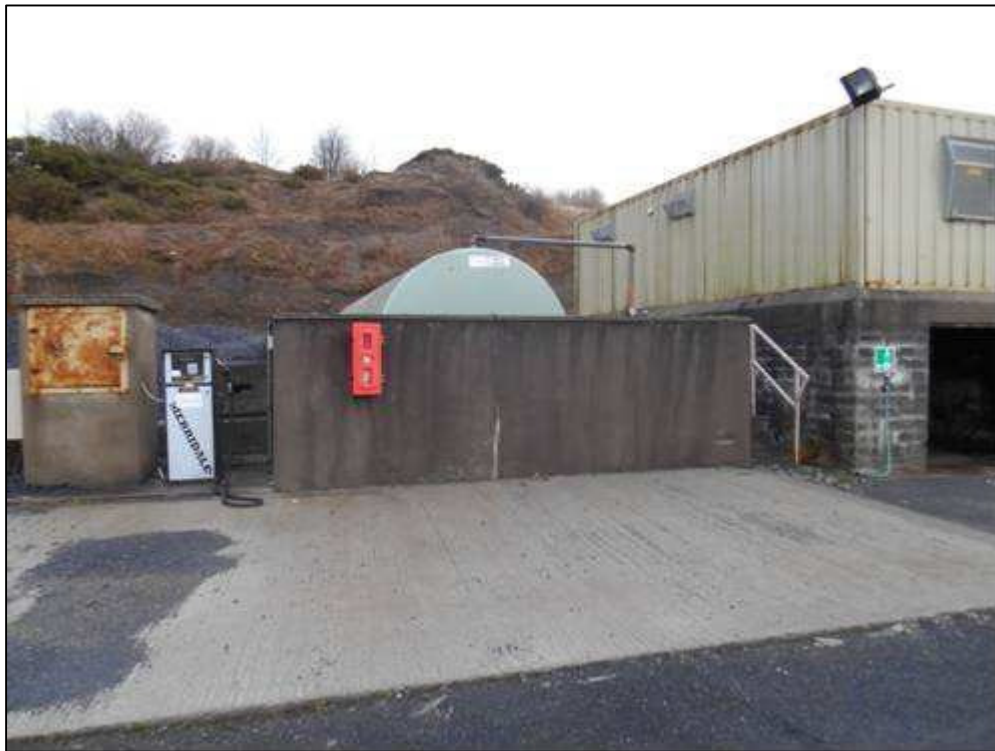
Figure 5 Bund identification

Aspect	Value/Finding	Comment
Date of Assessment	January 2014	
Location	Yard	
Hydrostatic test possible?	No	Self bunded tank
Bund construction	Blocks with cement render	Not best practice. Best practice is reinforced mass concrete to either BS 8007 or CIRIA 163.
Tank size, m ³	53.0	
110% of total tank size, m ³	58.3	
Bund size, m ³	70.0	Bund size exceeds best practice requirements
Bund roofed	No	
Defects	No

Associated refueling area?	Yes	
Impermeable ground?	Yes	
Interceptor?	Yes	
Defects	No

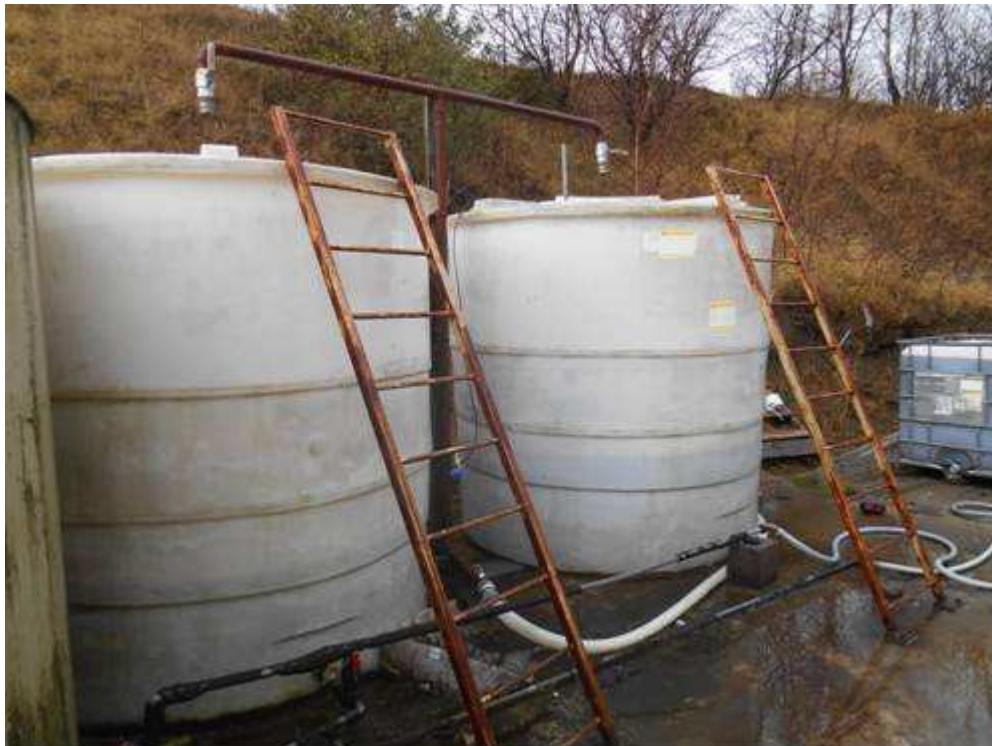
Figure 6 Bund identification

Aspect	Value/Finding	Comment
Date of Assessment	January 2014	
Location	Yard	
Hydrostatic test possible?	No	Self bunded tank
Bund construction	Plastic self bunded	
Tank size, m ³	Unknown	
110% of total tank size, m ³	Unknown	
Bund size, m ³	Sufficient	Self bund tank designed for 110% of tank volume.
Bund roofed	N/A	
Defects	No self-test facility to check void in self bunded tank	If the inner skin is to puncture, e.g. a corrosion pin hole, the void will fill with oil. This will result in the tank being effectively unbunded.

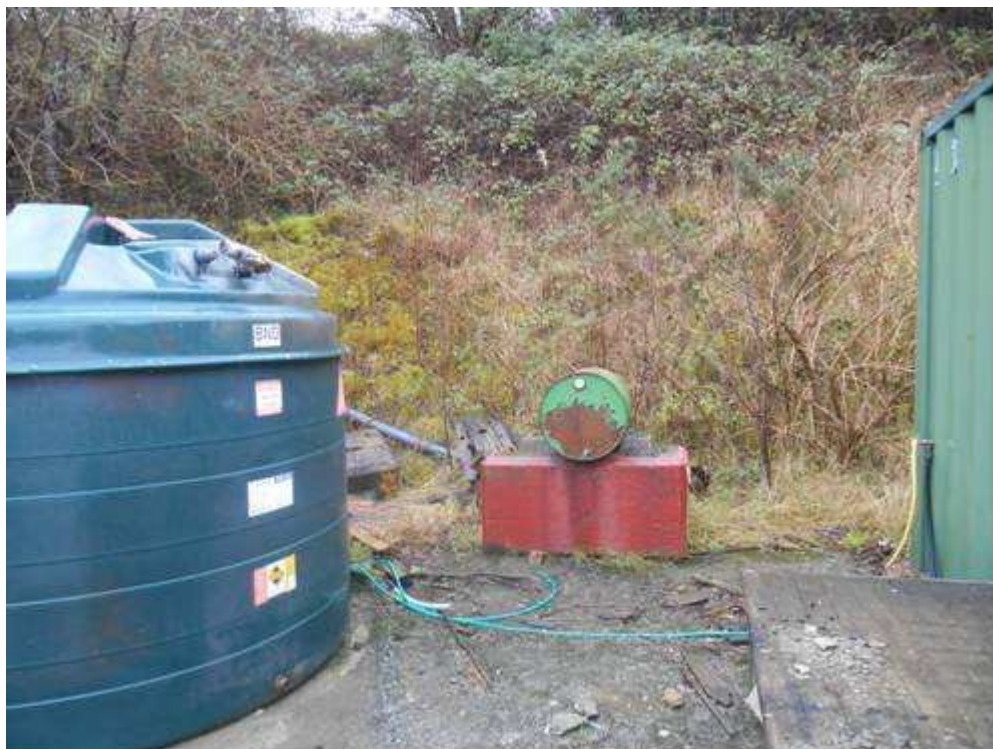
Figure 7 Bund identification

Aspect	Value/Finding	Comment
Date of Assessment	January 2014	
Location	Yard	
Hydrostatic test possible?	No	Self bunded tank
Bund construction	Plastic self bunded	
Tank size, m ³	Unknown	
110% of total tank size, m ³	Unknown	
Bund size, m ³	Sufficient	Self bund tank designed for 110% of tank volume.
Bund roofed	N/A	
Defects	No self-test facility to check void in self bunded tank	If the inner skin is to puncture, e.g. a corrosion pin hole, the void will fill with oil. This will result in the tank being effectively unbunded.

Item	Bund adequate size	Bund suitable construction	Bund integrity Assessment Result	Bund has roof	Refueling area has interceptor	Action Required
Drum Racks	Yes	Yes	Pass	Yes	N/A	Remove excess drums. Clear out oil in base of sump
Waste oil bund	Yes	Yes	Fail (Note 3)	N/A	N/A	Install self test devices
Gas oil tank	Yes	Yes	Fail (Note 3)	N/A	N/A	Install self test devices
Drum sump pallet	Yes	Yes	Fail (Note 1)	Yes	N/A	Discard and replace
Auto diesel tank	Yes	No (Note 2)	Pass	No	Yes	Roof bund.
Additive tanks	Yes	Yes	Fail (Note 3)	N/A	N/A	Install self test devices
Green Plastic Sika Tank	Yes	Yes	Fail (Note 3)	N/A	N/A	Install self test devices

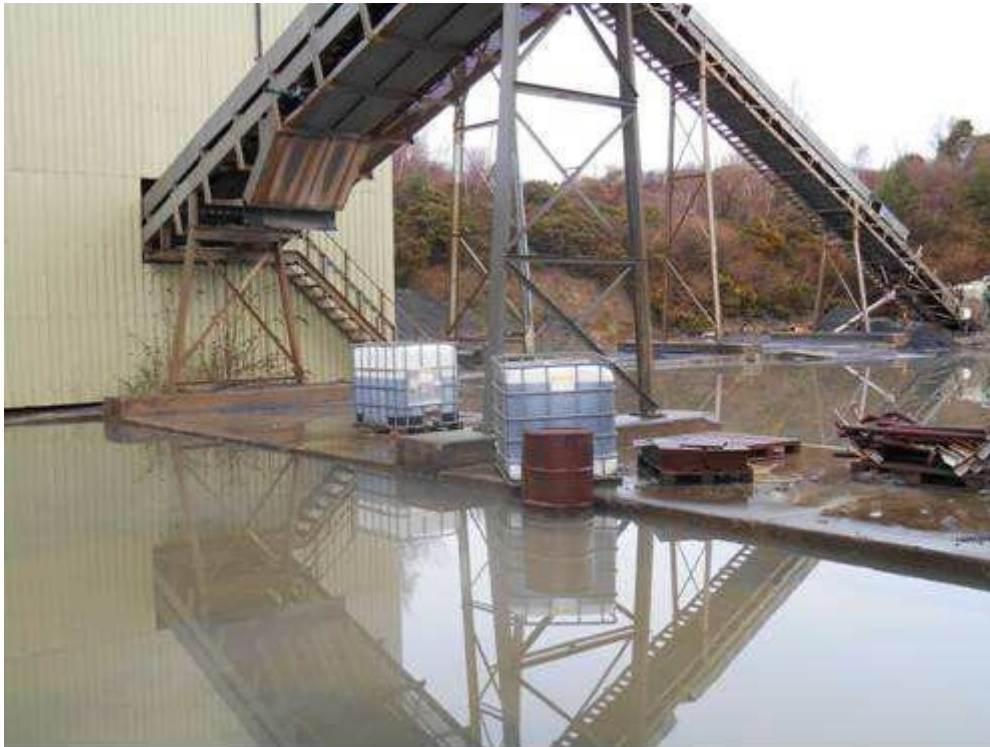
A large number of unbanded IBCs and drums were noted on the site, see photos below. These should all be appropriately banded.

Figure 8 2 off unbunded IBCs by concrete plant

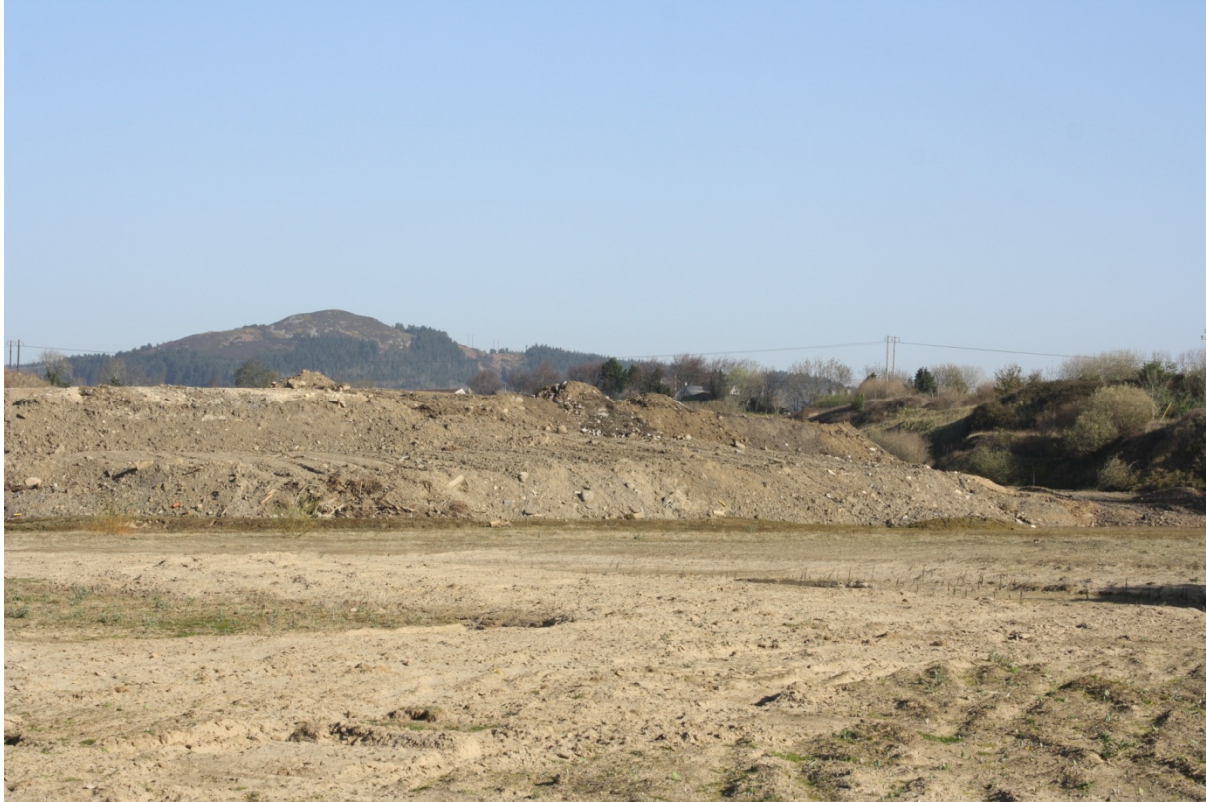
In general, the temporary slopes developed in backfilled material around the north-western corner of the former pit, estimated to vary from approximately 12m to 16m high and approximately 20° to 30°, were observed to be marginally stable. Photographs of the existing slopes in backfilled material are presented in Plates 1 and 2. The slopes comprise variable imported natural soils excavated at construction and utilities works sites. The soils principally comprise clayey glacial till, granitic sand and/or weathered granite rock. There were occasional inclusions of construction and demolition type waste within the natural soils, principally lumps of ready mixed concrete and fragments of blocks, bricks and ceramics.

The marginal stability of the backfilled slopes is only to be expected, given that they comprise imported material which has been end-tipped from HGV lorries and had not been spread or compacted by bulldozers or other earthmoving plant. That said, there was no evidence at the time of the site inspection of any recent or imminent instability across the temporary backfilled slopes such as development of tension cracks behind the crest, toe bulging, near-vertical backscarps etc.

Plate 1 : Global View of Slope in Backfilled Material in NW Corner of Former Pit

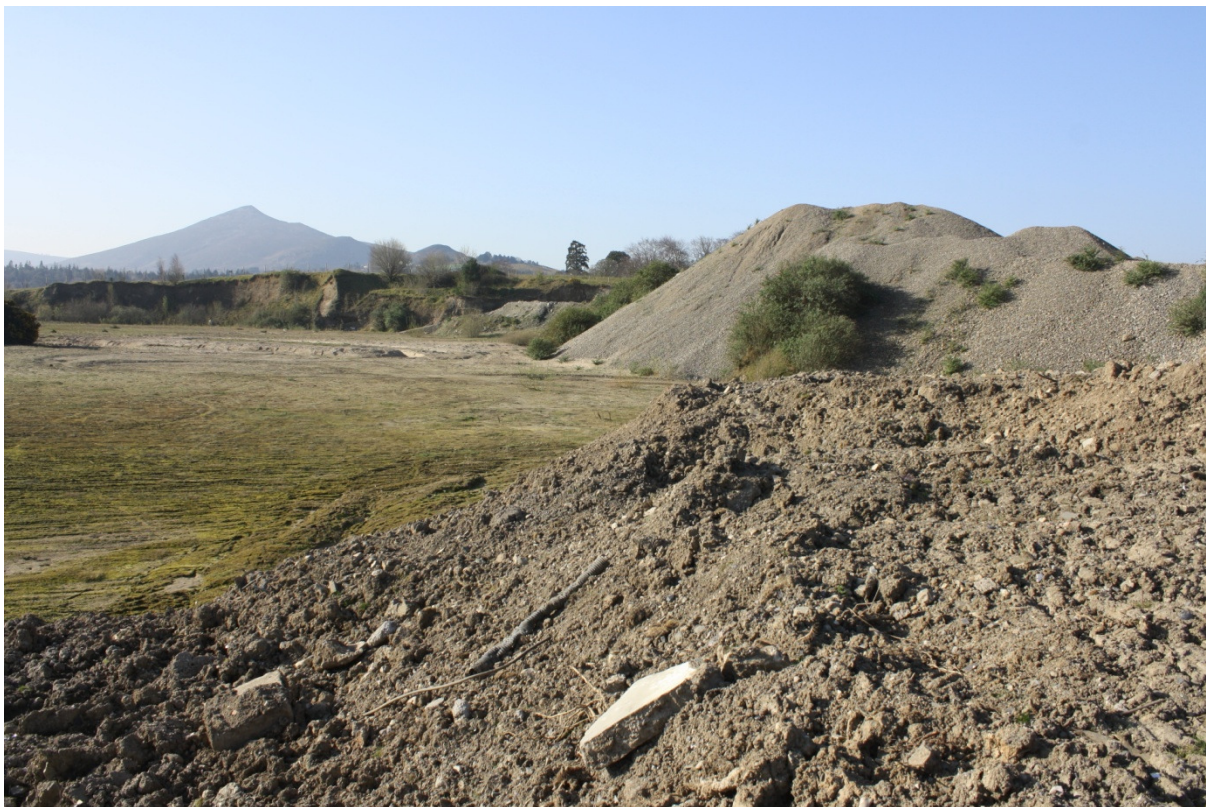
Plate 2 : View Southwards across Existing Backfilled Slope

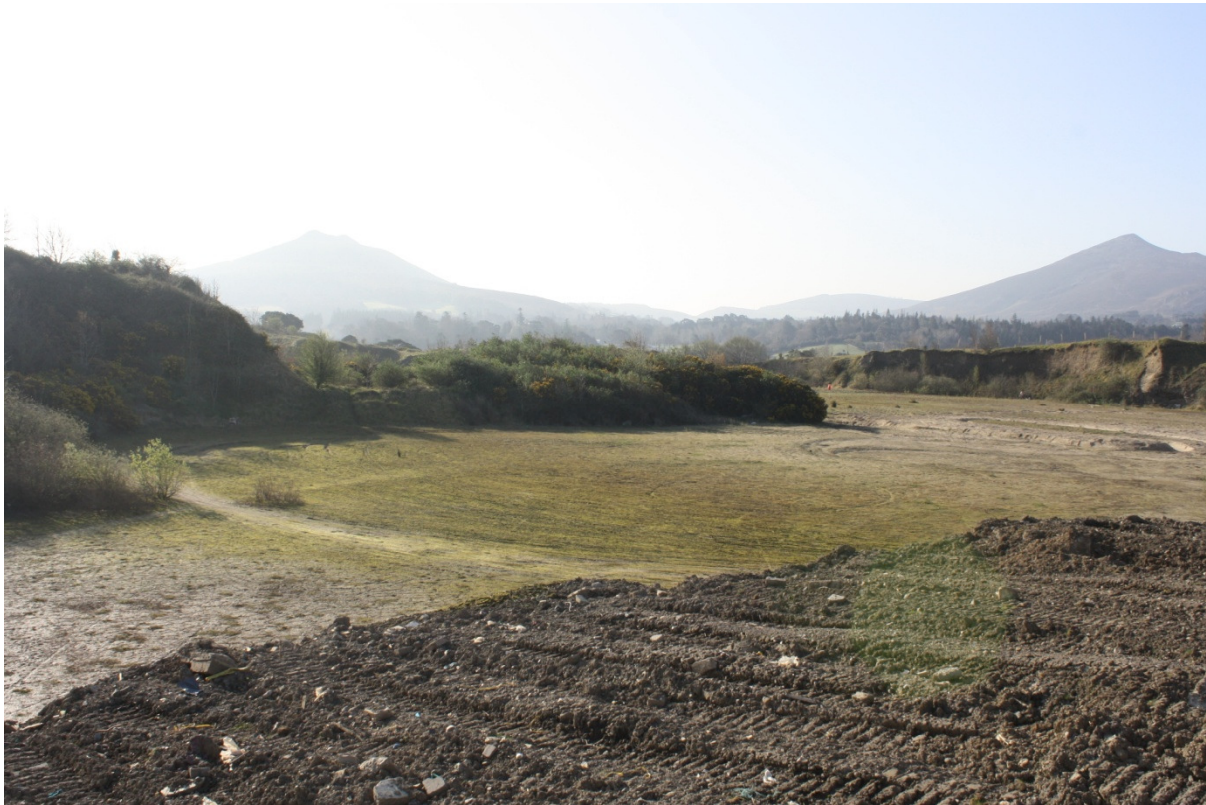
Plate 3 : View of Eastern and Southern Slopes of Former Pit from NW Corner

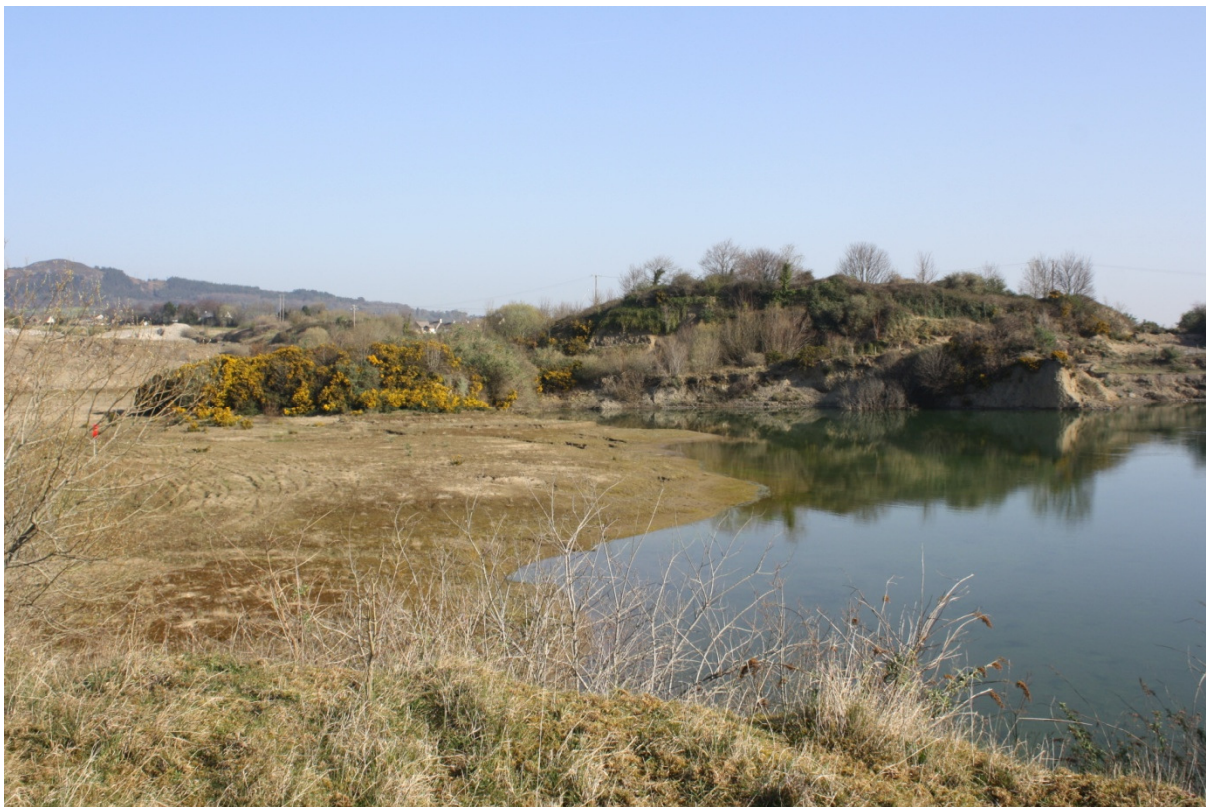
There does not appear to be any evidence of large scale (global) slope failure around the bare side slopes, rather it would appear that they are experiencing gradual regression, erosion and re-grading under both gravitational and climatic influences. No tension cracking or other sign of imminent instability was identified upslope or behind the crest of the steeper side slopes. The side slopes were generally dry, with no evidence of groundwater seepage, other than locally east of the descent ramp in the south-western corner of the former pit. It was also observed that

Taken together these observations indicate that the existing steep perimeter side slopes are relatively stable, albeit they are likely to be experiencing ongoing small scale spalling and erosion. This assessment concurs with experience and observations of Roadstone Wood's local site management.

Plate 4 : View of Both Vegetated and Bare Perimeter Side Slopes in SE Corner of Former Pit

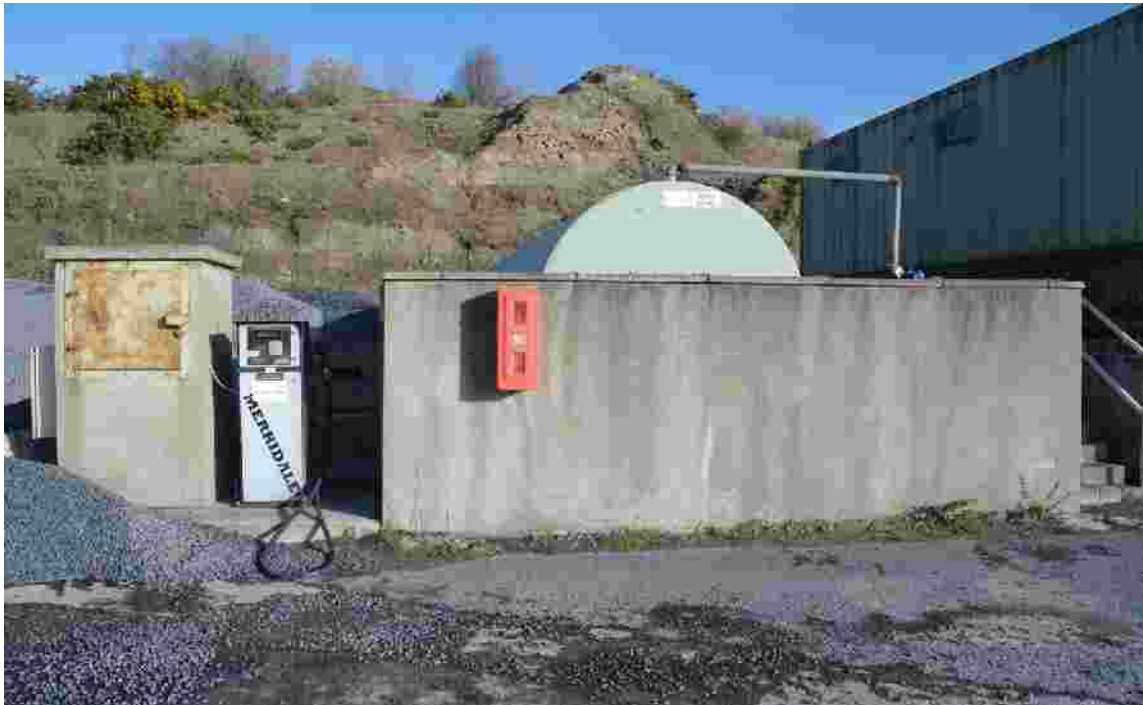
Photo 1 - Bunded 70,000 litre Diesel Tank

The severity of a 70,000 litre diesel spill to the gravel aquifer at the site is considered ‘very high’ as the clean-up costs could run to more than €100,000.

The 70,000 litre diesel tank is stored within a large concrete bund that is designed to contain more than the full volume of the tank. This provides mitigation against a major diesel spill at the site. An integrity test carried out in August 2011 showed that the bund is in very good condition and has capacity greater than 110% the capacity of the diesel tank.

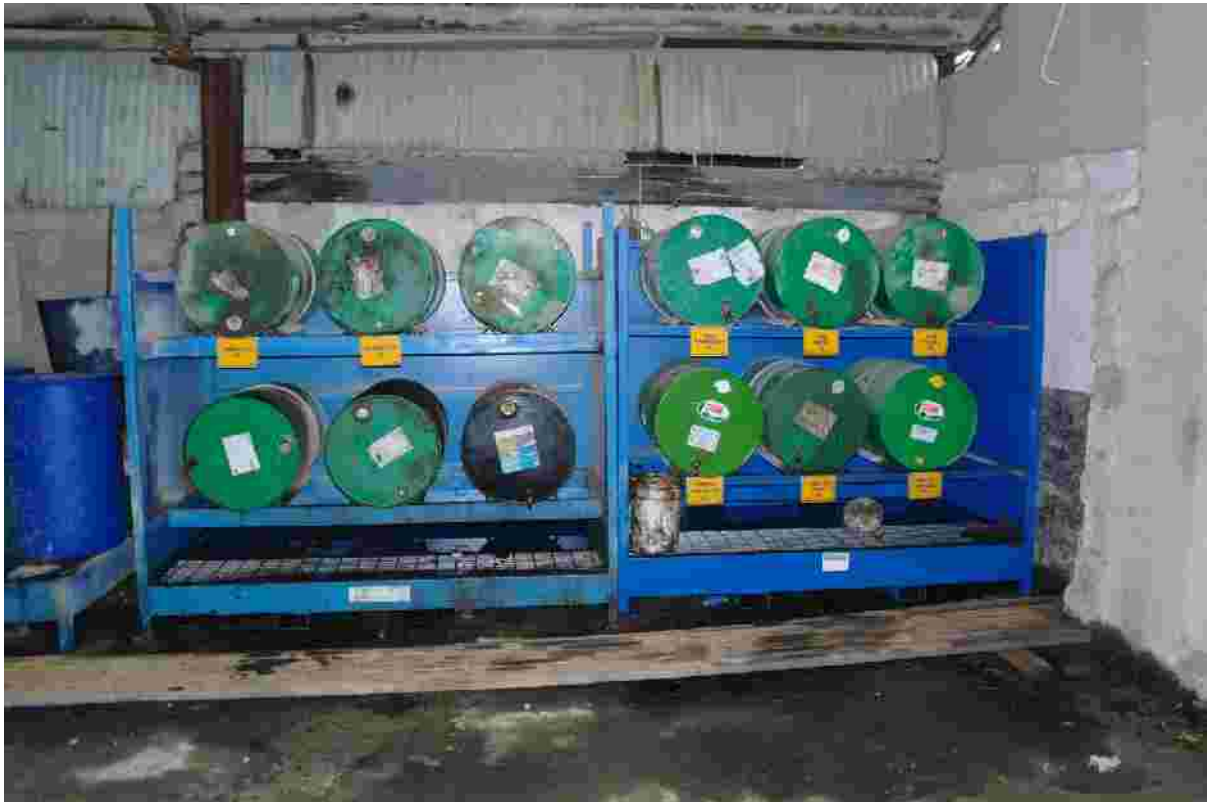
Photo 2 – Bunded Oil Drums in Maintenance Shed

The gas-oil, hydraulic oils, engine oils, transmission oils, waste oils, etc. are currently stored within bunded areas in the maintenance shed. The operator must maintain adequate capacity in these bunds for them to be effective.

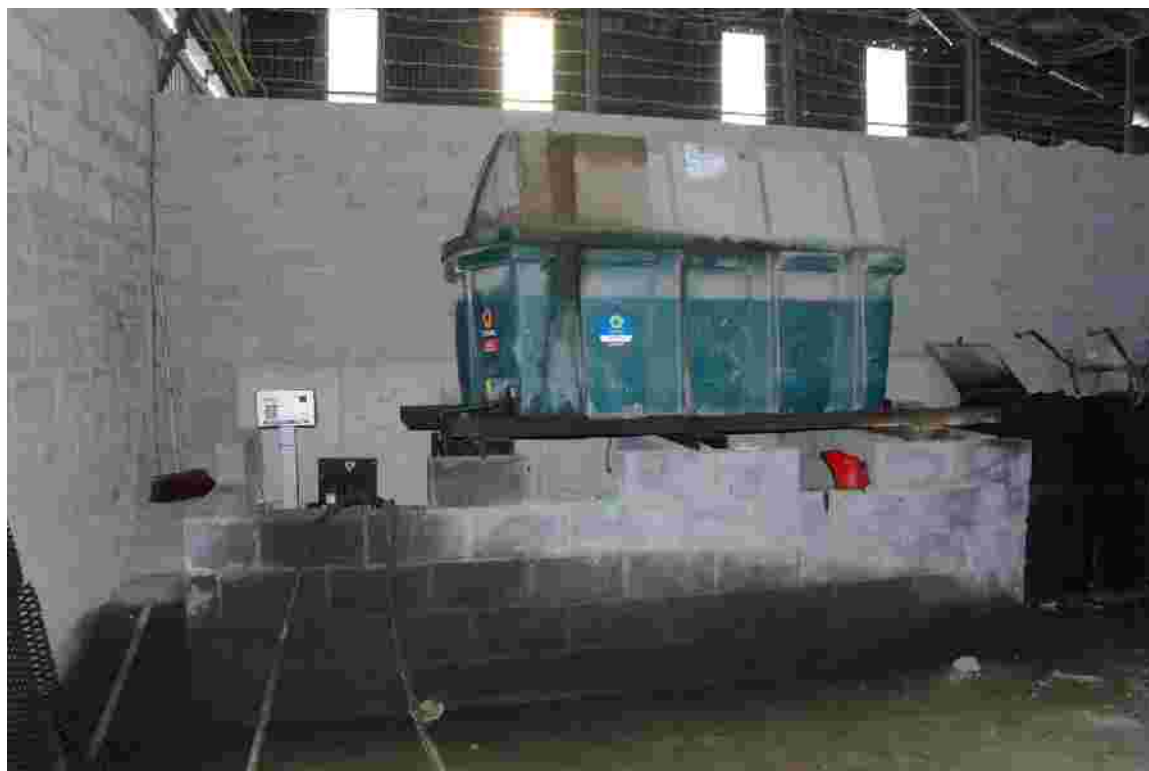
The 2,500 litre gas-oil tank consists of a self-bunded tank that is supported by the walls of a block-work bund (See Photo 3 below). There is a risk that a vehicle colliding with the bund wall would cause the tank to topple outside the bund and spill on the floor of the maintenance shed. The risk of such an occurrence is considered ‘high’.

Photo 3 – Bunded Gas Oil (Diesel) Tank in Maintenance Shed

A spill of up to 2,500 litres of gas oil (diesel) in the maintenance shed would be directed to the adjacent yard area. This is an unpaved yard, so we expect a spill of this size to percolate to ground rather than drain to the downgradient site pond, located approximately 200 metres away. The severity of such an event is considered ‘medium’ with clean-up costs between €10,000 and €50,000.

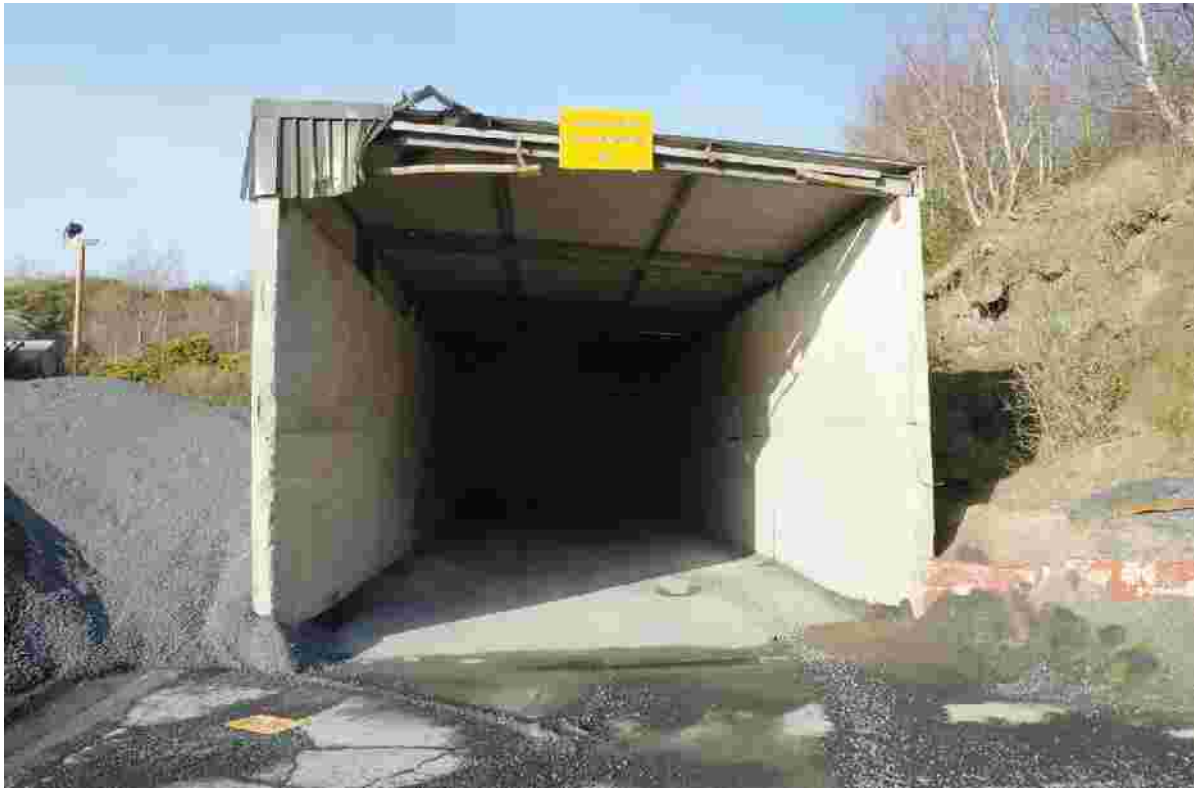
Photo 4 – Quarantine and Contamination Bay

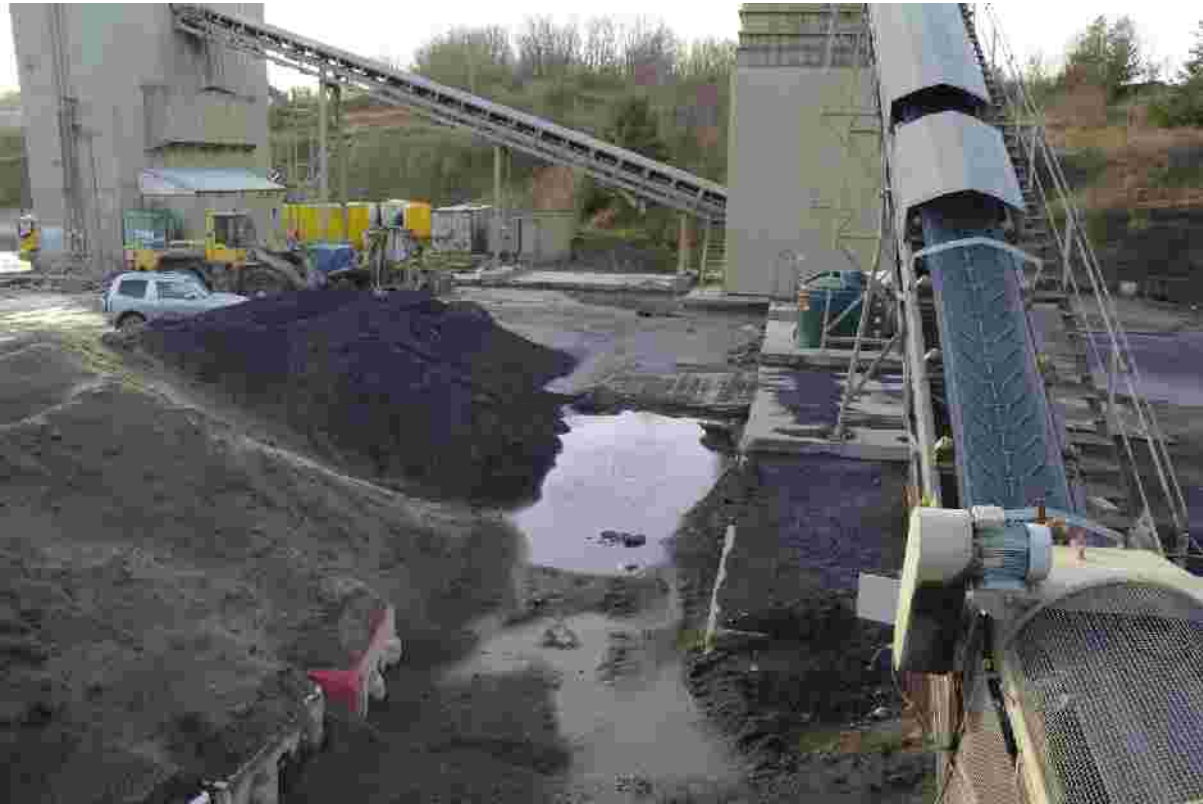
Photo 5 – Yard Drainage Impeded by Concrete Platform

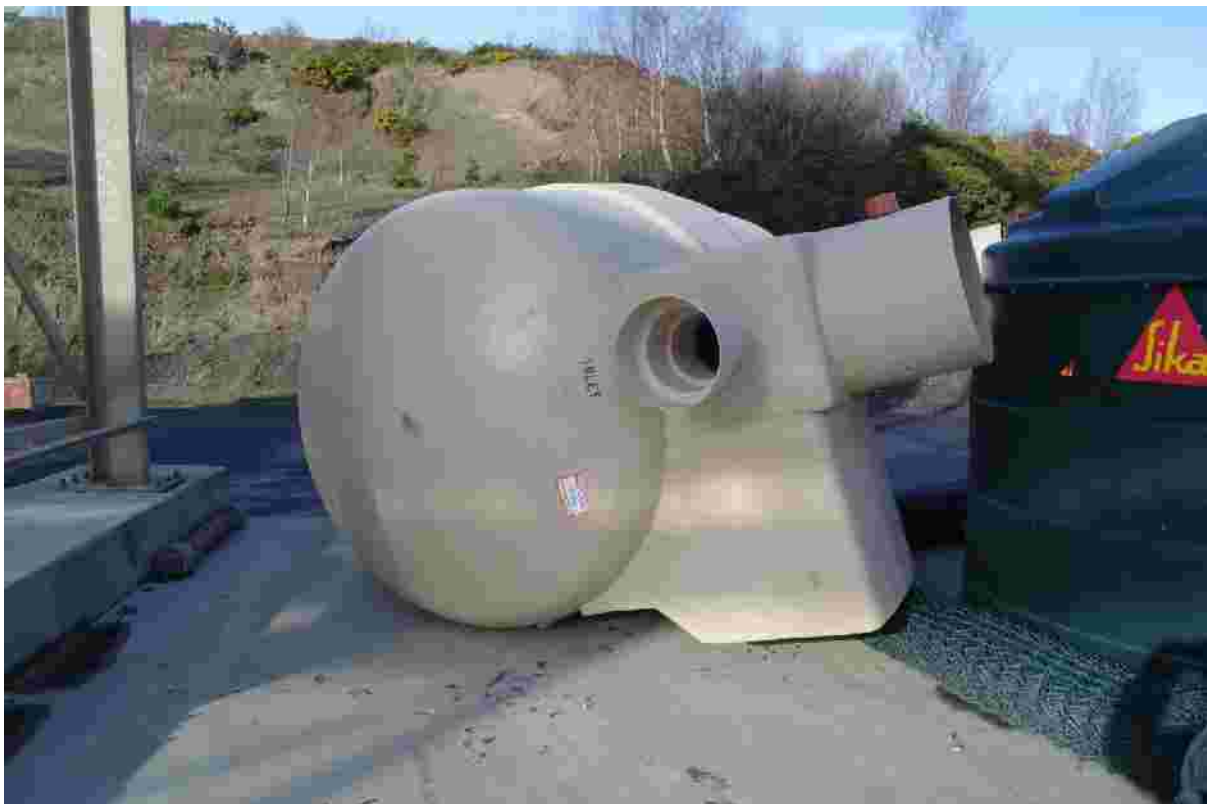
Photo 6 – Hydrocarbon Interceptor Awaiting Installation
