Annual Environmental Report (AER),  
Site 402, Greenogue Business Park.

January 1<sup>st</sup> – December 31<sup>st</sup> 2013

**Annual Environmental Report**

**Rilta Environmental Ltd.  
Site 402 – Environmental Monitoring**

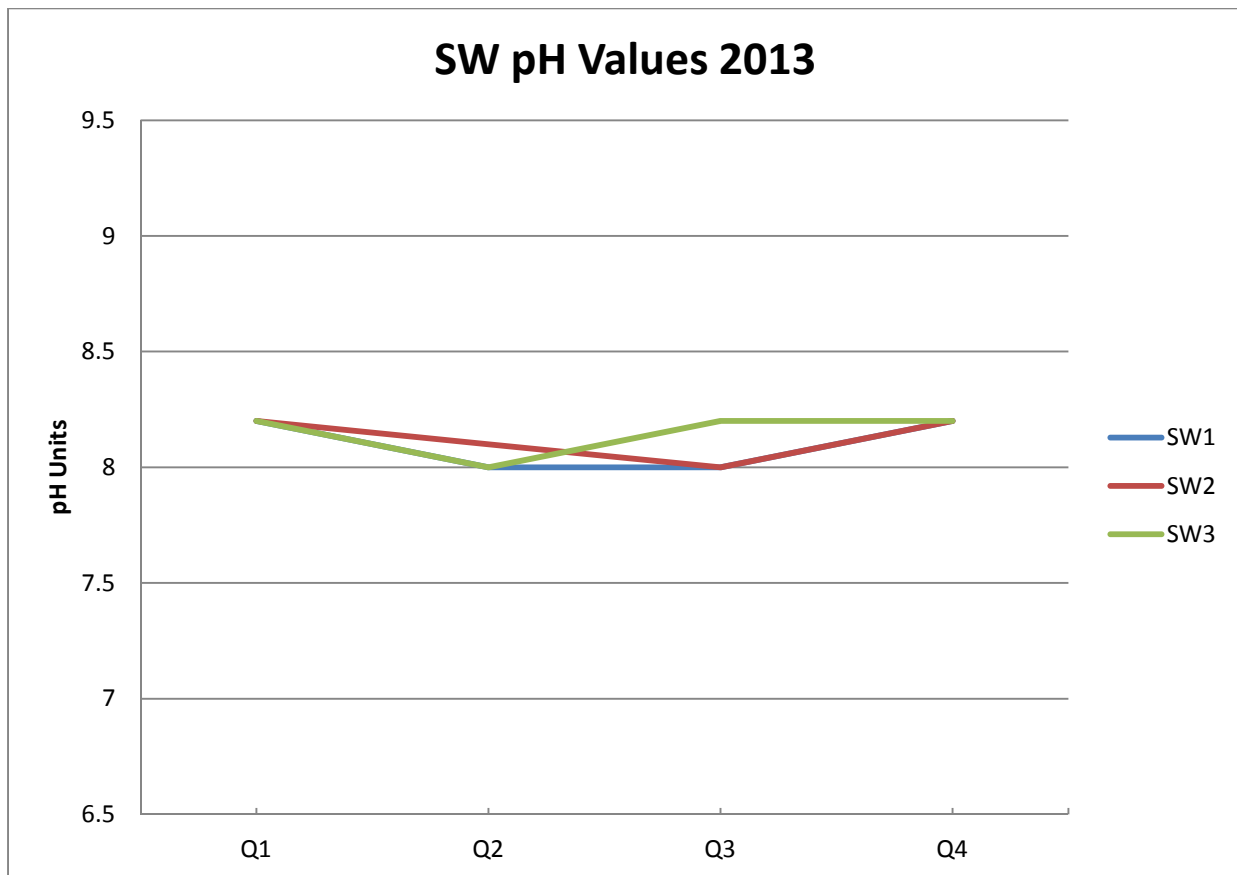
**Figure 2.1 Surface Water pH Results - 2013**

**pH:** The pH values at all surface water monitoring locations were within the normal range in 2013 ( $6.5 \geq \text{pH} \leq 9.5$ ) set out in SI No. 278 of 2007<sup>3</sup> and reflect the natural conditions of this surface water feature.

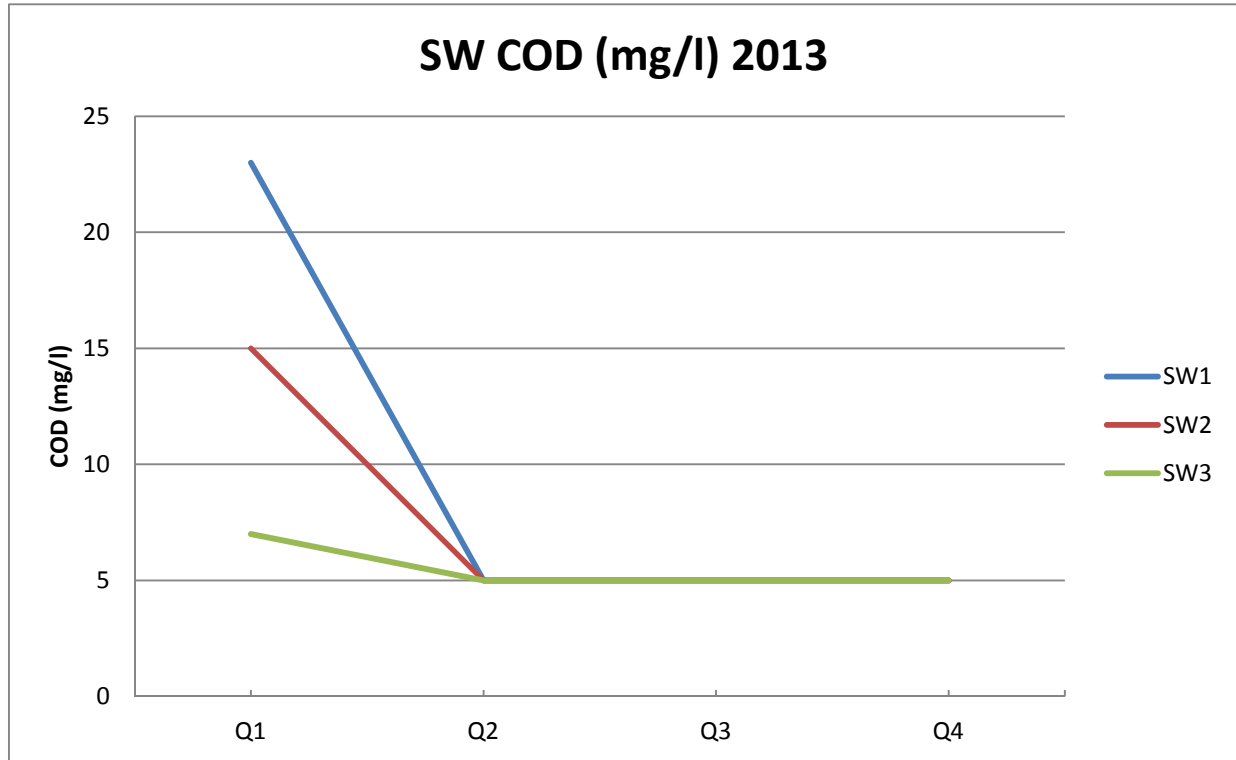
Figure 2.2 Surface Water COD Results - 2013

**Chemical Oxygen Demand:** The chemical oxygen demand at all monitoring locations was consistent with historic monitoring results from the site. Concentrations were slightly elevated in Q1 with peak concentrations of 23mg/l, 15mg/l and 7mg/l at SW1, SW2 and SW3, respectively. There is no limit for surface water COD set out in waste licence 192-03 or SI No. 278 of 2007m. COD results from 2013 are summarised in Table 2.2 below.

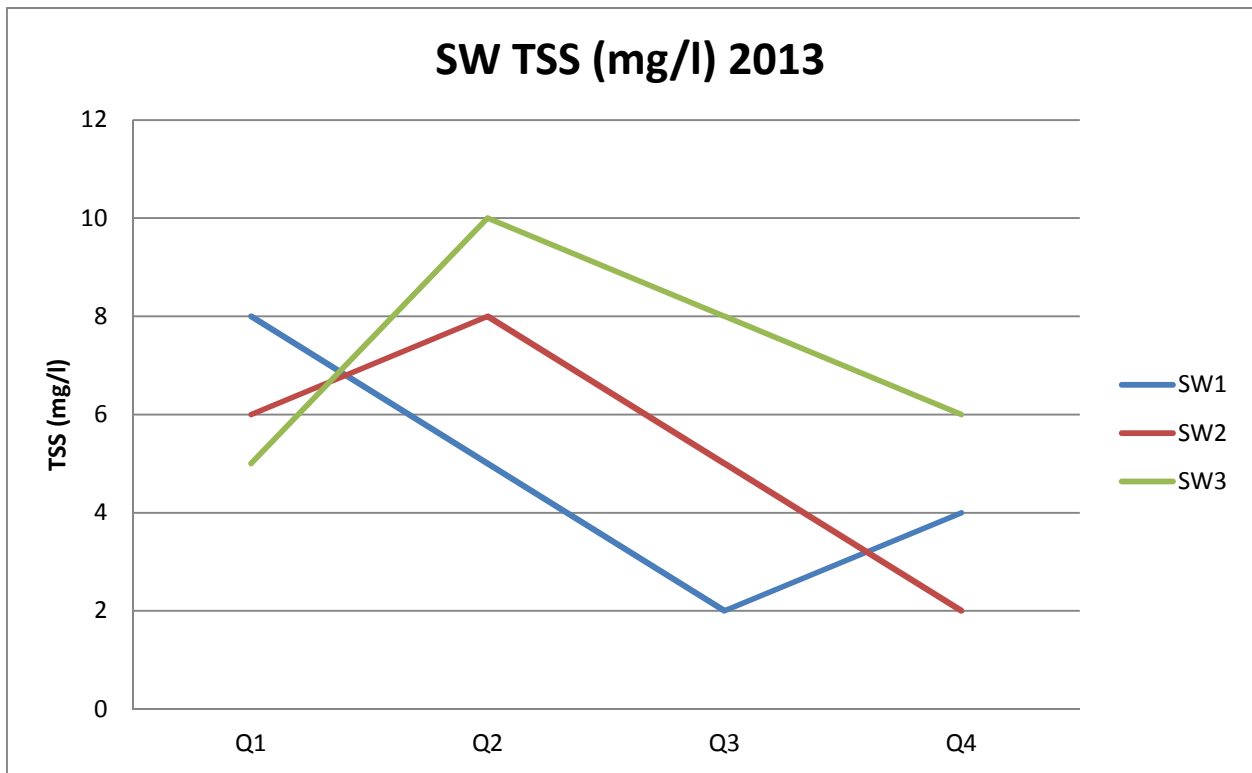
Figure 2.3 Surface Water Total Suspended Solids Results - 2013

**Suspended Solids:** The concentrations of suspended solids at all surface water monitoring locations were below the limit levels set out in waste licence 192-03 (35mg/l) for all monitoring events during 2013.

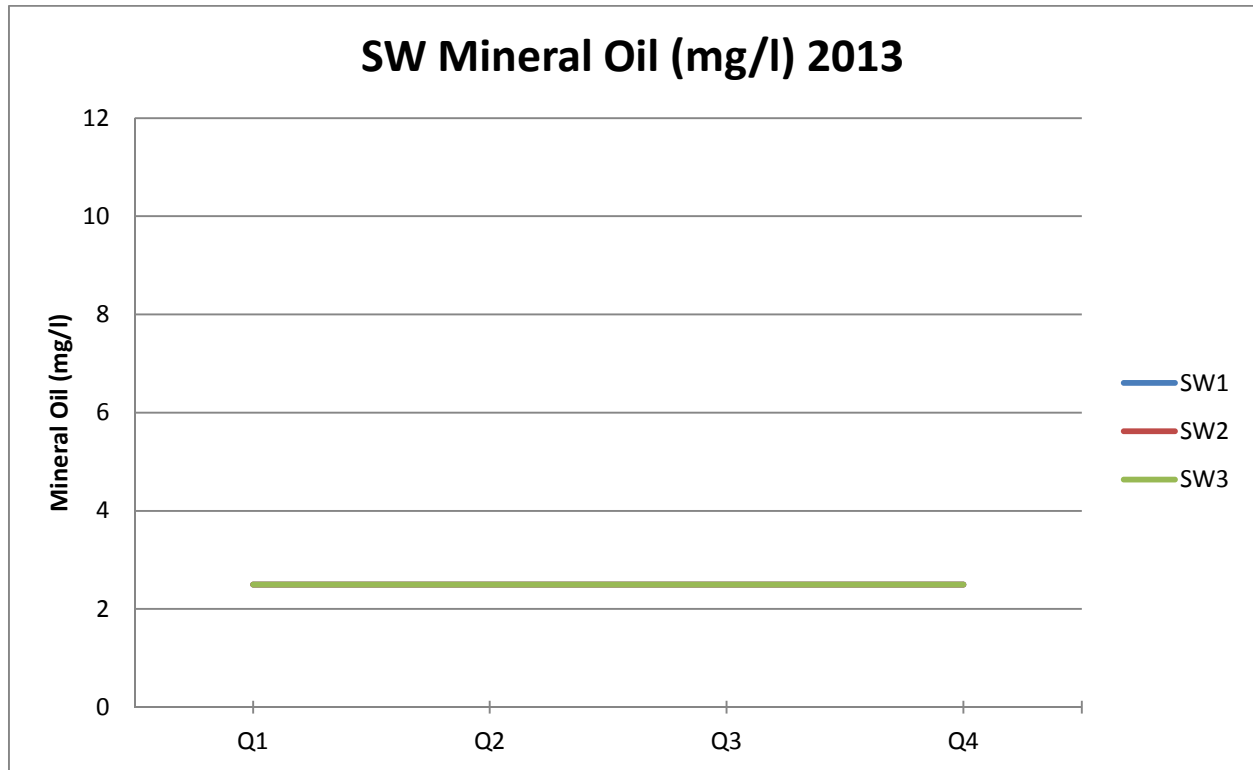
**Figure 2.4 Surface Water Mineral Oil Results – 2013**

**Mineral Oils:** Concentrations of Mineral Oil were below the laboratory detection limit (<2.5µg/l) during all monitoring events during 2013.

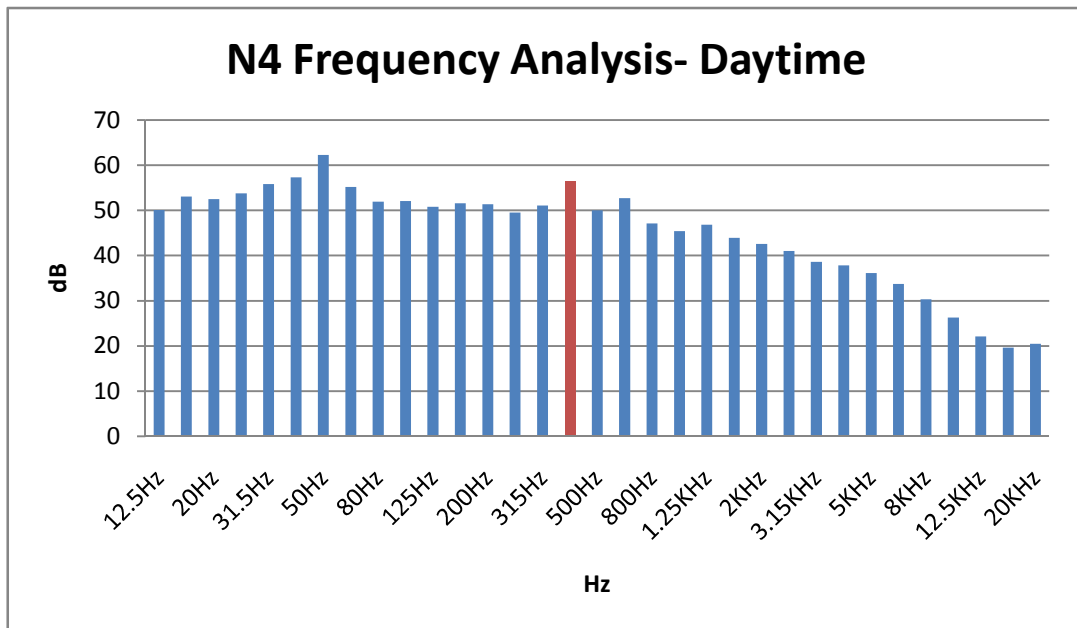
Figure 7 N4 Daytime Frequency Analysis

A tone was also observed at location N4 at 400Hz during the daytime survey, a 5dB(A) penalty has therefore been applied to this location bringing the Leq to 62.8dB(A).

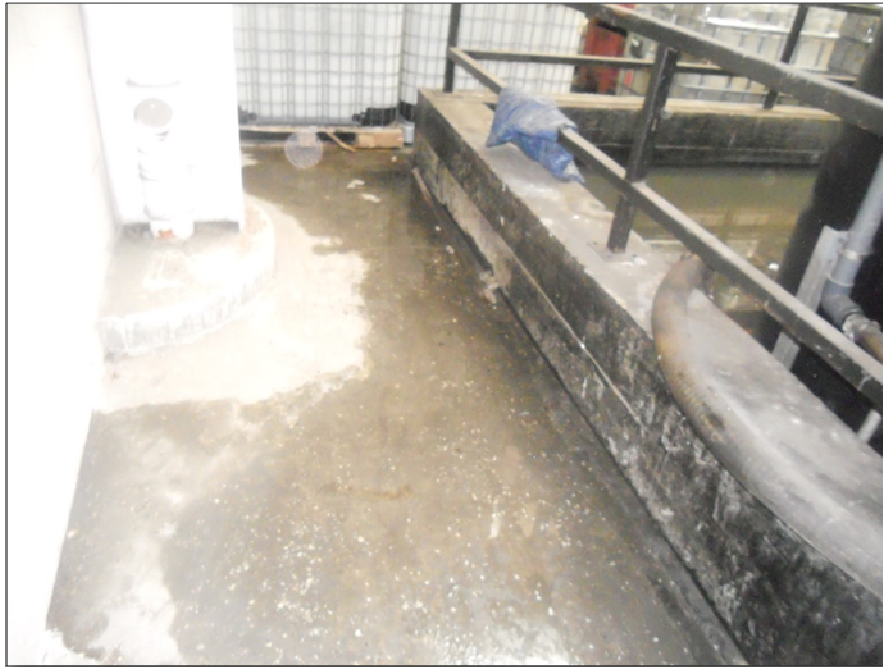
Upon visual assessment of this Bund some leakage was observed at the south western corner of the bund. It is recommended that a structural survey is undertaken and that any remedial works required to repair any faults in the bund are completed. See Photo No. 1 below for location of the suspected fault in the bund.

**Photo 1: Suspected fault in Area / Bund No. 9**

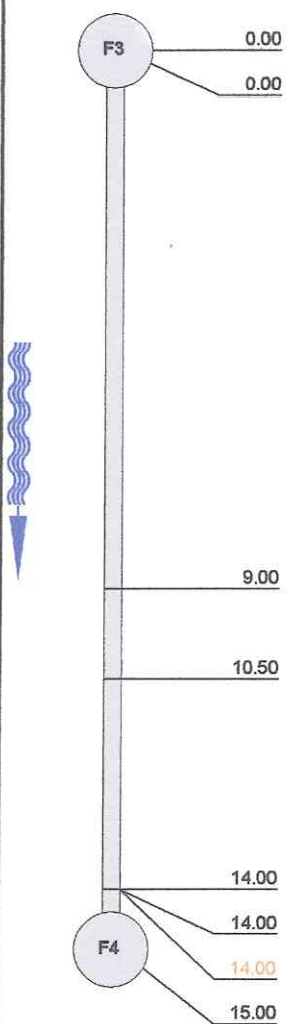
1:125	position	code	observation	photo	grade
		ST	Start of Survey		0
	0.00	WL	Water level, 5 % height/diameter		0
	0.00				
	9.00	WL	Water level, 20 % height/diameter		0
	10.50	WL	Water level, 40 % height/diameter		0
	14.00	WL	Water level, 50 % height/diameter		0
	14.00	CU	Camera Underwater		0
	14.00	GO	General Observation:BAD FALL BETWEEN F4 AND F10 IS BACKING UP THE WATER		3
	15.00	MH	Manhole Remark: F4		0

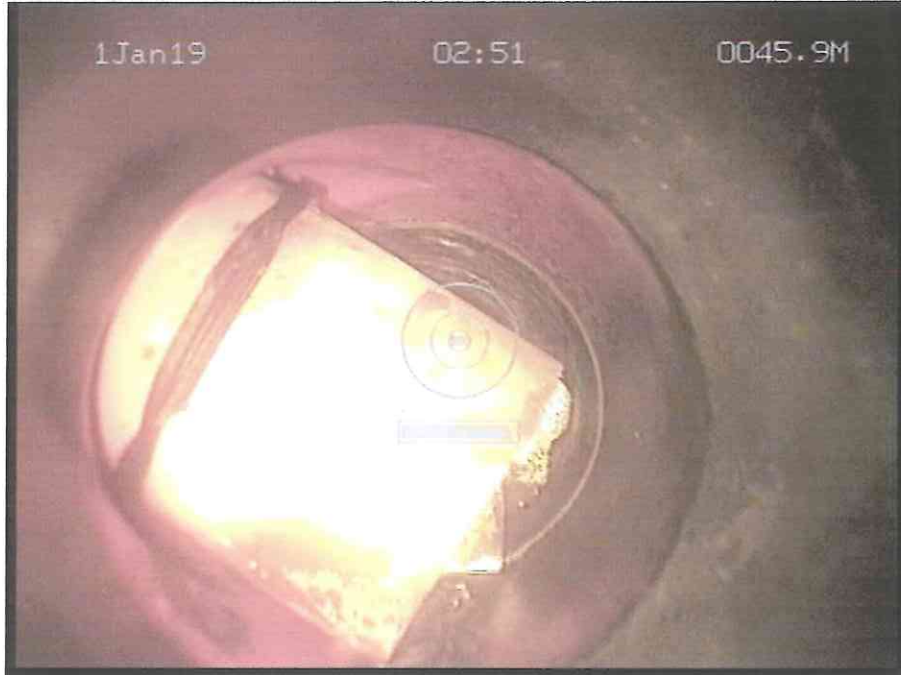
Photo: 14\_5a  
46.2m, Connection defective, at 10 o'clock, dia 125 mm, intrusion  
200 mm

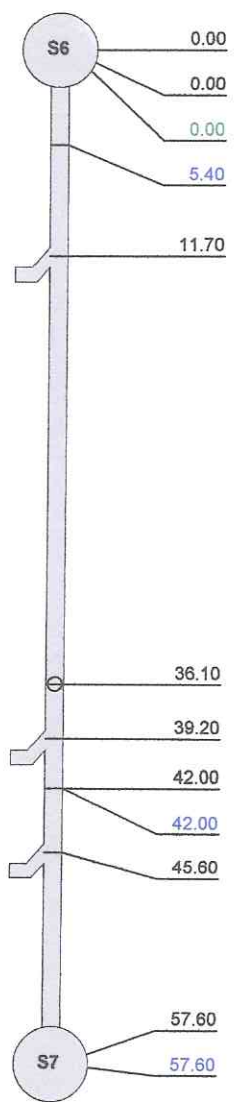
1:425	position	code	observation	photo	grade
	0.00	ST	Start of Survey		0
	0.00	WL	Water level, 5 % height/diameter		0
	0.00	DES	Debris silt, 10 % cross-sectional area loss		1
	5.40	D	Sewer Deformed, 10 %		2
	11.70	CN	Connection, at 03 o'clock, dia 125 mm		0
	36.10	CN	Connection, at 11 o'clock, dia 125 mm		0
	39.20	CN	Connection, at 02 o'clock, dia 125 mm		0
	42.00	WL	Water level, 20 % height/diameter		0
	42.00	GO	General Observation, Remark: PIPE SLIGHTLY DEPRESSED - HOLDING		2
	45.60	CN	Connection, at 03 o'clock, dia 125 mm		0
	57.60	MH	Manhole Remark: S7		0
	57.60	GO	General Observation: MANHOLE BURIED WITHOUT ACCESS		2

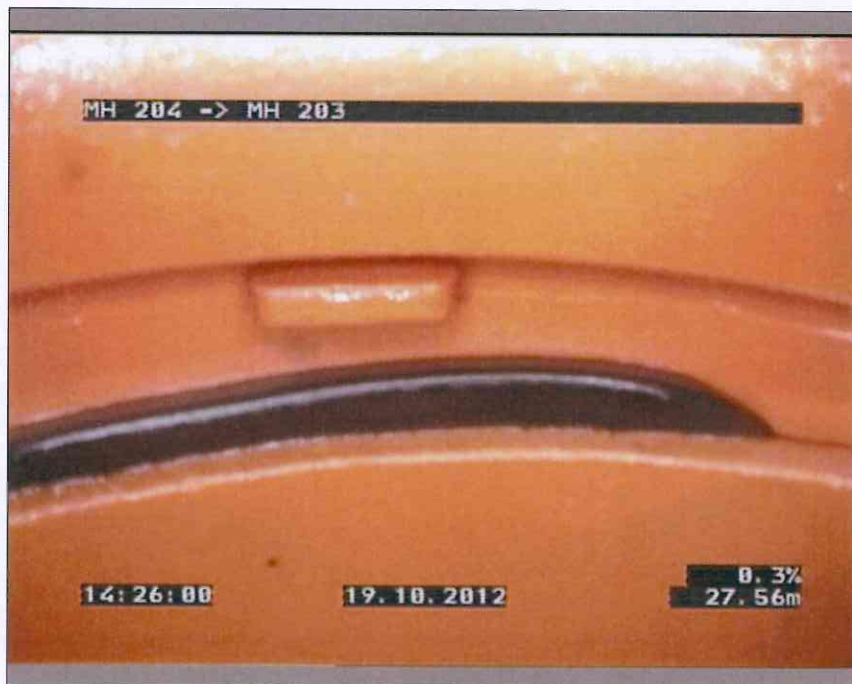
Photo: 1\_4A, MPEG #: 311013\_1, 00:06:31  
 27.49m, Open joint, medium (between 1.0 and 1.5 times the pipe wall thickness)

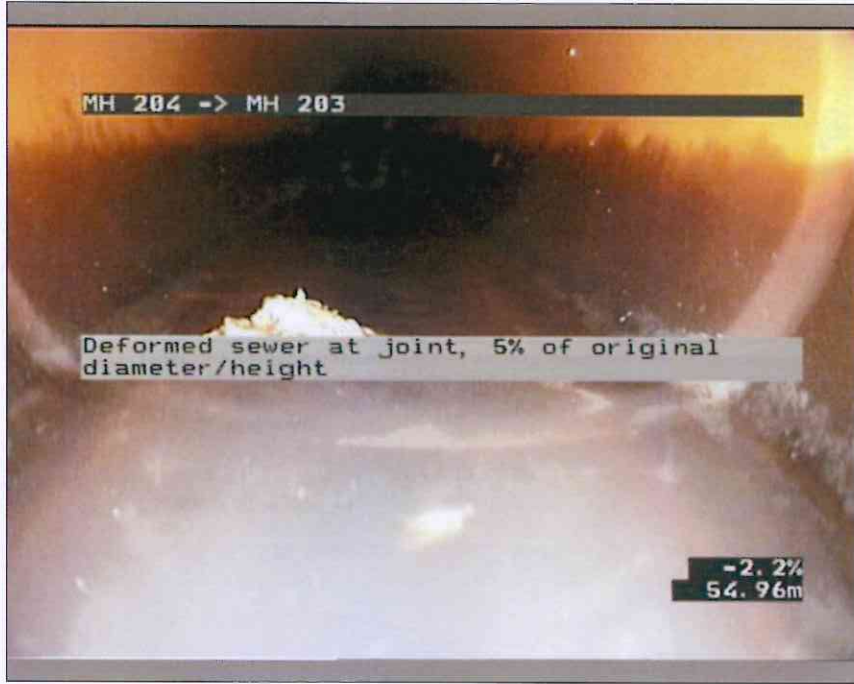
Photo: 1\_5A, MPEG #: 311013\_1, 00:14:48  
54.96m, Deformed sewer, 5% of original diameter/height
