Annual Environmental Report

CHURCHTOWN LANDFILL SITE
(Waste Licence Ref. W0062-1)

by
Donegal County Council
for
Environmental Protection Agency

Reporting Period: January to December 2013

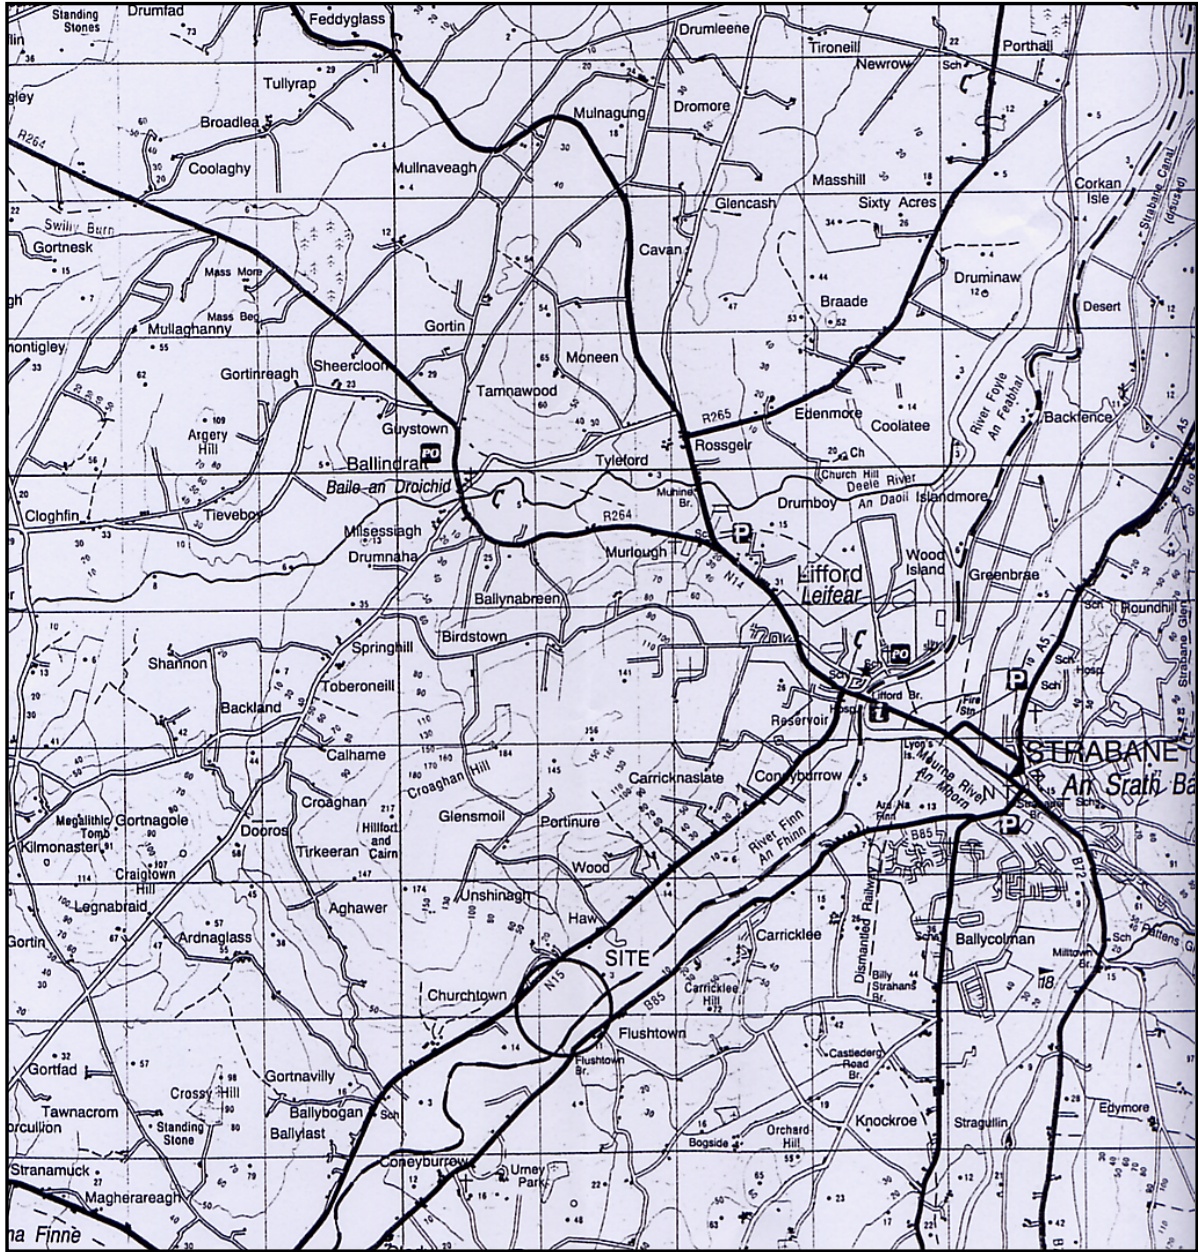
PLOT SCALE 1:50,000	DRAWN DATE 21 OCT 2004	PMcM	CHECKED DATE 21 OCT 2004	DJD	APPROVED DATE 21 OCT 2004	DJD	DWG No. 5234.63/100
---------------------	------------------------	------	--------------------------	-----	---------------------------	-----	---------------------

- 1.1 Donegal County Council holds Waste Licence ref. W0062-1 for Churchtown Landfill Site. The site closed on 31st August 2000. This report provides a review of environmental monitoring data collected for 2013.
- 1.2 The landfill facility at Churchtown occupies an area of approximately 9.7 hectares in the townland of Churchtown, near Lifford, Co. Donegal.
- 1.3 The site is located approximately 3km south west of Lifford and bordered to the northwest by the N15, the main Lifford to Ballybofey Rd. The ground to the northeast and southwest of the site is the low lying and gently undulating flood plain of the River Finn both areas being used for grazing. The southeastern boundary is formed by the River Finn. Site Location and Layout are shown on plans BL568640/100 and BL568640/106.

TITLE SITE LOCATION PLAN

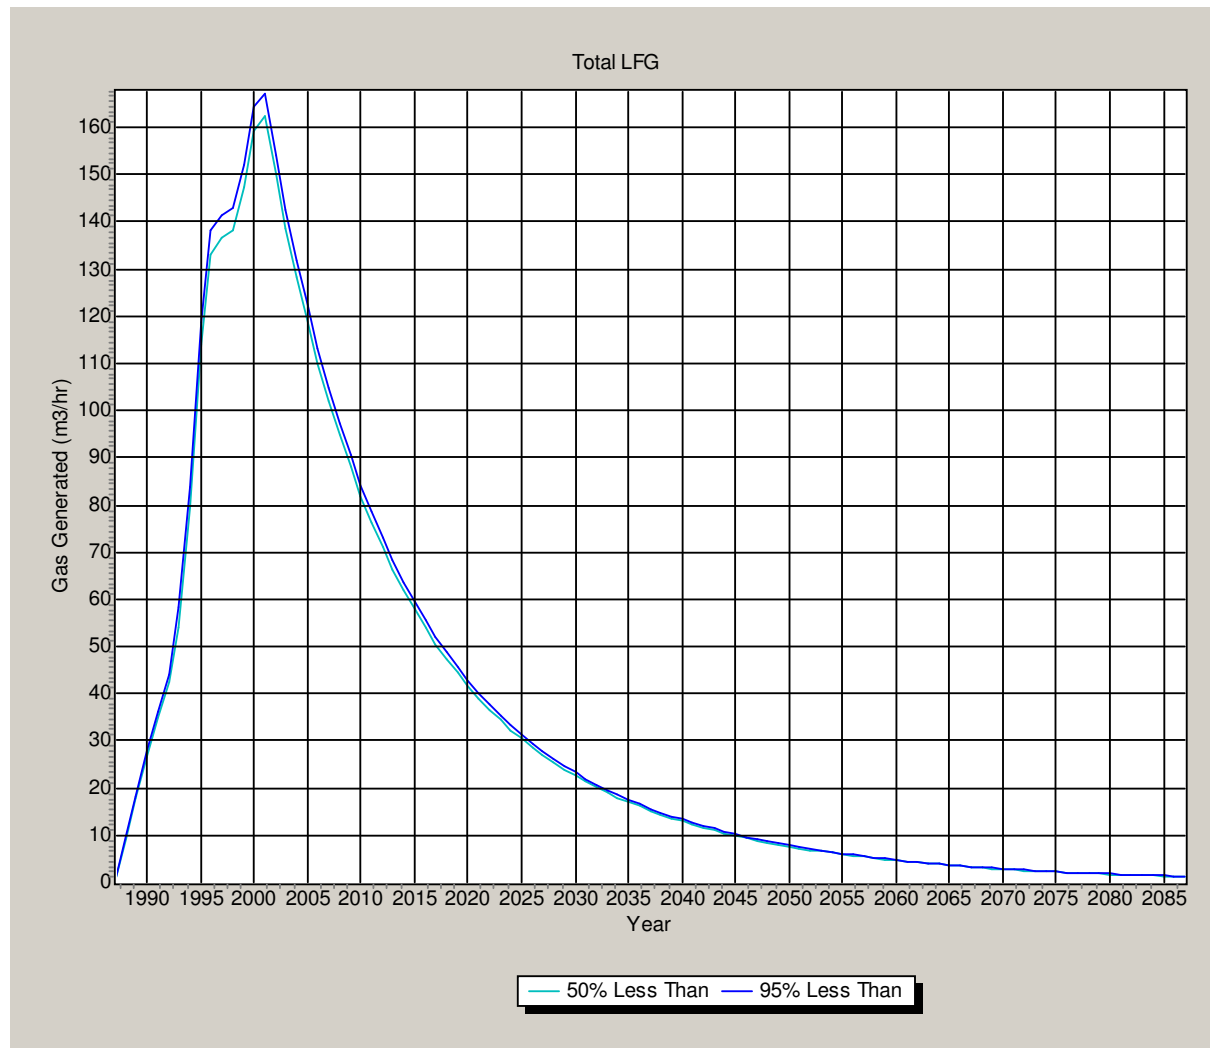
Figure D.1 – Total Bulk Landfill Gas Produced 1987-2087

- 13.1 Gas emissions from the landfill were remodelled using gassim in 2005. The revised model results are summarised in Appendix D.
- 13.2 The revised estimate for total bulk landfill gas produced in 2013 is 580,438m³.
