## SECTION 5: SOILS & GEOLOGY

**APPENDIX 5.1**  
**Ground Investigation Report (January 2009)**

**ROADSTONE LTD.**  
WASTE LICENCE APPLICATION  
WASTE RECOVERY FACILITY,  
MILVERTON, SKERRIES, CO. DUBLIN

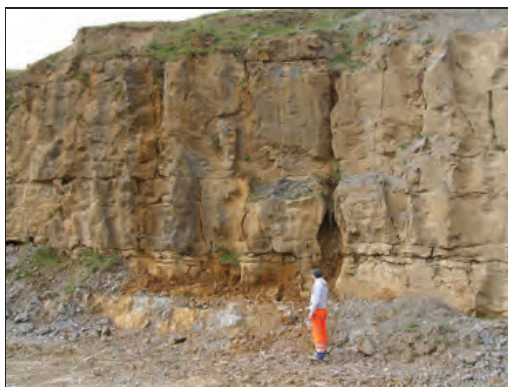
Left: This vertical feature, called a pipe, is the product of karst weathering. The pipe seen here is partially infilled with orange-brown clay. These features can only be seen along this particular section of the quarry.  
Right: A view from the south west corner of Milverton Quarry.

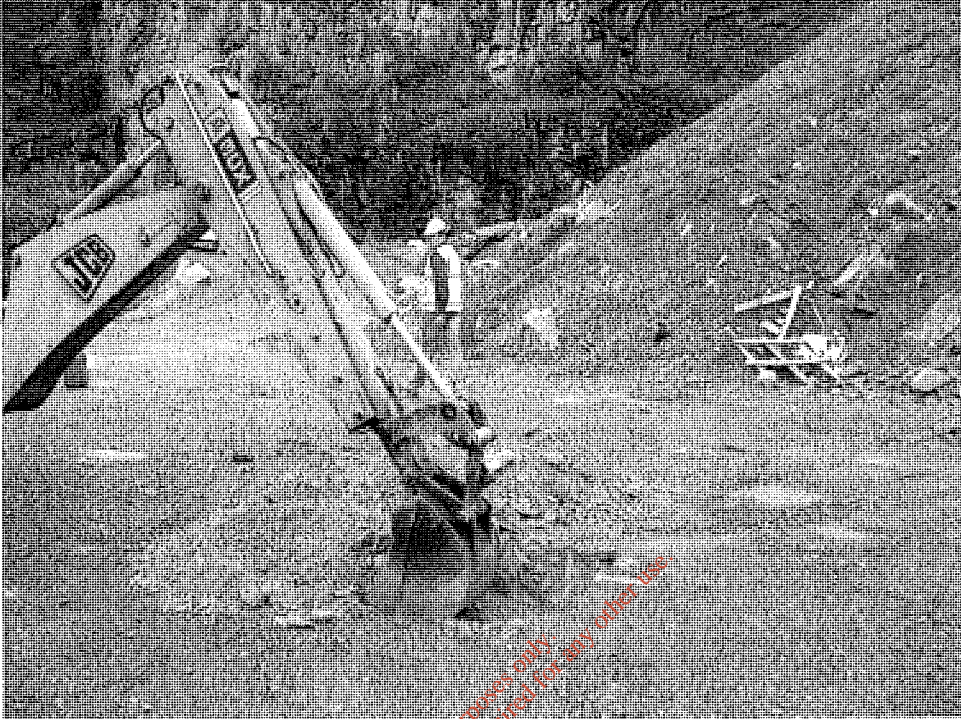
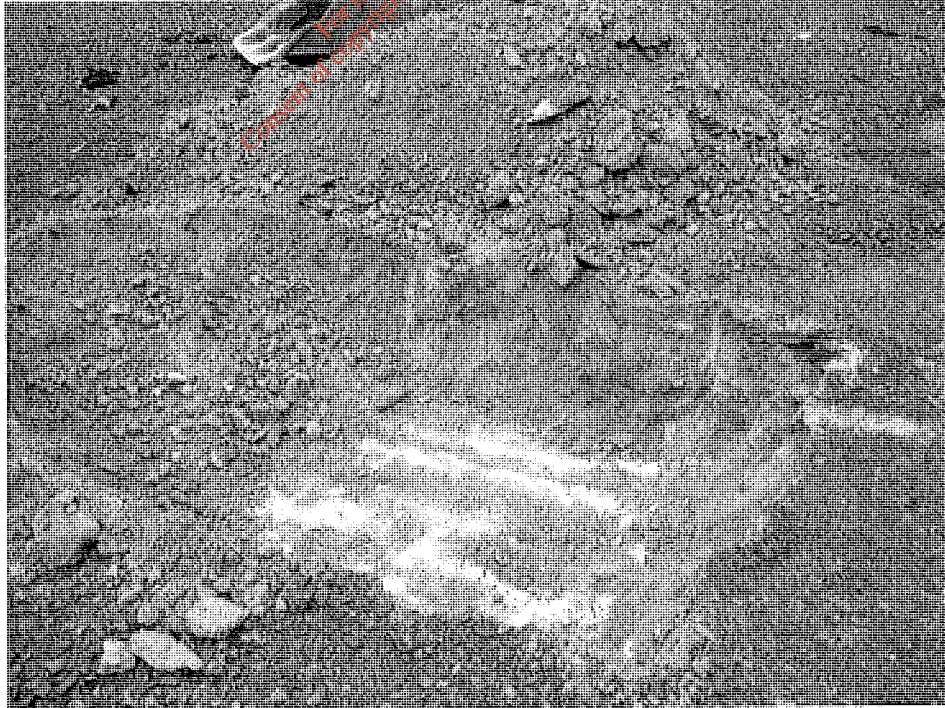
<p><b>Project Name:</b> Milverton Ground Investigation. <b>Location:</b> Milverton <b>Date:</b> December 2008</p>	<p><b>Trial Pit No.</b> <b>MTP2</b></p>

<p><b>Remarks:</b> Refer to Figure 2 for Trial Pit Locations.</p>	<p><b>MTP2</b></p>

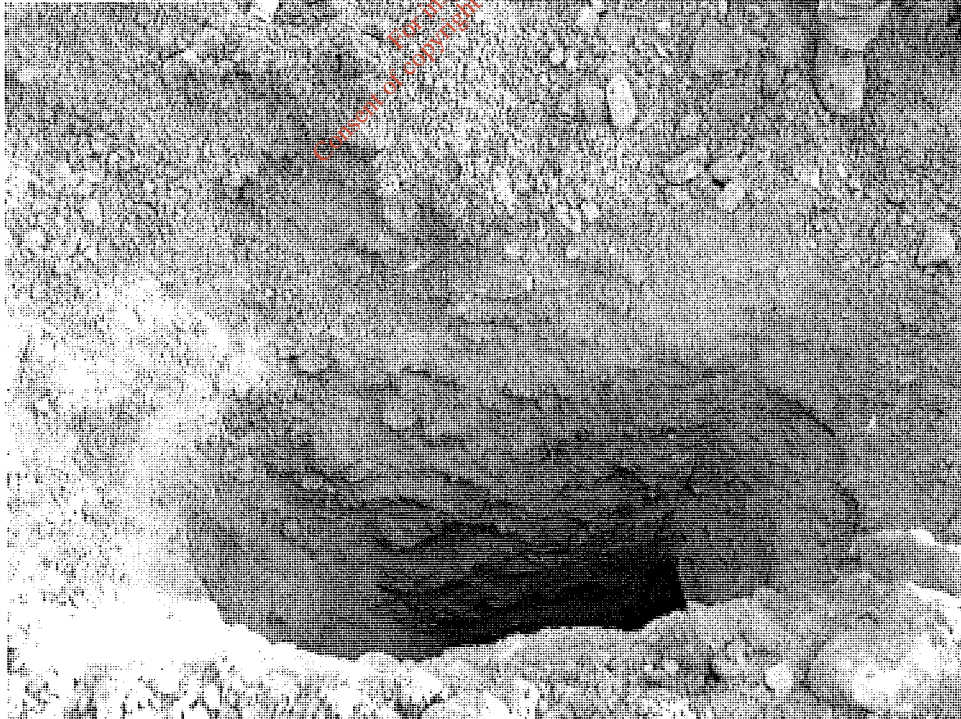
<p><b>Project Name:</b> Milverton Ground Investigation. <b>Location:</b> Milverton <b>Date:</b> December 2008</p>	<p>Trial Pit No. <b>MTP3</b></p>

<p><b>Remarks:</b> Refer to Figure 2 for Trial Pit Location</p>	<p><b>MTP3</b></p>

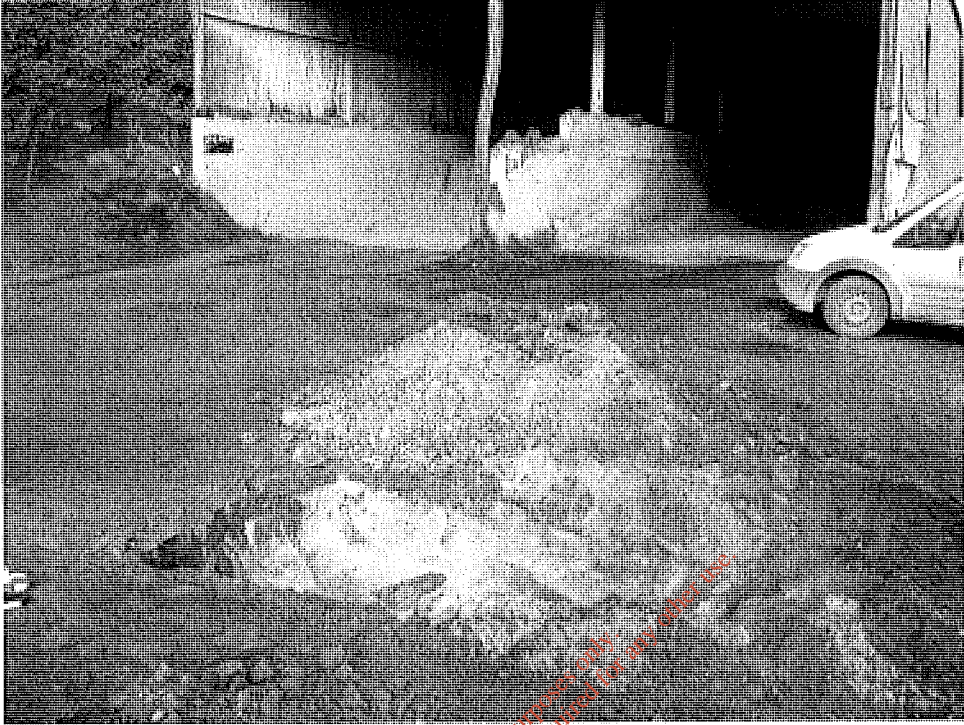
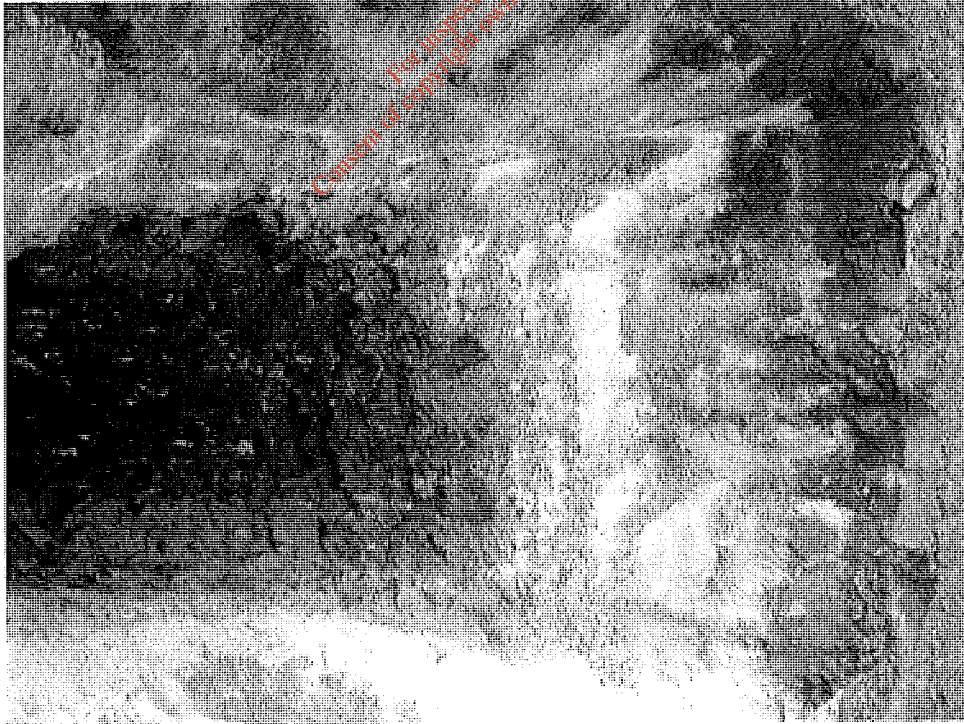
<p><b>Project Name:</b> Milverton Ground Investigation. <b>Location:</b> Milverton <b>Date:</b> December 2008</p>	<p>Trial Pit No. <b>MTP4</b></p>

<p><b>Remarks:</b> Refer to Figure 2 for Trial Pit Locations</p>	<p><b>MTP4</b></p>

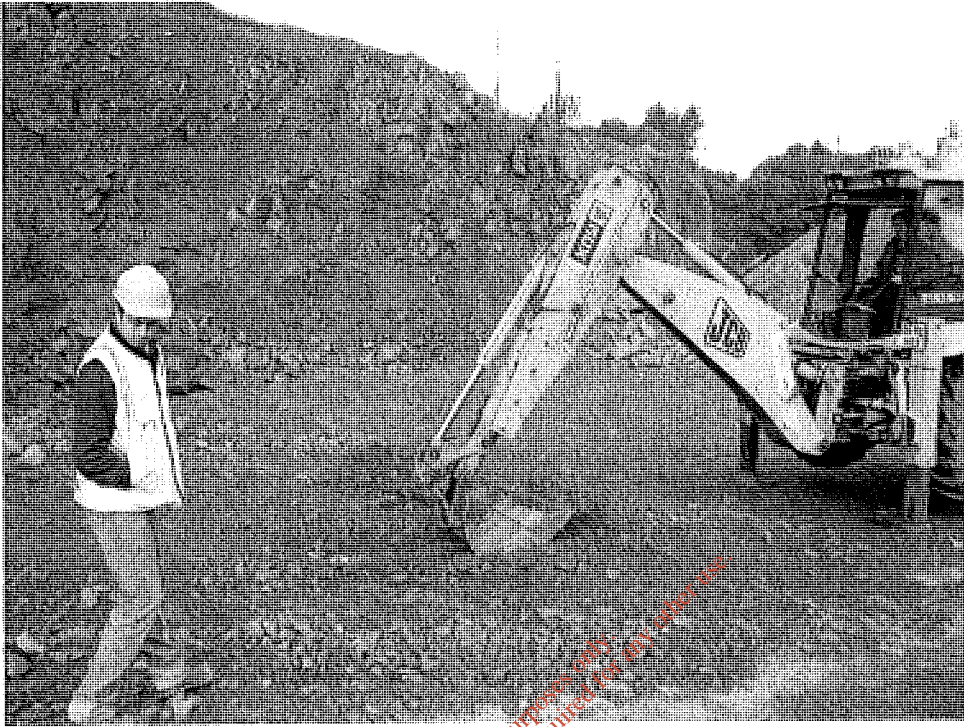
<p><b>Project Name:</b> Milverton Ground Investigation. <b>Location:</b> Milverton <b>Date:</b> December 2008</p>	<p>Trial Pit No. <b>MTP5</b></p>

<p><b>Remarks:</b> Refer to Figure 2 for Trial Pit Locations</p>	<p><b>MTP5</b></p>

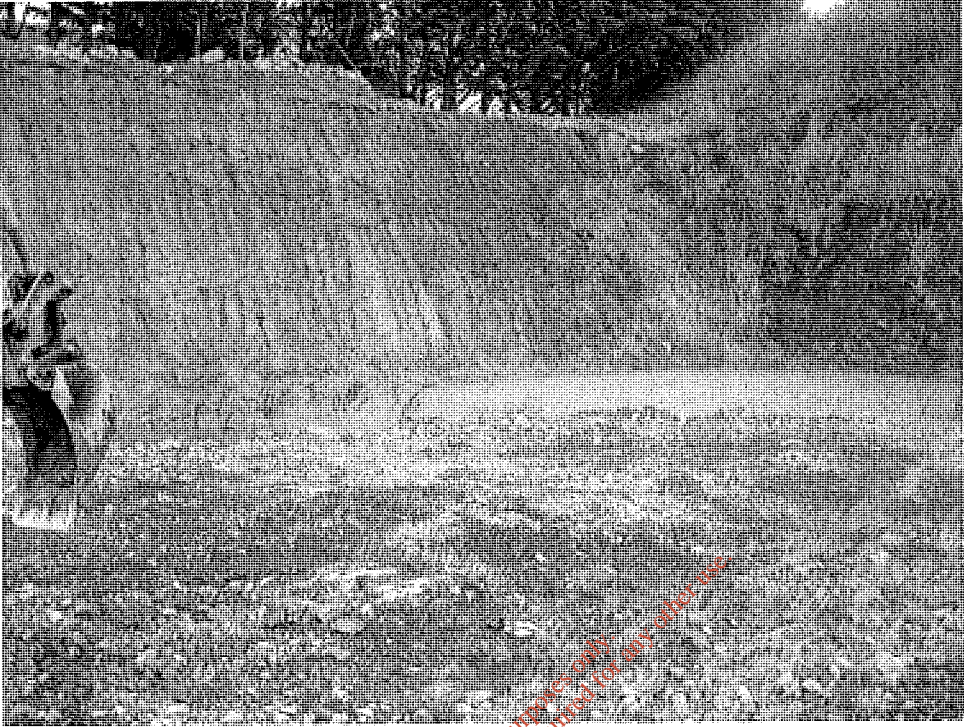
<p><b>Project Name:</b> Milverton Ground Investigation. <b>Location:</b> Milverton <b>Date:</b> December 2008</p>	<p>Trial Pit No. <b>MTP6</b></p>

<p><b>Remarks:</b> Refer to Figure 2 for Trial Pit Locations</p>	<p><b>MTP6</b></p>
