Please find enclosed a soft copy of the Soil and Groundwater Baseline Report for WO167-03.

Re: WO167-03 Notice for the purposes of Section 76A(3) of the Waste Management Act, as amended

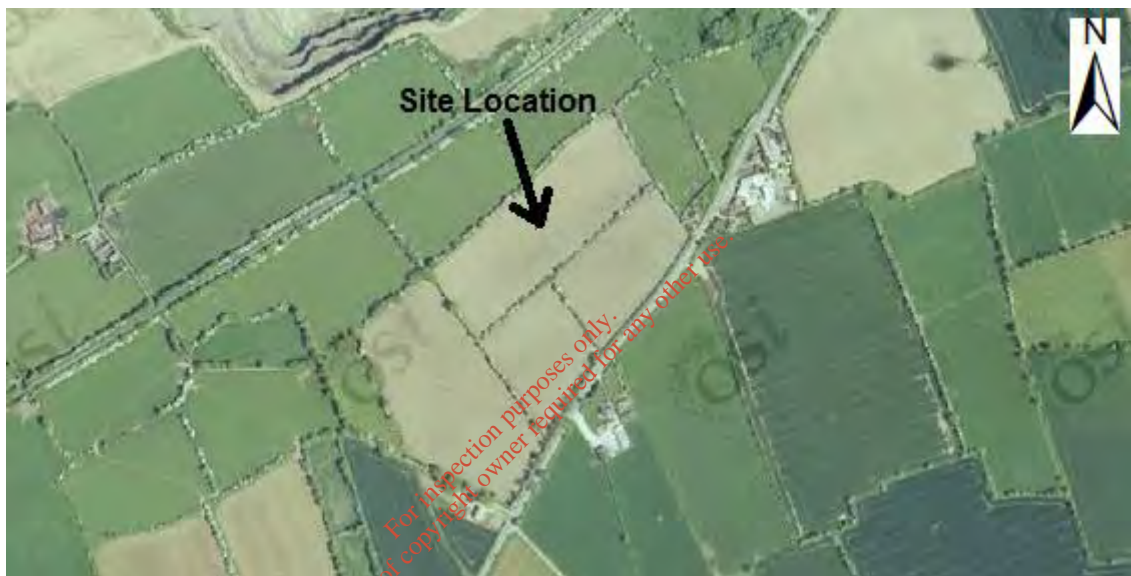
Figure 5.1 OSi Aerial Image (2005) (source www.osi.ie)

Aerial Imagery from the Ordnance Survey Ireland (OSi) (see Figure 5.1) and historic maps (refer Figure 5.2) were analysed and do not show any prior land use besides agricultural purposes at the site.

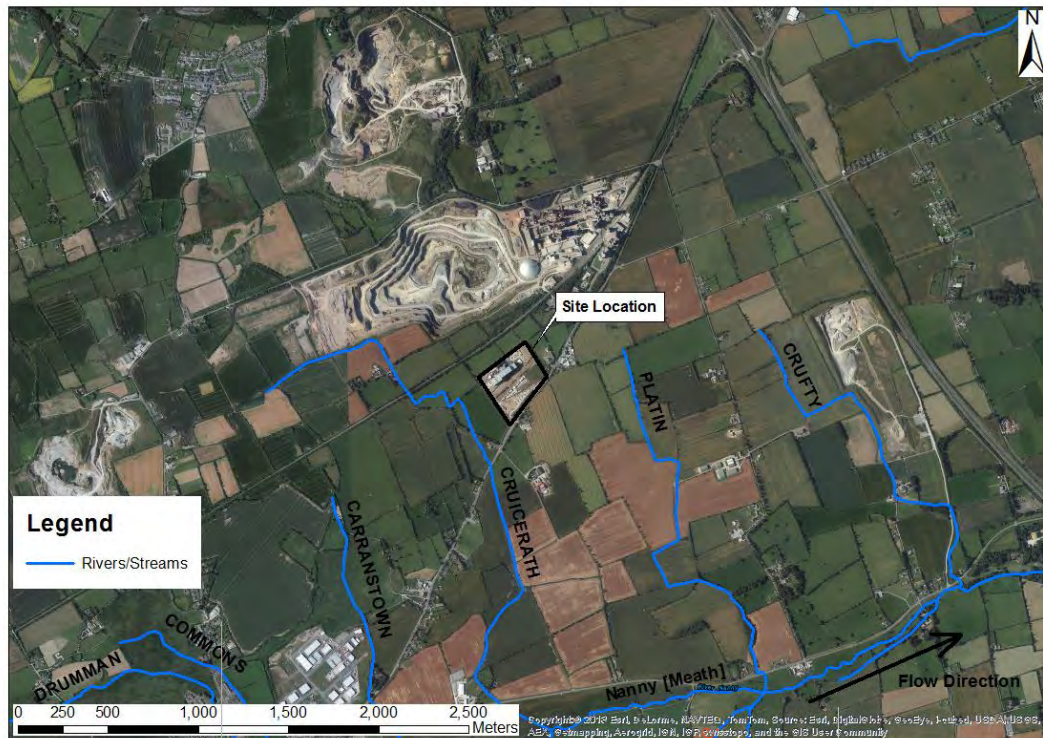
Figure 6.1 Site Location and Hydrological Environment (source www.epa.ie)

Figure 6.1 below presents the site location and hydrological environment.

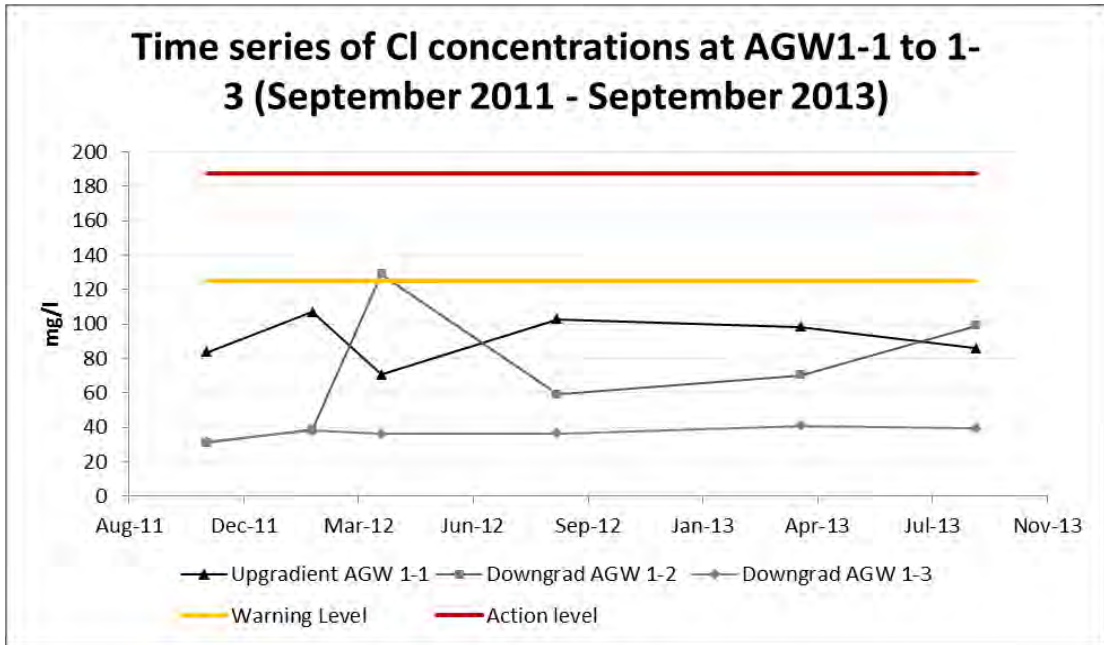
Figure 8.1 Time Series for Chloride (2011 – 2013)

Trends for Chloride, TOC and Ammonia are presented in Figure 8.1, Figure 8.2 and Figure 8.3 below.

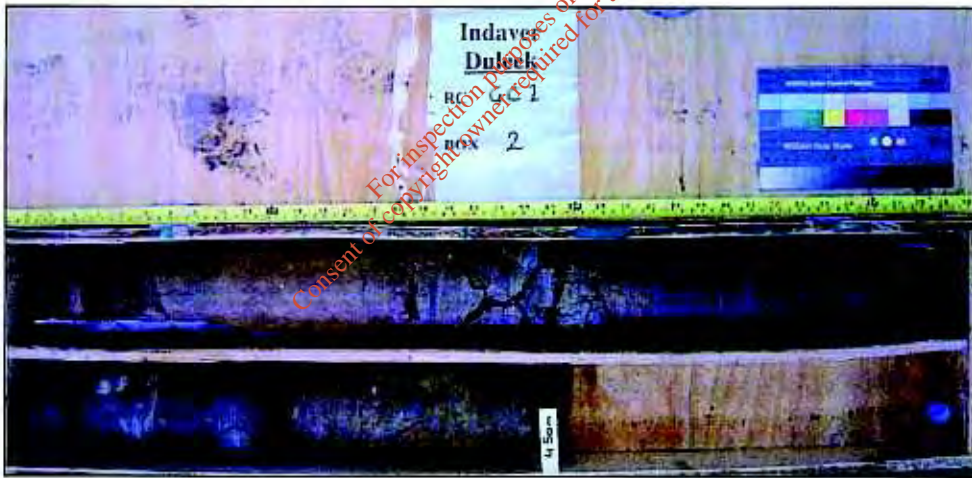
RC GC1 BOX 2 OF 7

Core Photography – Indaver Duleek (14039)

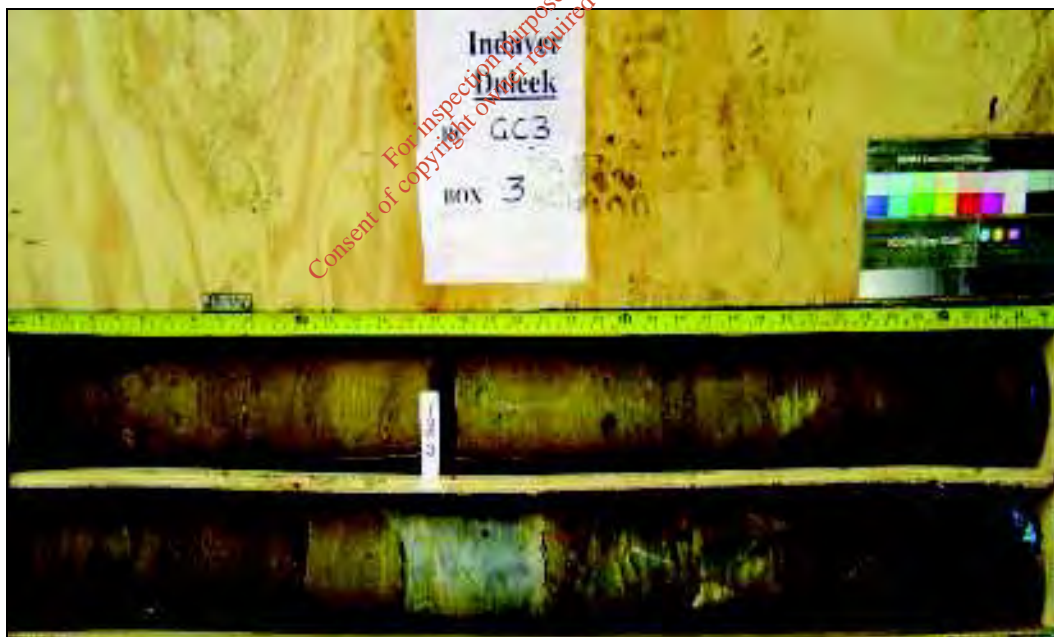
Plate 1 – Geobor Recovery in Glacial Till (GC 3)

The soils are thought to represent over-consolidated lodgement till and examination of the BLP borehole and trial pit descriptions show changes in colour and grading with depth. The gravel constituents or clasts range from fine to coarse, are subrounded to subangular and predominantly limestone in origin. Recovery of the glacial till in the Geobor drillholes was good to excellent and the cores show a complex and variable stratigraphy. An example of the core recovery in the glacial till is presented in Plate 1.

Consolidated quick undrained (CQu) triaxial compression and oedometer consolidation tests were performed by IGSL on selected Geobor samples. The CQu tests produced cohesion values of between 91 and 241 kN/m² (mean value of 166 kN/m²) and these indicate stiff and very stiff glacial soils. Bulk densities range from 2.06 to 2.36 Mg/m³ and these are characteristic of over-consolidated gravel or cobble dominant glacial till.

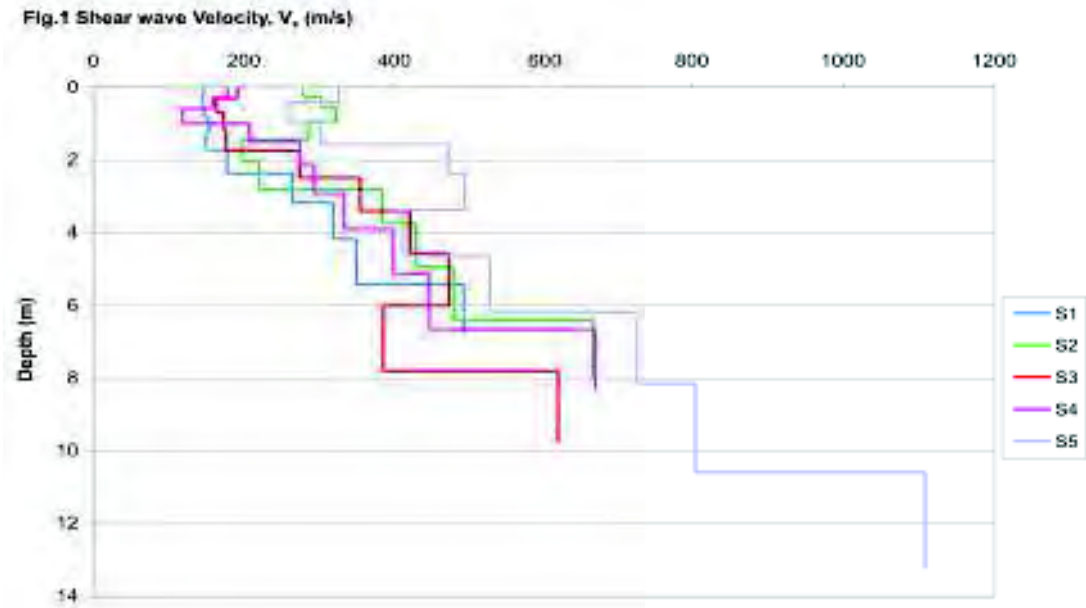
Figure 3 – Small Strain Stiffness (G_{max}) v Depth

Surface wave velocities (Rayleigh waves) were measured by Apex Geoservices at five spread locations using an array of geophones at designated spacings. The shear wave velocity data (V_s) was used to derive small strain shear modulus or stiffness values (G_{max}) with depth. The shear wave velocity and small strain stiffness plots have been combined and are presented in Figures 2 and 3 respectively. The shear wave velocities increase with depth and this data can be used to derive Bulk Modulus, Youngs Modulus, Poisson's Ratio and G_{max} . Values of dynamic moduli (G_{max}) are typically an order of magnitude *greater* than static values, established by routine in-situ testing. Ground strains are generally accepted to be $< 0.1\%$ and therefore small strain stiffness values can be used to make reasonable predictions of deformations (Jardine et al. 1986). The Apex geophysical report presents values of V_s , V_p , Density, Poissons Ratio, Youngs Modulus (dynamic & static) and Bulk Modulus.
