**The East Galway Landfill
EPA Waste Licence W0178-02**

Annual Environmental Report

January 2014 - December 2014

Project: Environmental Monitoring at The East Galway Landfill

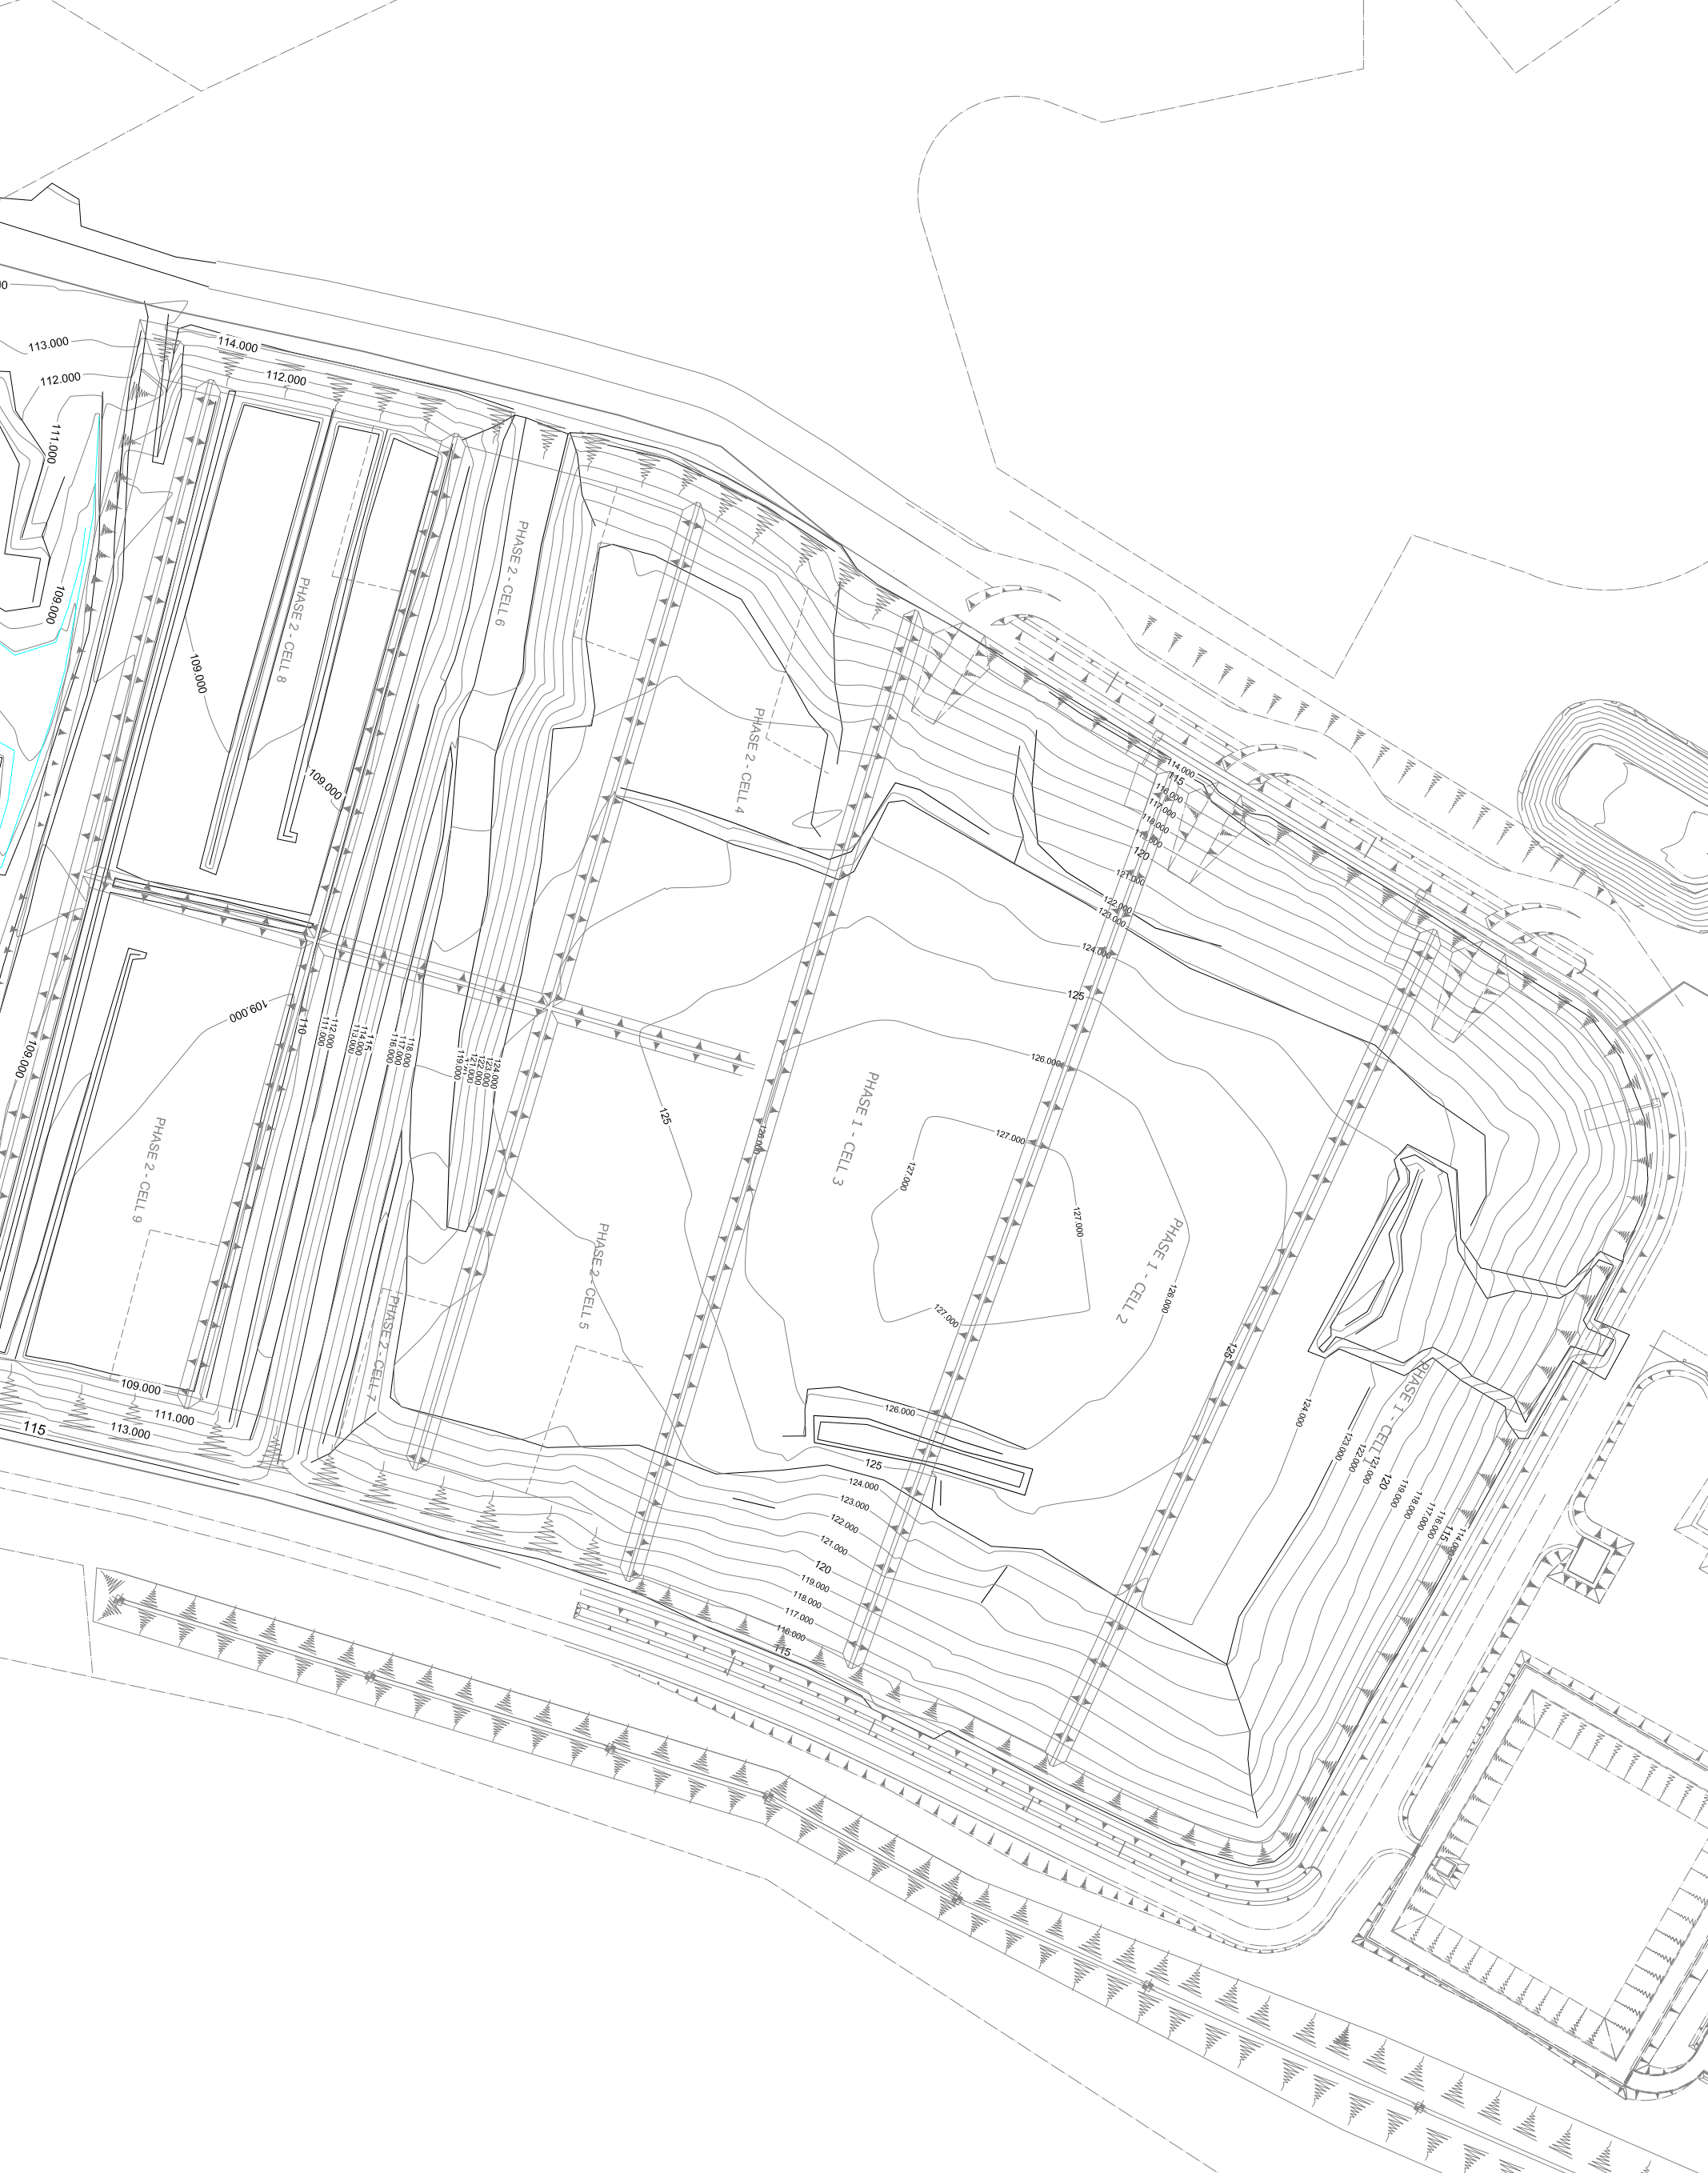
Topographical Site Survey – January 2014

As per condition 8.7 of the waste licence, a survey showing the topography of the facility at the end of the reporting period is included in Appendix D.
