Wexford County Council

Killurin Landfill
W0016-02

Annual Environmental Report 2014

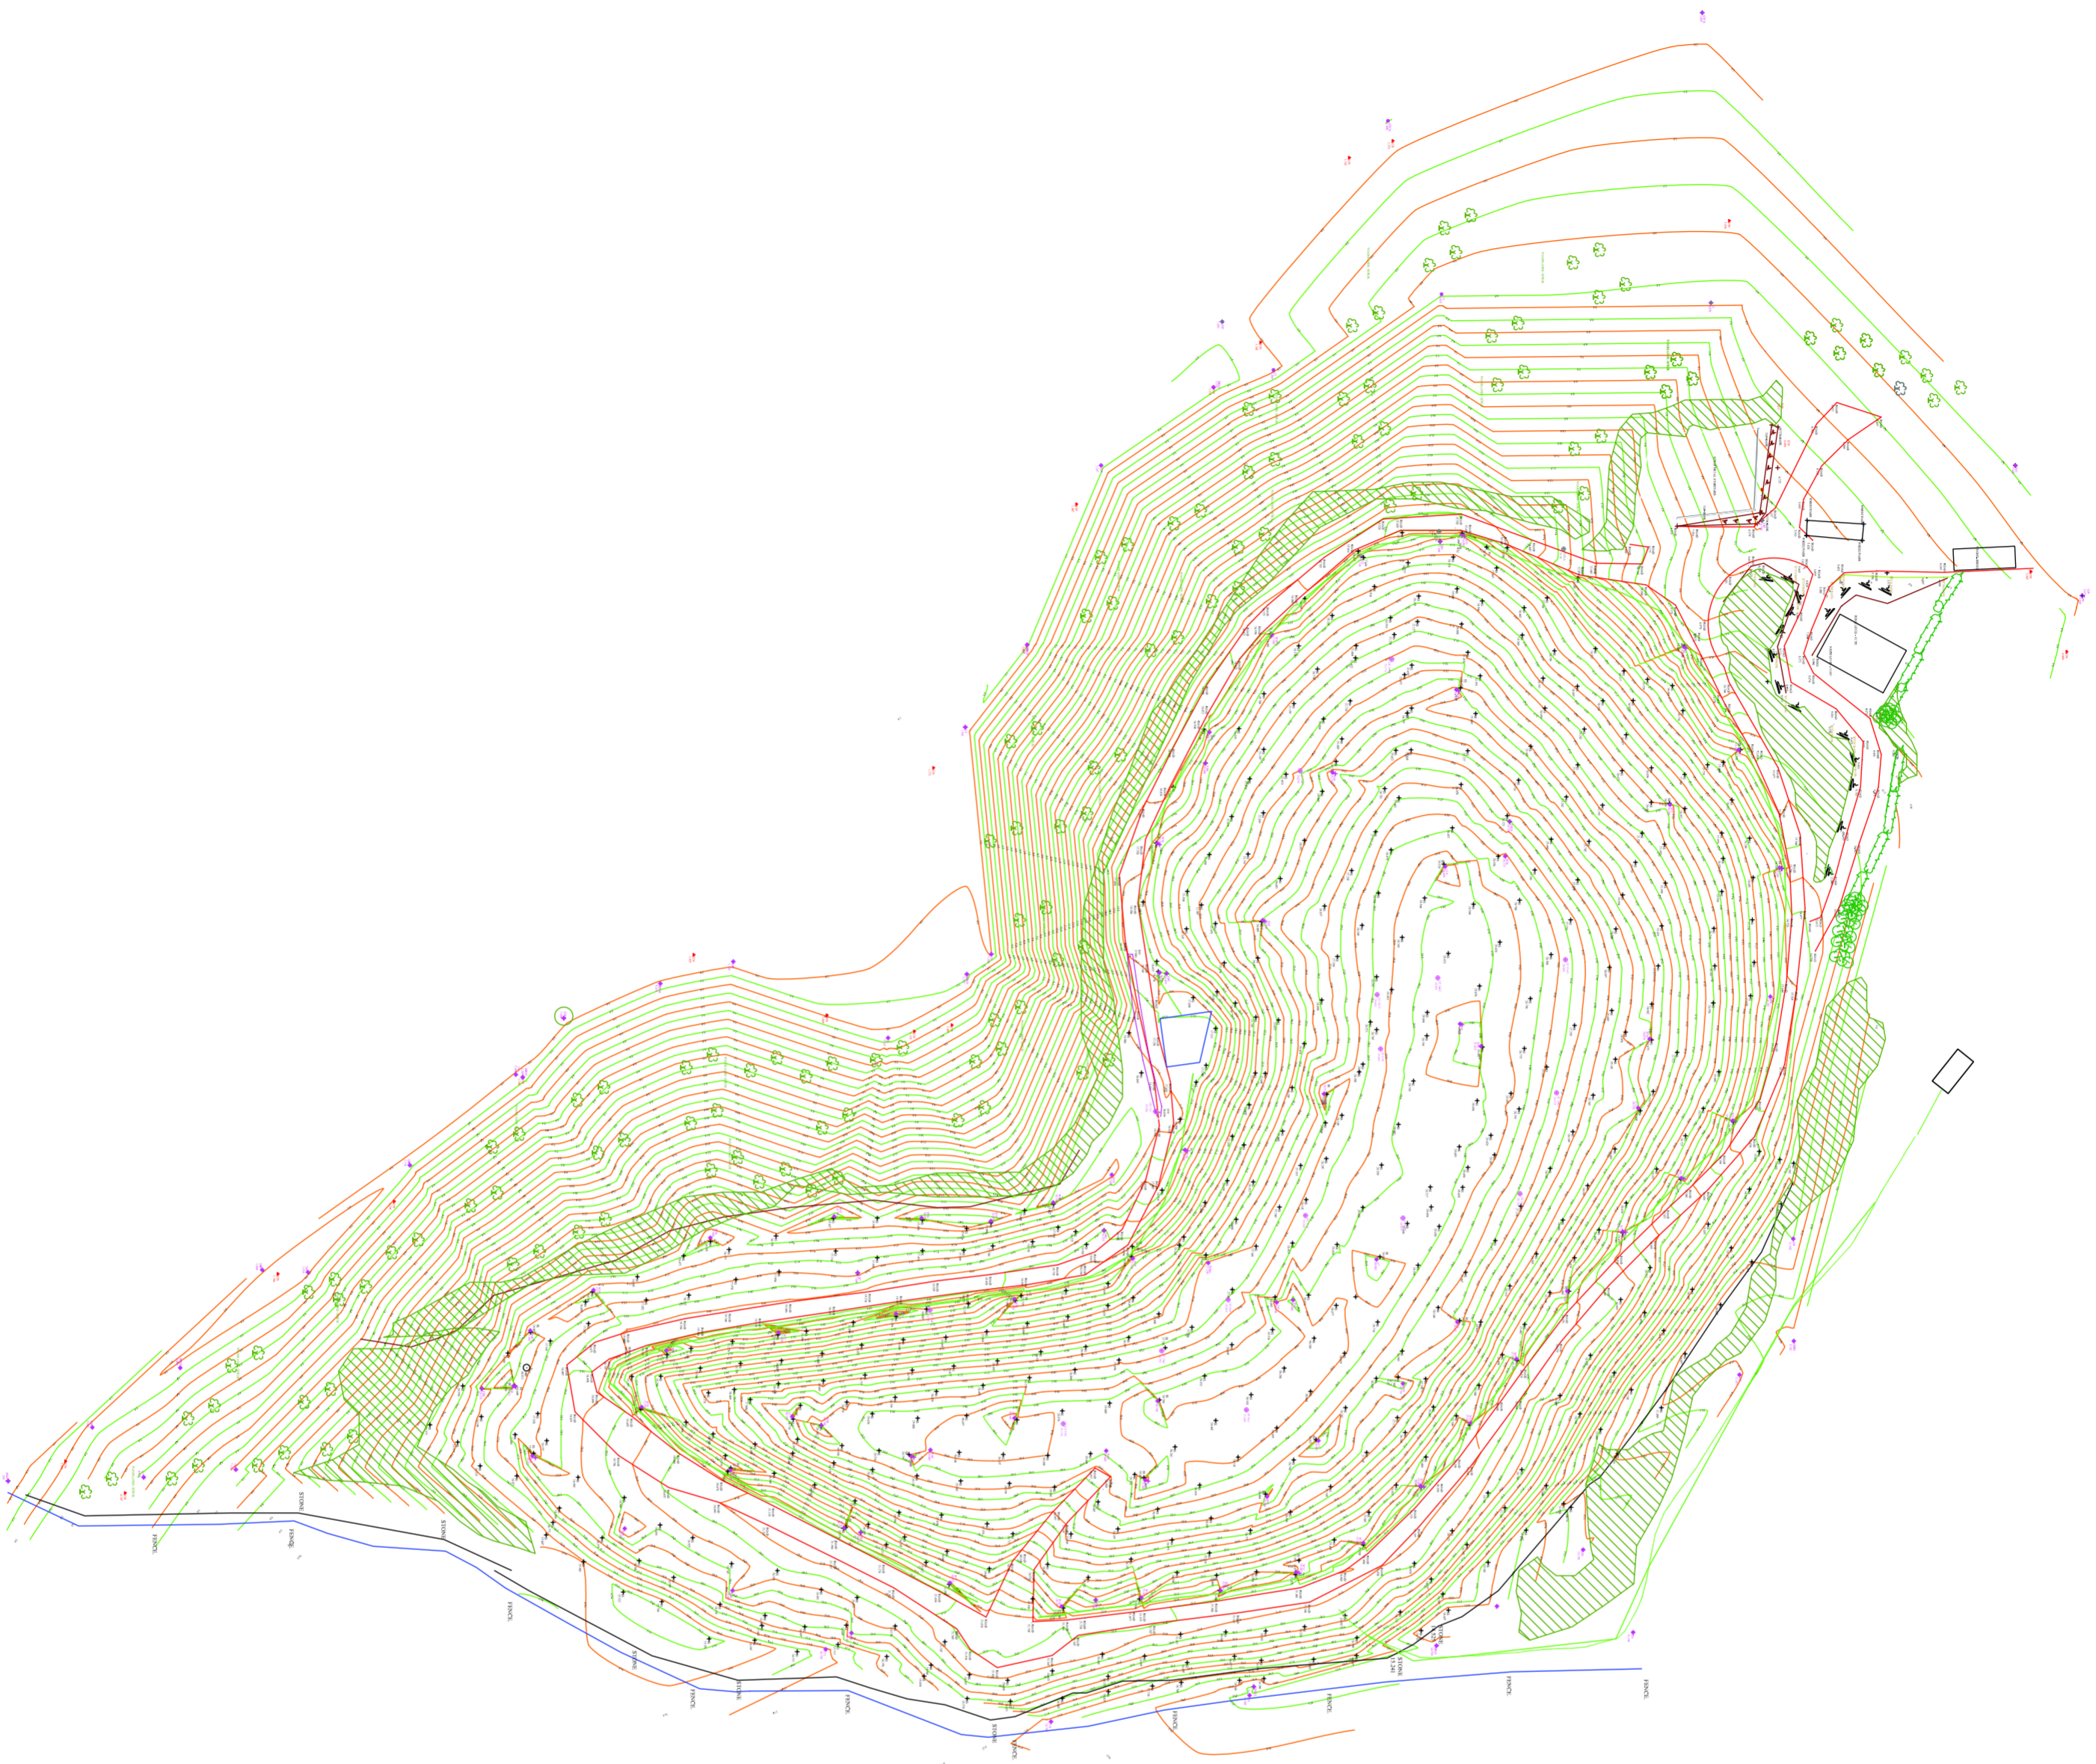
A2 Topographical and Monitoring location drawings

Capital Surveys Land Surveyors & Civil Engineers.		  CHARTERED SURVEYORS IRELAND	
Bridestown, Tappin, Co. Westford Phone: (053) 34218 or (087) 6857464		email: info@capitalsurveys.ie website: www.capitalsurveys.ie	
Project: Killarney Land Fill Topo Survey.		Client: Frab Hobbs, Westford Campy Council Homestown Land Fill Facility, Homestown, Co Westford	
Dwg Title: Site Plan			
Scale:	Date:	Job no.:	Dwg no.:
1 : 500	Nov 14	12-77	12-77/1
		Dr by:	Rev:
		J.K.	A

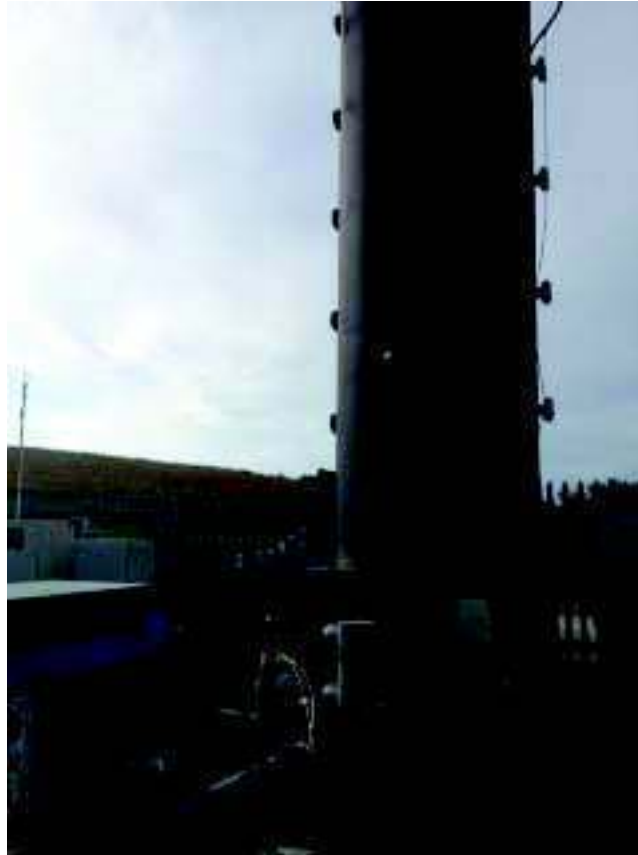
Stack Diagram

Sampling Location / Platform Improvement Recommendations
MEWP Required to reach port.

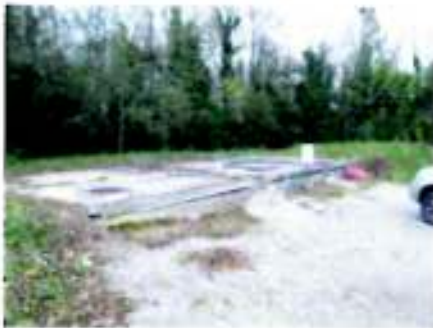
The tanks are partially buried and the eastern faces of all tanks, the southern face of LST 1 and the northern face of LST 3 are covered with soil. An inspection of the exposed external faces of each tank was made . The sealed joints between the precast sections are pointed with cement mortar on the external faces of LST 3, but are not pointed on LST 1 and LTS 2. The exposed bitumen seal are continuous and show no sign of cracking or weathering. The joints are approximately 1.32 m above the base of the tank.

The exposed concrete is in good condition and there are no cracks or corrosion in evidence.

There is no evidence of leakage or staining by leachate on the exposed external walls of the tanks.

External images of tanks at Killurin.

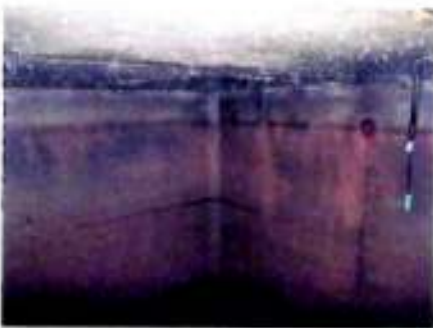
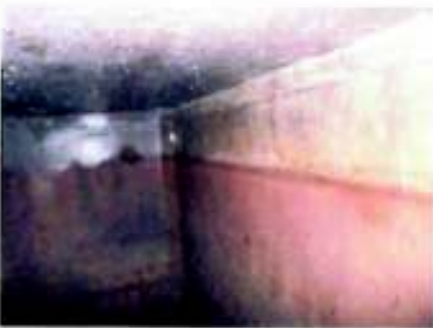
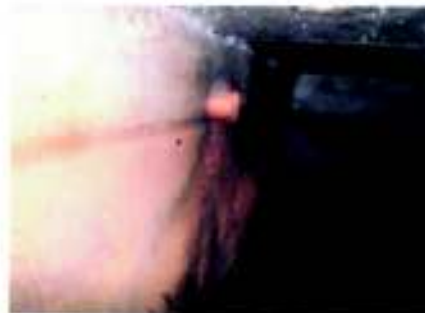
The internal joints between the upper and lower sections are pointed with cement mortar in LST 3 only, while LST1 and LST2 only some of the internal joints are pointed. The bitumen seal behind the cement pointing remains intact however. The concrete is in good condition throughout the internal surfaces of the tanks and no defects to the concrete, joints, water bar or reinforcement are in evidence.

Internal images of LST 1

The LSTs were drained and inspected. Some of the seals in LST 1 and LST 2 were not pointed with cement mortar, however the bitumen seals were found to be in tact. The pointing should be replaced to maintain the integrity of the seals.

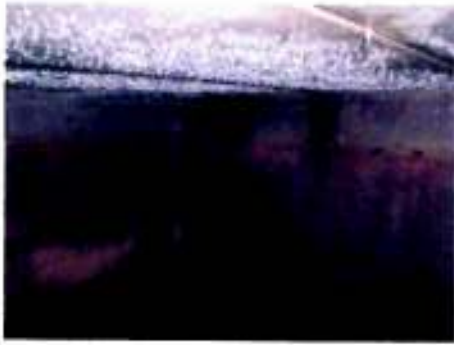
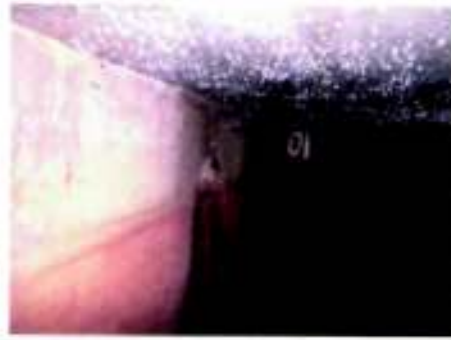
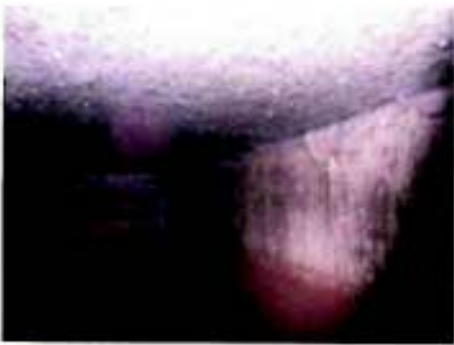
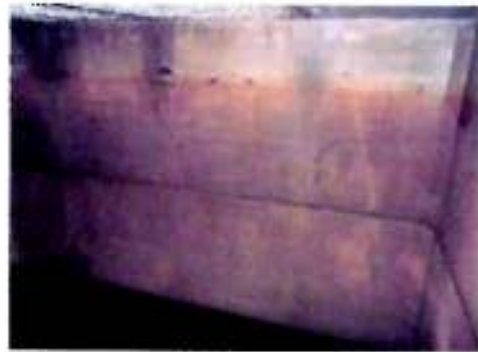
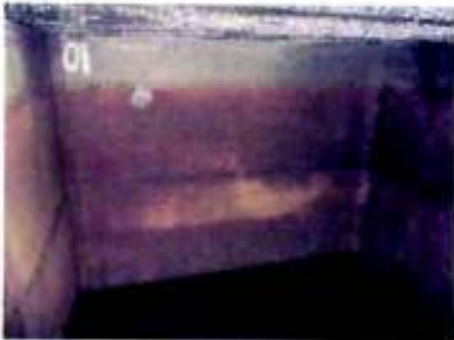
Internal images of LST 2

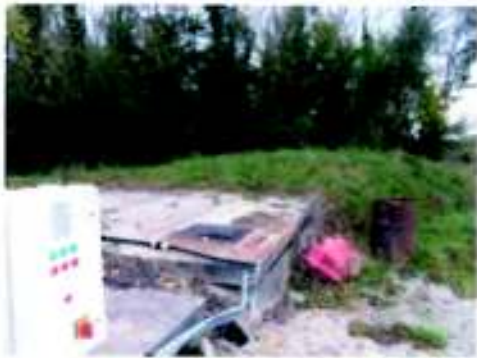
There is some minor damage to the external north west corner of LTS 3, where a thin layer of concrete has

broken away. There are no cracks or deterioration of concrete around this damaged area.

External image of LST 3

The small area of damage concrete was noted on the upper north western corner of LST 3. The damages should be made good.

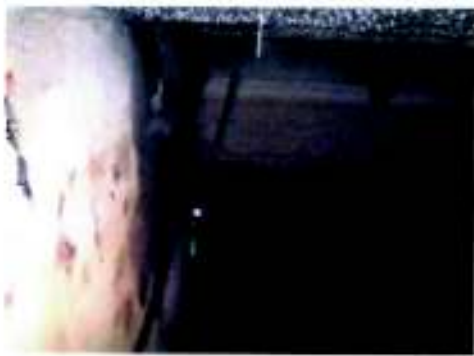
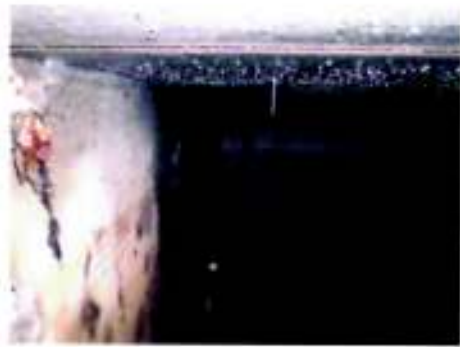
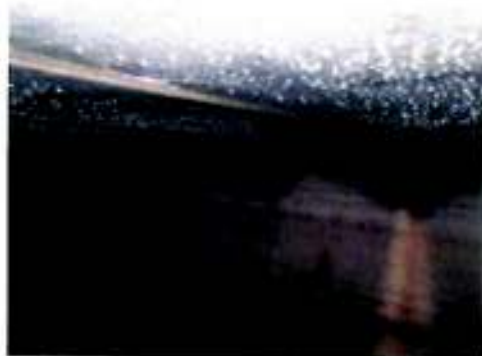
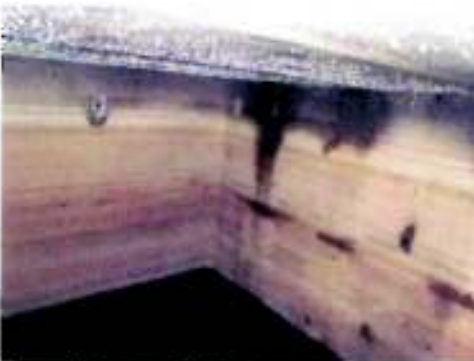
Internal Images of LST 3.
