Annual Environmental Report (AER),
Site 402, Greenogue Business Park.

January 1st – December 31st 2014

Annual Environmental Report

**Rilta Environmental Ltd.
Site 402 – Environmental Monitoring**

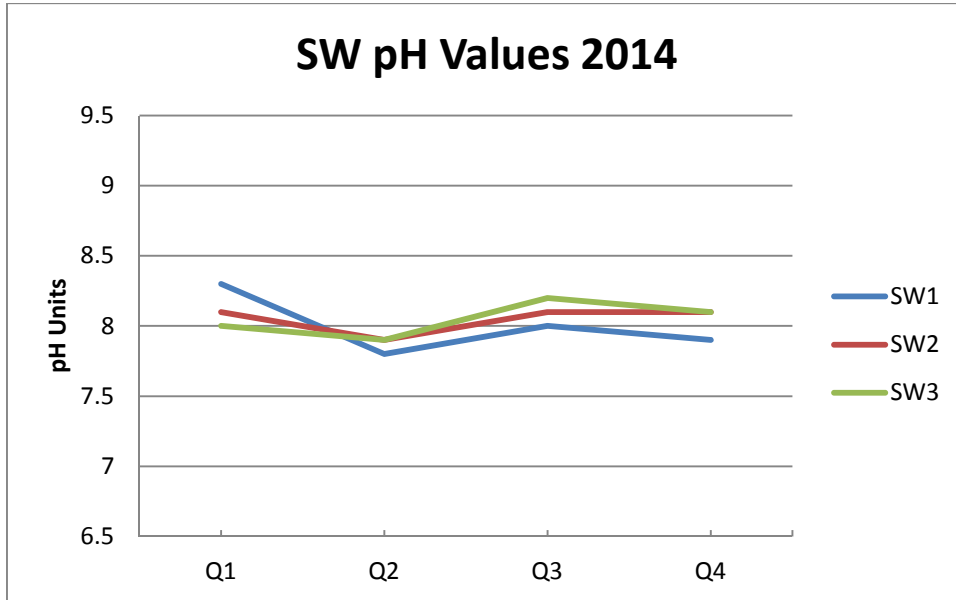
Figure 2.1 Surface Water pH Results - 2014

pH: pH results from 2014 are summarised on Figure 2.1 and Table 2.1 below. The pH values at all surface water monitoring locations were within the normal range in 2014 (6.5 - 9.5), as set out in the European Union (Drinking Water) Regulations 2014 (SI 122) and reflect the natural conditions of this surface water feature.

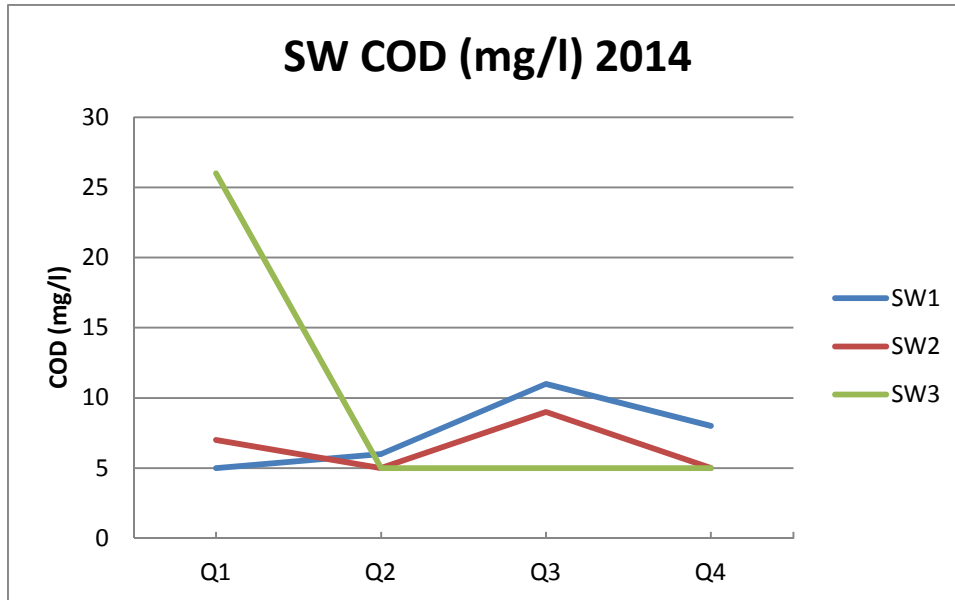
Figure 2.2 Surface Water COD Results - 2014

Chemical Oxygen Demand: Chemical Oxygen Demand (COD) results from 2014 are summarised on Figure 2.2 and Table 2.2 below. COD results at all monitoring locations was consistent with historic monitoring results from the site. Concentrations were slightly elevated at SW3 in Q1 with a peak concentrations of 26mg/l. There is no limit for surface water COD set out in waste licence 192-03.

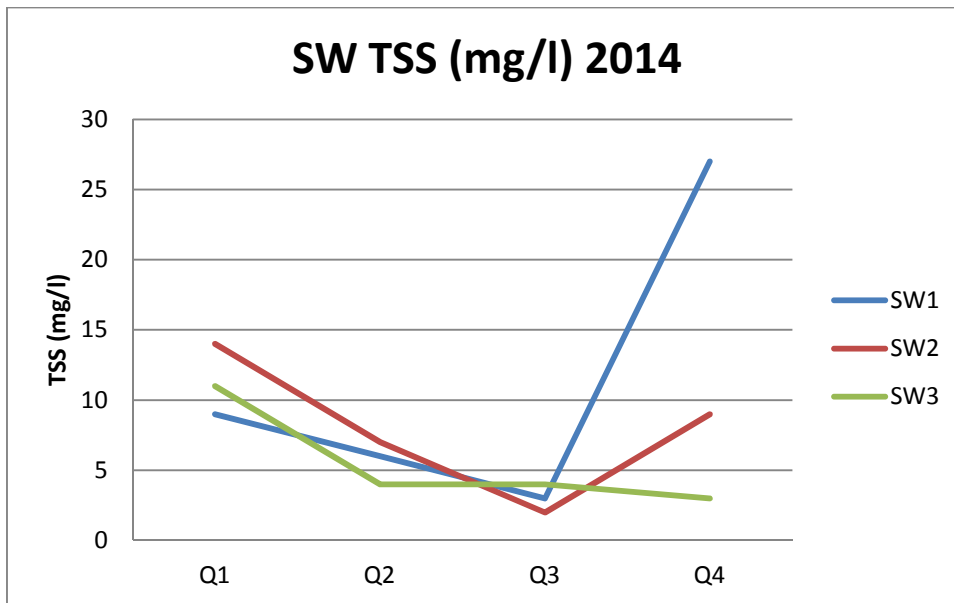
Figure 2.3 Surface Water Total Suspended Solids Results – 2014

Total Suspended Solids: Total Suspended Solids (TSS) results from 2014 are summarised on Figure 2.3 and Table 2.3 below. The concentrations of TSS at all surface water monitoring locations were below the limit levels set out in waste licence 192-03 (35mg/l) for all monitoring events during 2014.

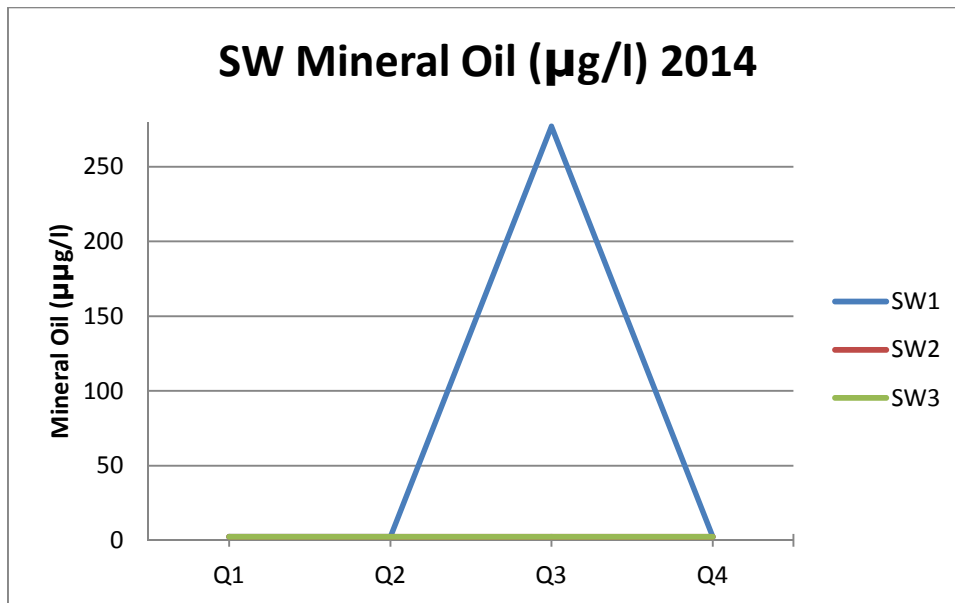
Figure 2.4 Surface Water Mineral Oil Results – 2014

Mineral Oils: Mineral Oil results from 2014 are summarised on Figure 2.4 and Table 2.4 below. Concentrations of Mineral Oil were below the laboratory detection limit (<2.5µg/l) and the limit level set out in waste licence 192-03 (<5,000µg/l) for all monitoring events during 2014. Mineral Oil at SW1 in Q3 2014 was untypically high for the site (276.82µg/l), although it was still below the waste licence limit set for the discharge location SW3 (5,000µg/l). Monitoring point SW1 is located along the eastern boundary of the facility and is upstream of potential impacts from the facility. It may be possible that contamination of the sample occurred during sampling.

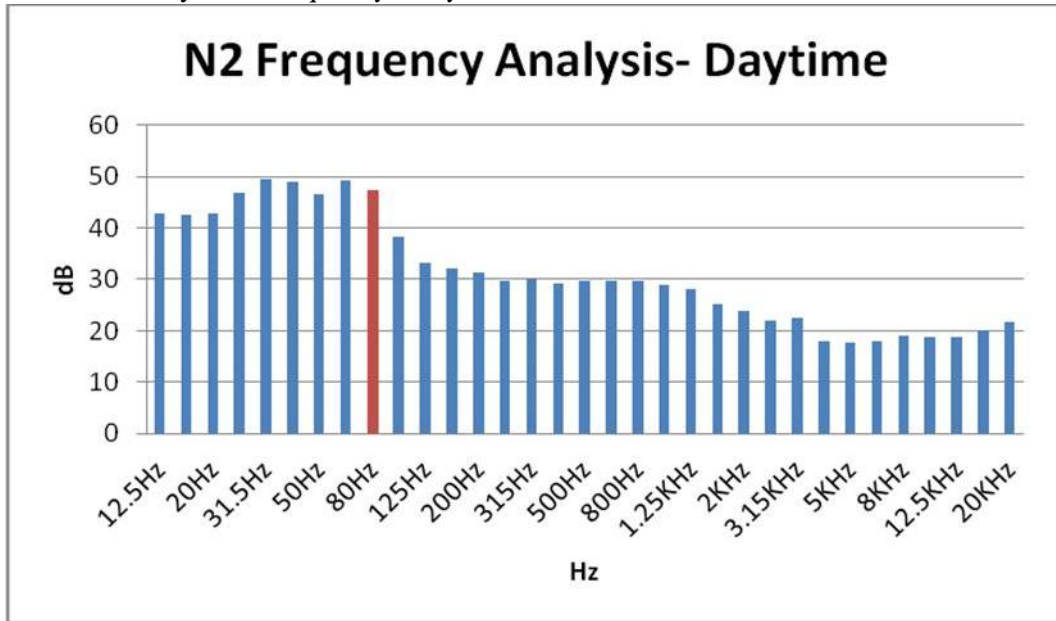
Figure 3 N2 Day Time Frequency Analysis

A tone was also observed at location N2 at 100Hz during the daytime survey, a 5dB(A) penalty has therefore been applied to this location bringing the Leq to 43.6dB(A).

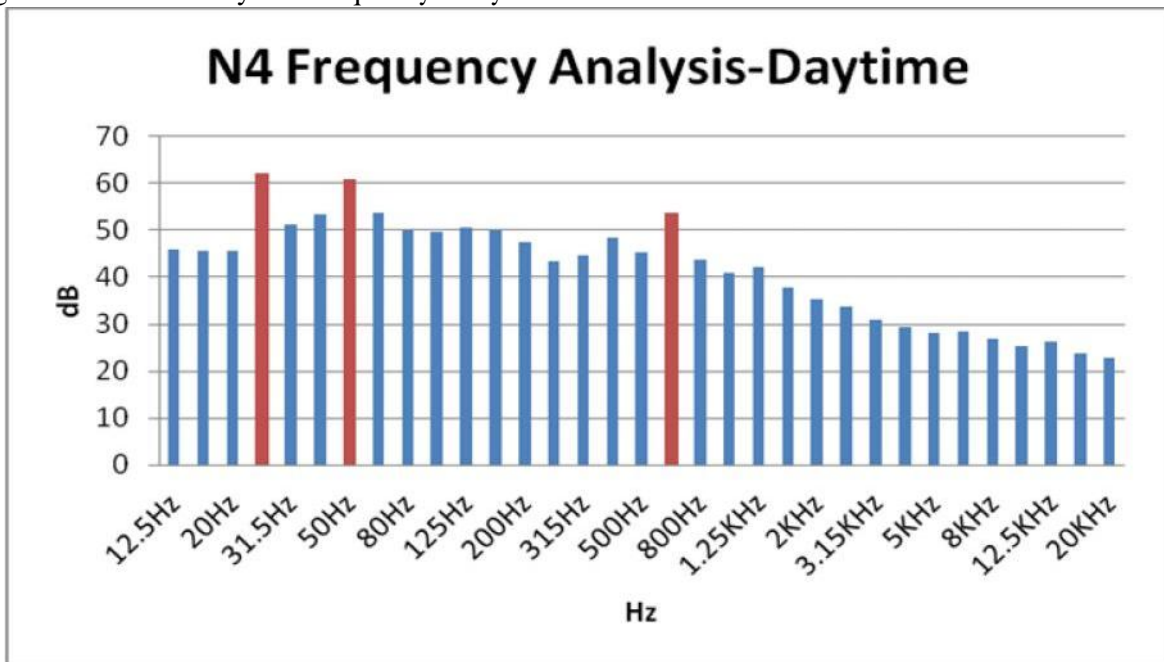
Figure 7 N4 Daytime Frequency Analysis

Tones were also observed at N4 (25Hz, 50Hz and 630Hz) during the daytime survey. Although passing traffic and overhead aircraft contributed to the noise levels at this location, site activity and a radio on in one of the facilities' warehouses was also highly audible at this location. A 5dB(A) penalty has therefore been applied to this location bringing the Leq to **59.4dB(A)**, which exceeds the limit of 55dB(A).

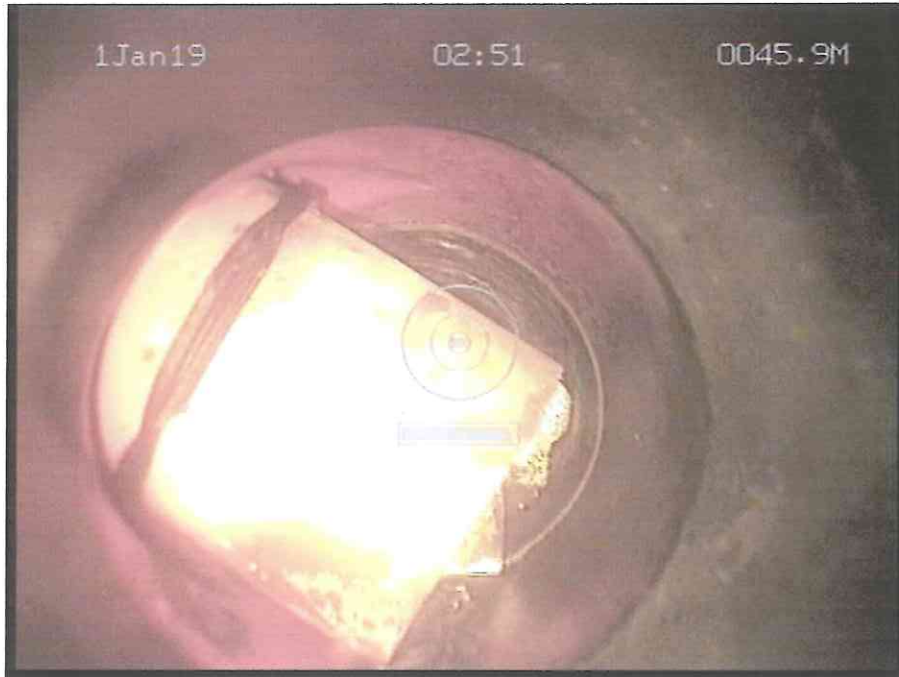
Photo: 14_5a
46.2m, Connection defective, at 10 o'clock, dia 125 mm, intrusion
200 mm

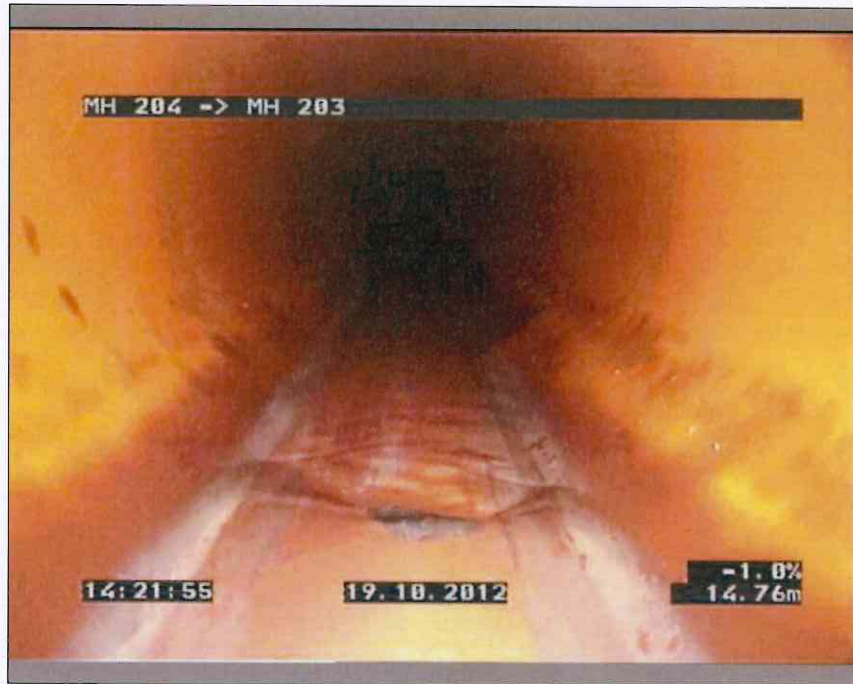
Photo: 1_3A, MPEG #: 311013_1, 00:03:07
 14.76m, Deformed sewer, 5% of original diameter/height

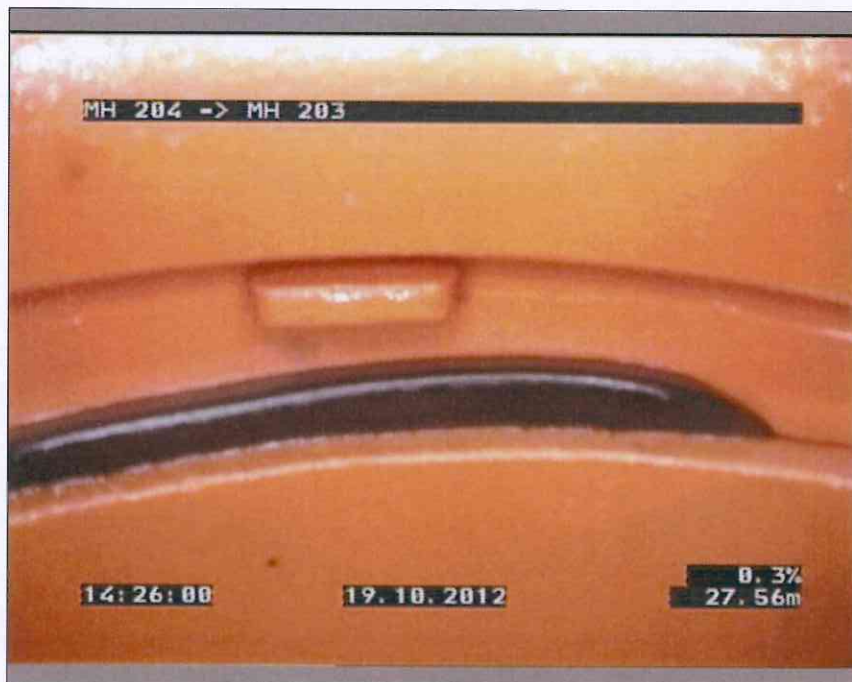
Photo: 1_4A, MPEG #: 311013_1, 00:06:31
 27.49m, Open joint, medium (between 1.0 and 1.5 times the pipe wall thickness)

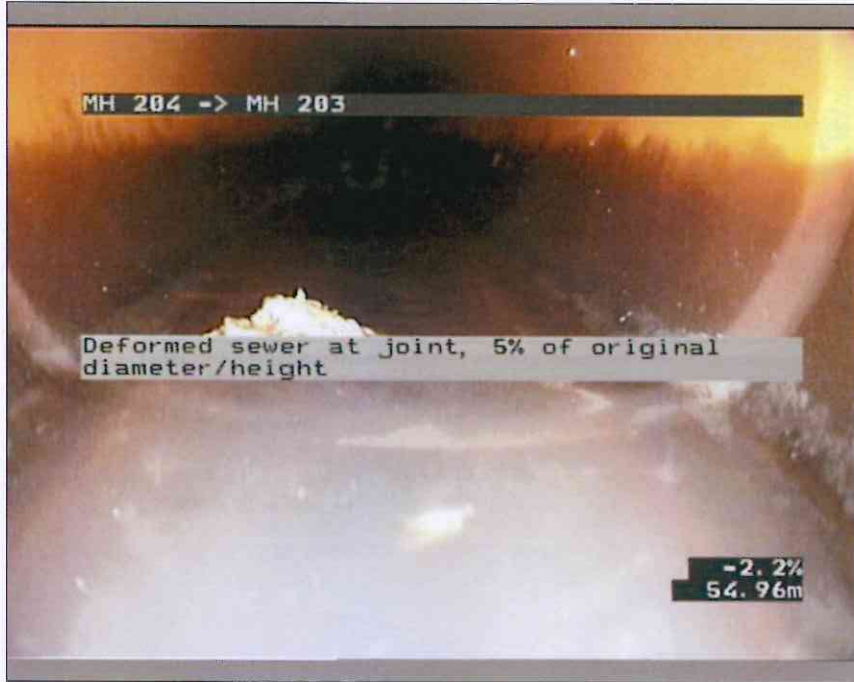
Photo: 1_5A, MPEG #: 311013_1, 00:14:48
54.96m, Deformed sewer, 5% of original diameter/height
