ANNUAL ENVIRONMENTAL REPORT 2014

KMK METALS RECYCLING LTD
Cappincur Industrial Estate,
Daingean Road,
Tullamore,
Co. Offaly

QED Engineering Ltd.
M-TEK Building 1
Armagh Road
Monaghan
Tel: 047 72060

REPORT PERIOD:
JANUARY 2014-DECEMBER 2014

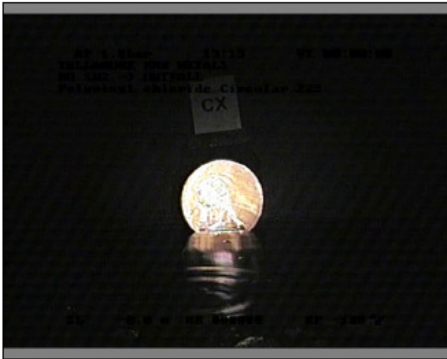
Photo: 3_1A
0m, Start node type, manhole, reference number : MH SW2

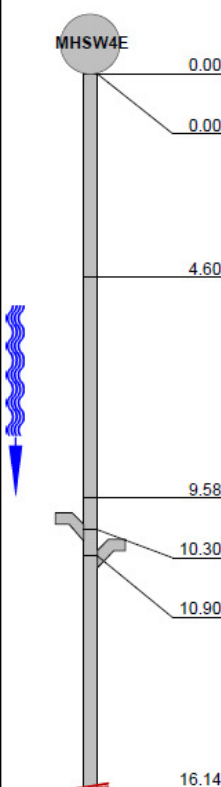
MH	Start node type, manhole, reference number : MHSW4E		0
		WL	Water level, 0% of the vertical dimension		0
		LR	Line deviates right		0
		LL	Line deviates left		0
		JN	Junction, at 3 o'clock, diameter 100mm		0
		JN	Junction, at 9 o'clock, diameter 100mm		0
		SA	Survey abandoned Remarks: DUE TO BENDS		0

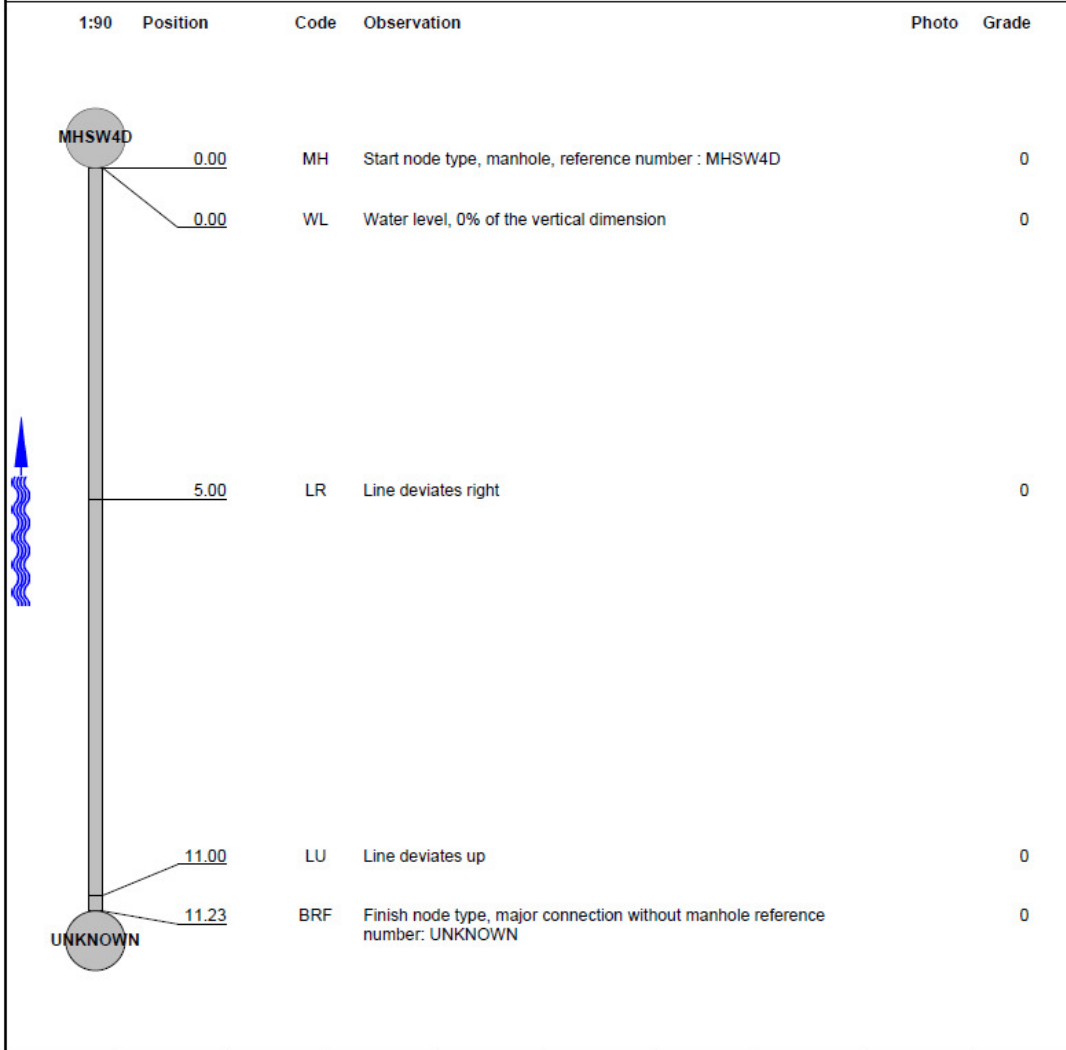
MH	Start node type, manhole, reference number : MHSW4D		0
	0.00	WL	Water level, 0% of the vertical dimension		0
	5.00	LR	Line deviates right		0
	11.00	LU	Line deviates up		0
	11.23	BRF	Finish node type, major connection without manhole reference number: UNKNOWN		0

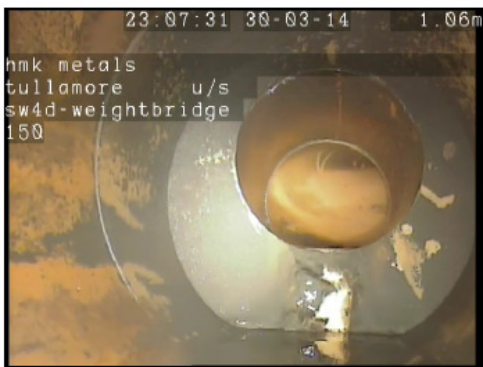
Photo: 5_3A
1.3m, Shape changes to circular, 100mm high
