16.5 Mitigation

16.6 Flood Risk Assessment (FRA)

Appendix 6 Photomontages for Landscape and Visual Impact Assessment

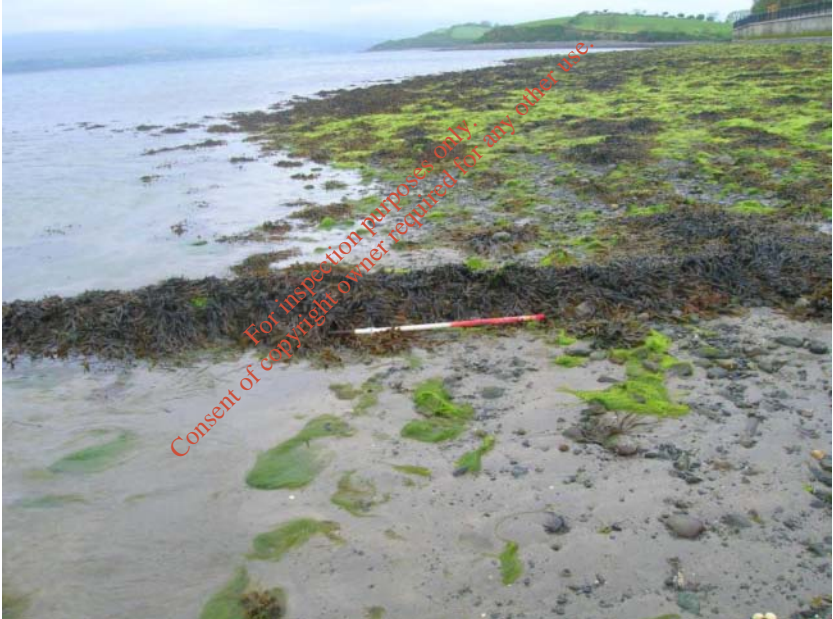
Ref No.	Classification	Townland	Easting	Northing
ADCO 5	Outfall pipe	Reenrou West	99010	48836
Description	Seaweed-covered metal pipe extending seaward across the lower reaches of the intertidal foreshore. This feature is reasonably considered to be magnetic anomaly mg7.

Development Impact	The location is being considered for the reuse of dredge material as part of the beach nourishment component.			
Mitigation	Archaeological monitoring of any seabed excavation activity.

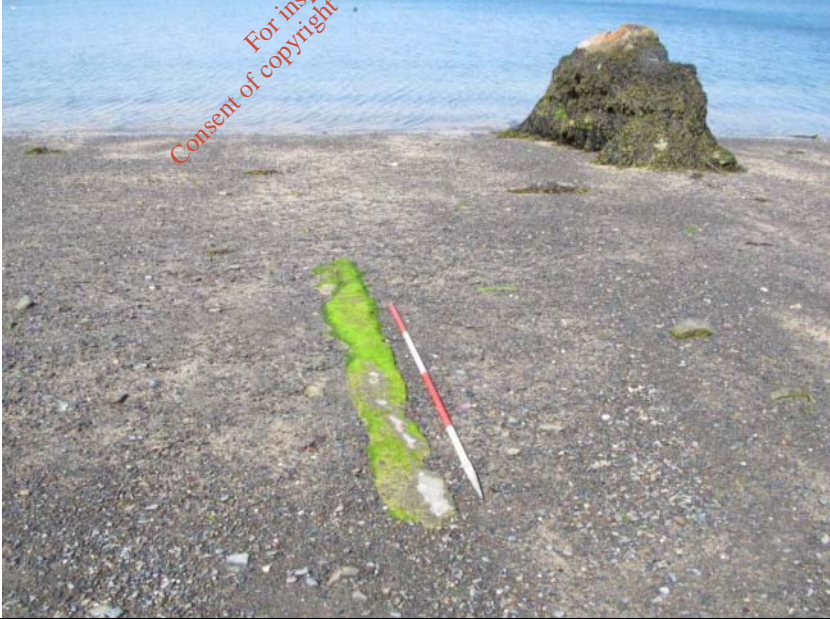
Ref No.	Classification	Townland	Easting	Northing
ADCO 7	Groyne	Reenrou West	99031	48714
Description	3m long line of reinforced concrete slab, 40cm wide, crossing lower foreshore at right angles to the shoreline. It corresponds with mg 6. A similar feature (ADCO 8) is observed 30m to the south, and both are part of a series of groynes identified on aerial photographs of the area.

Development Impact	The location is being considered for the reuse of dredge material as part of the beach nourishment component.			
Mitigation	Archaeological monitoring of any seabed excavation activity.

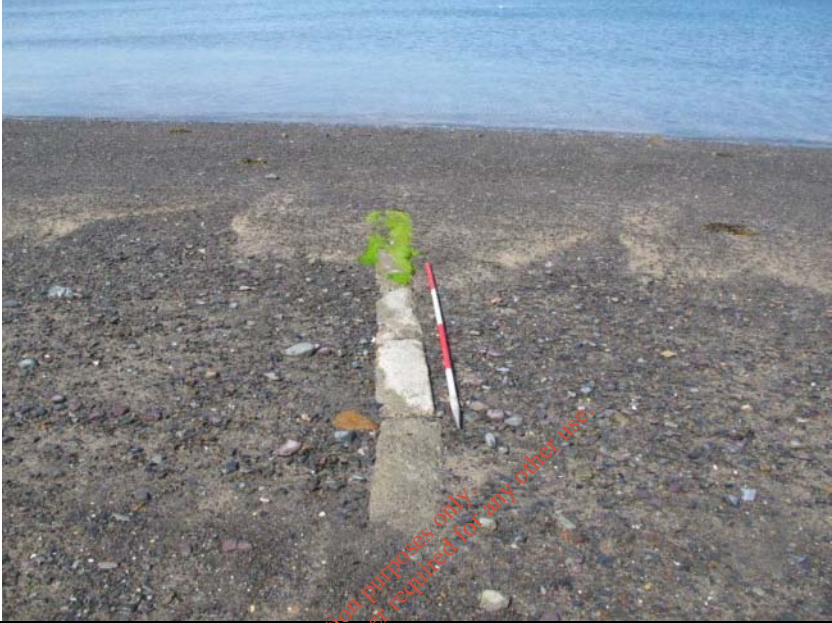
Ref No.	Classification	Townland	Easting	Northing
ADCO 8	Groyne	Reenrou West	99032	48685
Description	3.8m long line of reinforced concrete slab, 40cm wide, crossing lower foreshore at right angles to the shoreline. A similar feature (ADCO 7) is observed 30m to the north, and both are part of a series of groynes identified on aerial photographs of the area.

Development Impact	The location is being considered for the reuse of dredge material as part of the beach nourishment component.			
Mitigation	Archaeological monitoring of any seabed excavation activity.

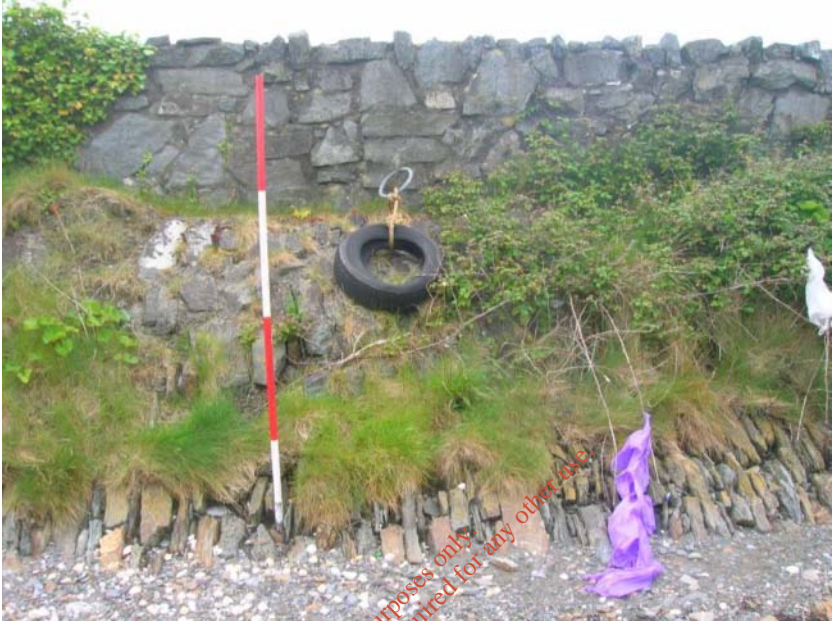
Ref No.	Classification	Townland	Easting	Northing
ADCO 9	Mooring ring	Reenrou West	99194	48588
Description	Galvanized mooring ring secured to modern wall to secure light vessels to the north quay area.

Development Impact	The existing masonry walls to be replaced, resulting in a direct impact on this modern mooring ring.			
Mitigation	None

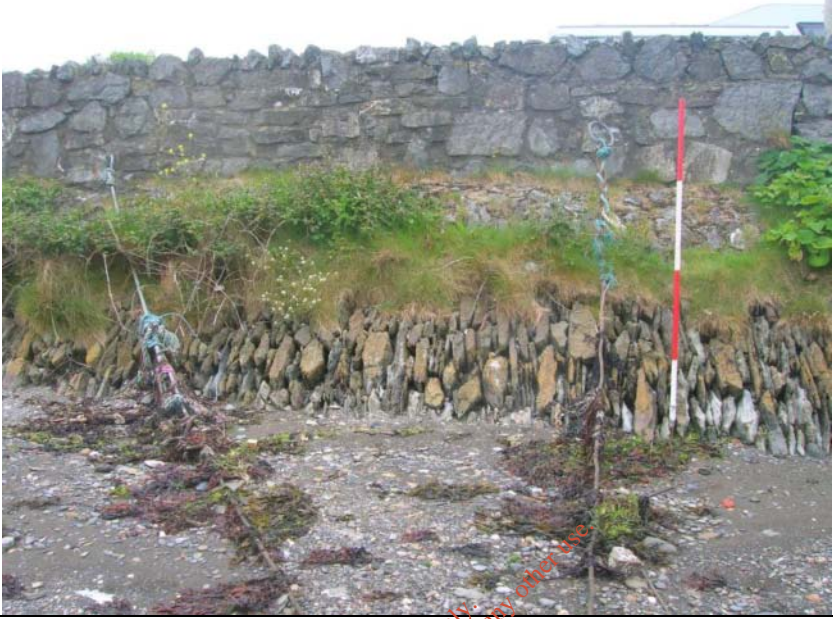
Ref No.	Classification	Townland	Easting	Northing
ADCO 10	Mooring rings x 2	Reenrou West	99217	48588
Description	Two galvanized mooring rings set 5 m apart secured to modern wall to secure light vessels to the north quay area.

Development Impact	The existing masonry wall is to be replaced, resulting in a direct impact on these modern mooring rings.			
Mitigation	None

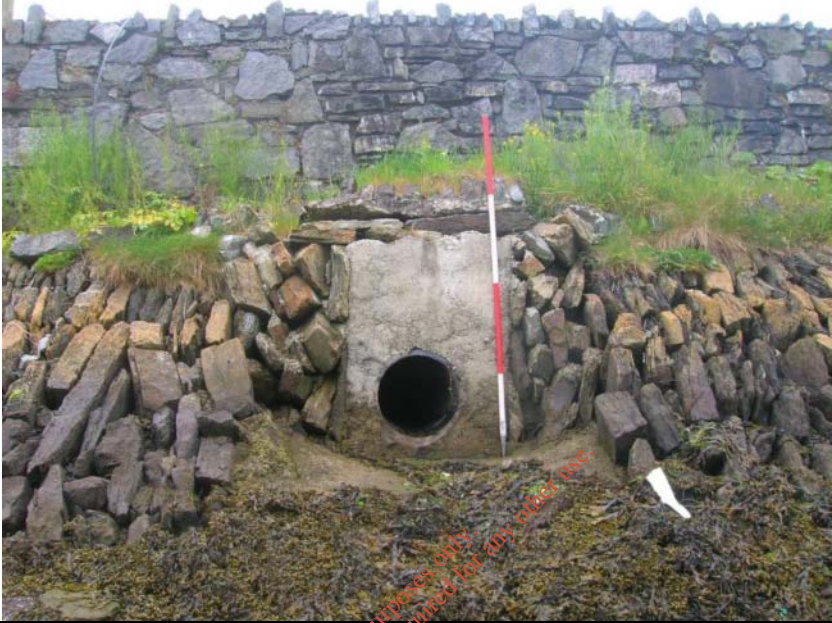
Ref No.	Classification	Townland	Easting	Northing
ADCO 11	Outfall	Reenrou West	99304	48609
Description	Modern steel outfall pipe embedded in concrete and inserted through existing stonework of the north quay area. The pipe is located more or less on the townland boundary with TownLots, which suggests that it carries a former stream into the inner harbour area.

Development Impact	The existing masonry wall is to be replaced, and the rock armouring may be upgraded around this modern culvert.			
Mitigation	None

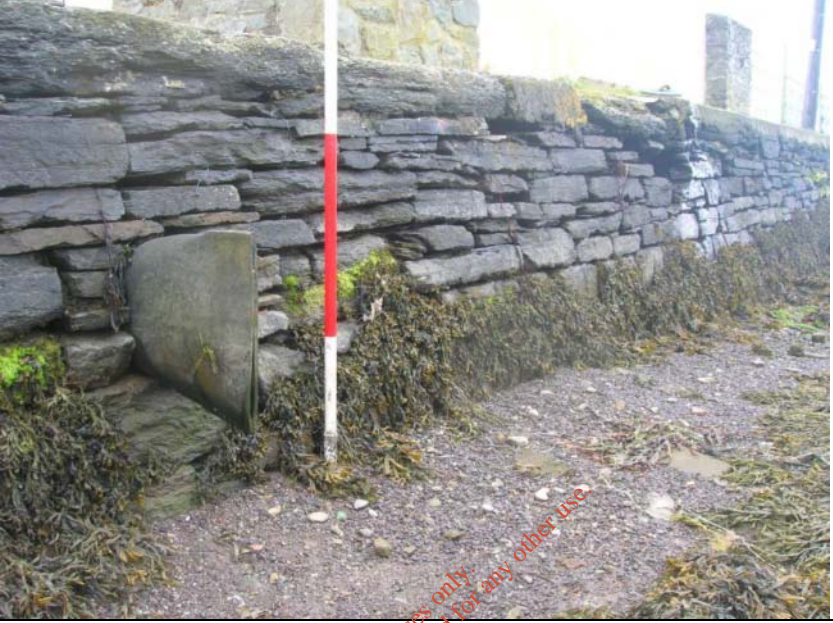
Ref No.	Classification	Townland	Easting	Northing
ADCO 12	Quay and Outfall	Town Lots	99394	48525
Description	Stone-built south quay area comprising neatly laid horizontal slabs. A modern outfall pipe sheathed in a rubberized one-way valve is neatly integrated into the stonework, indicating the comparative recent date of this quay façade in this location, or at least its rebuilding.

Development Impact	The quay wall will be concealed behind a new revetment that will be extended and it is to be a reclamation area.			
Mitigation	Detailed pre-development recording of the existing quay wall. Archaeological monitoring during development.

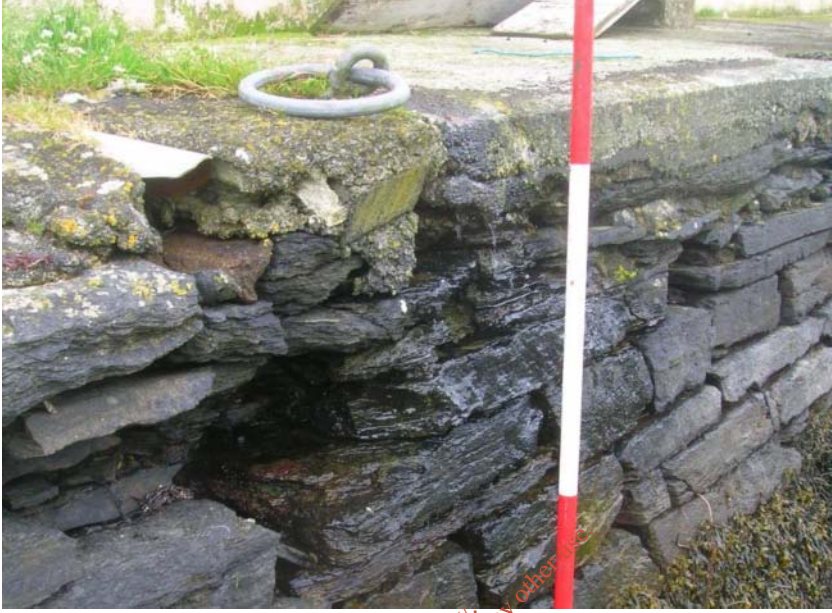
Ref No.	Classification	Townland	Easting	Northing
ADCO13	Mooring ring	Town Lots	99382	48498
Description	Galvanized mooring ring set into concrete pad that forms the modern upper surface of the south quay wall in this location, used to secure light vessels to the south quay area.

Development Impact	The quay wall will be concealed behind a new revetment that will be extended and it is to be a reclamation area.			
Mitigation	Detailed pre-development recording of the existing quay wall. Archaeological monitoring during development.

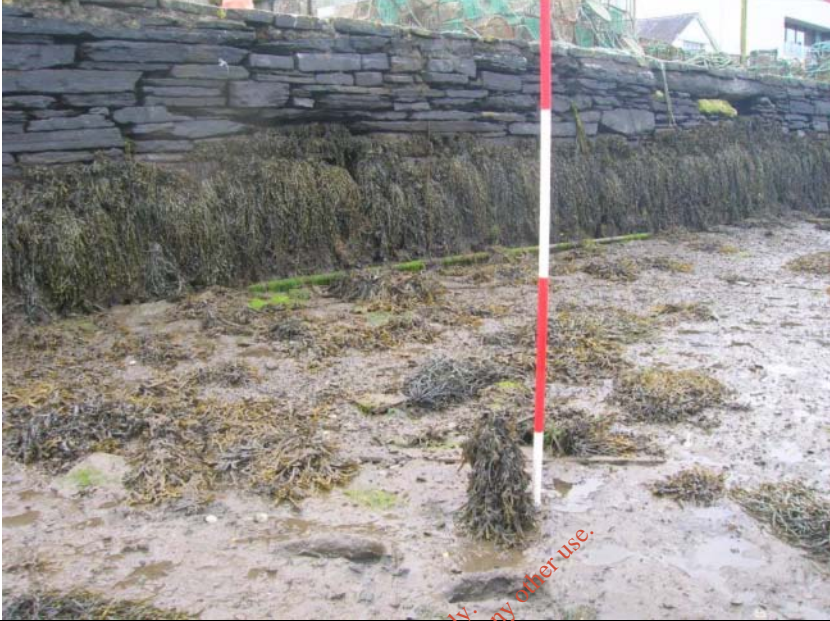
Ref No.	Classification	Townland	Easting	Northing
ADCO14	Wood	Town Lots	99343	48500
Description	Water worn stump of vertical timber protruding c. 40 cm above the silt deposit on the intertidal foreshore of the inner harbour, downstream of Slipway 1 and close to the south quays.

Development Impact	The location will be concealed below a new revetment that will be extended.			
Mitigation	Archaeological monitoring.

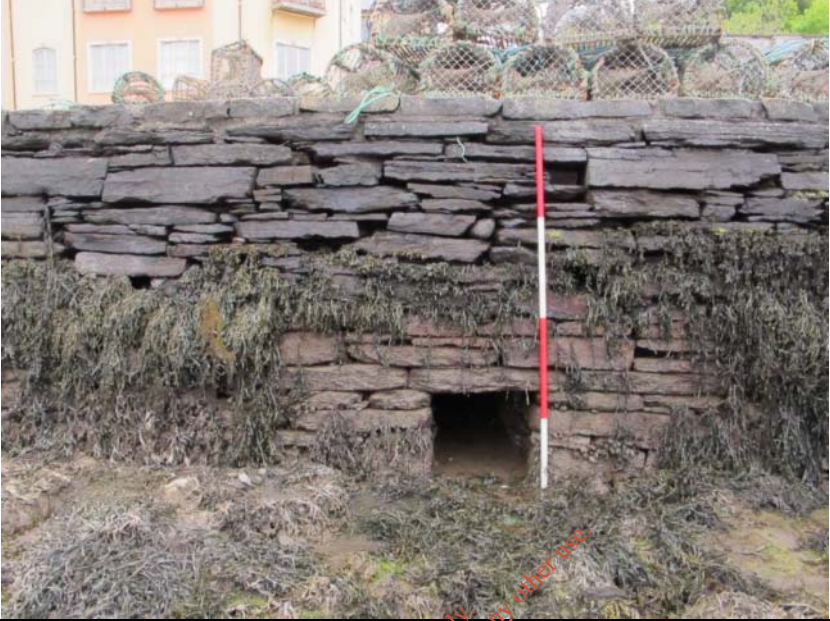
Ref No.	Classification	Townland	Easting	Northing
ADCO15	Culvert, stone	Town Lots	99235	48497
Description	Square-built stone culvert, measuring 55 cm wide and high, constructed at the base of the south quay wall, and extending straight back from the quayside.

Development Impact	The location will be concealed below a new revetment that will be extended.			
Mitigation	Detailed pre-development recording of the existing quay wall. Archaeological monitoring during development.

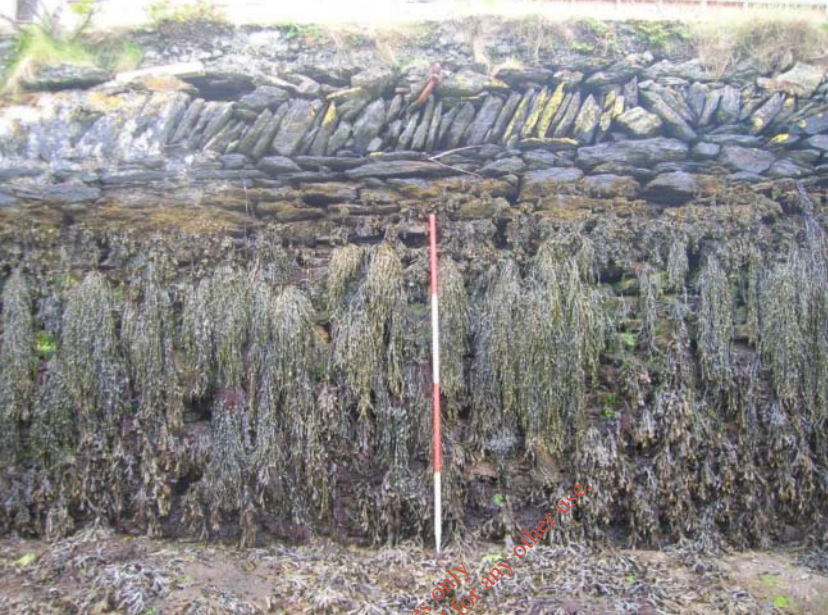
Ref No.	Classification	Townland	Easting	Northing
ADCO16	Shackle	Town Lots	99151	48494
Description	Iron shackle embedded into the upper levels of the south quay, for use as a mooring aid. The fact that the piece is iron and not galvanized metal indicates that it is not of modern date.

Development Impact	The location will be concealed below a new revetment that will be extended.			
Mitigation	Detailed pre-development recording of the existing quay wall. Archaeological monitoring during development.

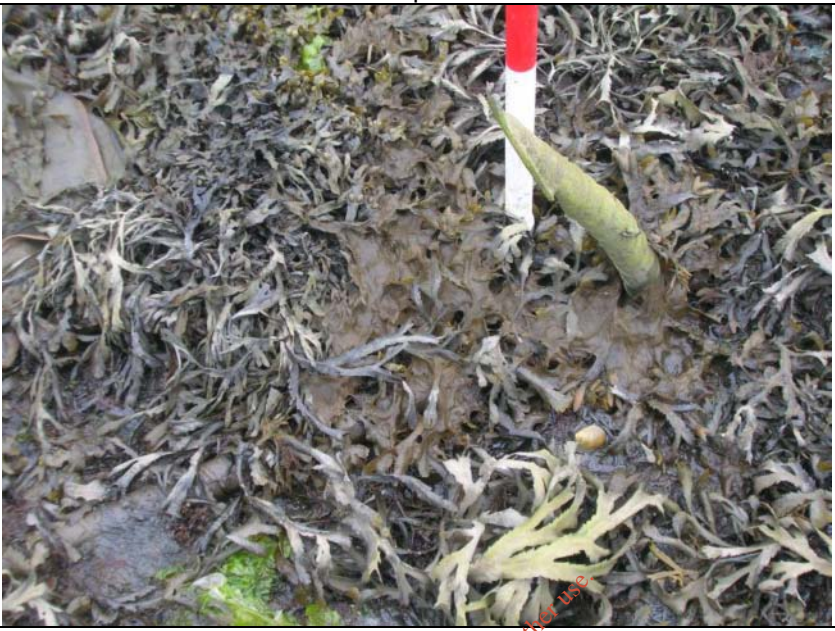
Ref No.	Classification	Townland	Easting	Northing
ADCO17	Anchor	Town Lots	99202	48495
Description	Modern galvanized small anchor, with one fluje protruding above the silt deposits.

Development Impact	This area will be dredged as part of the development.			
Mitigation	Archaeological monitoring.

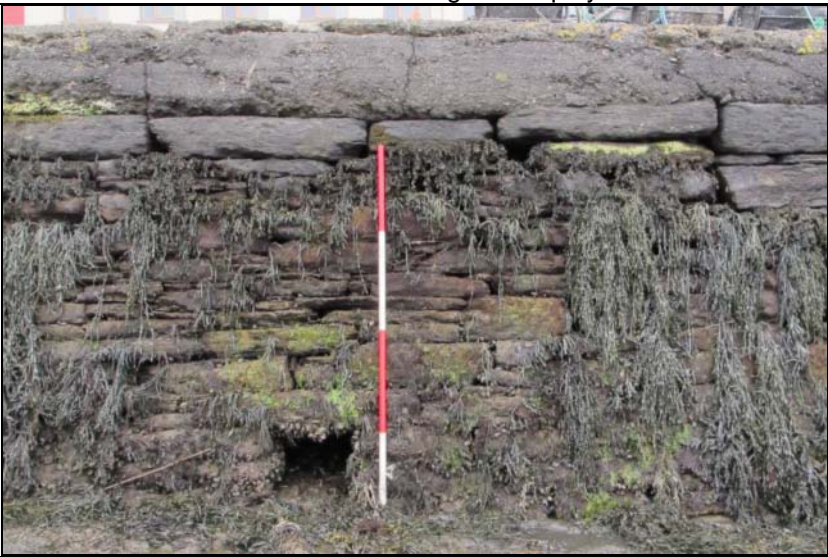
Ref No.	Classification	Townland	Easting	Northing
ADCO18	Culvert	Town Lots	99094	48483
Description	Square-shaped stone-built culvert, measuring c. 40 cm wide and high, built into base of existing south quay wall.

Development Impact	The location will be concealed below a new revetment that will be extended.			
Mitigation	Detailed pre-development recording of the existing quay wall. Archaeological monitoring during development.

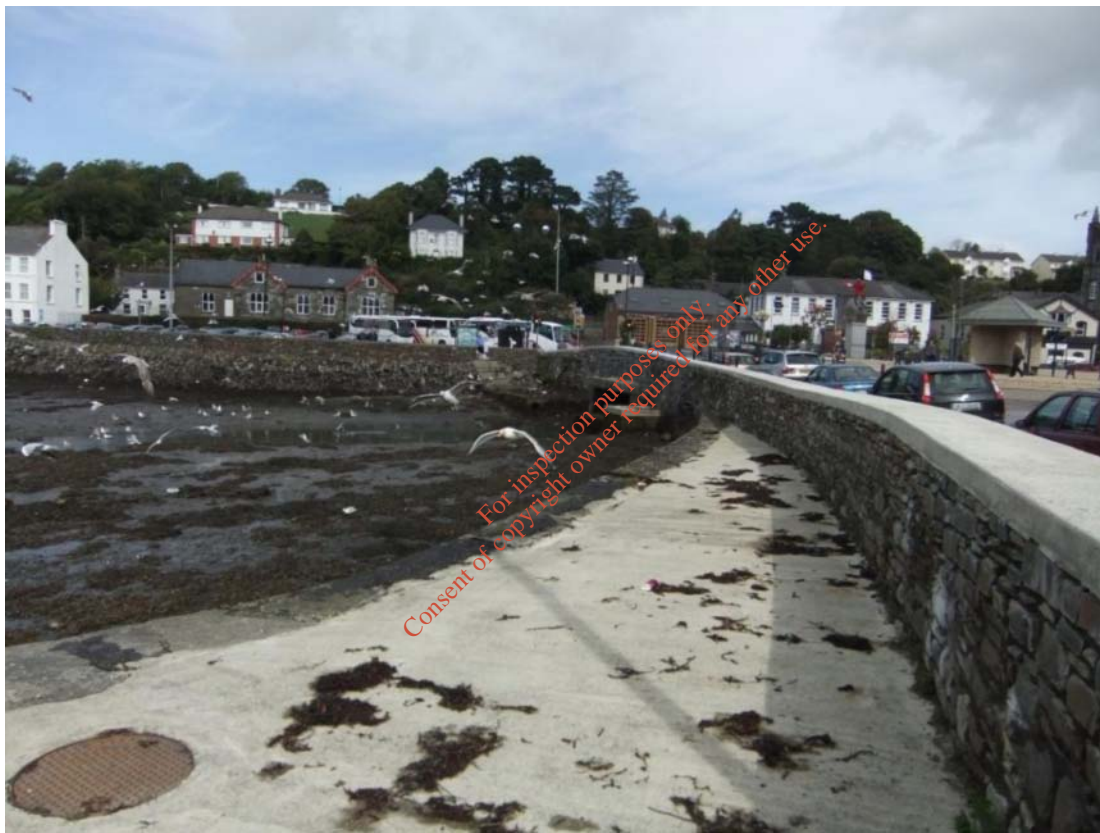
Photograph 2.7 Culvert Discharging to Harbour

A culvert discharges into the harbour at the eastern end as shown on Plate 2.7. This culvert carries storm drainage from the town of Bantry.
