The Environmental Protection Agency,
Office of Environmental Enforcement,
Headquarters,
PO Box 3000,
Johnstown Castle Estate,
Co. Wexford.

Re: 2015 Annual Environmental Report for W0269-01, Fassaroe Waste Recovery Facility

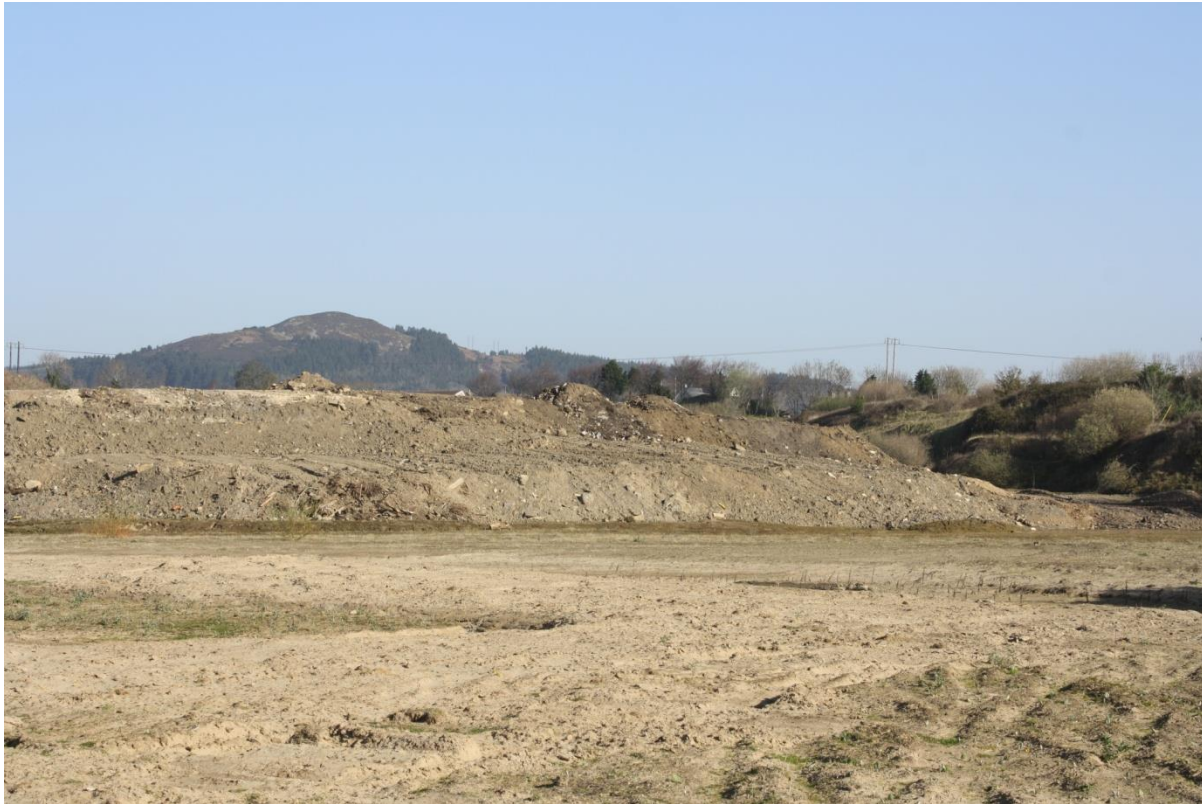
Plate 1 : Global View of Slope in Backfilled Material in NW Corner of Former Pit

In general, the temporary slopes developed in backfilled material around the north-western corner of the former pit, estimated to vary from approximately 12m to 16m high and approximately 20° to 30°, were observed to be marginally stable. Photographs of the existing slopes in backfilled material are presented in Plates 1 and 2.

The marginal stability of the backfilled slopes is only to be expected, given that they comprise imported material which has been end-tipped from HGV lorries and had not been spread or compacted by bulldozers or other earthmoving plant. That said, there was no evidence at the time of the site inspection of any recent or imminent instability across the temporary backfilled slopes such as development of tension cracks behind the crest, toe bulging, near-vertical backscarps etc.

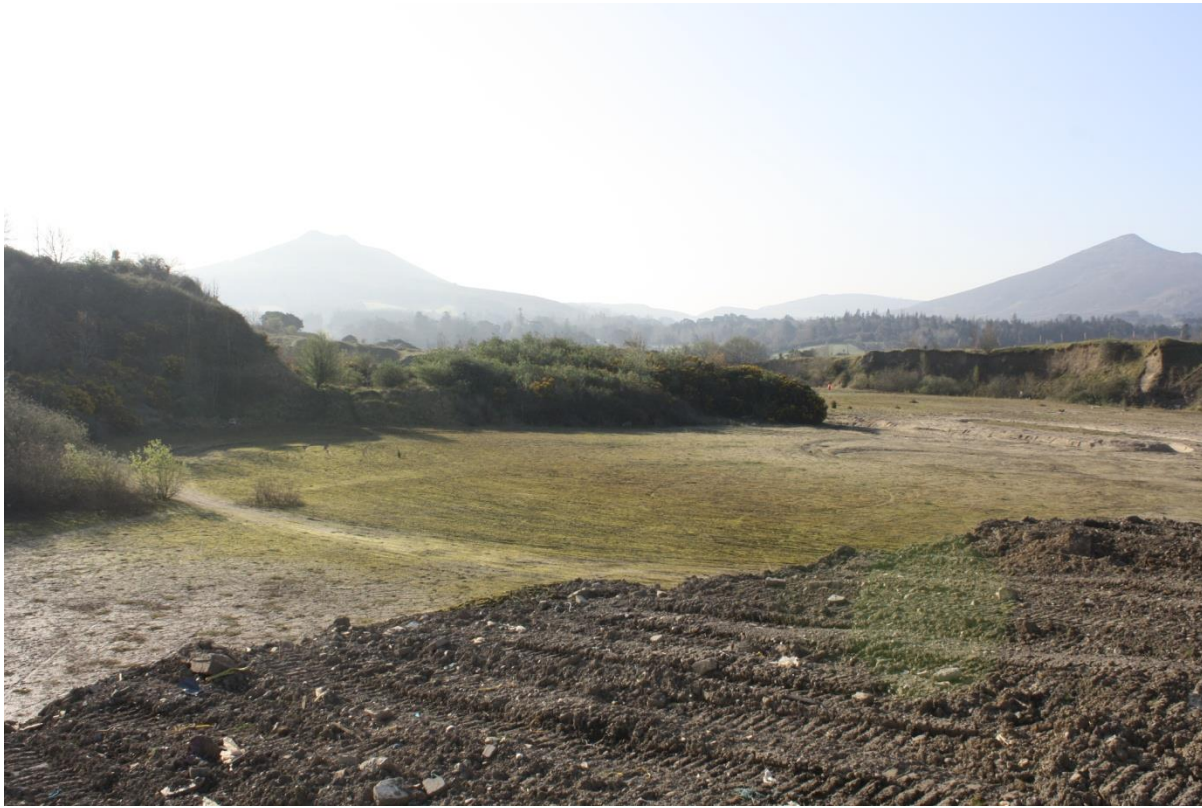
Plate 3 : View of Eastern and Southern Slopes of Former Pit from NW Corner

There does not appear to be any evidence of large scale (global) slope failure around the bare side slopes, rather it would appear that they are experiencing gradual regression, erosion and re-grading under both gravitational and climatic influences. No tension cracking or other sign of imminent instability was identified upslope or behind the crest of the steeper side slopes. The side slopes were generally dry, with no evidence of groundwater seepage, other than locally east of the descent ramp in the south-western corner of the former pit. It was also observed that

Taken together these observations indicate that the existing steep perimeter side slopes are relatively stable, albeit they are likely to be experiencing ongoing small scale spalling and erosion. This assessment concurs with experience and observations of Roadstone Wood's local site management.

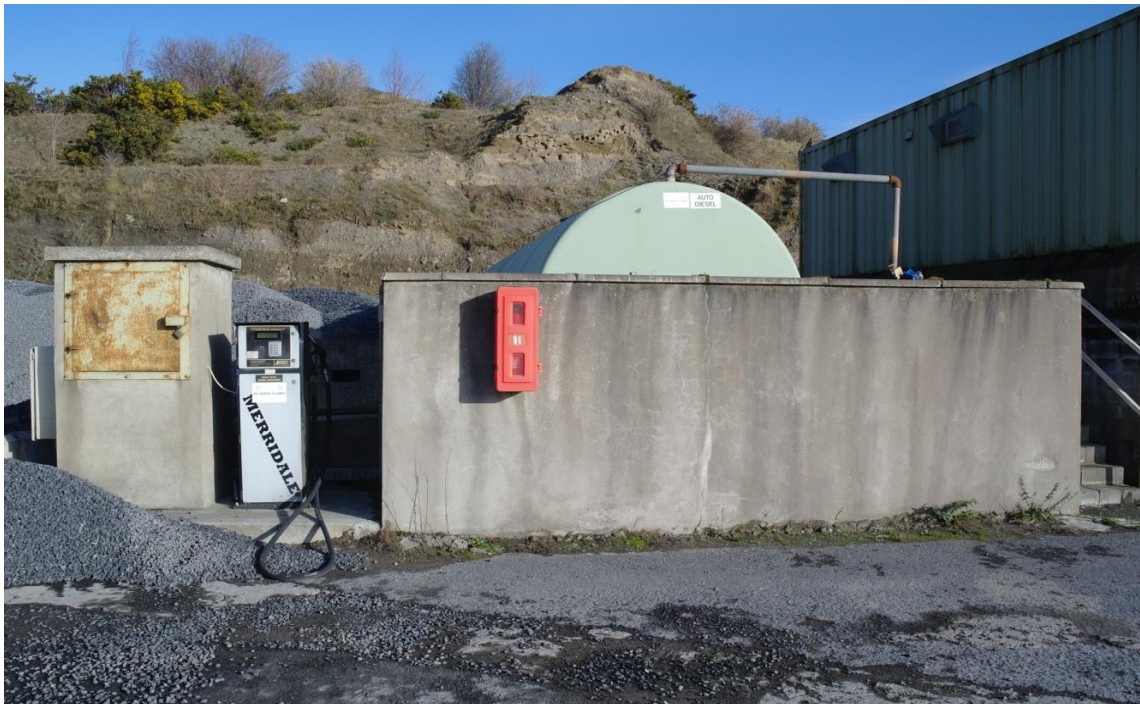
The site contains a 70,000 litre road diesel tank that is used to fuel company vehicles. The tank is protected against damage and leaks by a mass concrete bund, so the likely occurrence of a major rupture to the tank is considered low. However, without mitigation, there is a 'medium' risk of spillage of diesel during re-fuelling operations. The volume and location of such spillage may depend on mitigation measures employed at the site.

Photo 1 - Bunded 70,000 litre Diesel Tank

The severity of a 70,000 litre diesel spill to the gravel aquifer at the site is considered 'very high' as the clean-up costs could run to more than €100,000.

The 70,000 litre diesel tank is stored within a large concrete bund that is designed to contain more than the full volume of the tank. This provides mitigation against a major diesel spill at the site. An integrity test carried out in August 2011 showed that the bund is in very good condition and has capacity greater than 110% the capacity of the diesel tank.

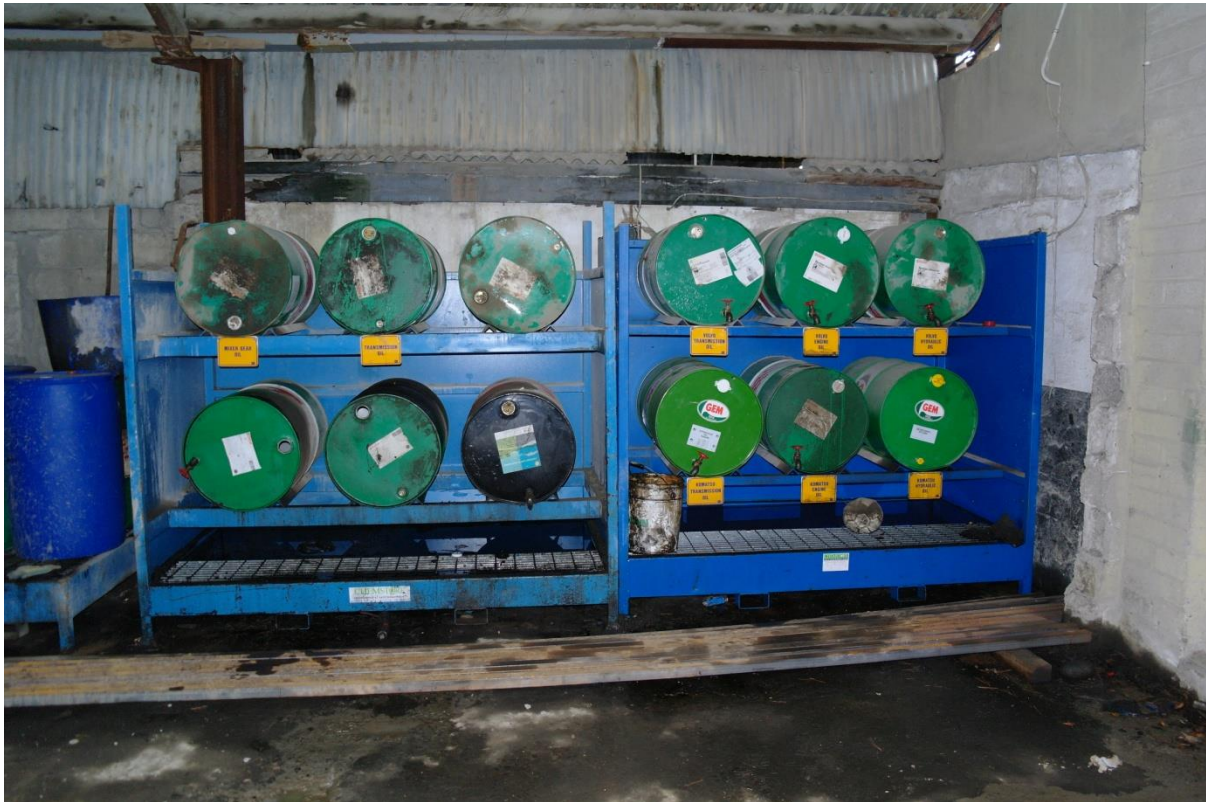
Photo 2 – Bunded Oil Drums in Maintenance Shed

The gas-oil, hydraulic oils, engine oils, transmission oils, waste oils, etc. are currently stored within bunded areas in the maintenance shed. The operator must maintain adequate capacity in these bunds for them to be effective.

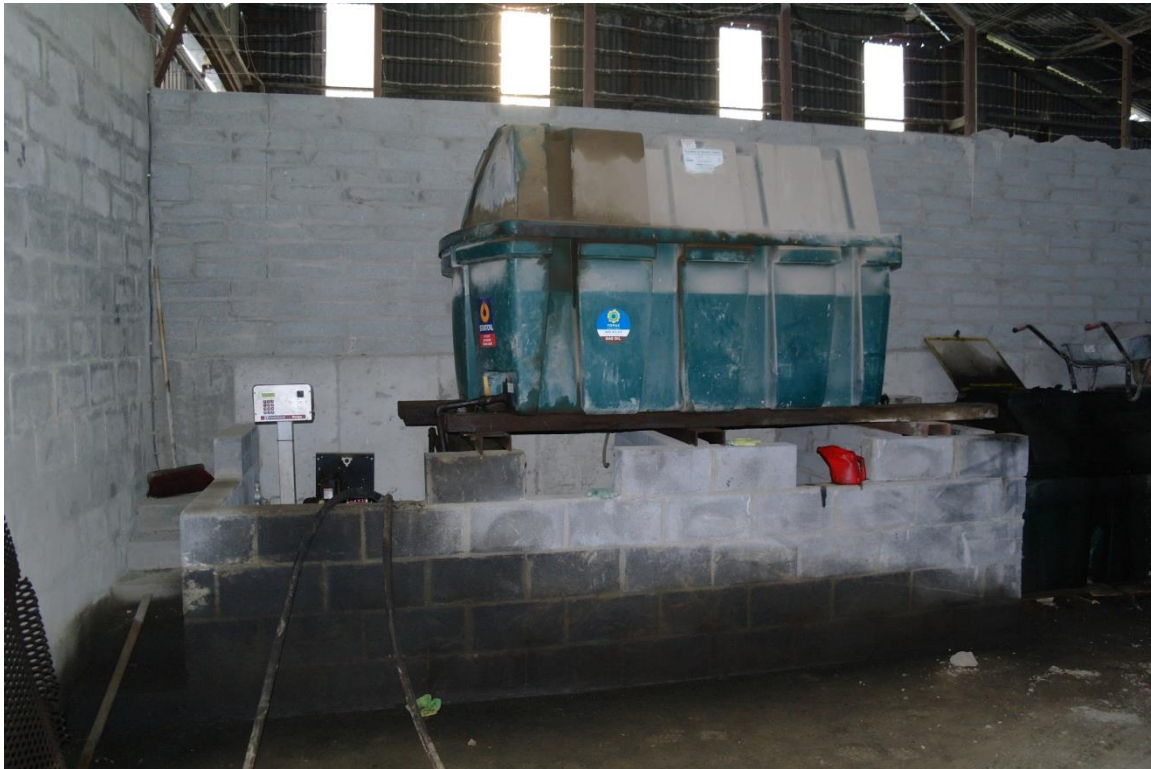
The 2,500 litre gas-oil tank consists of a self-bunded tank that is supported by the walls of a block-work bund (See Photo 3 below). There is a risk that a vehicle colliding with the bund wall would cause the tank to topple outside the bund and spill on the floor of the maintenance shed. The risk of such an occurrence is considered 'high'.

Photo 3 – Bunded Gas Oil (Diesel) Tank in Maintenance Shed

A spill of up to 2,500 litres of gas oil (diesel) in the maintenance shed would be directed to the adjacent yard area. This is an unpaved yard, so we expect a spill of this size to percolate to ground rather than drain to the downgradient site pond, located approximately 200 metres away. The severity of such an event is considered ‘medium’ with clean-up costs between €10,000 and €50,000.

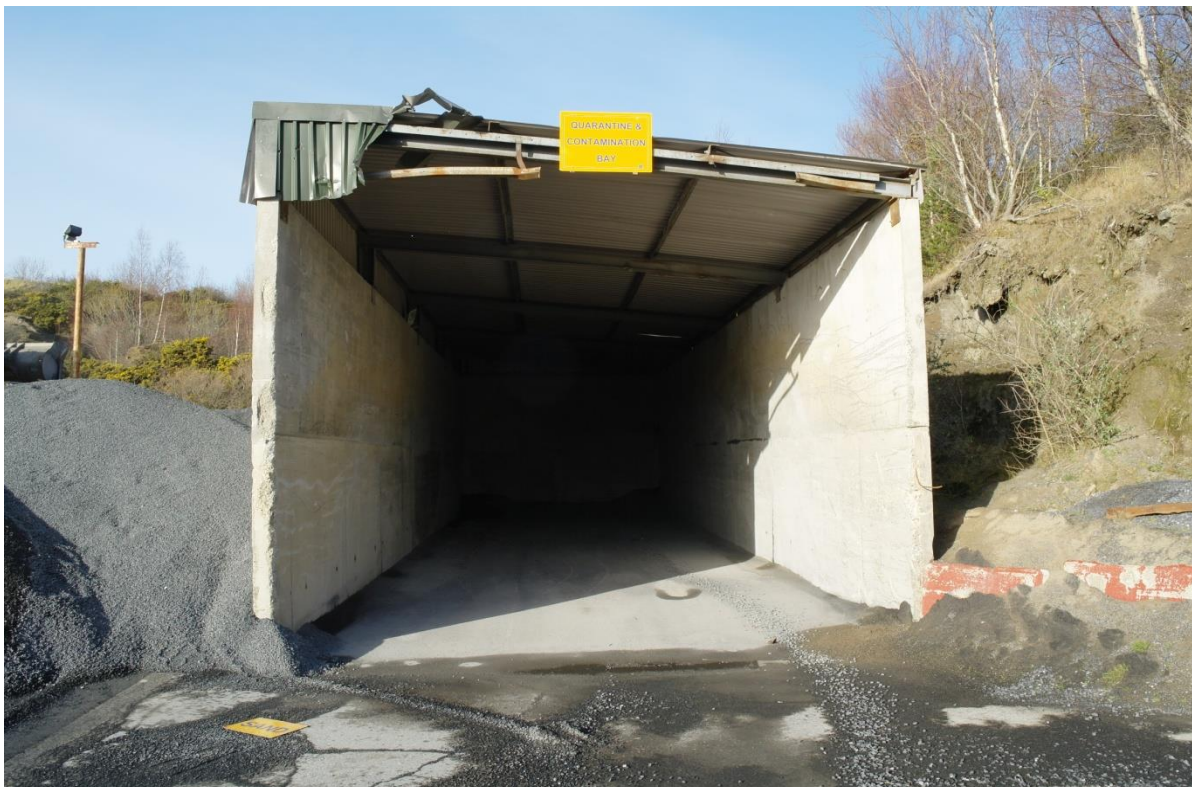
Photo 4 – Quarantine and Contamination Bay

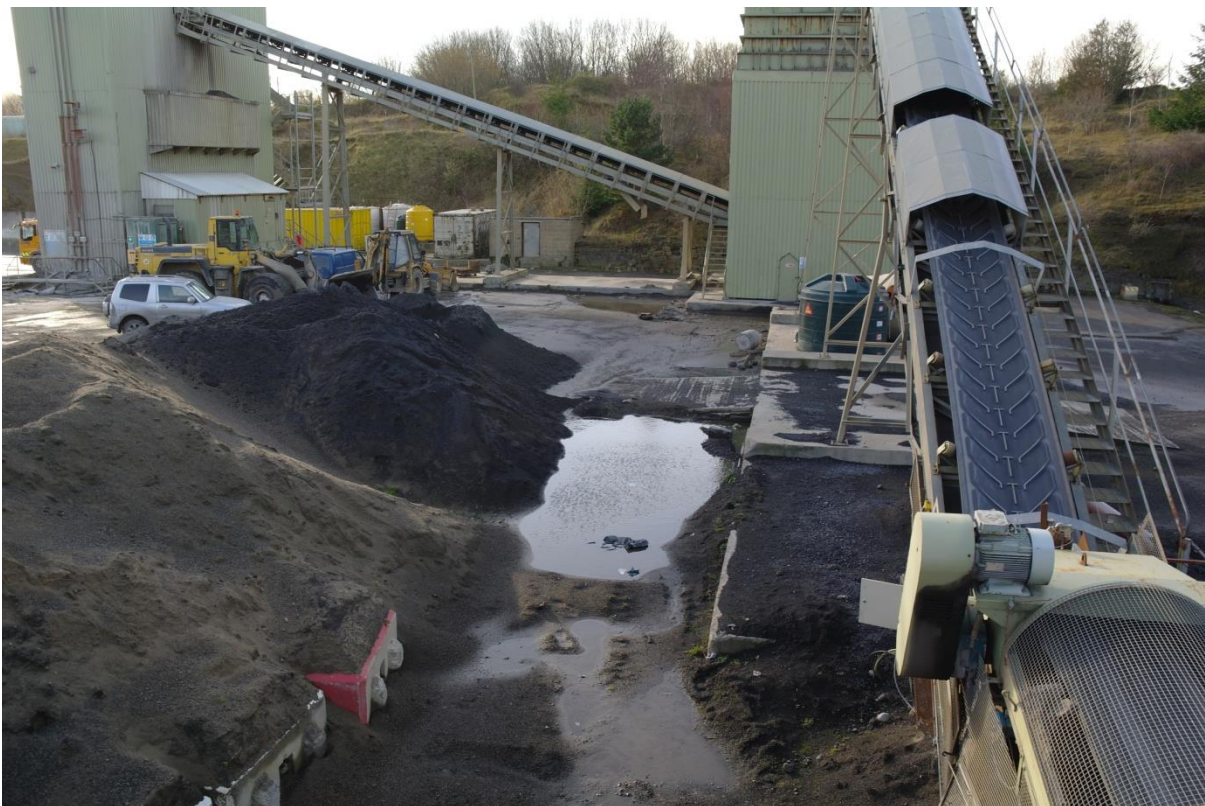
Photo 5 – Yard Drainage Impeded by Concrete Platform

The licensee is currently in the process of installing a Class II By-Pass Separator that will contain minor hydrocarbon spills or leaks emanating from the concrete production yard. The interceptor must be regularly inspected and adequately maintained. These mitigation measures, when fully installed and properly maintained reduce the risk of occurrence of this event from 'Medium' to 'Low'.
