ANNUAL ENVIRONMENTAL REPORT
FOR
BALLYNAGRAN LANDFILL LIMITED
LICENCE NO. W0165-02
JANUARY 2015 – DECEMBER 2015

Ballynagran Landfill Ltd.,
Ballynagran Landfill,
Ballynagran,
Co. Wicklow

18 May 2016

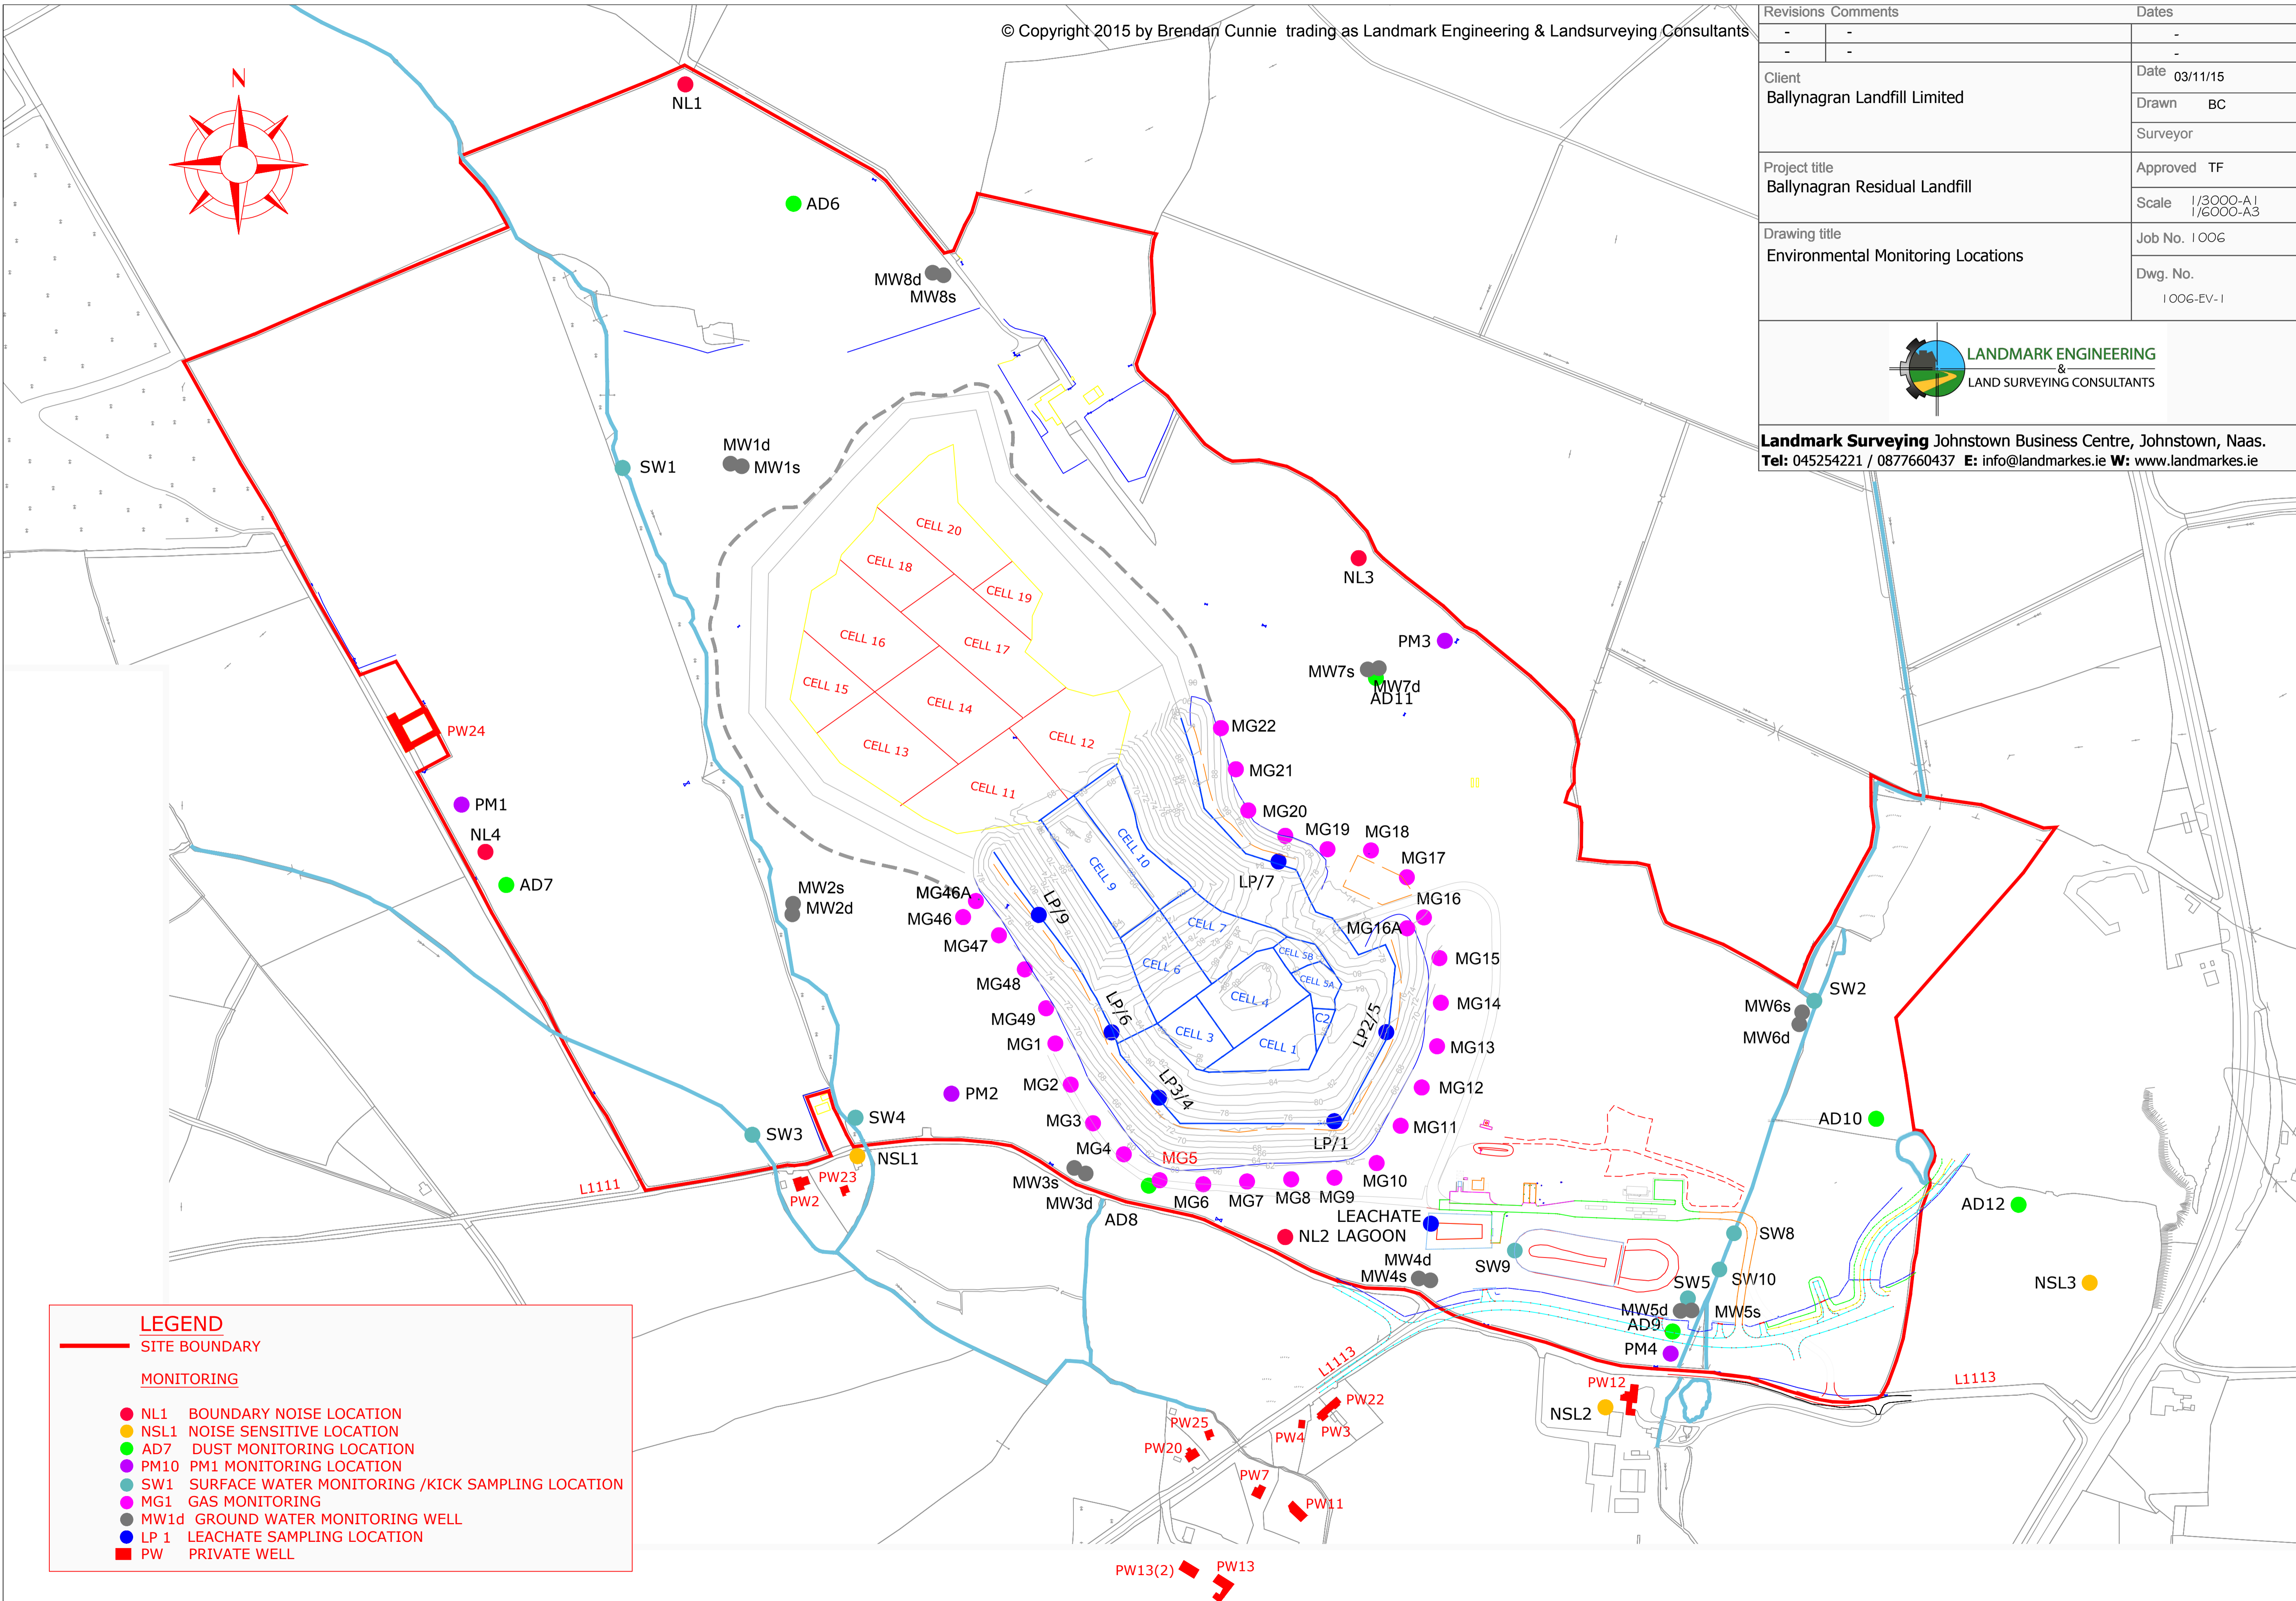
Revisions	Comments	Dates
-	-	-
-	-	-
Client Ballynagran Landfill Limited		Date 03/11/15
		Drawn BC
		Surveyor
Project title Ballynagran Residual Landfill		Approved TF
		Scale 1/3000-A1 1/6000-A3
Drawing title Environmental Monitoring Locations		Job No. 1006
		Dwg. No. 1006-EV-1
