**ANNUAL ENVIRONMENTAL REPORT 2015**

**DUNGARVAN WASTE DISPOSAL SITE**

**Waste Licence Register No. W0032-3**

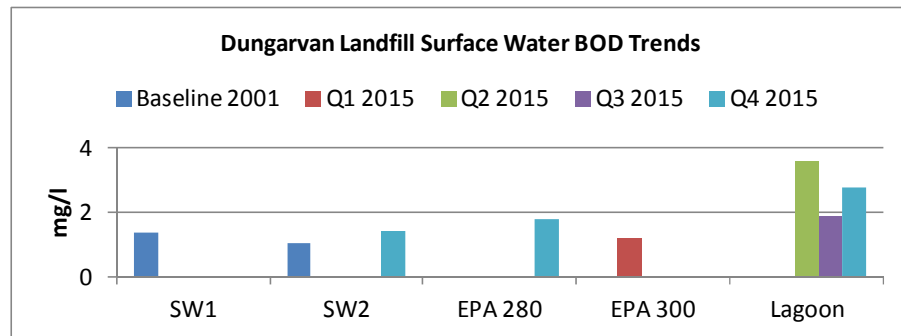
BOD levels were low in the lagoon and at river sites throughout the year. . Other water quality tests were satisfactory.

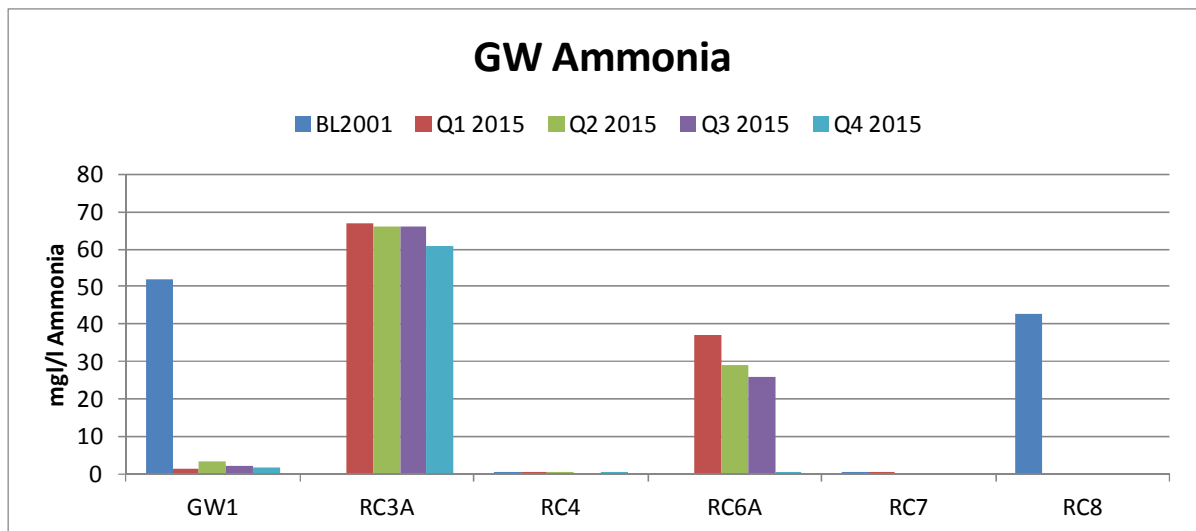
#### Key Parameter – Ammonia

*Ammonia* was elevated at sites RC3a and RC6a. RC4 and RC7, outside the landfill area, had relatively low *ammonia*. RC7 had a high ionic content at times, possibly indicating brackish water intrusion.

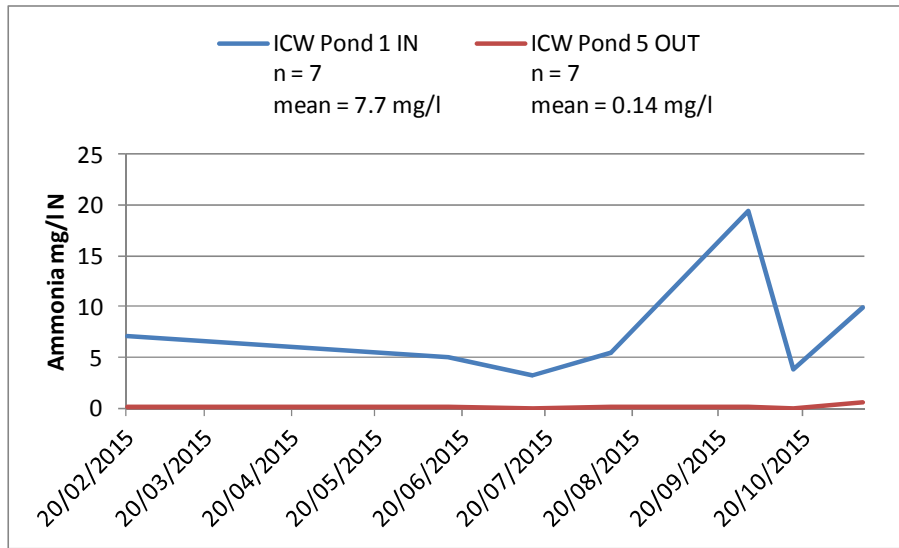
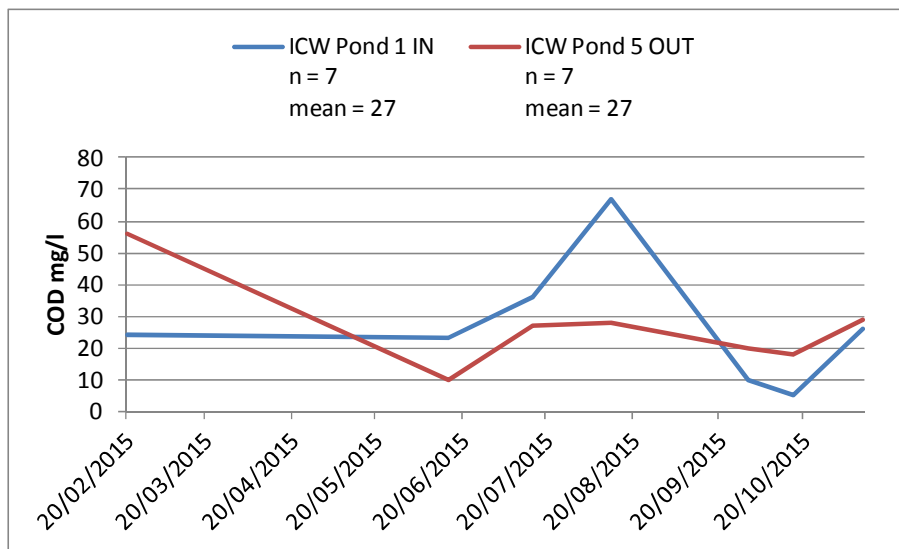
Figure 5.3.1: ICW inlet / outlet concentrations a) ammonium, b) chemical oxygen demand.

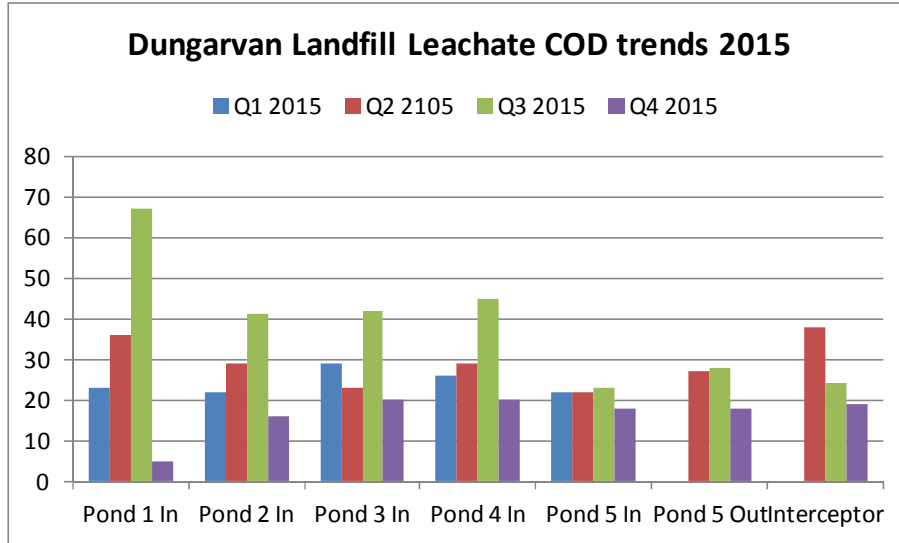
Figure 5.3.2 Leachate COD trends 2015

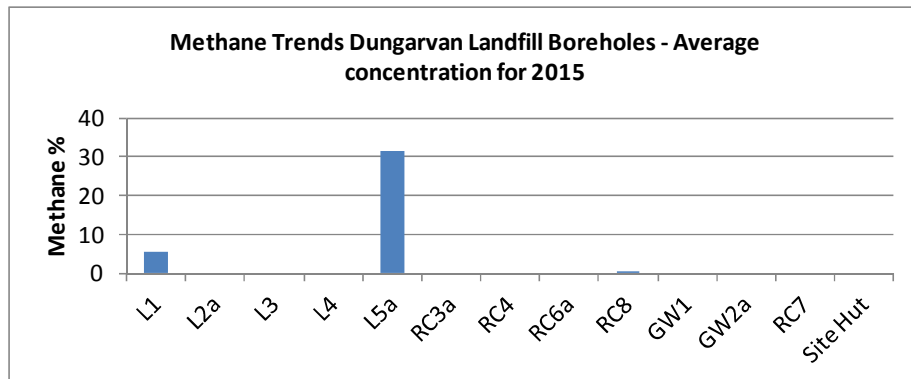
Figure 5.5.1 Methane spatial trends 2015

Relatively high levels (63.7%) of methane were detected at L5a within the waste deposit area in Q1 and 2. No methane was detected in the site buildings or at monitoring points outside the landfill area.

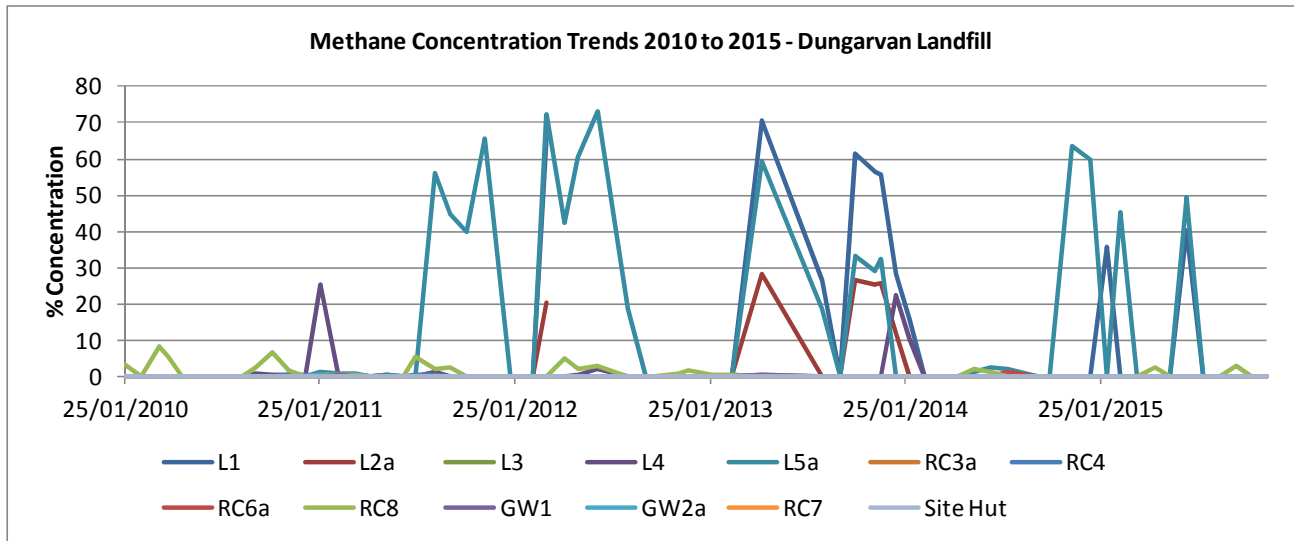
Figure 5.5.2 Methane temporal trends 2010 to 2015

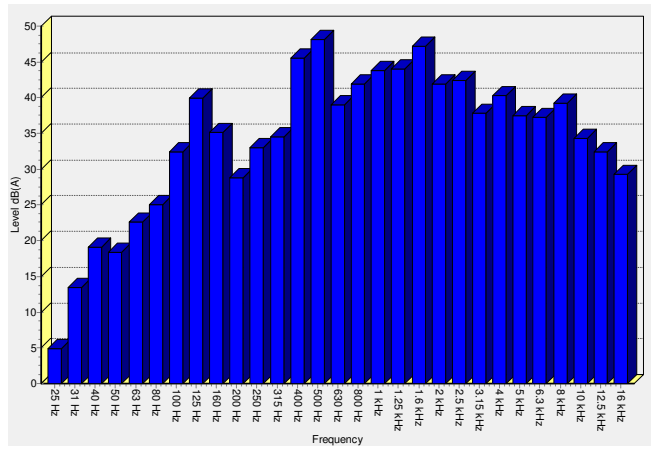
Fig 5.6 Dugarvan landfill noise monitoring 11/6/14, site entrance, octave band analysis, A weighting

Noise level recorded in June 2014 was 55.7, which was slightly in excess of the noise emission requirement of 55 dB(A) LAeq (30 mins) and was higher than the baseline level of 54 dB recorded in 1998. No unusual vehicle or other noise sources were reported by the operator. The octave analysis followed the usual pattern for this site, with no tonal extremes at either end of the frequency spectrum.

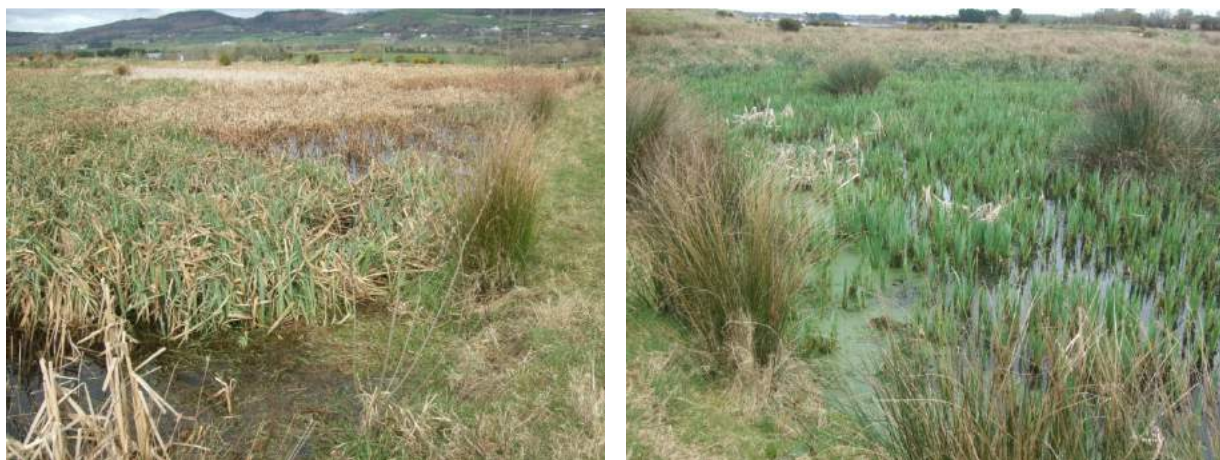
A series of 6 constructed wetlands were established on the landfill cap and are designed to collect and treat residual leachate from the landfill. The wetlands installed in autumn 2008 were planted with a mix of wetland vegetation such as reeds and sedges. Another artificial pond occurs in the south east of the landfill site and supports some submerged and emergent vegetation and has an extensive reedbed behind it. Artificial lakes and ponds occupy approximately 45% of the site area.

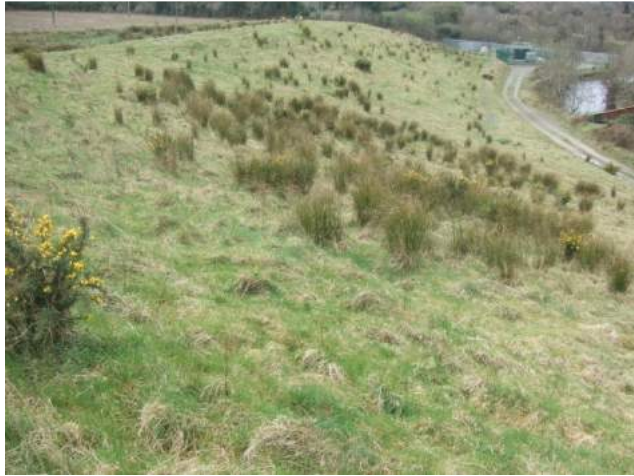
Patches of wet grassland occur on the western and northern side of the site with a frequent presence of *Juncus* species. Wet grassland accounts for 2% of habitat cover.

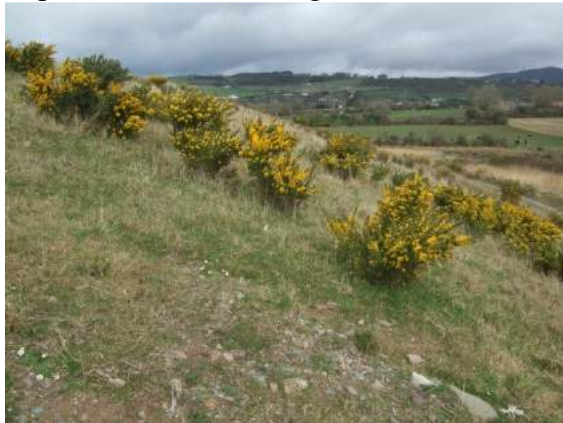
Some small areas of scrub occur around the periphery of the landfill site. The most extensive area of scrub is found on the riverbank along the north-eastern edge of the site. This area has developed from other habitats particularly recolonising bare ground (ED3). A narrow strip of scrub also occurs along the southern boundary. Scrub habitat accounts for 4% of the site area. The ability of Gorse to spread quickly will likely mean a rapid succession from grassland to scrub cover on the landfill cap. The presence of willow around the wetland margins and eastern slopes will also encourage the acceleration of scrub cover.

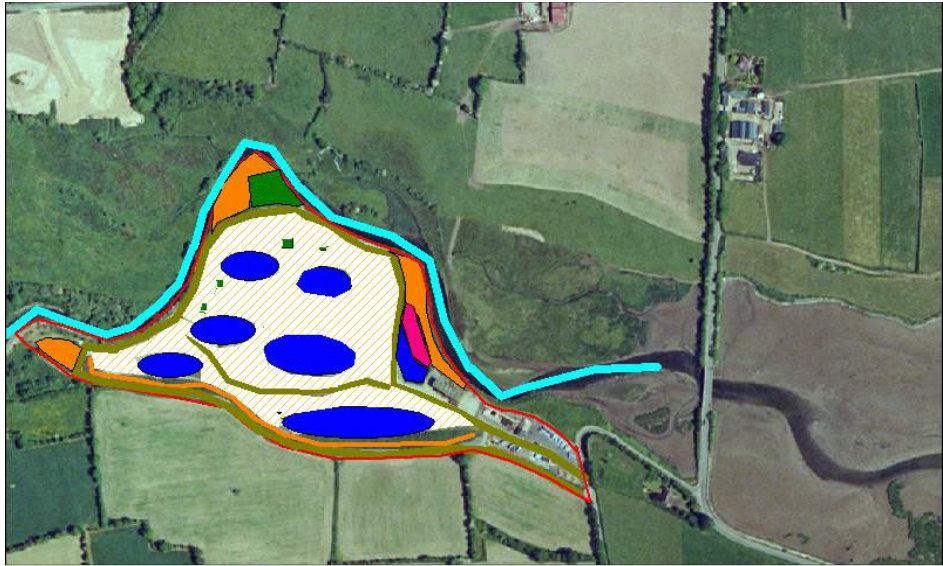
### **Figure 3 Habitat Map 2010**

Figures 3 and 4 below illustrate the habitat cover of the landfill site in 2010 and 2013

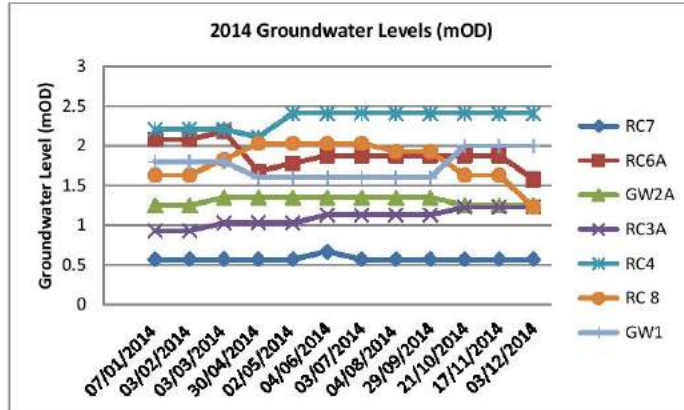
Figure 2.1: Groundwater Level Monitoring 2014

A seasonal variation of 0.10m to 0.80m is demonstrated **Figure 2.1**. The groundwater quality monitoring indicates that RC7 and RC8 are affected by saline intrusion from the estuary as seen in the intermittently high electrical conductivity levels due to the proximity of the Colligan Estuary which is tidal as far as SW2.

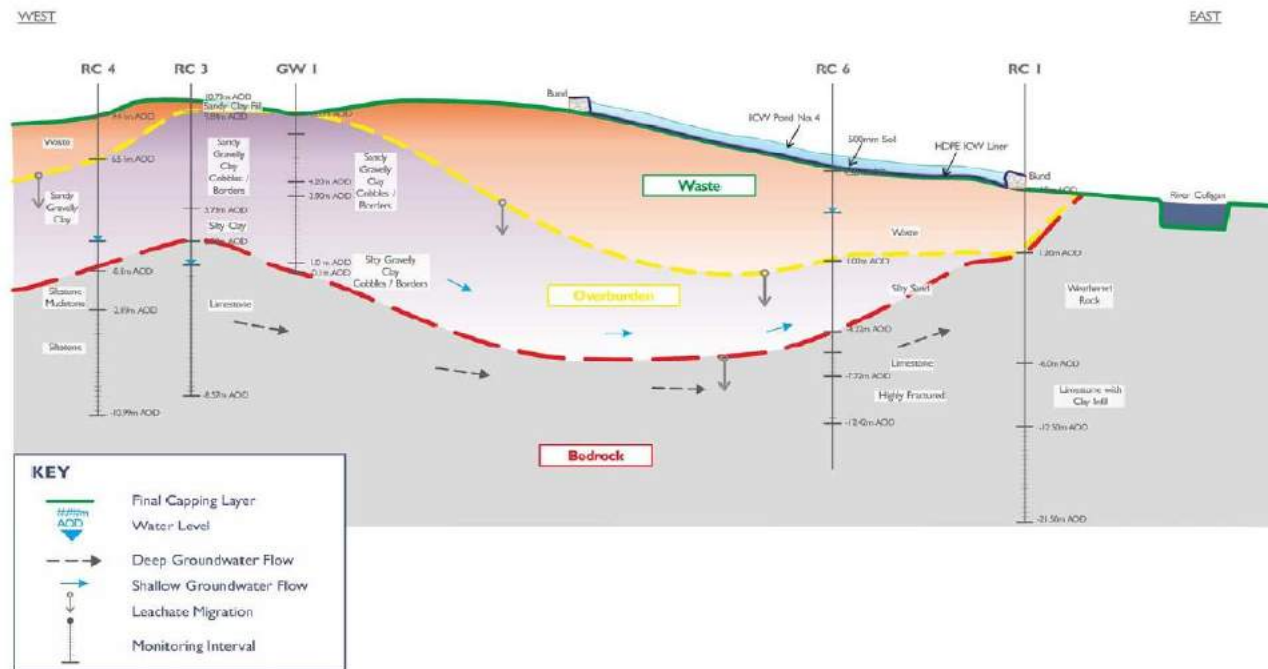
Figure 3.1: Dungarvan Landfill Conceptual Site Model

Dungarvan Landfill - Conceptual Site Model Cross Section n.t.s.

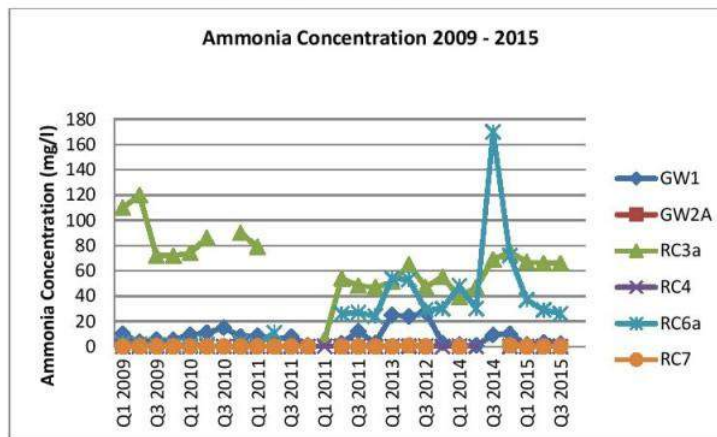
**Figure 4.1: Ammonia Concentration 2009 - 2015**

Ammonia is not classed as a hazardous substance but it has been identified as the main parameter of concern at the site. Concentrations greater than 100 times the threshold value of 0.065 mg/l have been measured at the site at monitoring locations RC3a (bedrock) and RC6a (bedrock) on all sampling dates and at GW1 in Q3 2014. On this basis the monitoring data for ammonia for the period 2008 to 2015 was reviewed and is presented on **Figure 4.1** to demonstrate trends to determine if there is any evidence of an expanding or shrinking plume at the site. Similar ammonia concentrations are seen at RC3a (range 39 to 75mg/l) and RC6a (range 26 to 72 mg/l) for the 2014 and 2015 data. There is no borehole log is available for monitoring borehole RC7 but it is reported to be monitoring the shallow groundwater in the overburden deposits down gradient of the site. Monitoring at RC7 indicates there is no issue with elevated ammonia concentrations in the shallow groundwater in the overburden deposits down gradient of the site.

The concentration of ammonia is currently monitored on a quarterly basis in accordance with the Waste Licence and it is recommended that this monitoring frequency be maintained. It is recommended that a groundwater monitoring borehole be installed in the bedrock aquifer down gradient of the site to serve as a compliance monitoring point.
