# Attachment I

## Existing Environment & Impact of the Facility

## **I.1 Assessment of Atmospheric Emissions**

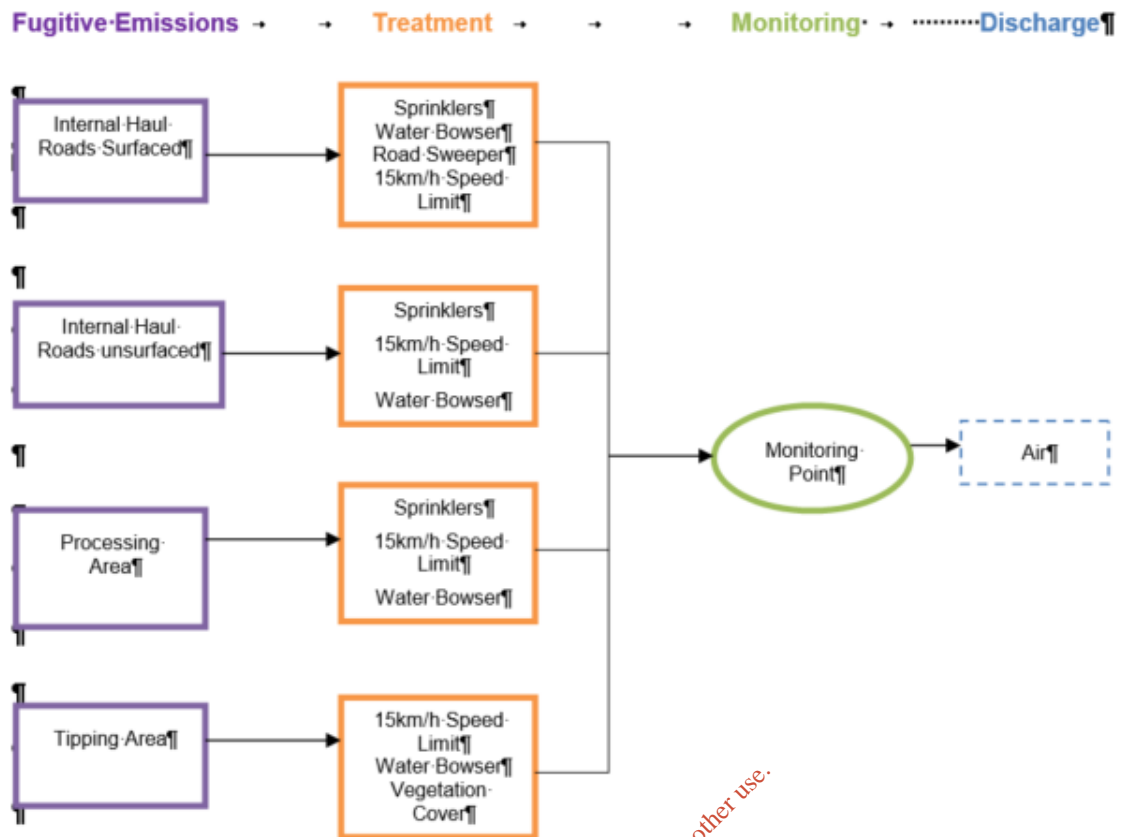
**Figure I.1.(ii) Air Emissions - Operational Activities**

The following flow diagram shows the sources of fugitive dust emissions arising on site and the methods of treatment/ abatement to be employed.

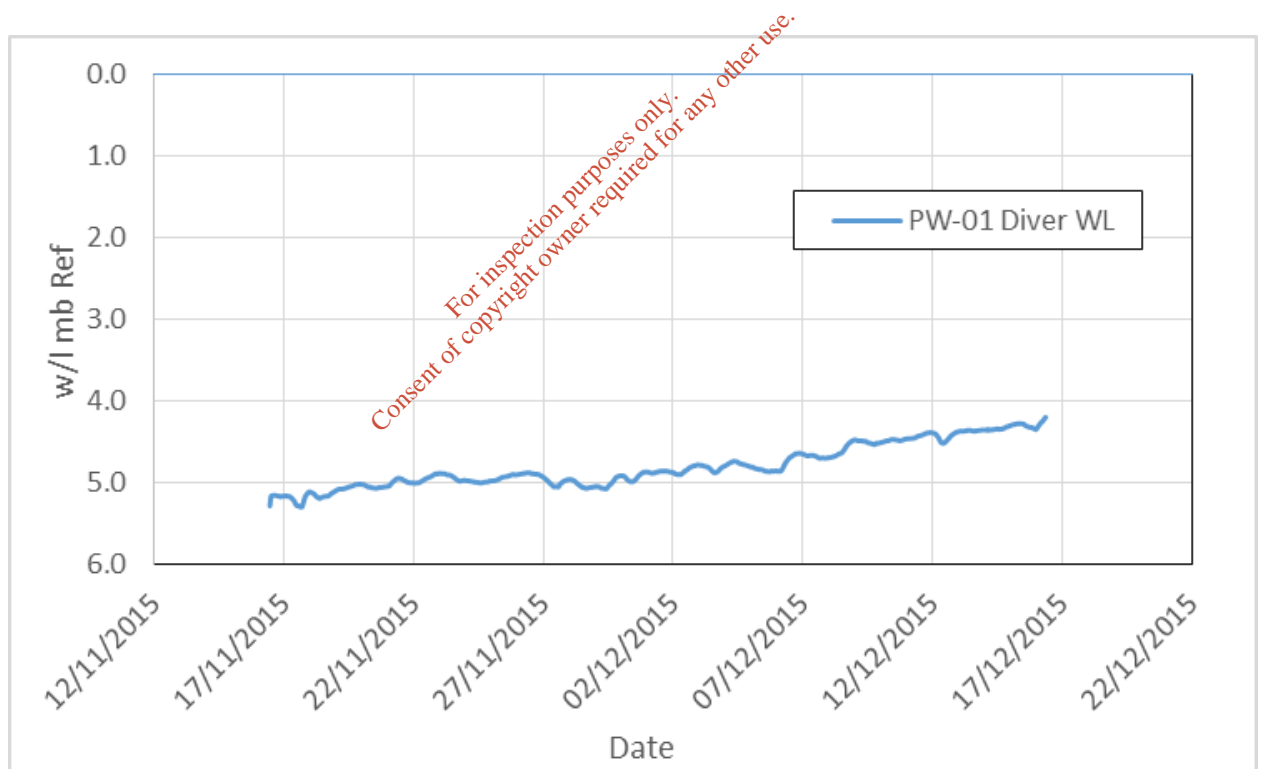
Location I.D.	16/11/2015 w/l mbRef	16/11/2015 (mOD)	16/12/2015 w/l mbRef	16/12/2015 (mOD)
PW-01	4.65	94.89	4.2	95.34
MW15-01	-	-	25.65	95.15
MW15-02	-	-	4.39	95.55

**Figure I:** Water level hydrograph for PW-01 between 16/11/2015 and 16/12/2015

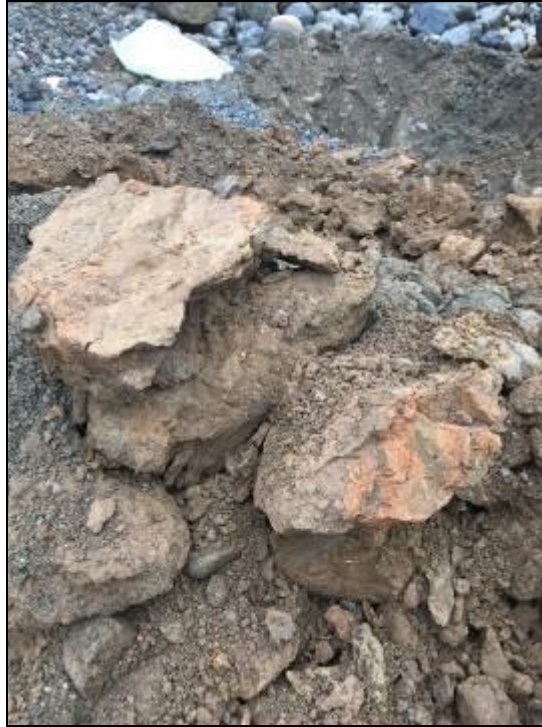
The trial pits on the floor of the excavated pit show that a laminated clays/lacustrine strata also exists below the sands and gravel, although this appears to be intermitted and not continuous across the site. Where this is present it is solid/hard and dry and relatively impermeable. The spring that emerges on the floor of the pit may be related to groundwater flow above the lacustrine layer, which appears to be mostly present along the western boundary of the pit. An example of the lacustrine deposits found at the site [below the sand and gravel deposits] is illustrated on **Figure K**.

**Figure K:** Hard laminated clay and lacustrine deposits from TP15-12

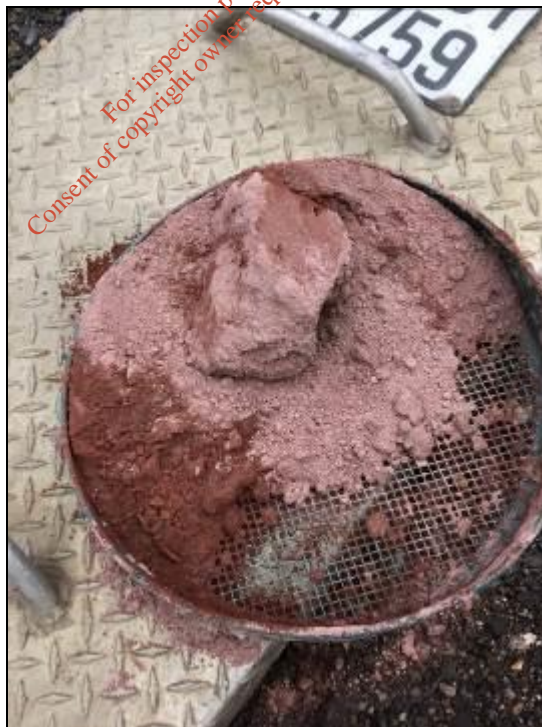
The bedrock drilling below the site has proven that the site is underlain by red sandstone. Red sandstone drilling returns from drilling at MW15-02 are shown on **Figure L**.

**Figure L:** Red sandstone drilling returns from MW15-02

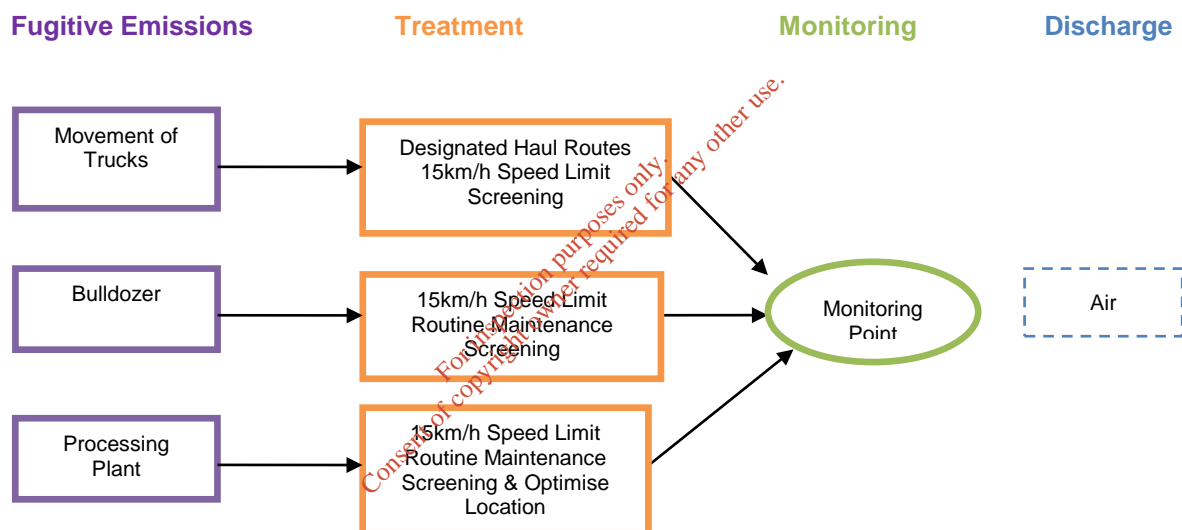
### I.6.(i) Noise Emissions - Operational Activities

The following flow diagram shows the main sources of noise emissions arising on site and the methods of treatment/abatement employed.
