R755 PAVEMENT CONDITION SURVEY
AND GEOMETRIC ALIGNMENT REPORT

# Planning Reference 08/1650: Response to Request for Further Information – Roads Issues

Roadstone Dublin Ltd.

Calary Quarry, Killough Upper, Kilmacanogue, Lee Co. Wicklow

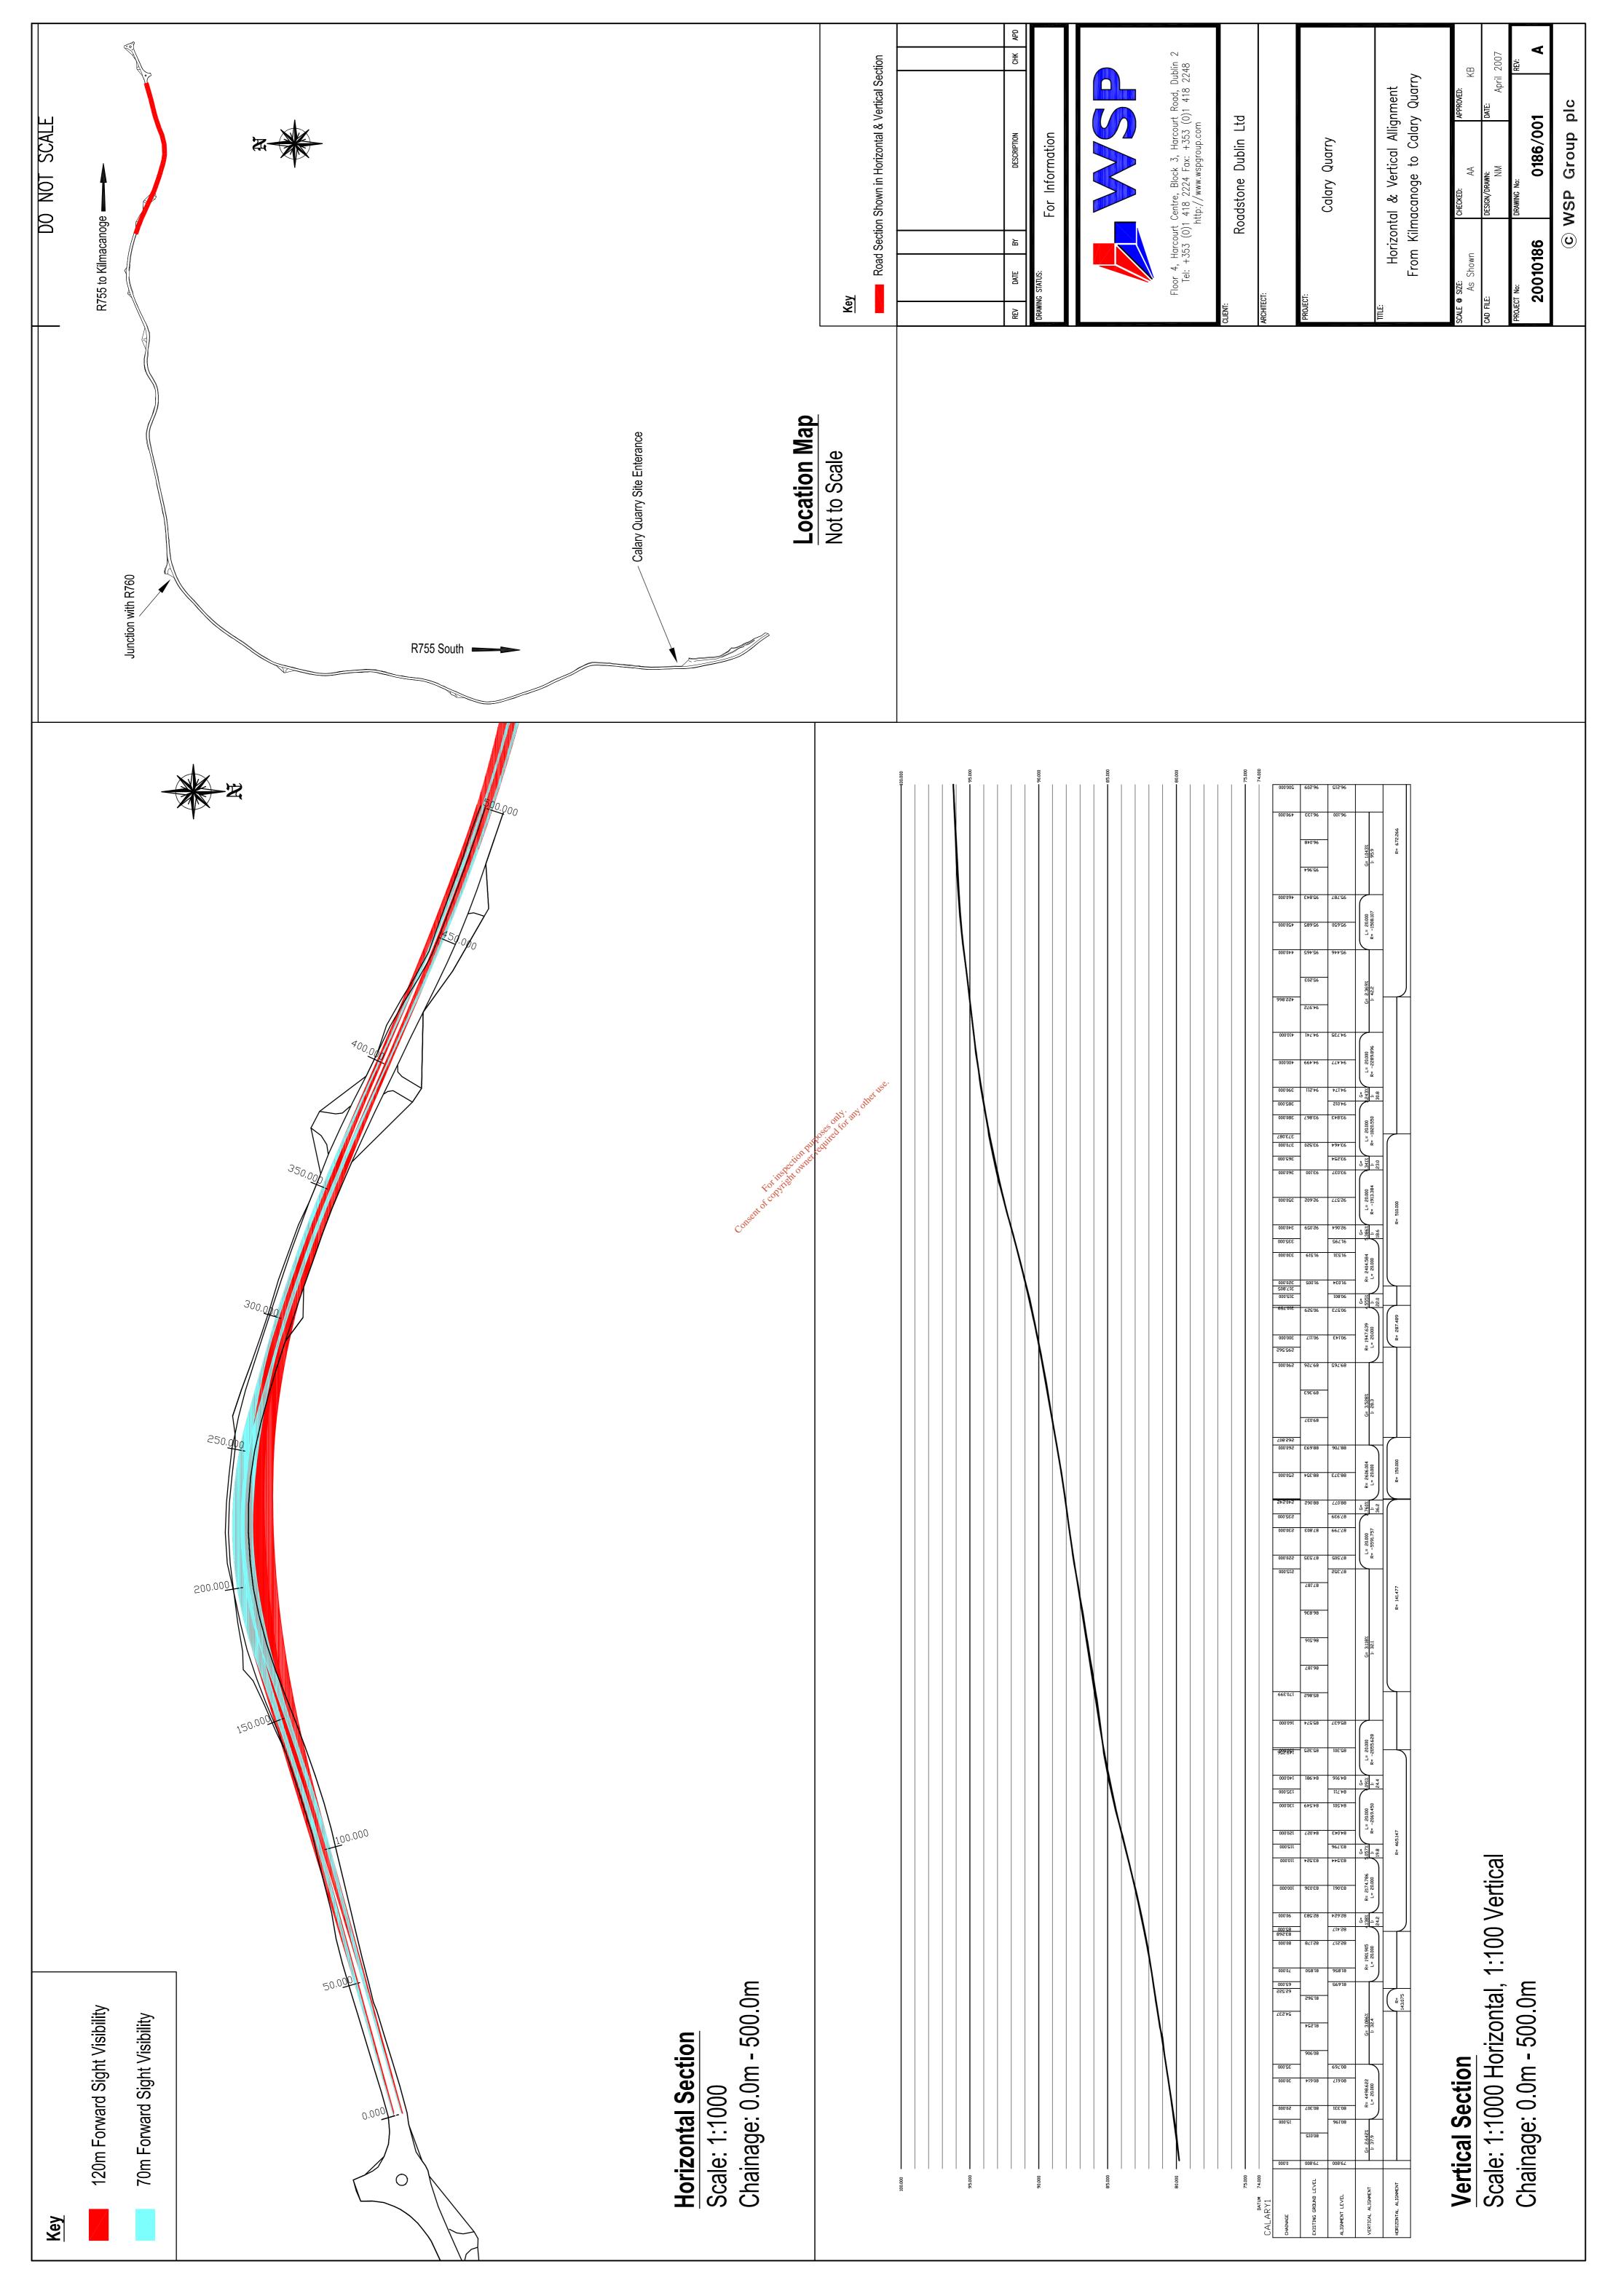
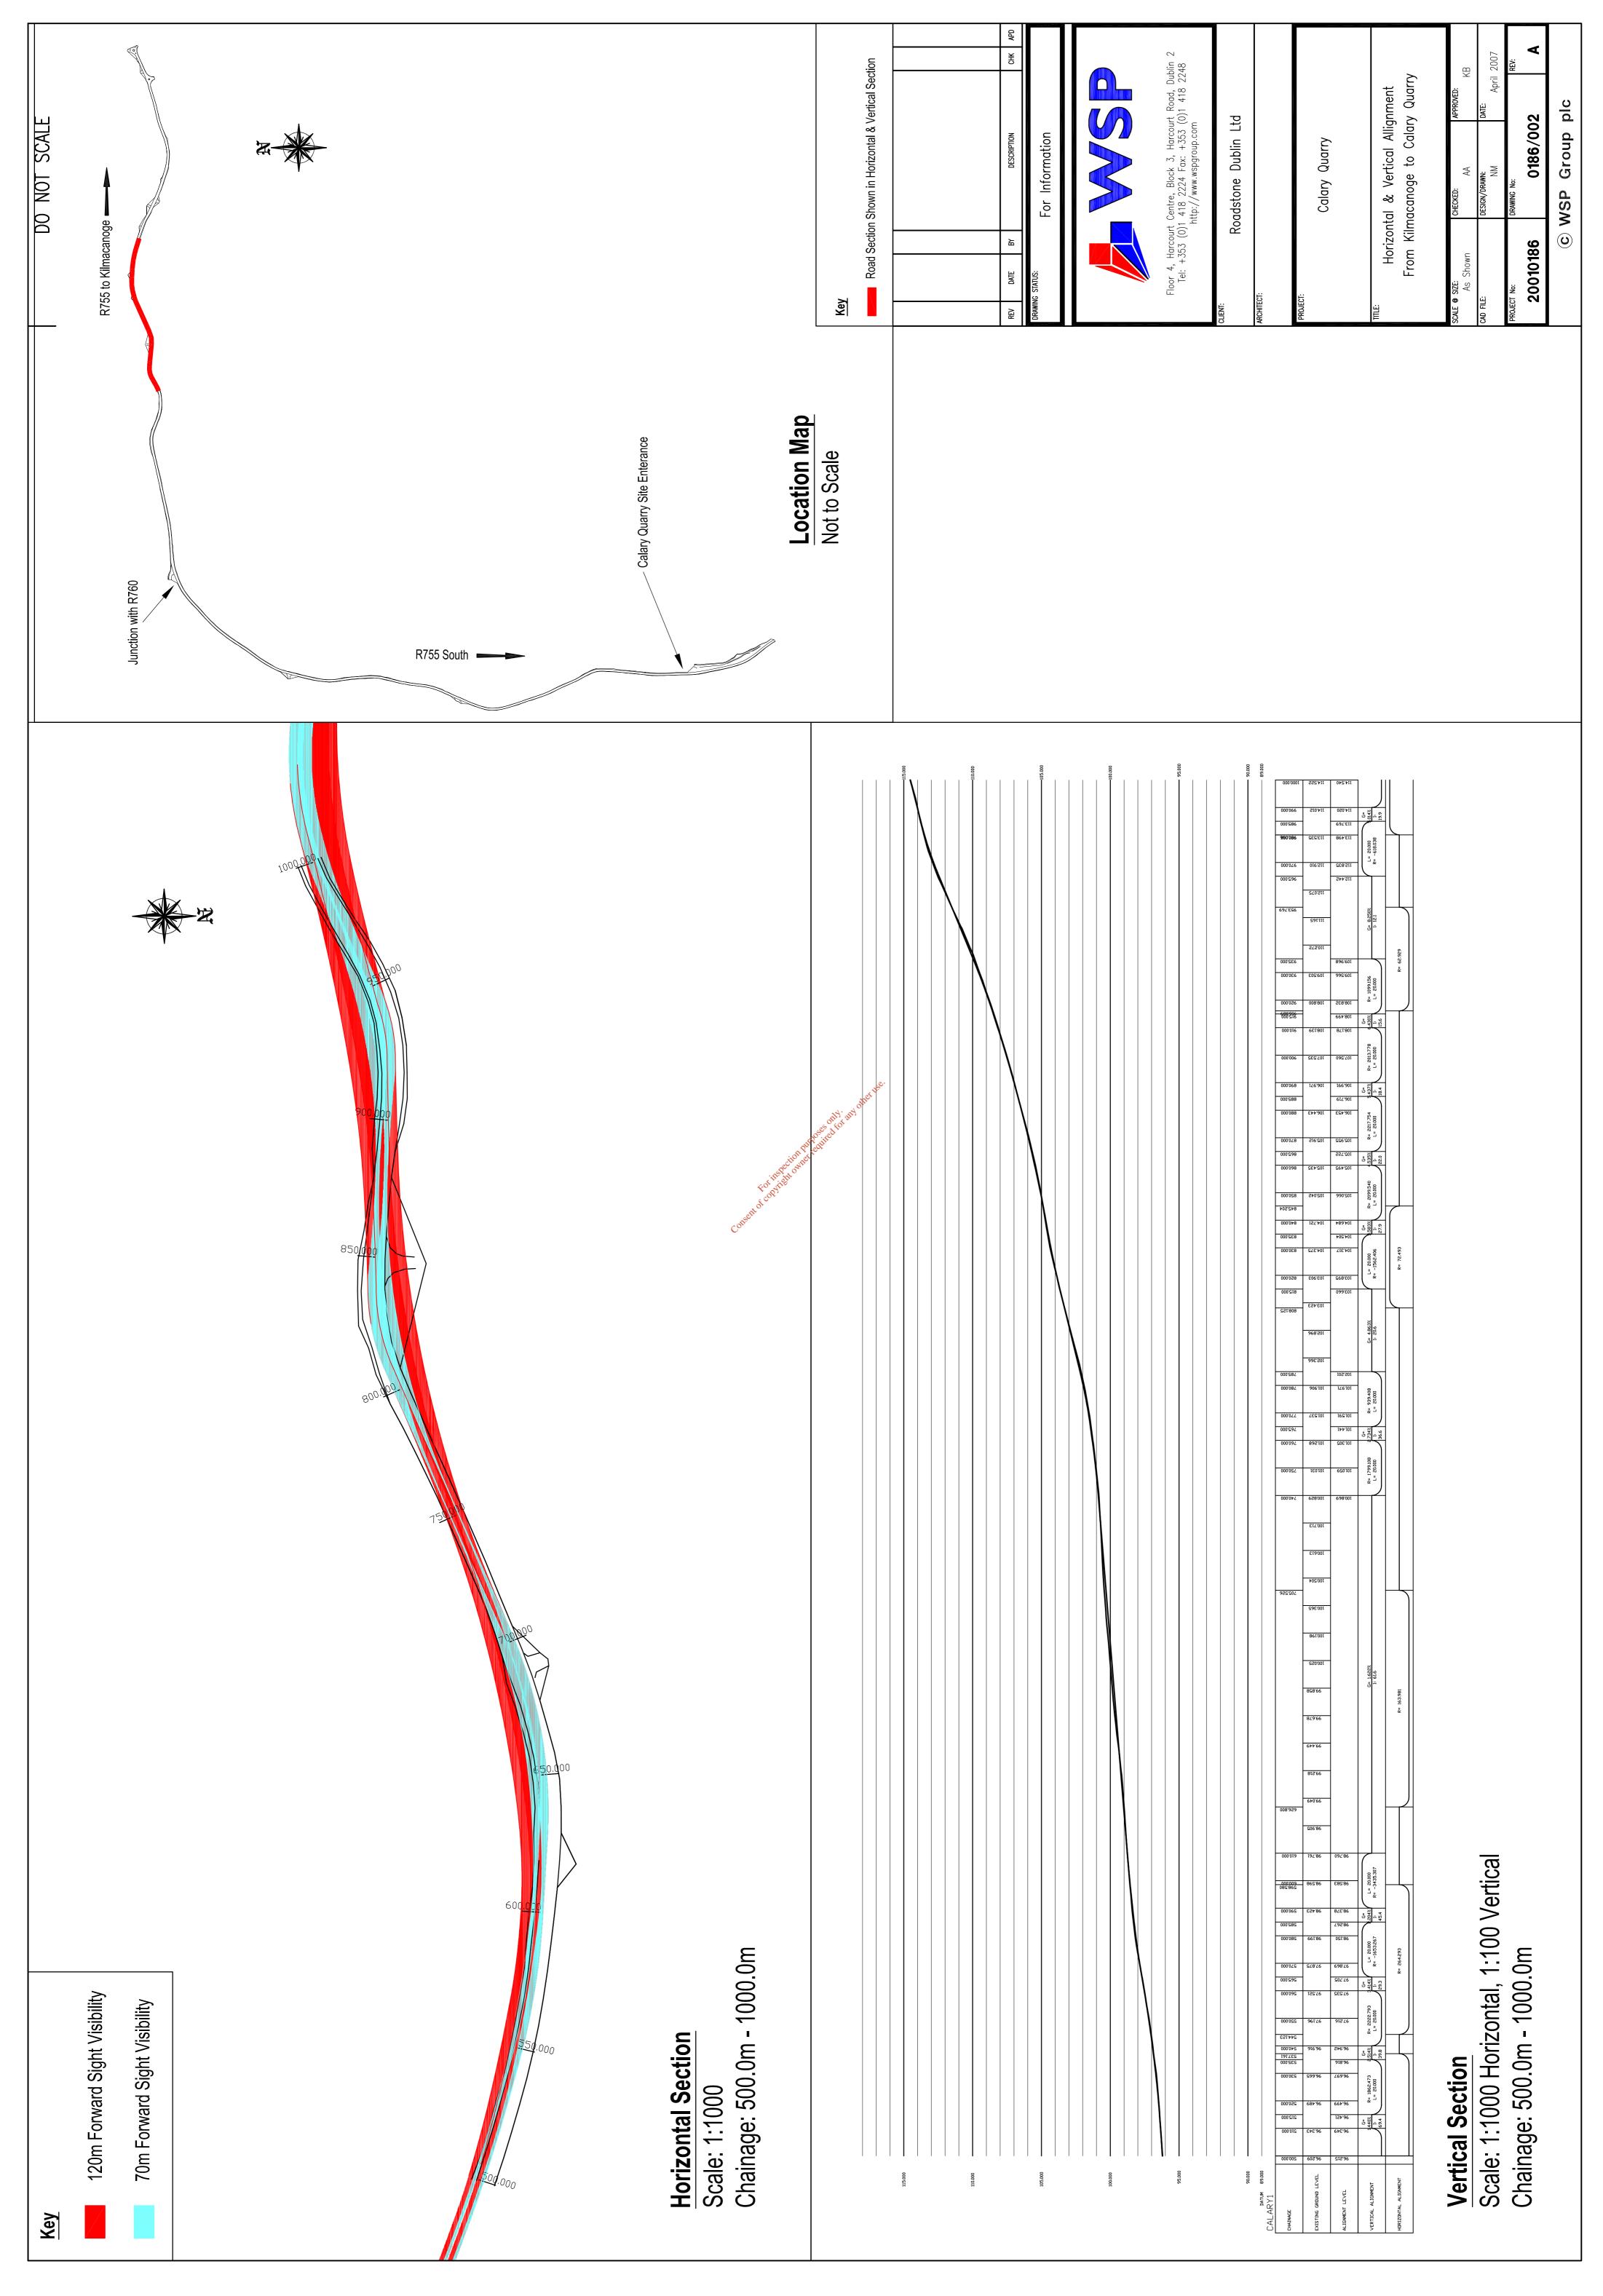
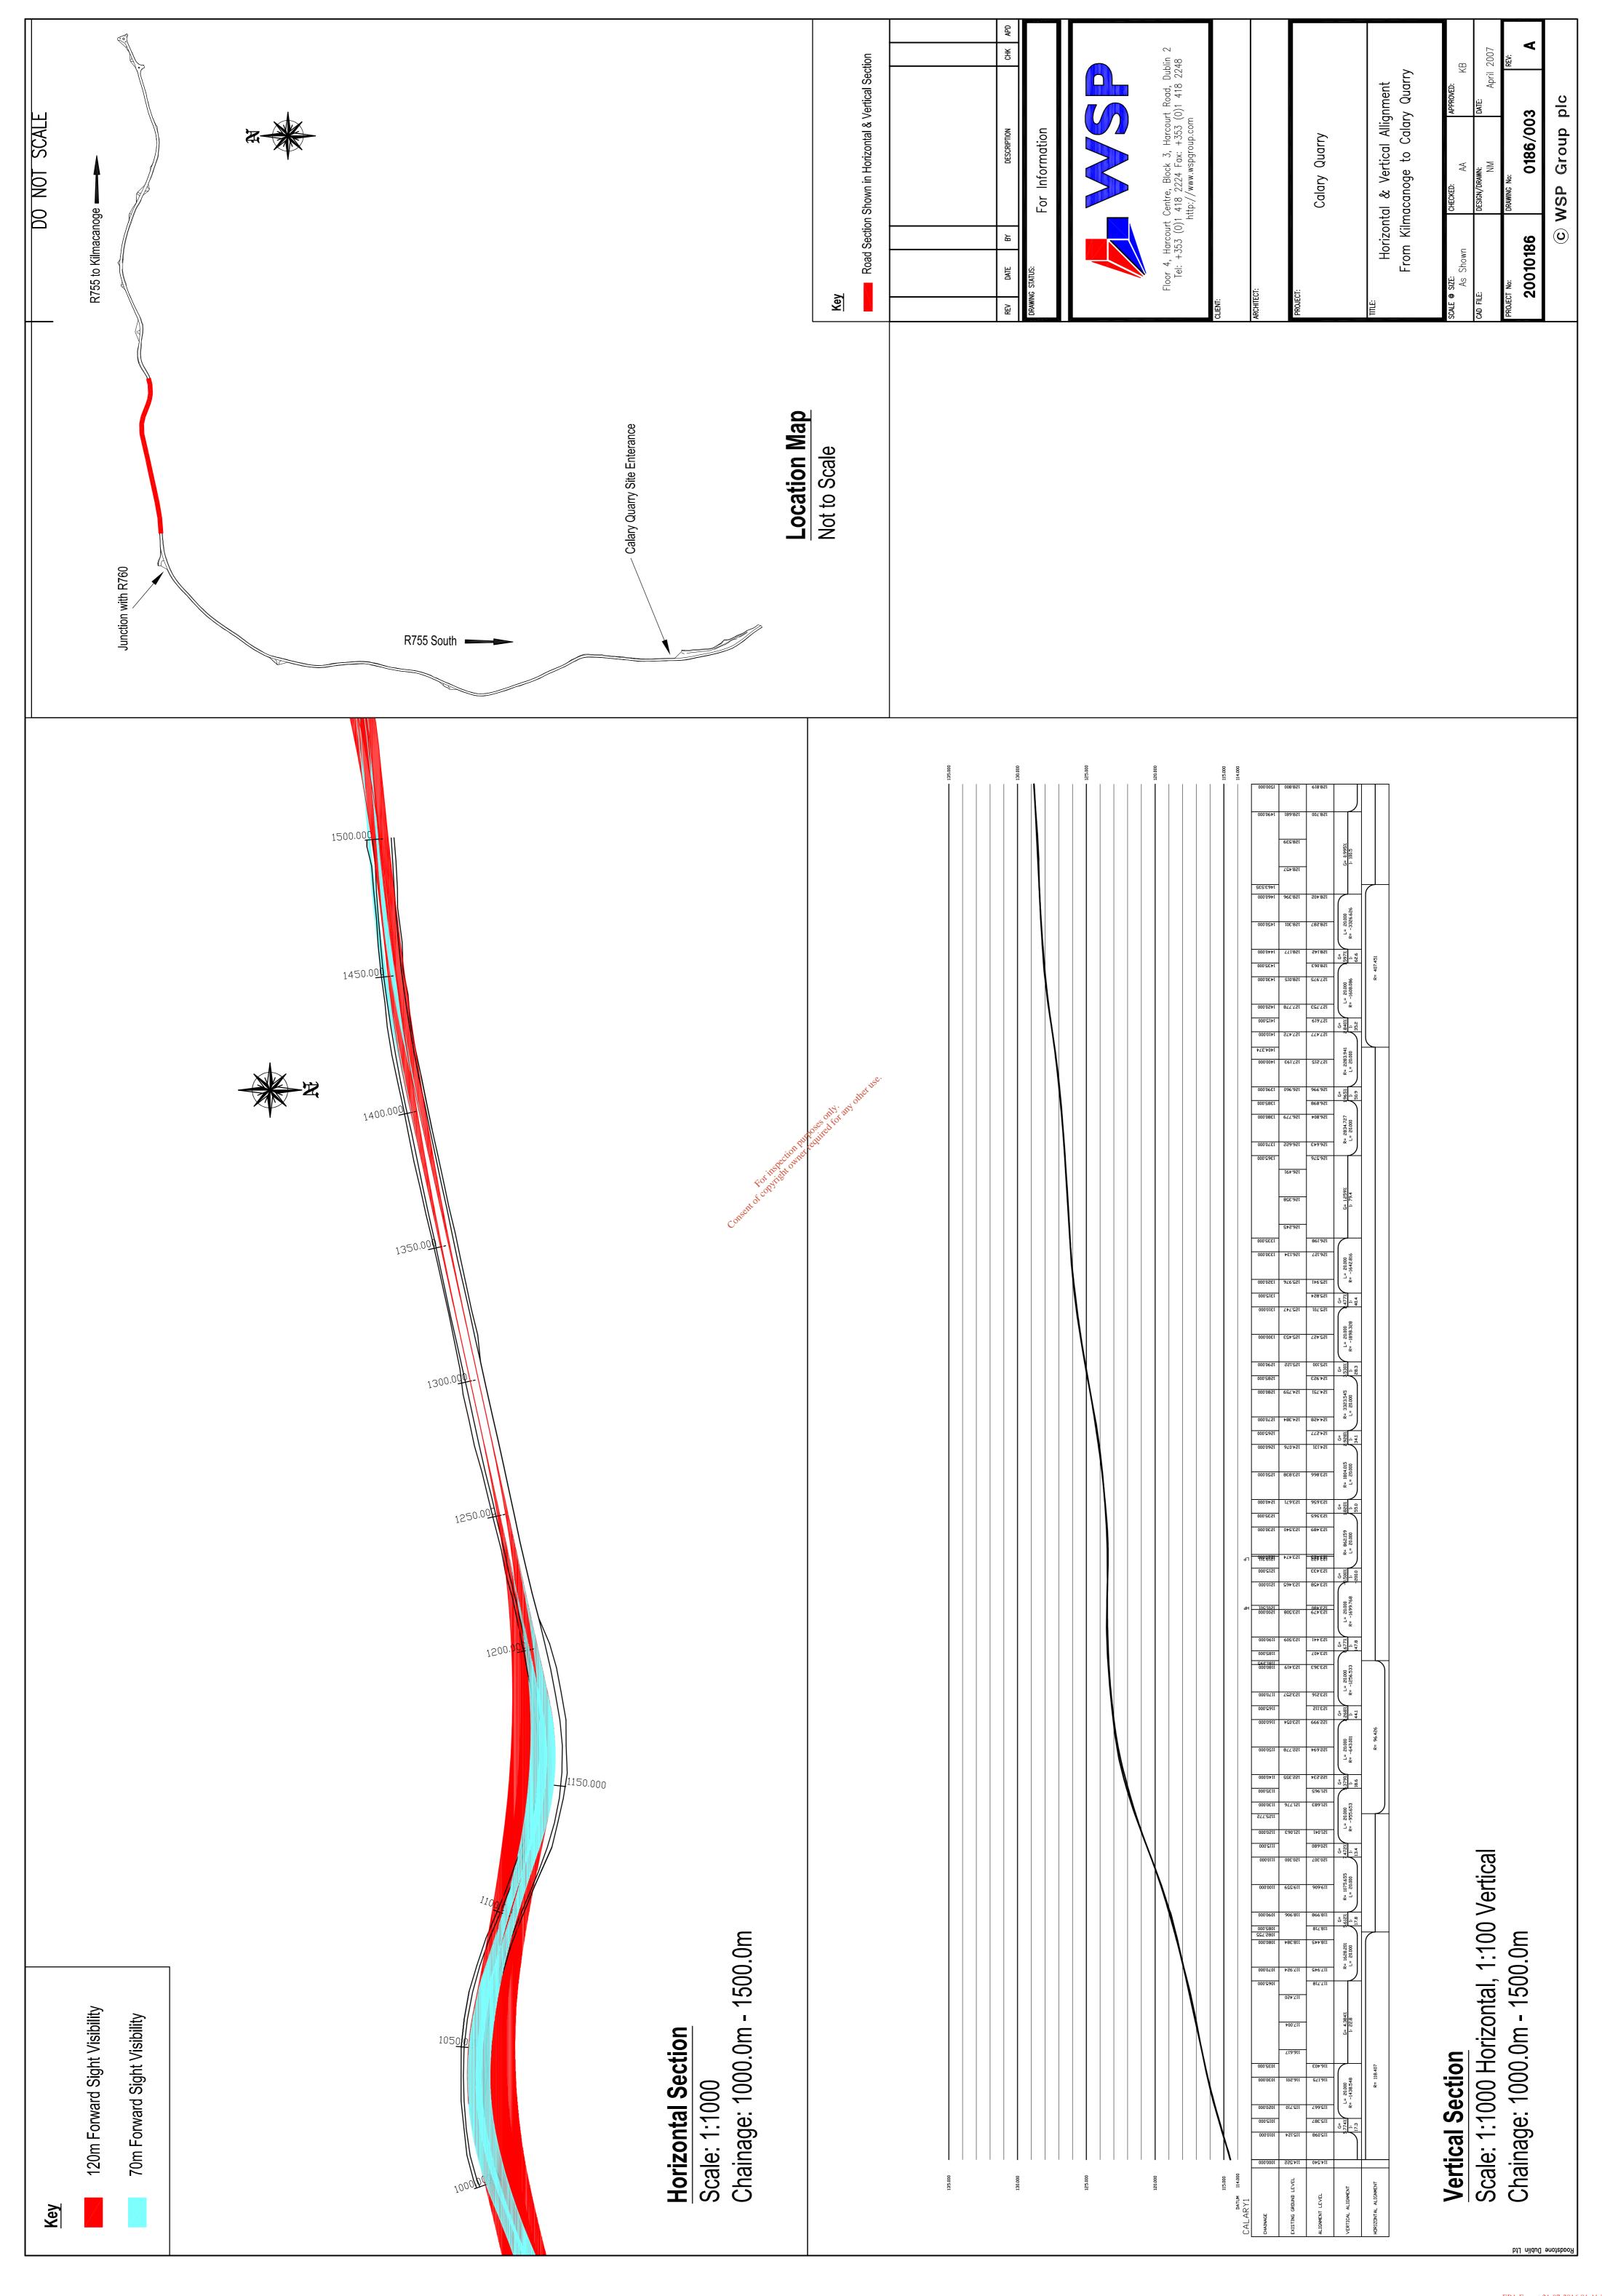
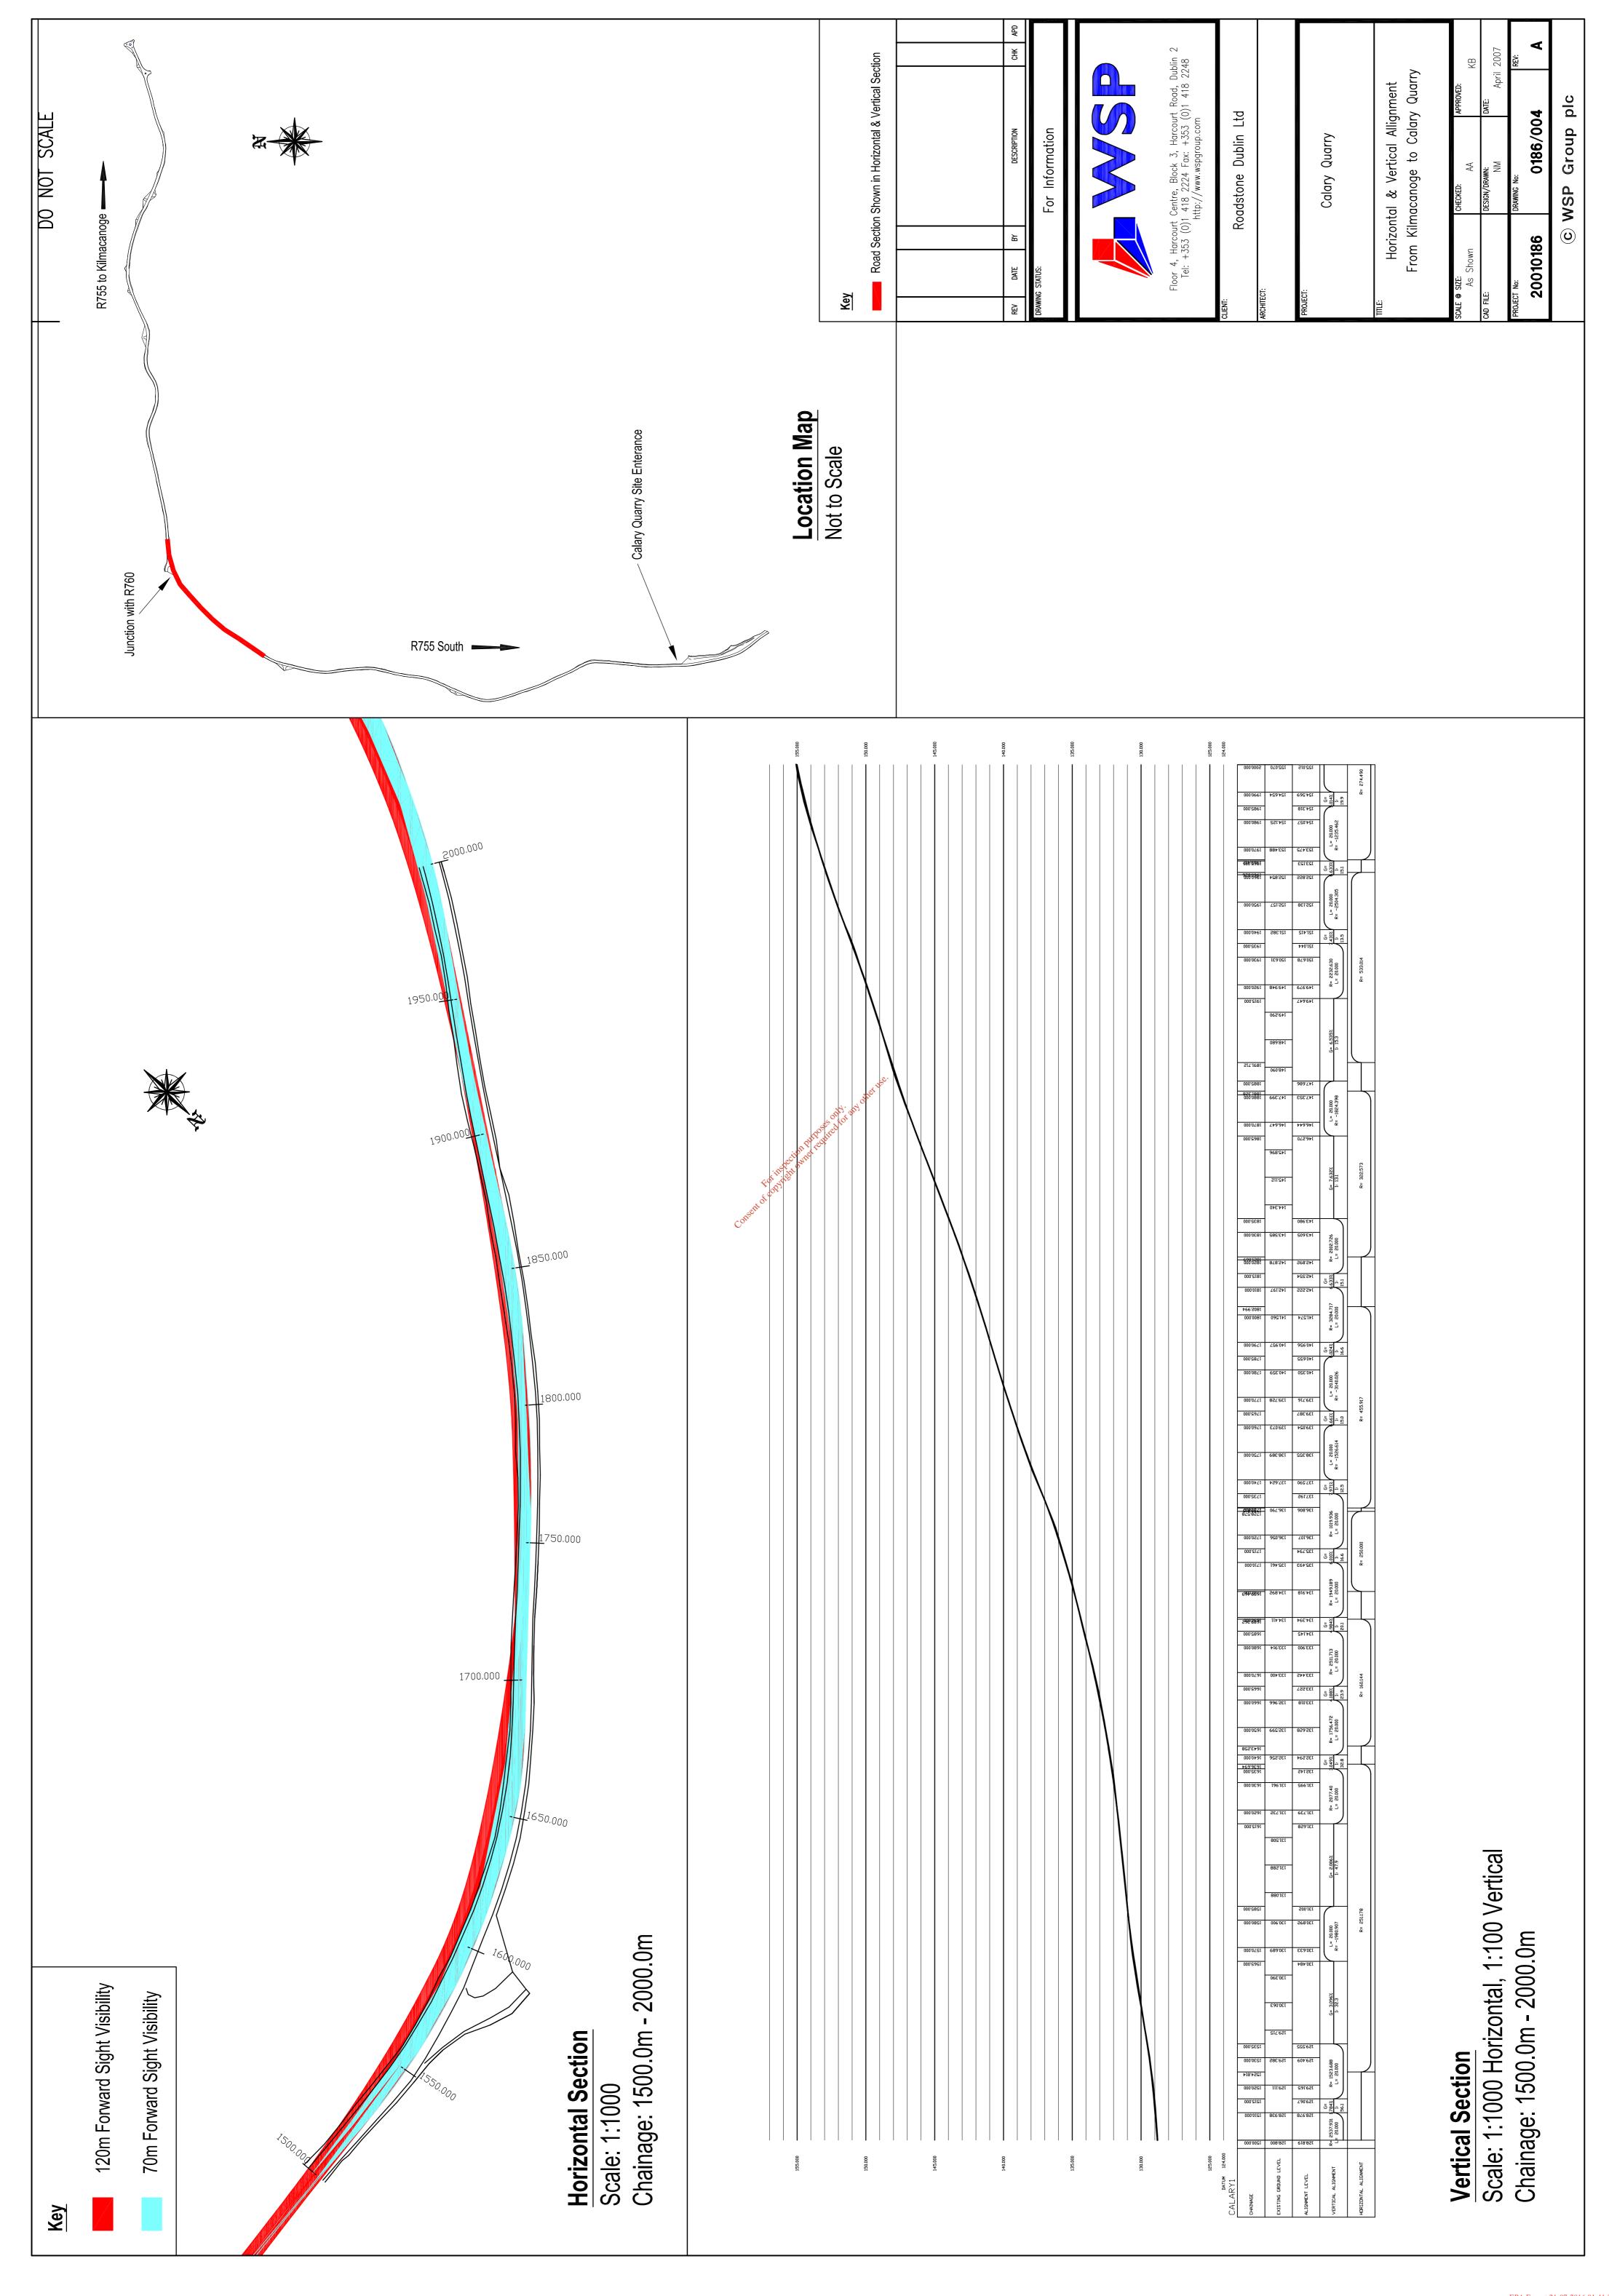
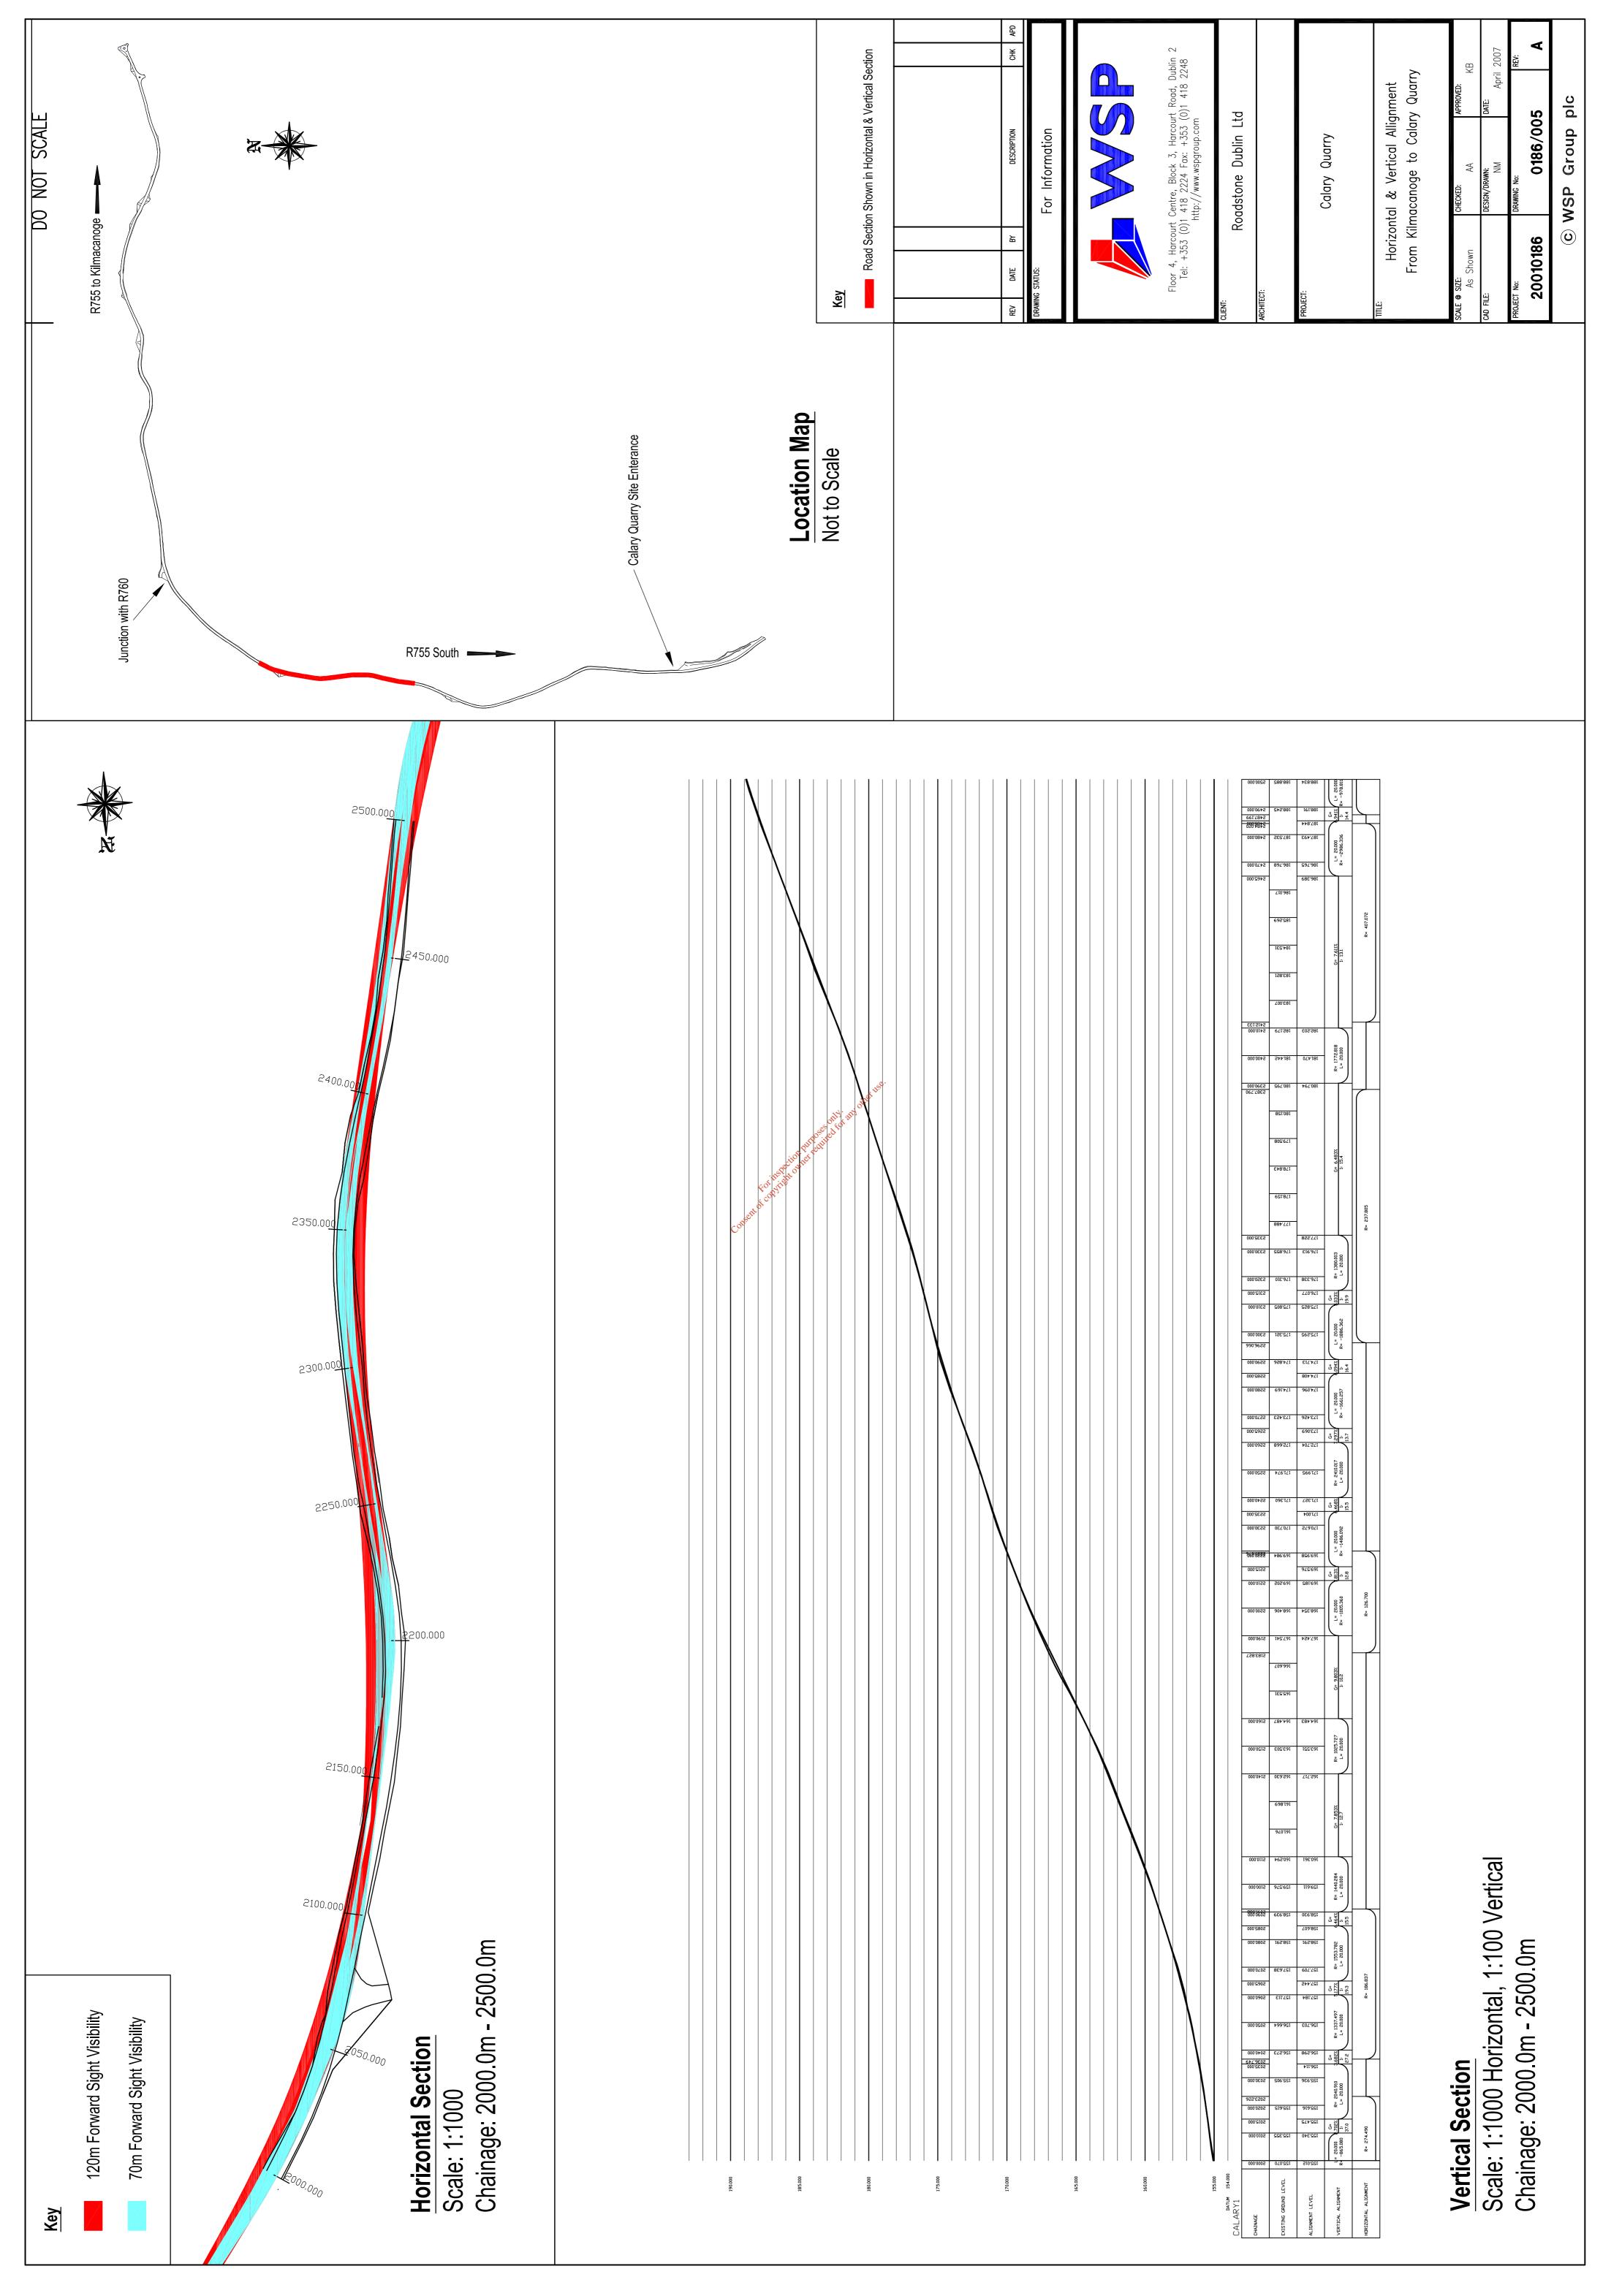
# Appendix A Drawings and Mapping

Drawing No's 20010186-001 to 20010186-007 contained within Appendix A, indicate locations along the R755 where the Desirable Minimum Sight Distance of 120metres cannot be achieved. These drawings also indicate locations where the Stopping Sight Distance at two steps below desirable minimum of 70metres cannot be achieved. Table 4.1 below lists the locations at which the 120metre, Desirable Minimum Stopping Sight Distance cannot be achieved and Table 4.2 lists the locations at which the 70metres two steps below Desirable Minimum Stopping Sight Distance cannot be achieved. Each table lists the prevailing carriageway width along these sections. Table 1 Appendix E, lists the width of the R755 from the N11 to the quarry entrance at 75 metre intervals.

At locations where the stopping sight distance cannot be achieved and the prevailing road width is less than 6.0metres, it is recommended that the road be locally widened to achieve satisfactory road widths. It can be seen from examination of Drawing 20010186/005 and the above table that this occurs at Chainage 2400 where the road narrows briefly to between 5.7 and 6.0 metres for a distance of approximately 27 metres. In order to insure quarry traffic can pass at this point and in the interest of increased safety along the road, this short section should be widened to 6 metres if sufficient lands are available.

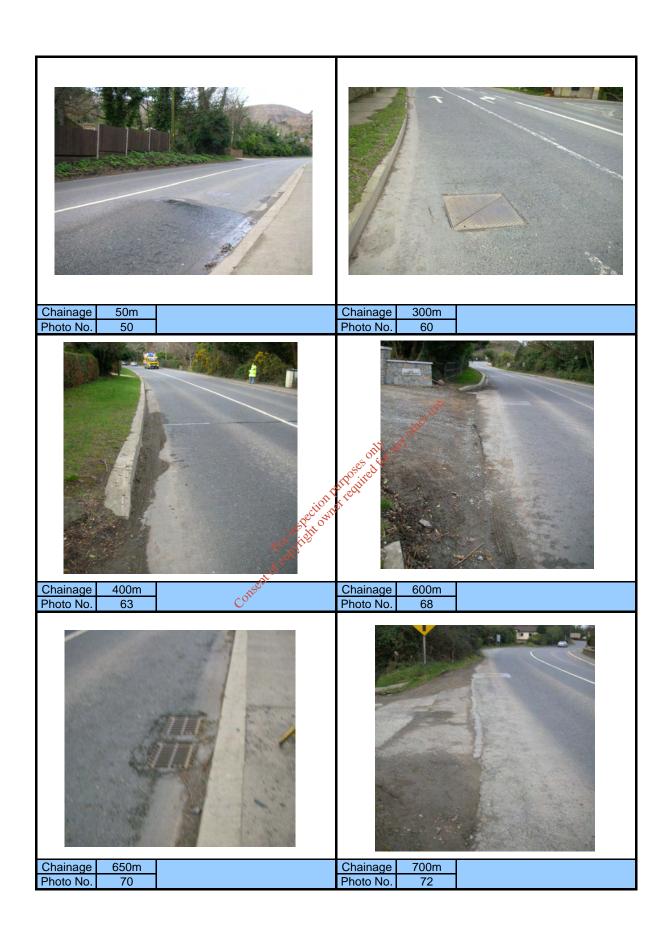
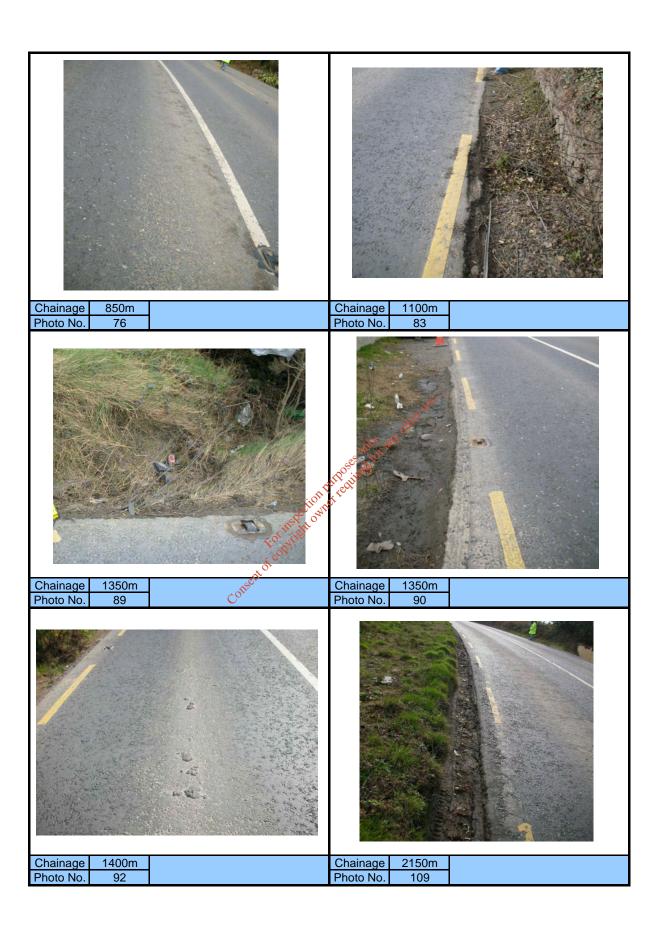
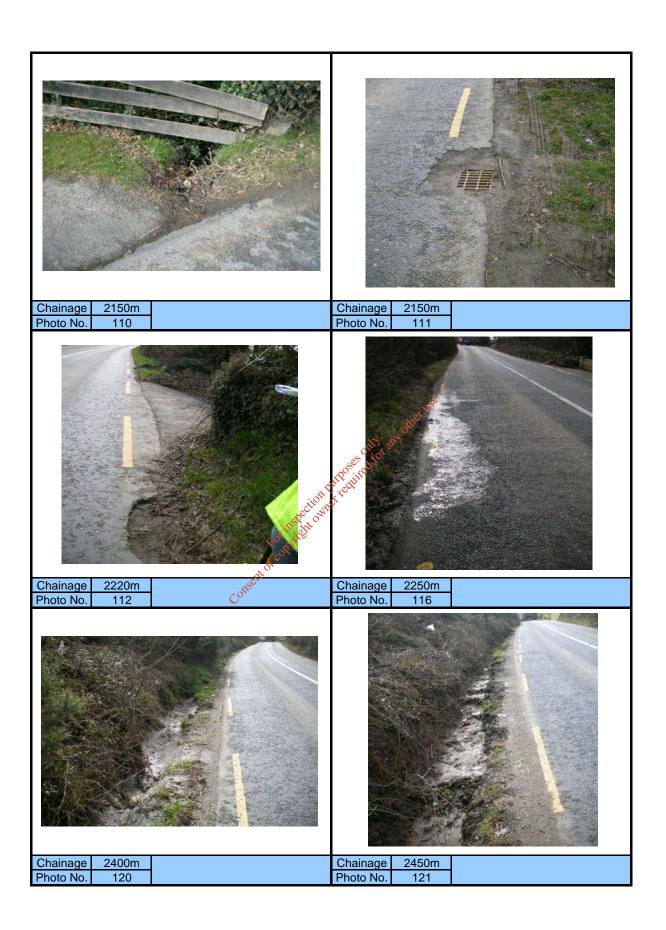
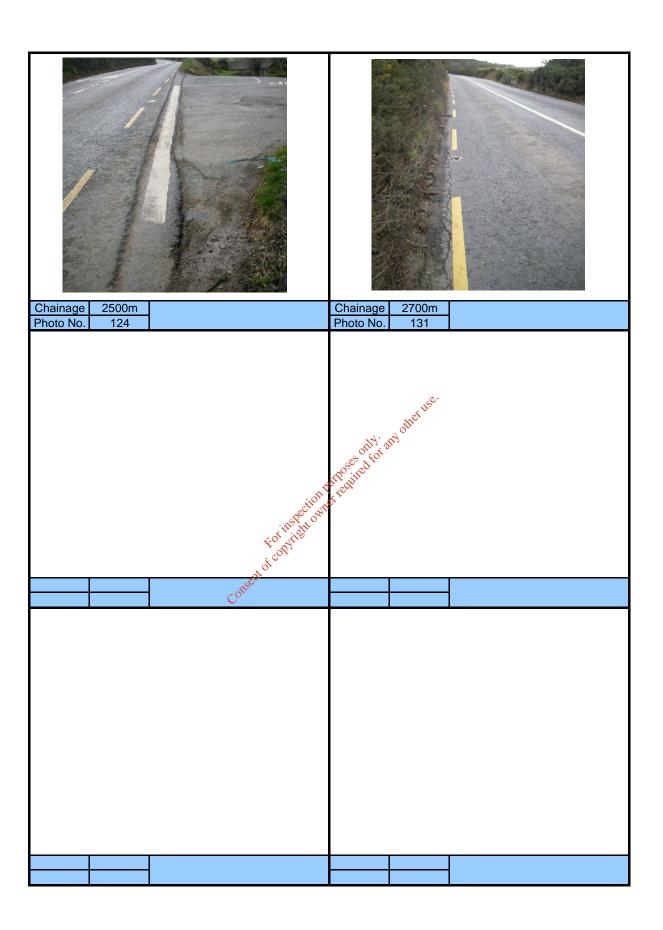
# Appendix C Pavement Condition Photographs

Location	Road	Pavement Defect	Photograph Reference (See Appendix C)
Ch 50m	R755	Drainage – needs minor improvement	50
Ch 300m	R755	Shoving	60
Ch 400m	R755	Drainage – needs maintenance	63
Ch 600m	R755	Road Edge Deterioration	68
Ch 650m	R755	Ravelling/Loss of Blacktop	70
Ch 700m	R755	Road Edge Deterioration	72
Ch 850m	R755	Crocodile Cracking	76
Ch 1100m	R755	Road Edge Deterioration	83
Ch 1350m	R755	Drainage – needs maintenance	89
Ch 1350m	R755	Drainage – needs maintenance	90
Ch 1400m	R755	Bleeding / Fatting Up	92
Ch 2150m	R755	Road Edge Deterioration	109
Ch 2150m	R755	Drainage needs maintenance	110
Ch 2150m	R755	Pothole round Gully	111
Ch 2200m	R755 💉	Road Edge Deterioration	112
Ch 2250m	R755150	Drainage – needs maintenance	116
Ch 2400m	R7550 1750 R755	Drainage – needs maintenance	120
Ch 2450m	₹755	Drainage – needs maintenance	121
Ch 2500m	R755	Inconsistent Road Layer Build Up	124
Ch 2700	R755	Road Edge Deterioration	131

Table 3.1 Location of surface defects on the R755 – N11 Road

Whilst the pavement of the R755 from the site entrance to the N11 is in good condition, a small number of localised pavement defects have been identified in Table 3.1 which could be repaired.

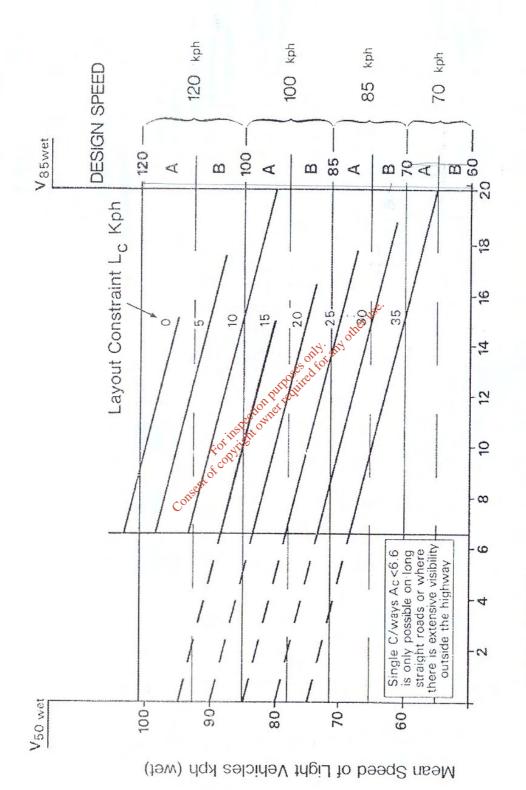
Figure 1: Selection of Design Speed (Rural Roads)

Single C/ways=12-ViSI/60+ 2B/45 ALIGNMENT CONSTRAINT Ac kph for Dual C/ways=6.6+B/10

Arising from the calculation of the above constraint factors, the design speed of the road can be derived from table 1 of 10 9/00, 'Road Link Design'. A copy of this table is contained in Appendix D. Given an Ac value of 21 and an Lc value of 28, the Design Speed of the R755 from the quarry entrance to the N11 is 70km/h.
