Groundwater Analysis Report – 03/12/2015

ENVIRONMENTAL RISK ASSESSMENT REPORT FOR A PROPOSED WASTE SOILS RECOVERY FACILITY AND ECO-PARK AT PRETTY BUSH, KILCOOLE, CO. WICKLOW

JULY 2016

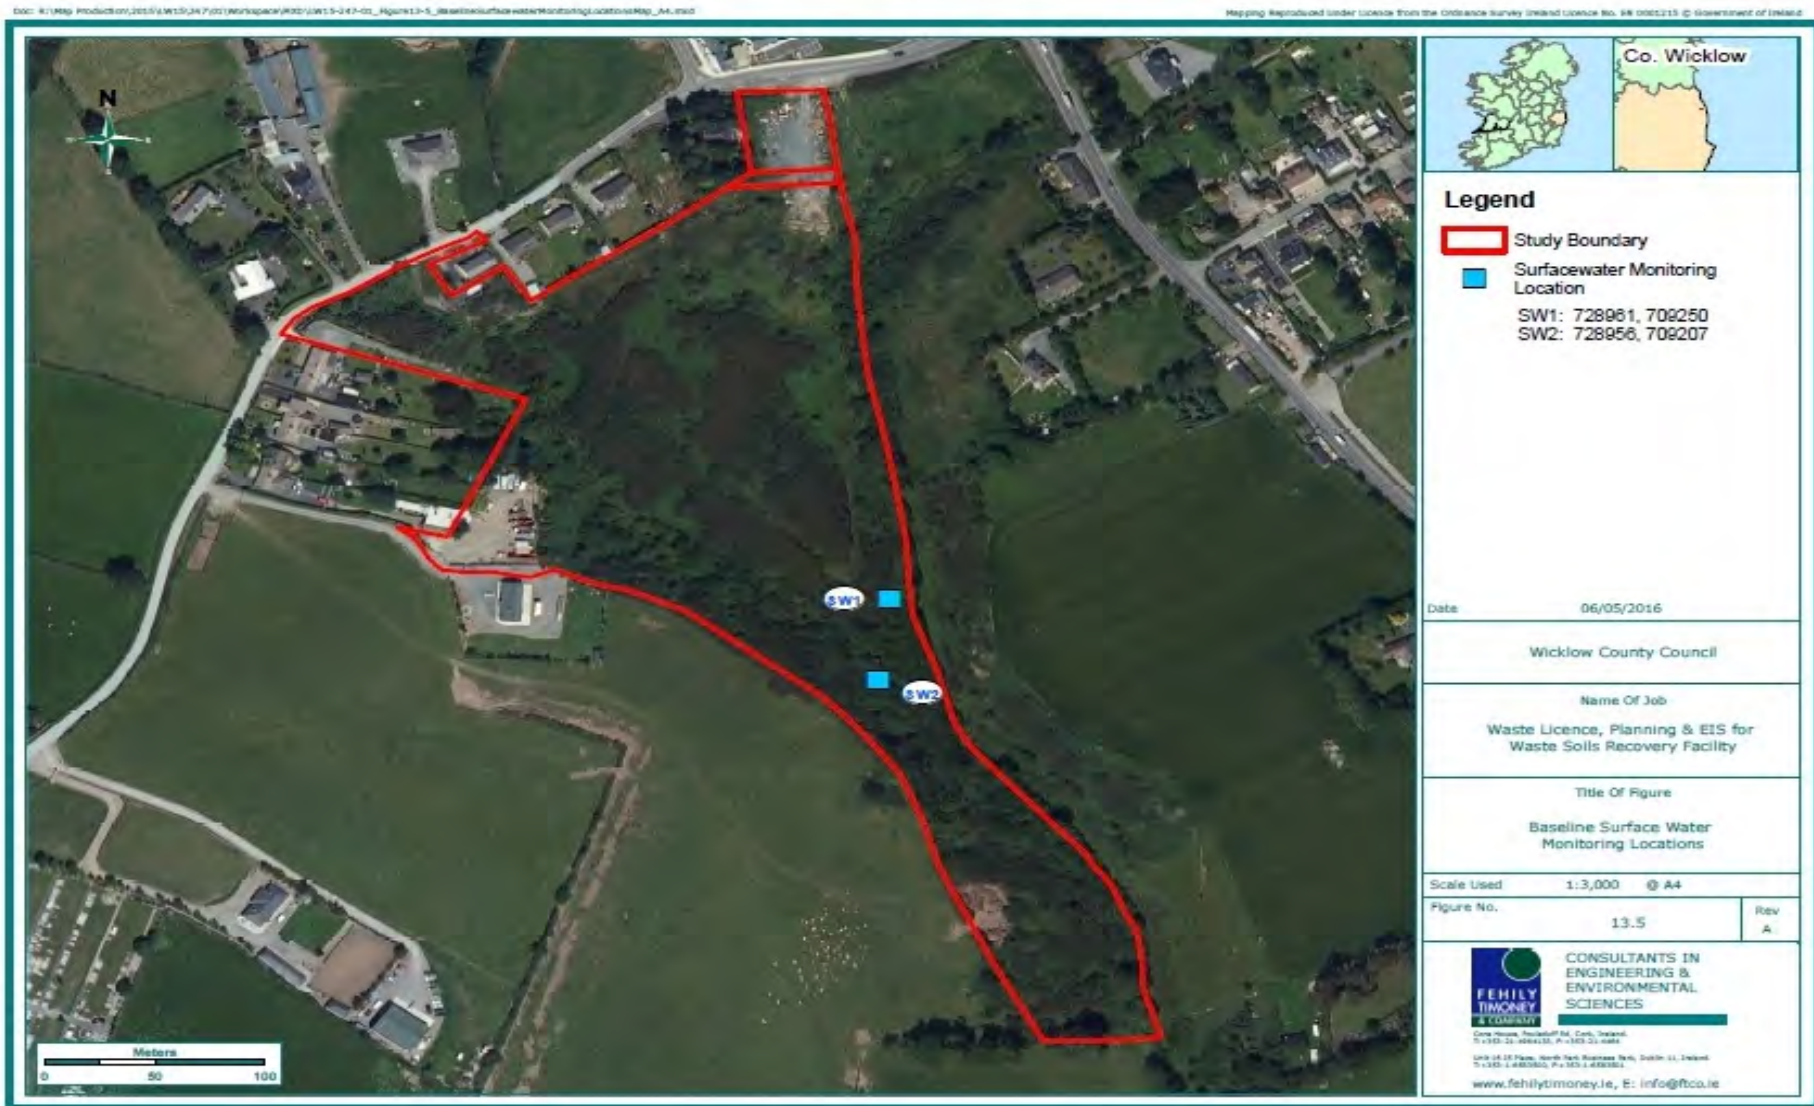
Figure 3.4: Baseline surface water monitoring locations

Monitoring of two surface water monitoring points, namely SW1 and SW2, was carried out in September 2015. The locations of these monitoring points are shown in Figure 3.4.

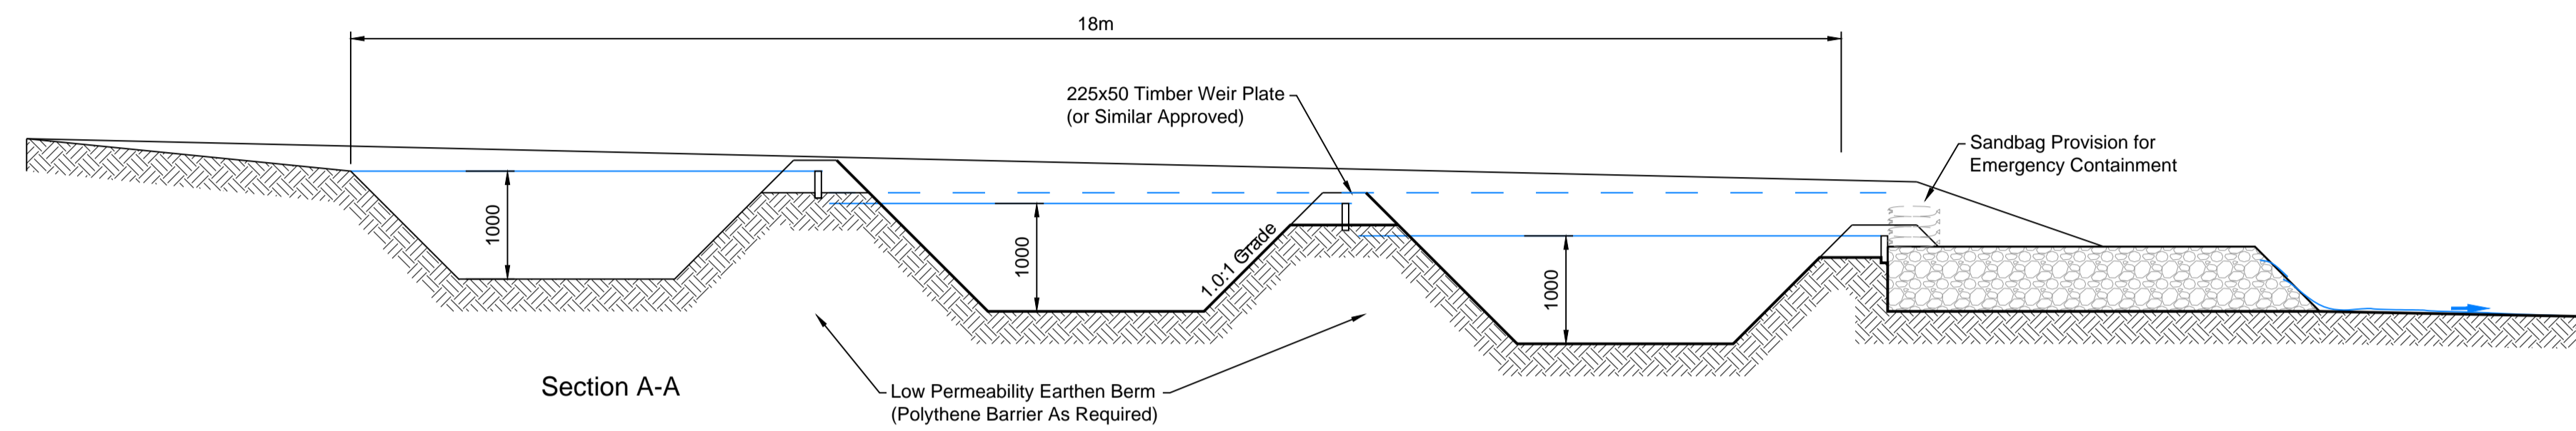
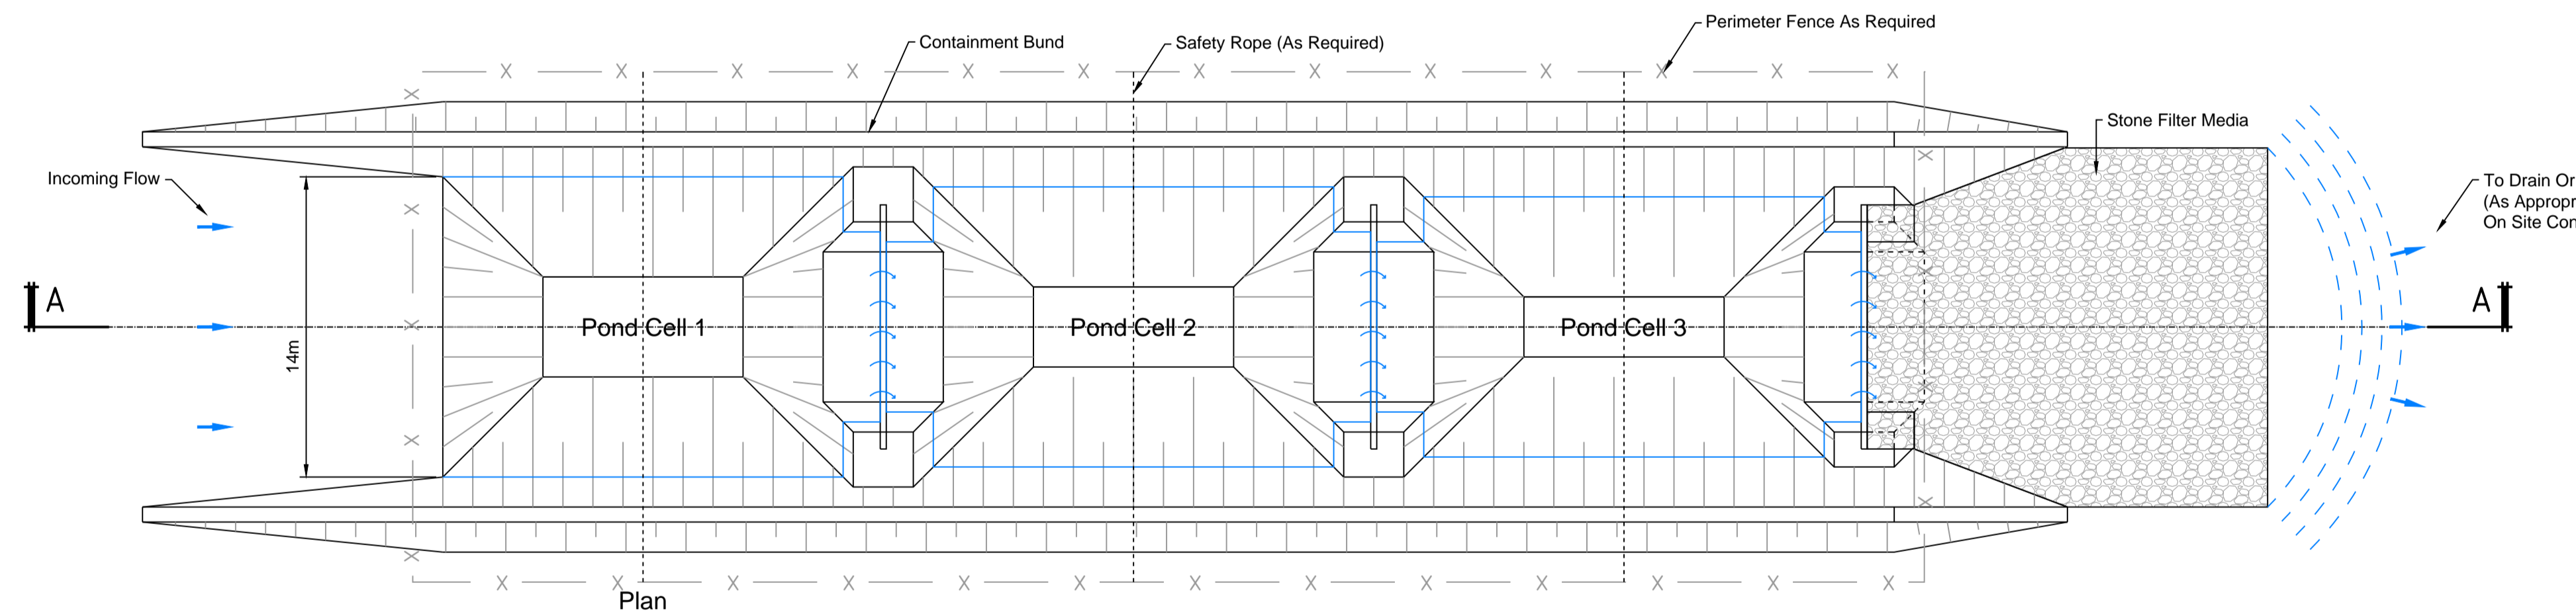
PLAN DETAIL - MULTISTAGE STILLING POND

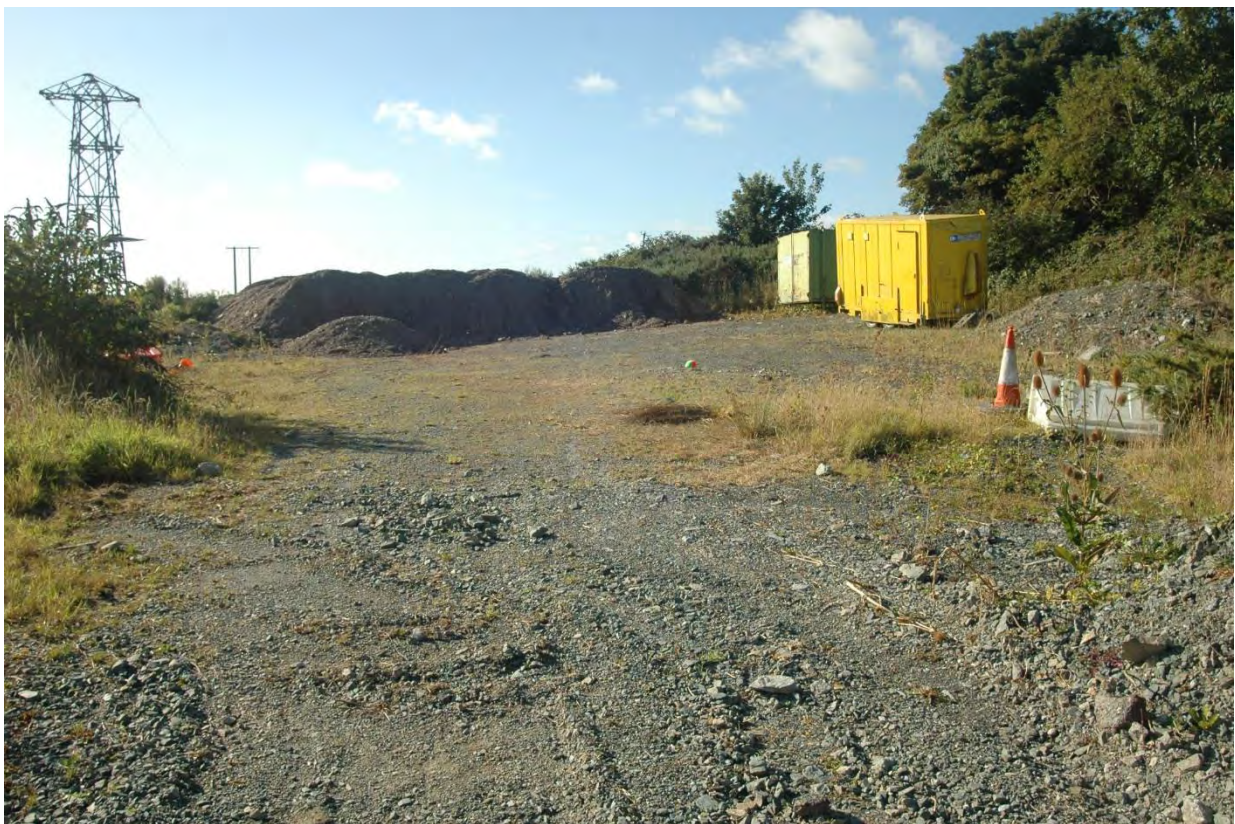
Plate 15-1: North east corner of proposed development area, looking south

The north east corner of the proposed development area (Plate 15-1) was shown to be a levelled, possibly scarped, compact surface with a spoil heap at its southern end. The remainder of the site was shown to be very overgrown with tall bushes and trees. A roughly north west/south east generally overgrown informal path extends the full length of the site, with all other areas of land take being inaccessible (Plates 15-2 – 15-6). The site is slightly elevated at its northern end, although with poor visibility in all directions from that area, and as it extends southwards it becomes generally steep-sided. The site was mainly dry, but it was occasionally slightly wet underfoot in the middle and at the southern end. Views were poor from all areas of proposed land take.
