ESB Moneypoint Conceptual Site Model

47093013 / CKRP0001

Issue No. 2 Final

Sub Title:
Conceptual Site Model

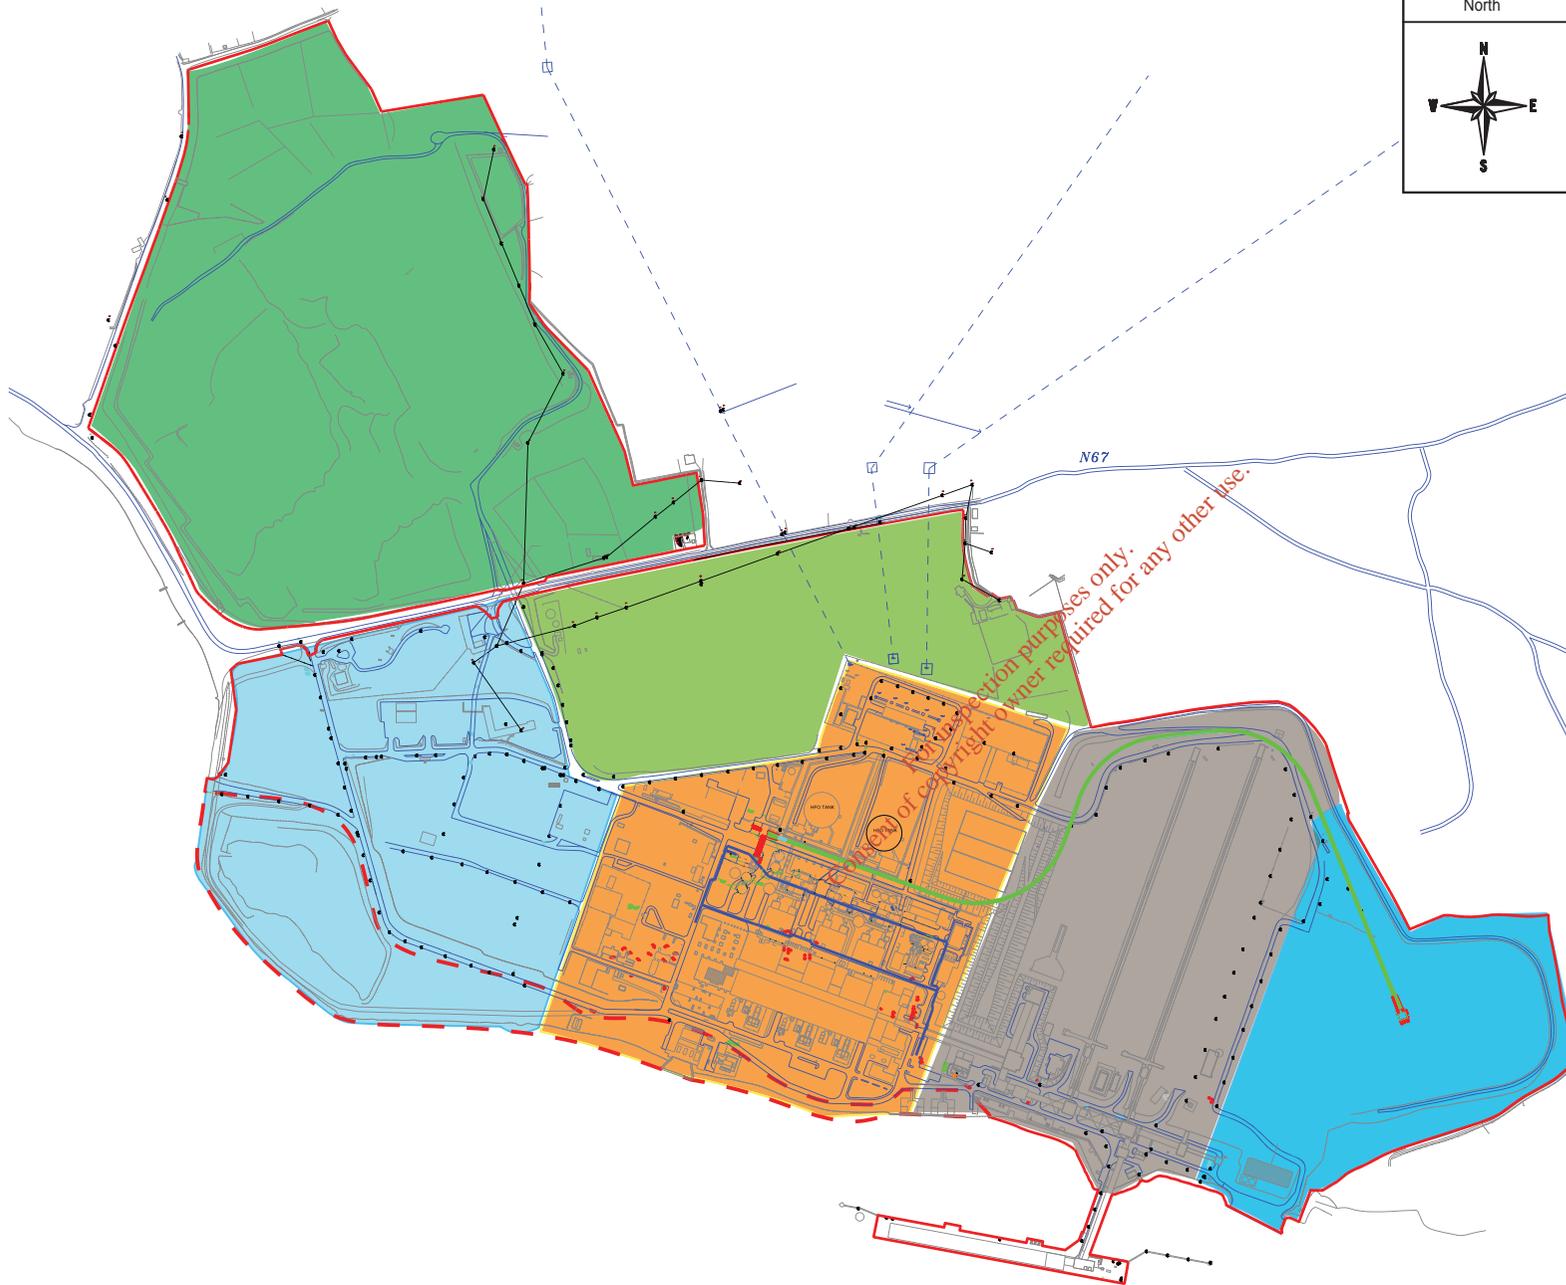
DRAWING TITLE
FIGURE 3_ SITE LAYOUT

- SITE BOUNDARY
- - - AREA OF RECLAIMED LAND
- COAL ASH DIPOSAL
- FGD CELLS
- COAL YARD
- GREEN AREA
- GENERATING STATION
- CONTRACTORS COMPOUND & GREEN AREA

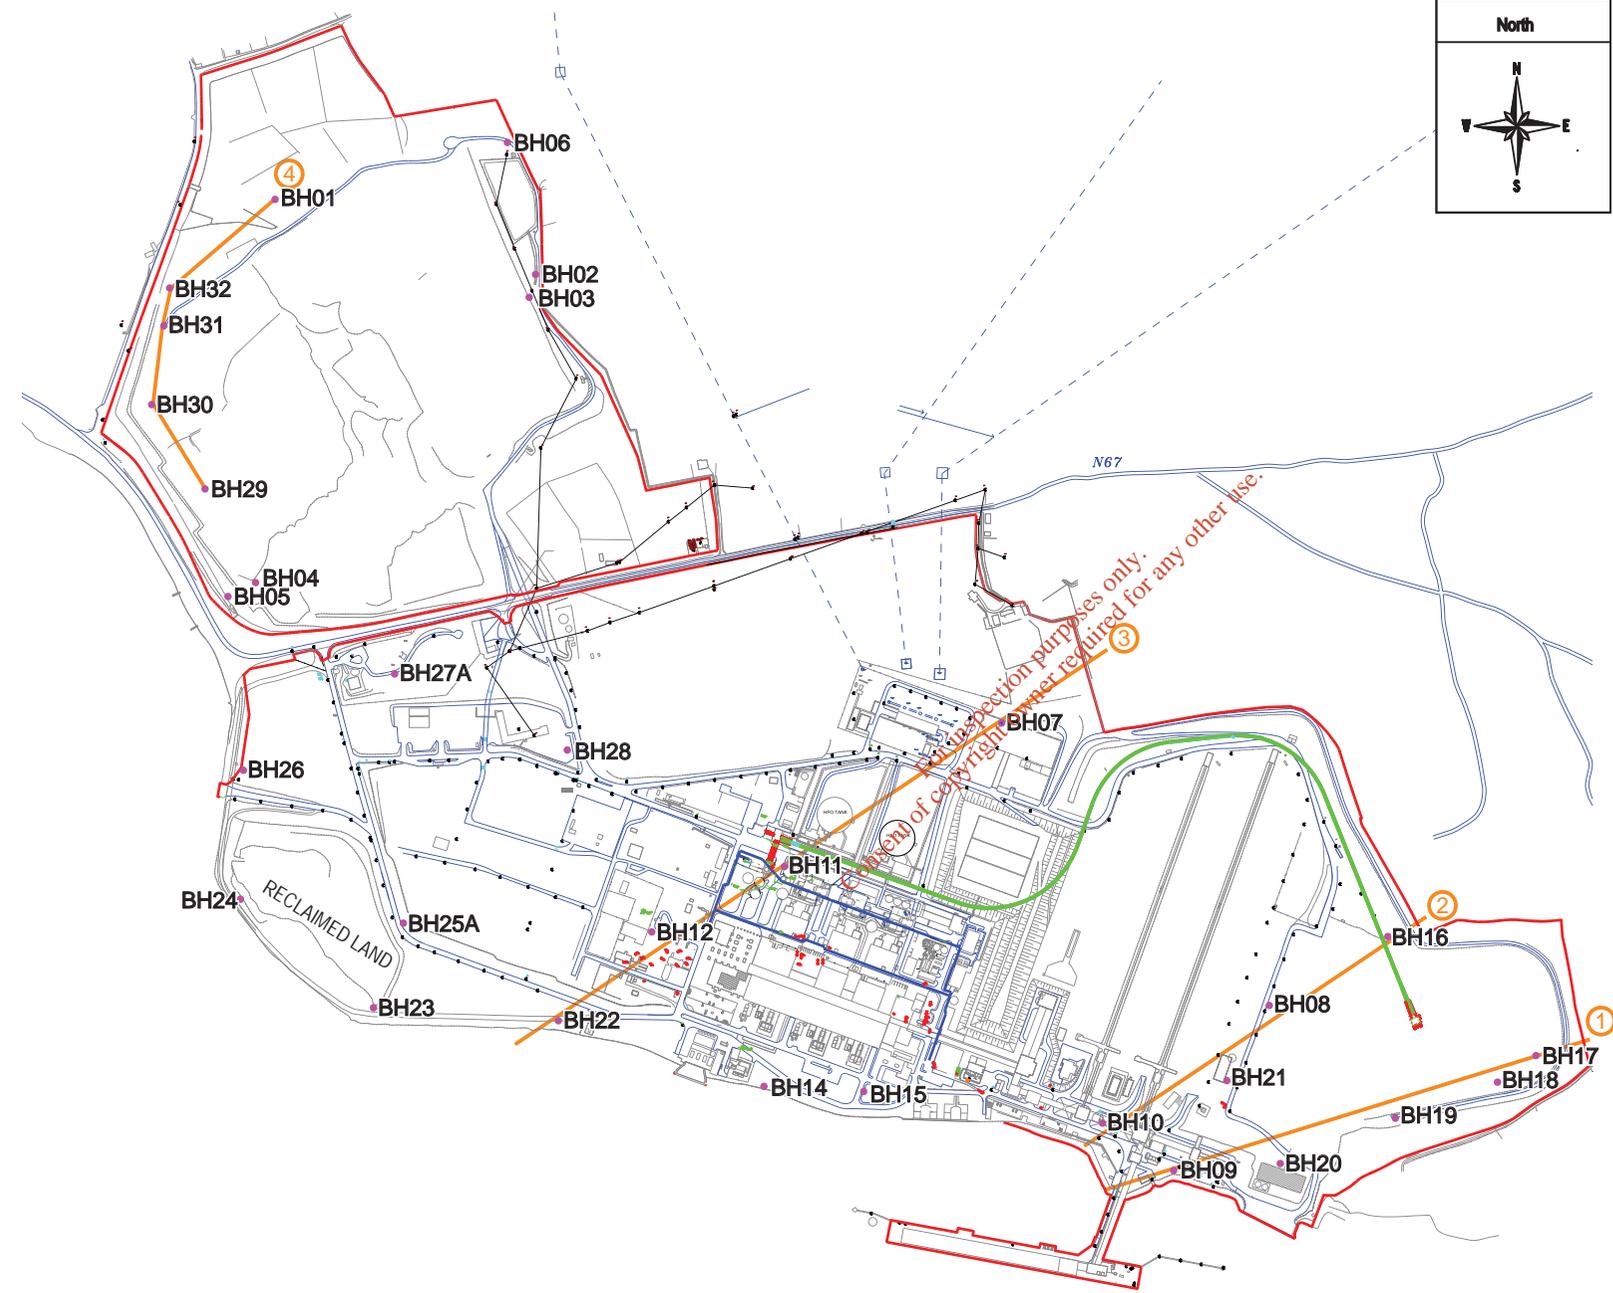
DRAWING TITLE
FIGURE 6_ SITE LAYOUT SHOWING CROSS SECTION ORIENTATION

- SITE BOUNDARY
- CROSS SECTION ORIENTATION
- MONITORING WELL LOCATION

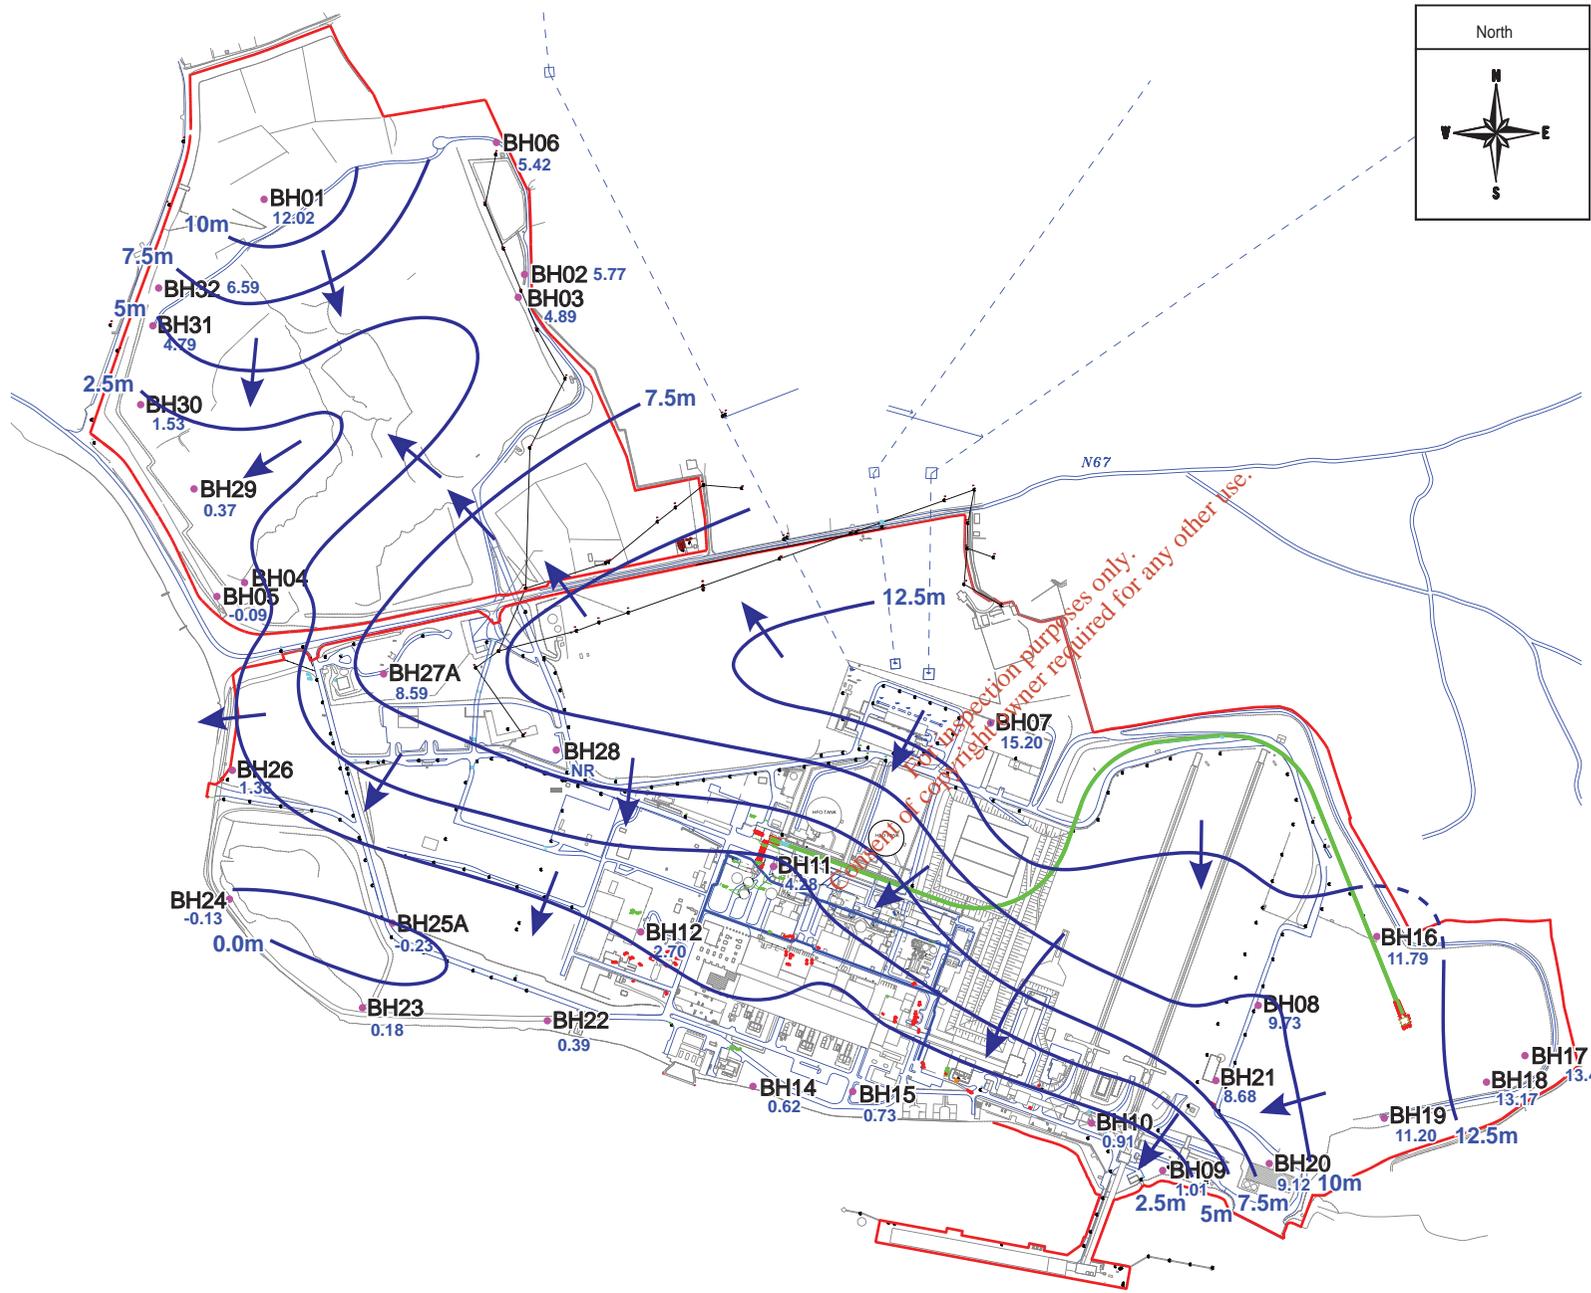
DRAWING TITLE
**FIGURE 8_ GROUNDWATER CONTOUR MAP
FEBRUARY 2003**

- SITE BOUNDARY
- MONITORING WELL LOCATION
- GROUNDWATER CONTOURS
- 53.65 ELEVATION IN METERS ABOVE ORDNANCE DATUM
- NR NOT RECORDED
- FLOW DIRECTION
- - - INFERRED GROUNDWATER CONTOURS

Given the site's location, the direction of groundwater flow through bedrock is expected to follow the topographic gradient, i.e. southwards across the main site area and possibly more south-westwards across the Ash Landfill. Fracturing within the bedrock may locally alter the groundwater flow direction. However, groundwater from the site is expected to ultimately discharge to the Shannon Estuary.

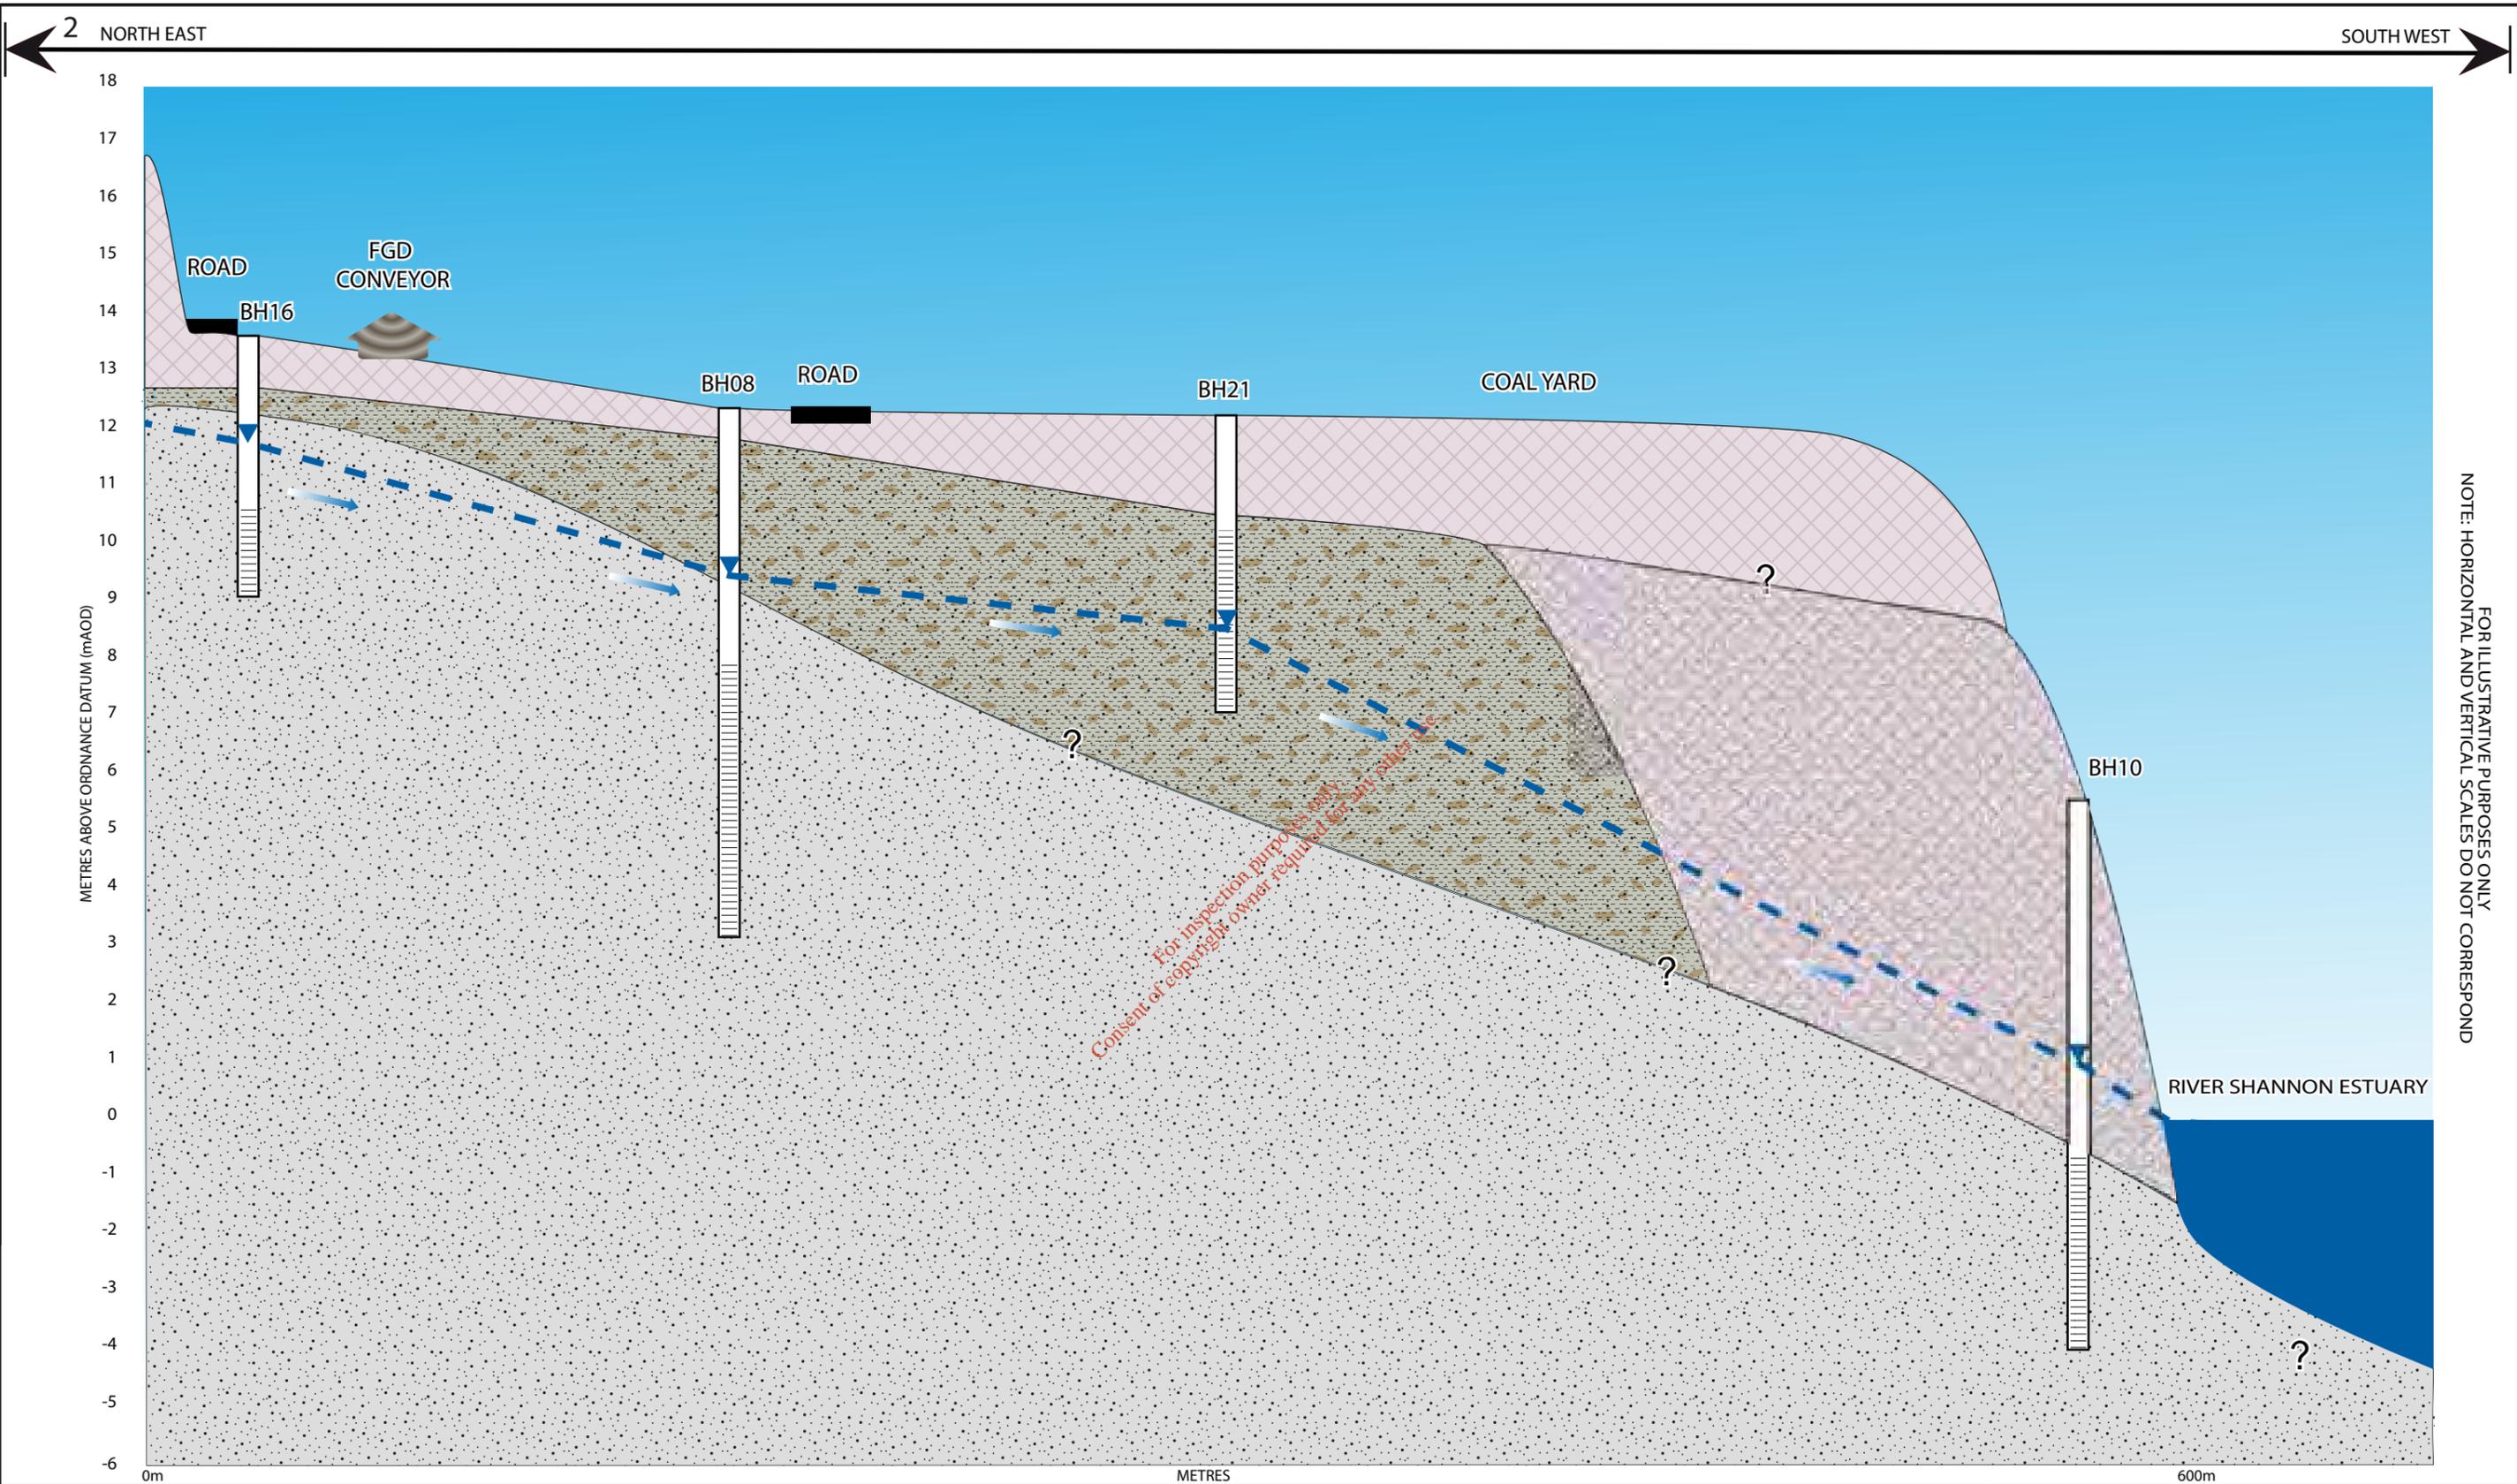
DRAWING TITLE
FIGURE 9 _ CROSS SECTION 2

- MADE GROUND
- SANDY GRAVELLY CLAY
- ROCK FILL
- PRESUMED BEDROCK
- INFERRED GROUNDWATER FLOW DIRECTION
- INFERRED GROUNDWATER ELEVATION
- GROUNDWATER ELEVATION FEBRUARY 2003

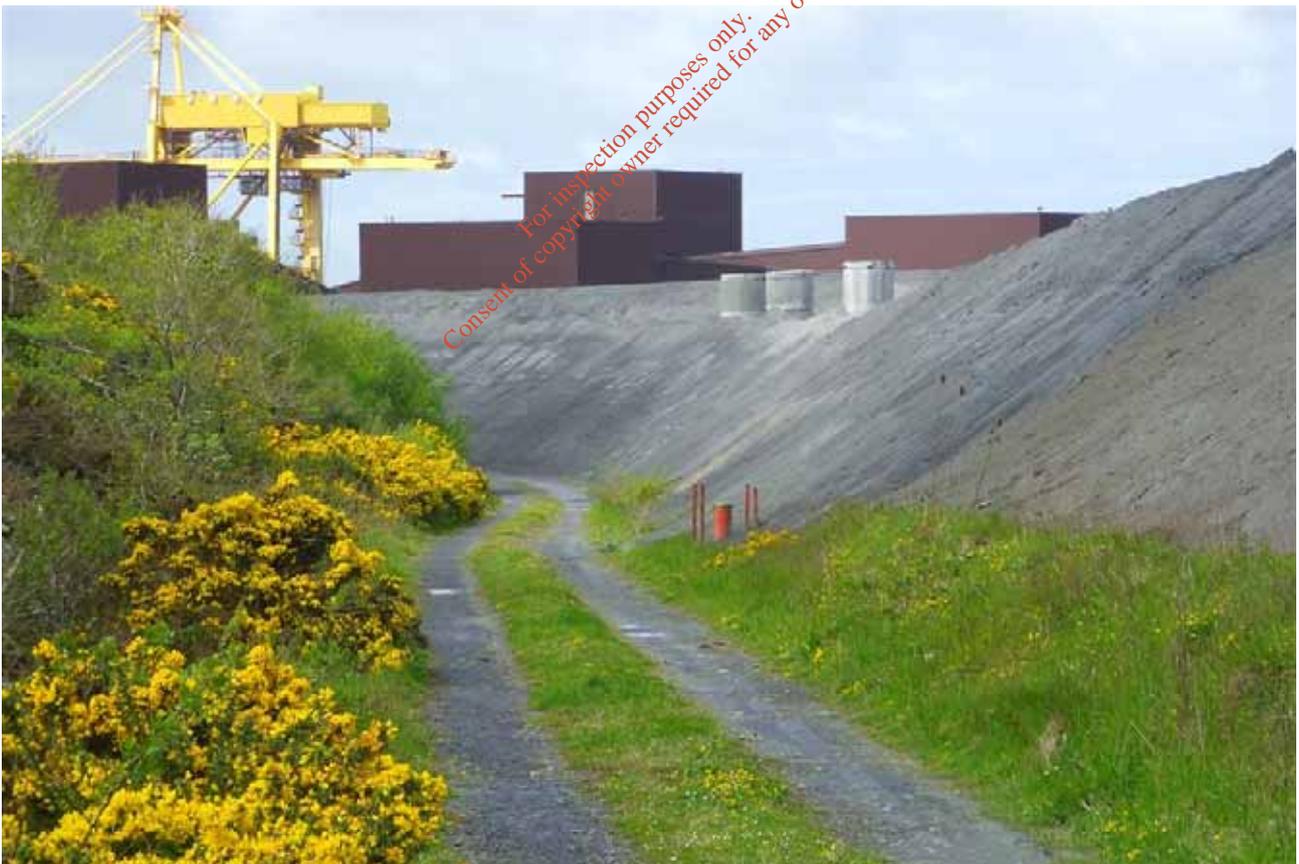
Photograph 8 – view west from perimeter road around FGD Landfill to the Coal Yard in the distance. FGD waste embankment on RHS and rock fill embankment on LHS, well BH19 in the centre-ground.

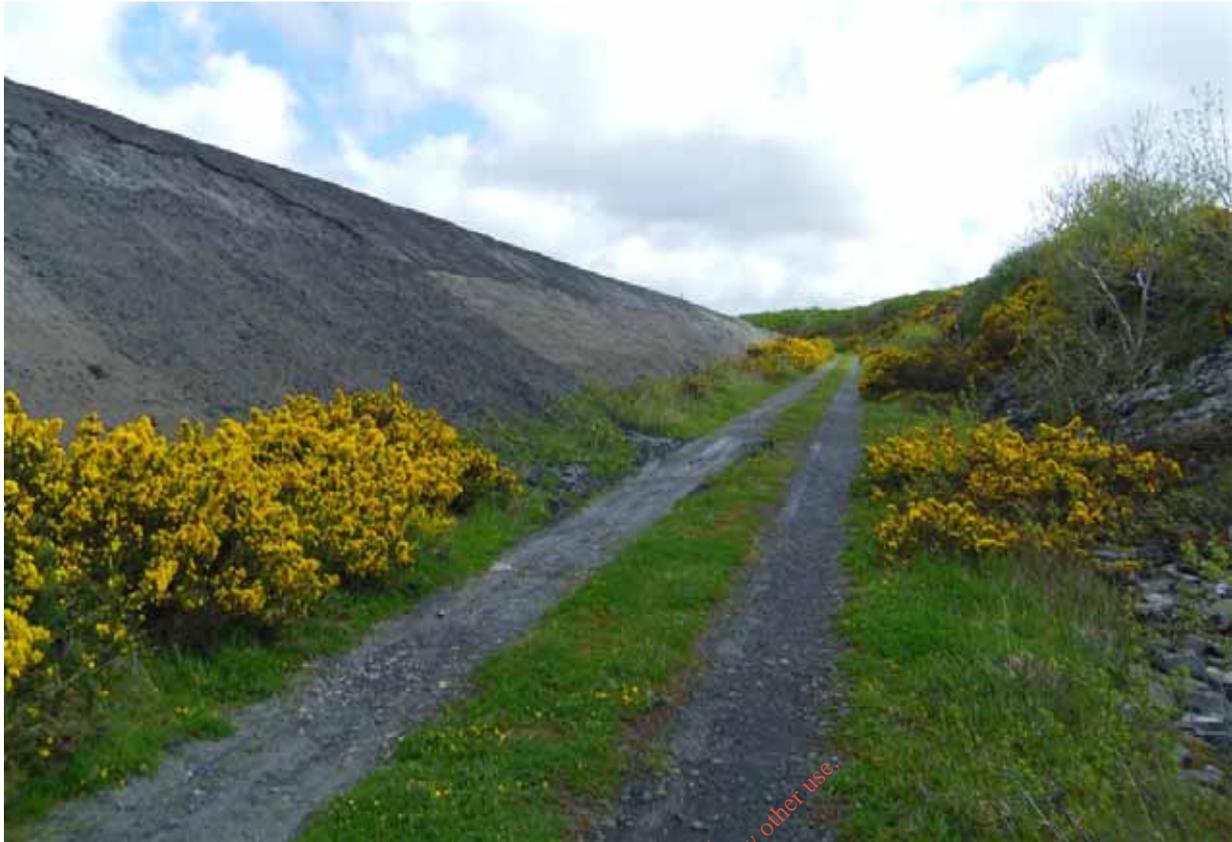
Photograph 9 – view east from perimeter road around FGD Landfill. FGD waste embankment on LHS and rock fill embankment on RHS.

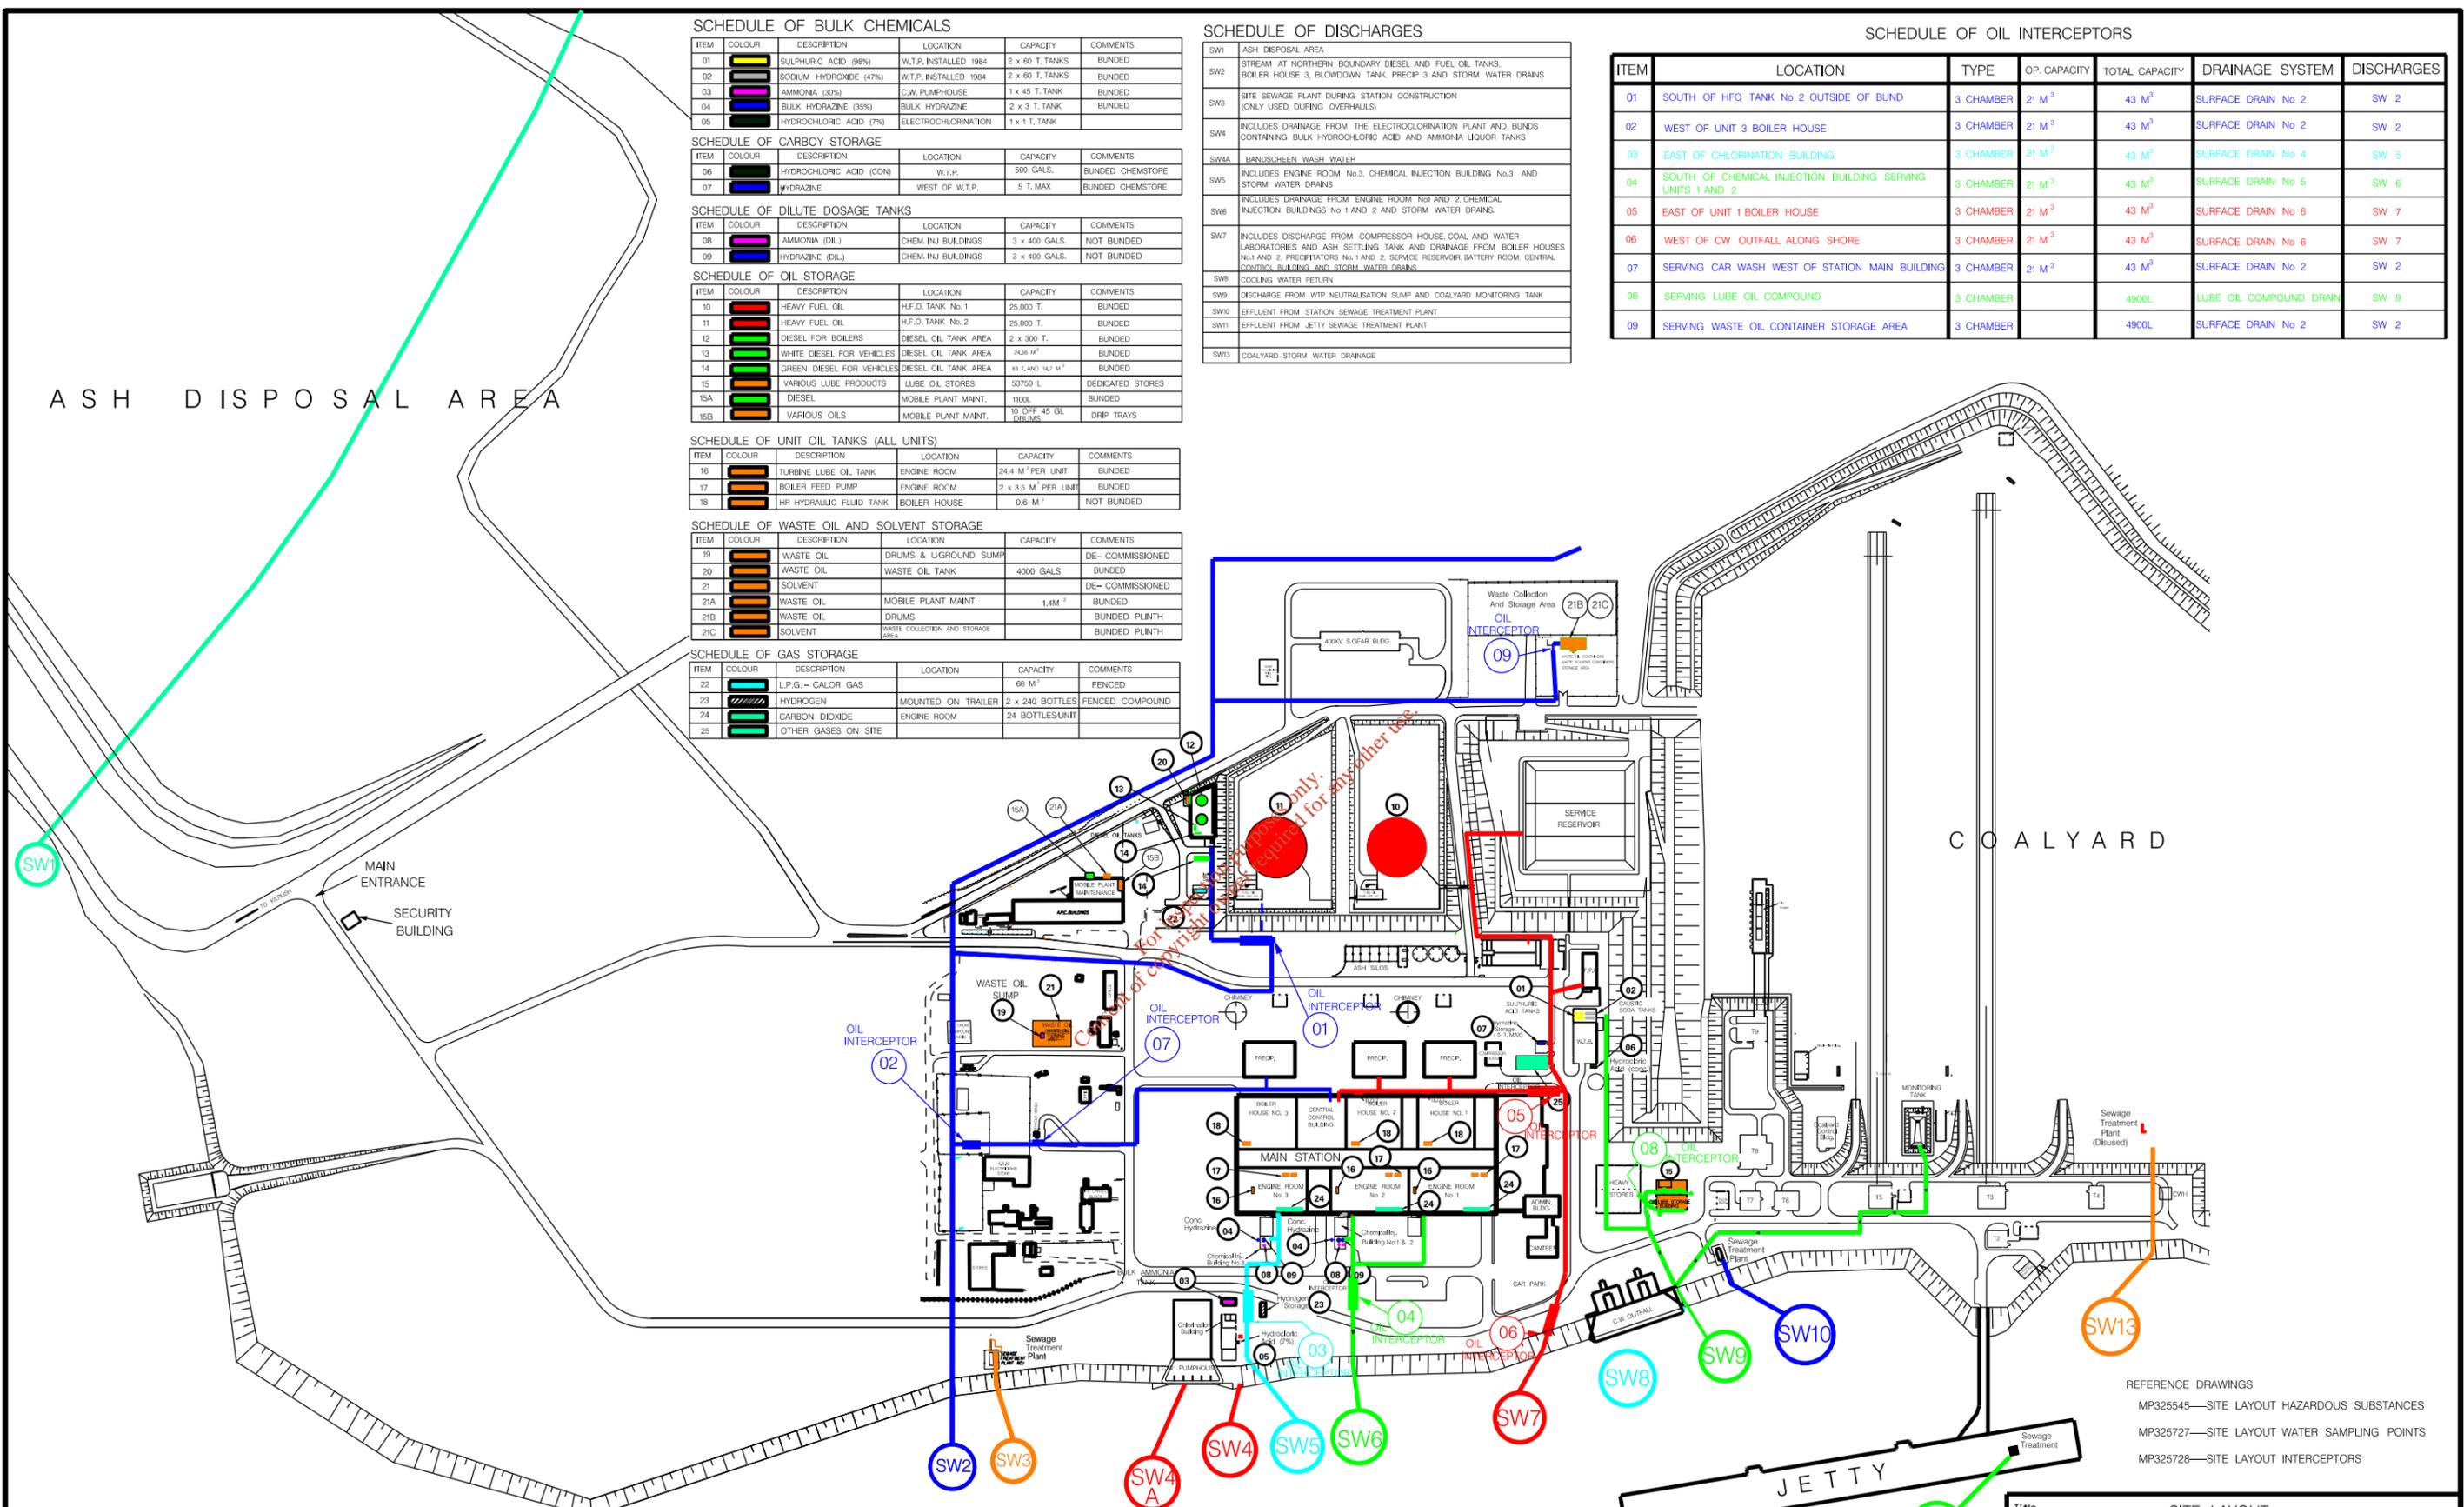
Site LAYOUT HAZARDOUS SUBSTANCES, OIL INTERCEPTORS AND DISCHARGE POINTS

ITEM	LOCATION	TYPE	OP. CAPACITY	TOTAL CAPACITY	DRAINAGE SYSTEM	DISCHARGES
01	SOUTH OF HFO TANK No.2 OUTSIDE OF BUND	3 CHAMBER	21 M ³	43 M ³	SURFACE DRAIN No.2	SW 2
02	WEST OF UNIT 3 BOILER HOUSE	3 CHAMBER	21 M ³	43 M ³	SURFACE DRAIN No.2	SW 2
03	EAST OF CHLORINATION BUILDING	3 CHAMBER	21 M ³	43 M ³	SURFACE DRAIN No.4	SW 5
04	SOUTH OF CHEMICAL INJECTION BUILDING SERVING UNITS 1 AND 2	3 CHAMBER	21 M ³	43 M ³	SURFACE DRAIN No.5	SW 6
05	EAST OF UNIT 1 BOILER HOUSE	3 CHAMBER	21 M ³	43 M ³	SURFACE DRAIN No.6	SW 7
06	WEST OF CW OUTFALL ALONG SHORE	3 CHAMBER	21 M ³	43 M ³	SURFACE DRAIN No.6	SW 7
07	SERVING CAR WASH WEST OF STATION MAIN BUILDING	3 CHAMBER	21 M ³	43 M ³	SURFACE DRAIN No.2	SW 2
08	SERVING LUBE OIL COMPOUND	3 CHAMBER		4900L	LUBE OIL COMPOUND DRAIN	SW 9
09	SERVING WASTE OIL CONTAINER STORAGE AREA	3 CHAMBER		4900L	SURFACE DRAIN No.2	SW 2
