- 5.1 This Chapter of the Environmental Impact Statement evaluates the regional and local geological conditions of the proposed increase in the current rate of waste intake at the licensed inert soil waste recovery facility at Huntstown and assesses the impact that the intensification of backfilling activity will have on the soils and geology of the area.

SOIL AND GEOLOGY 5

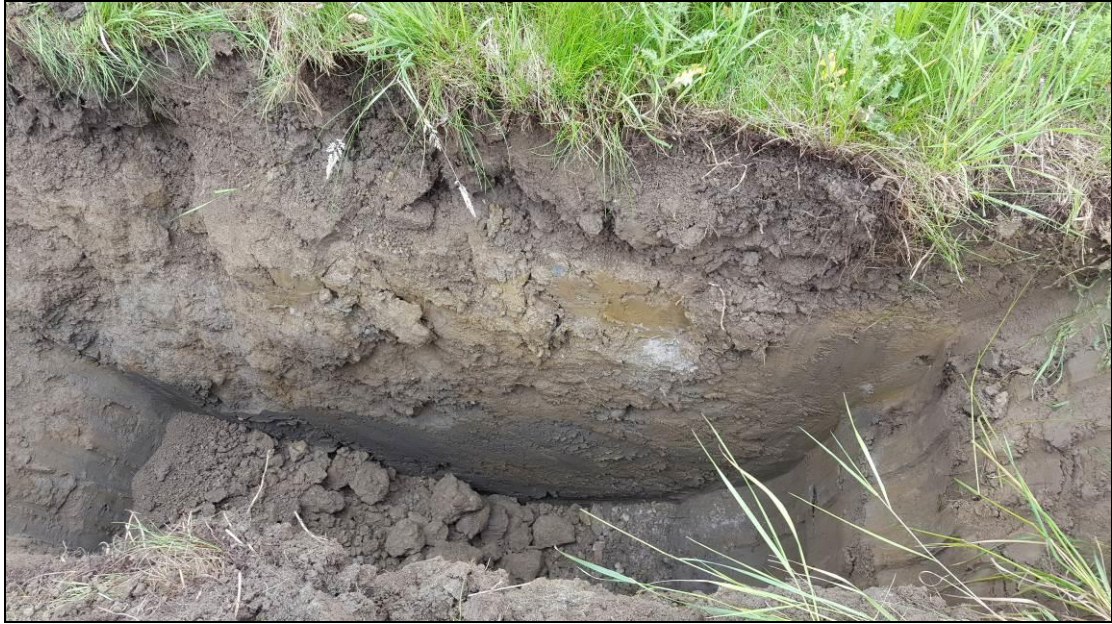
Plate 5-1. Sidewall of 16-TP1 showing topsoil over glacial till.

- 5.17 As previously noted, two trial pits were excavated at the rear of the residential property to the west of the North Quarry (at locations indicated in Figure 5-4). The trial pits confirmed the presence of natural ground. Trial pit 16-TP1 encountered topsoil over firm brown mottled grey to orange sandy gravelly CLAY with occasional cobbles (Glacial Till) to 1.8m depth. Trial pit 16-TP2 encountered topsoil over firm to stiff mid brown minor orange mottled sandy gravelly CLAY with occasional cobbles (Glacial Till) before being terminated on weathered rock at 1.6m. Photographs of the trial pit excavations are provided in Plates 5-1 to 5-3. Trial pit logs are presented in Appendix 5-A.

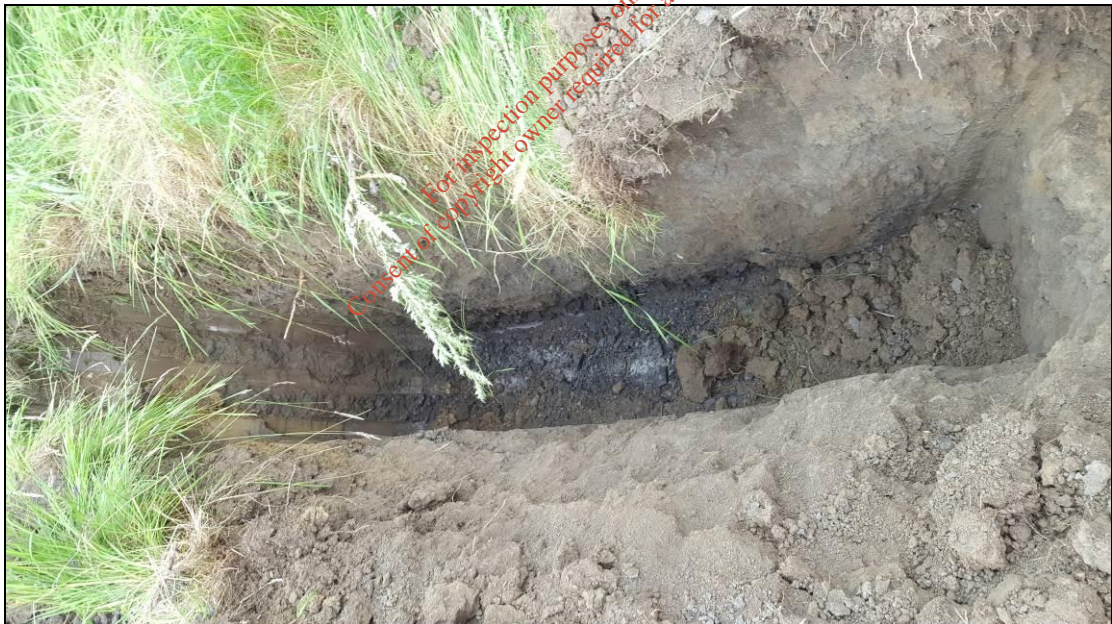
Plate 5-2. Trial hole 16-TP2 showing exposed bedrock at the base.

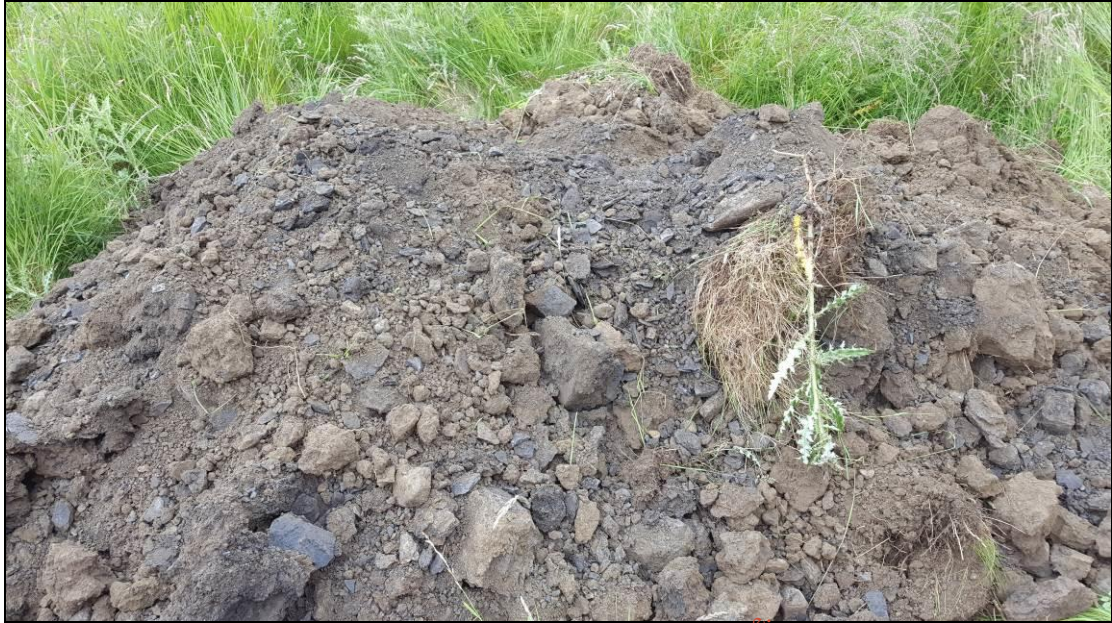
Plate 5-3. Trial hole 16-TP2 spoil heap and weathered bedrock.

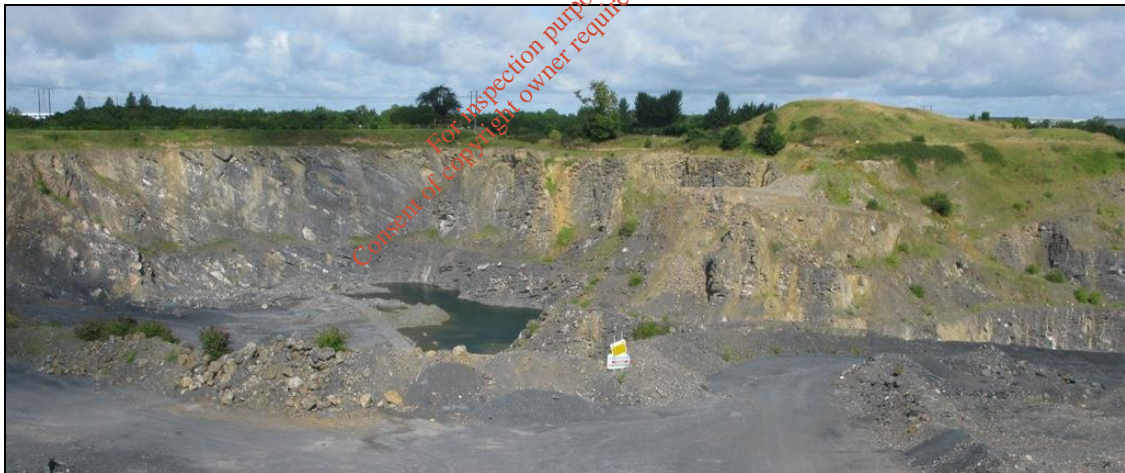
Plate 5-4 Limestones Exposed in Western Face of the North Quarry.
Note steep dip to north-west and well-bedded nature of the limestones.

- 5.31 The sequence in the West Quarry dips steeply (25° to 45°) to the north or north-northwest. The rock is strong to very strong and weathering is rarely significant more than a few tens of metres below the rock surface.
- 5.32 The Malahide Formation within the West Quarry at Huntstown is fault separated from the North Quarry by a major reverse fault, exposed along the south faces of the North Quarry and identified by geophysics and drilling in the north-western part of the West Quarry.
- 5.33 A detailed local bedrock geology map prepared on the basis of information presented and discussed above is presented in Figure 5-4, while a simplified geological cross-section through the Huntstown Quarry complex is provided in Figure 5-5. Some of the geological features and characteristics discussed above are illustrated in Plates 5-4 to 5-9 at the end of this chapter.

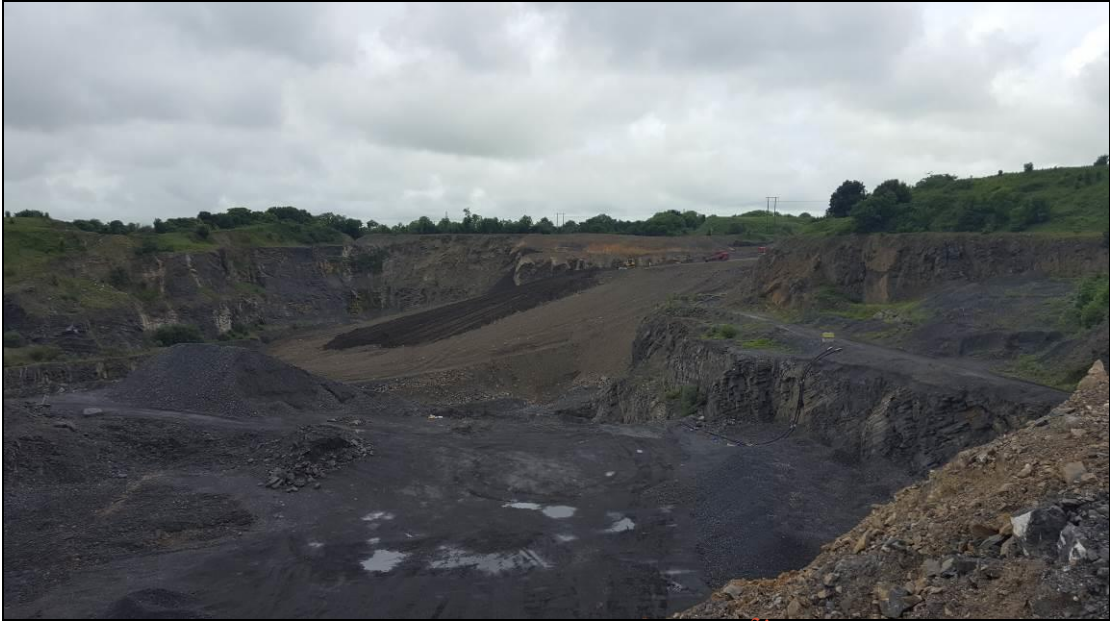
Plate 5-5 Partially Backfilled Area of North Quarry.

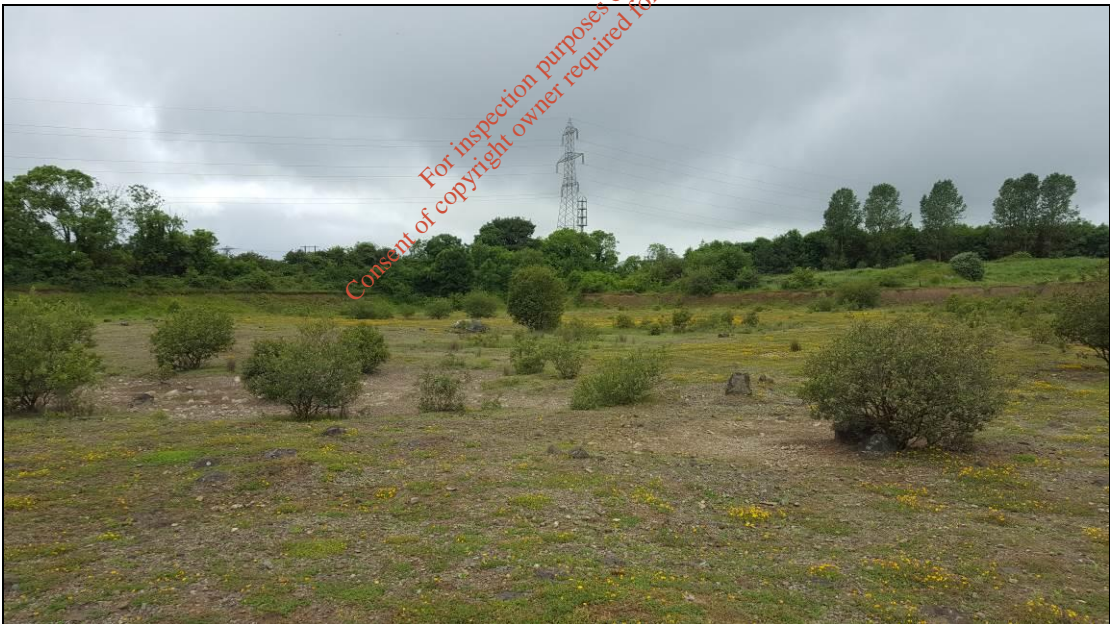
Plate 5-6 View across the stripped overburden area of the West Quarry.

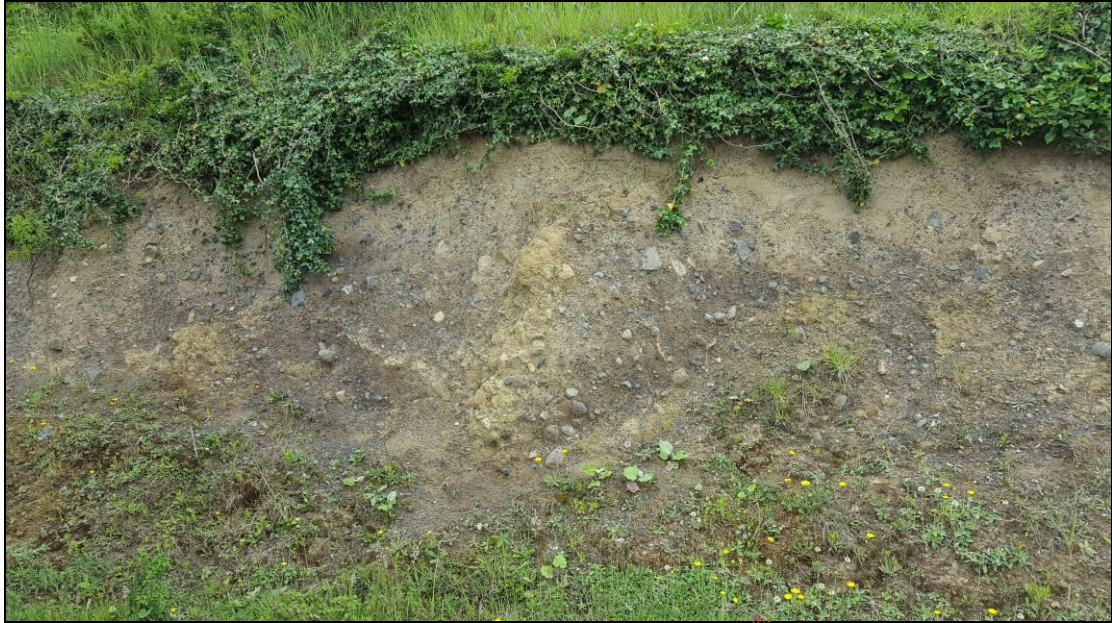
Plate 5-7 Close up view of the overburden material at the West Quarry.

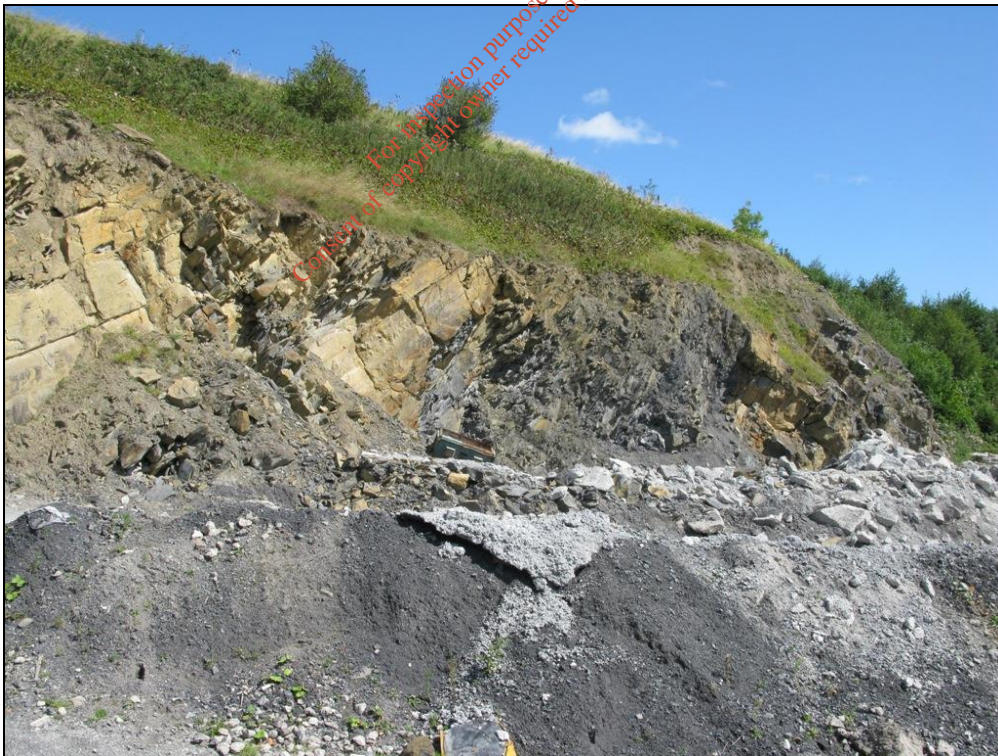
Plate 5-8 Huntstown Central Quarry. Exposure of the Geological Contact between the Waulsortian Limestones of the Feltrim Limestone Formation (to right) and Tober Colleen Formation (to left). Contact marked by arrow.

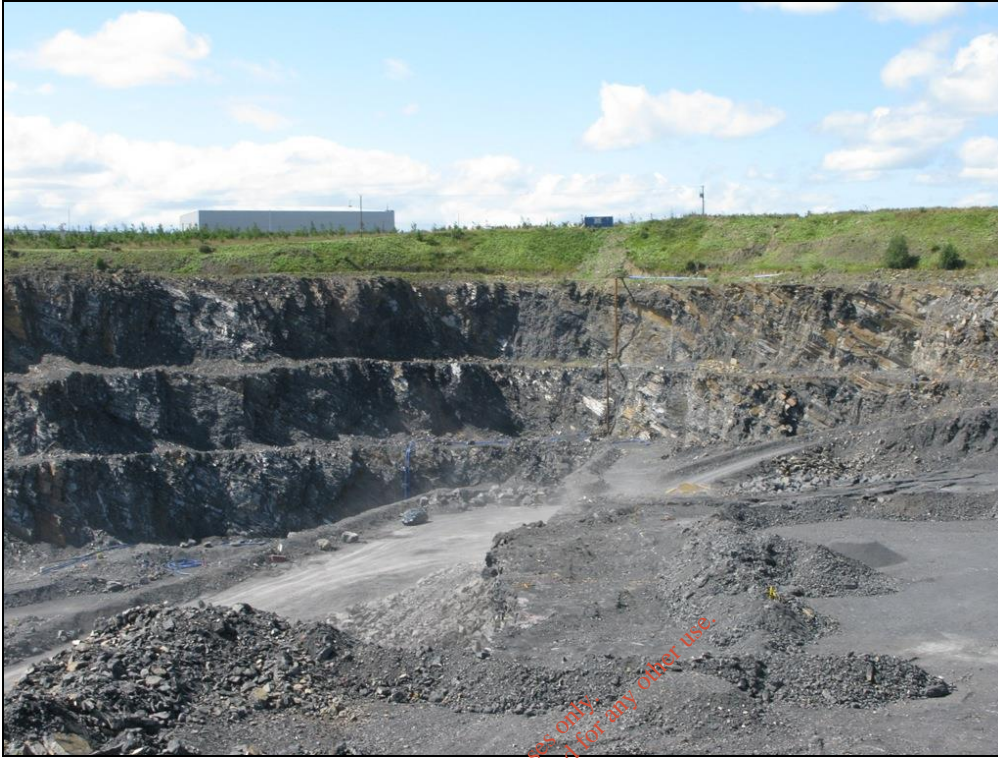
Plate 5- 9 Limestone Sequence Exposed in SW Area of South Quarry
