# Kildare Architects & Design Ltd

Re: - Michael Ennis intends to apply for permission for development at site at Boherkill, Rathangan  
The development will consist of Restoration of the existing excavated gravel pit (previously granted planning permission (01/1270, 07/188 & 15/515) to the original ground levels & use as agricultural land, in order to comply with condition 2(a) of planning permission 07/188, by importing c1,500,000 tonnes (i) of imported inert natural materials, principally excess soil, stones and/or broken rock excavated on construction sites, (ii) Recovery of imported inert construction materials, including stones, granular fill, concrete, blocks, bricks and ceramic tile & (iii) reinstating existing overburden contained on site & all other associated site works for a period of 10years.  
The planning application is accompanied by an Environmental Impact Statement (EIS).  
The application relates to a restoration development for the purpose of an activity requiring a waste licence to be issued by the Environmental Protection Agency.

Planning Ref: 16/526

**PROPOSED RESTORATION & INFILLING OF SAND AND GRAVEL PIT,**

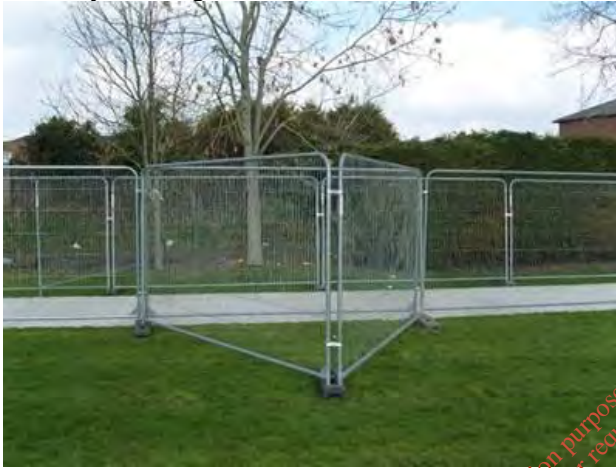
(g) Enclosed please find 6no copies of dwg no. 151324-P-05-FI showing location of proposed security fencing for the overall site.

Proposed Security Fencing

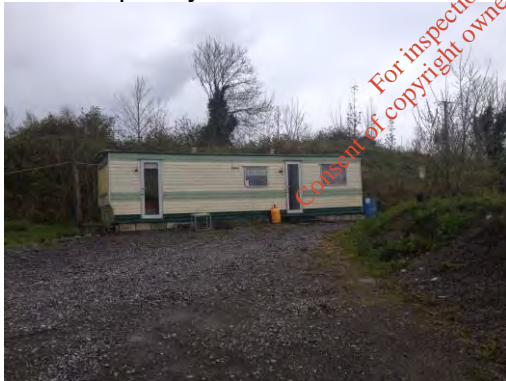
Staff Building

- (a) The existing & intended use of the mobile home on site has been & will be used as a staff facility incorporating staff tea station, store, changing room & wc. The mobile home was shown on drawing no 061063-AI-04 which was granted planning permission ref. 07/188.

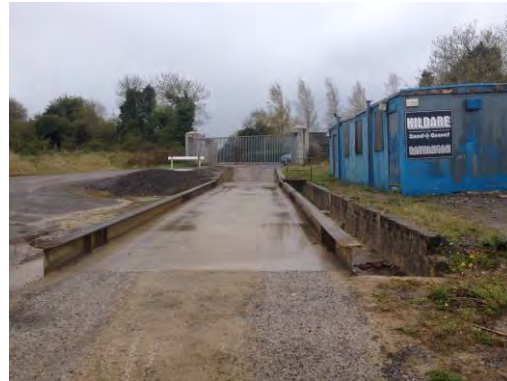
(d) The existing weighbridge & wheelwash currently on site were granted planning permission under planning file 07/188 (15/515 Extension of Duration). Enclosed please find 6no copies of dwg no. 151324-P-07-FI showing Weighbridge & wheelwash location & specification.

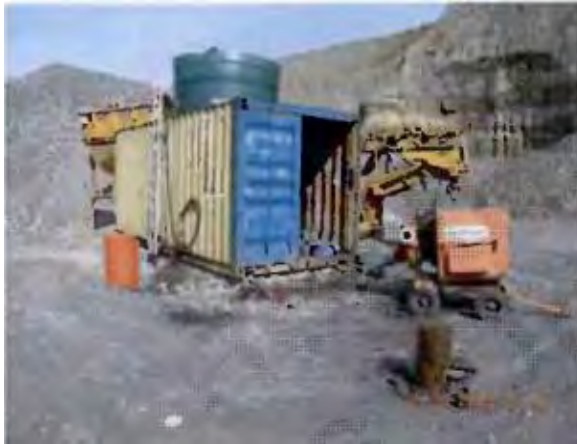
Photo 3 from EAA-I Submission

The photographs contained within the submission reflect particular conditions on site & have no particular relevance to matters which KCC have to deal with now. Please see below current photographs taken on site.

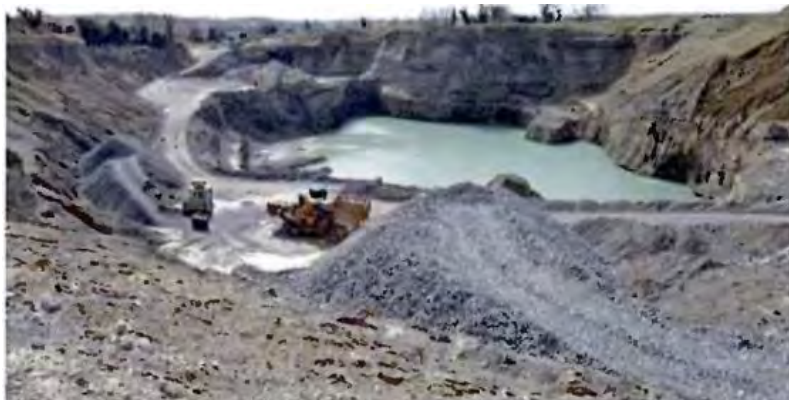
Photo 4 from EAA-I Submission

Photos show occasional surface water ponding due to the rainfall over the previous months which was substantially greater than previous years. Refer to Met Eireann rainfall reports taken from Oakpark Carlow & Baldonnell – Casement Aerodrome. As can be seen, the rainfall during the months leading to the surface water ponding was substantially greater than previous years

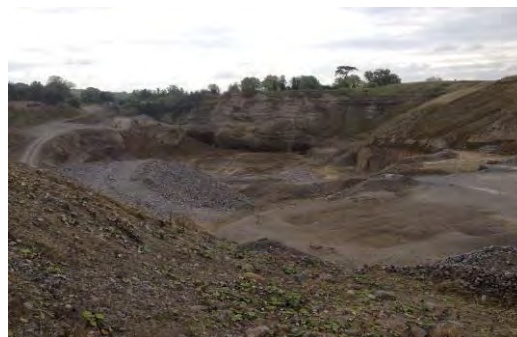
Current on site (12<sup>th</sup> October 2016)

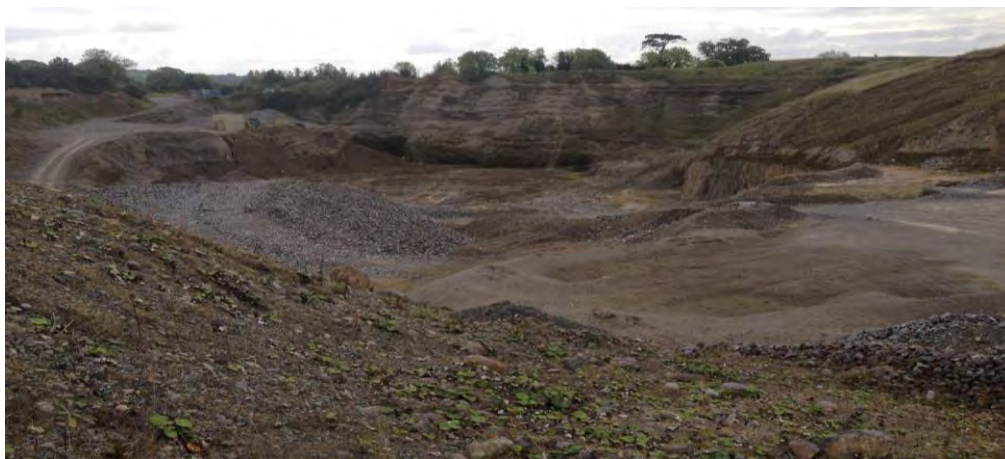
Current On-site Photo (12<sup>th</sup> October 2016) – no surface water ponding

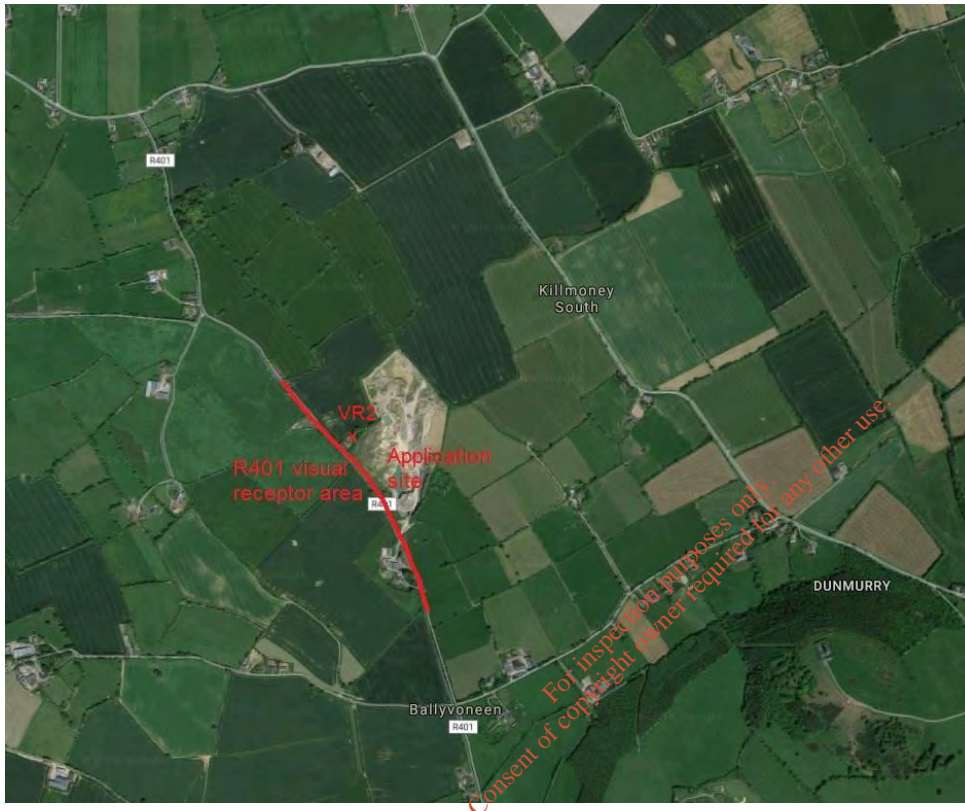
Visual Receptor Area - Map

Visual receptors include users of the R401 who get a glimpse of the site entrance as they pass it & view the temporary overburden stockpile which will be reinstated as part of the restoration process. Private residents adjacent to gravel pit with view of temporary overburden stockpile.

The views of the road users along the R401 are grouped into one visual Receptor Area, as the views from all locations within this area are similar.

Visual Receptor Area No.	Approximate Location/Extent	Types of Receptor	Nature of Views/Visual Amenity
1	Approximately 800m along the R401 to the north & south of the entrance	Road users	Short distance views towards the site entrance and access road. Medium visual amenity.
2	Private Dwelling	People living in the area	Views of temporary overburden stockpile Medium visual amenity.

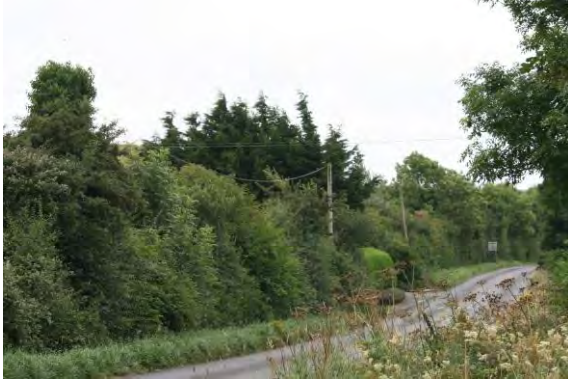
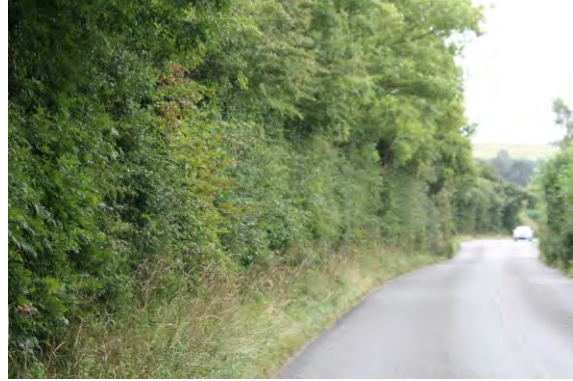
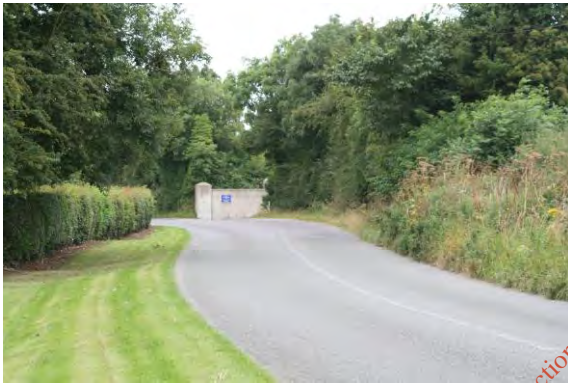
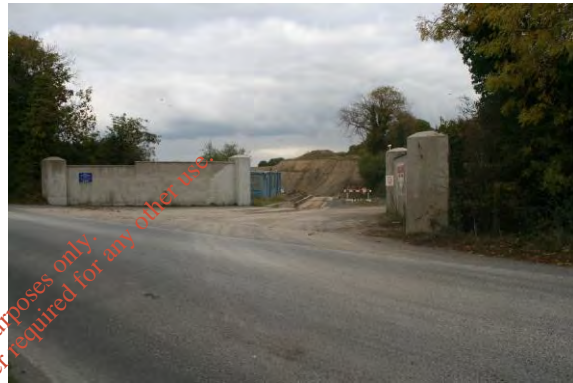
Visual Receptor Area 1 – Photographs

Photography and fieldwork analysis of views of the site were carried out from the surrounding landscape. The object was to determine which locations offer the clearest views of the application site and/or are most accessible to the public and to identify representative viewpoints for detailed viewpoint analysis. The existing views from each of these points are briefly described with the aid of photographs.

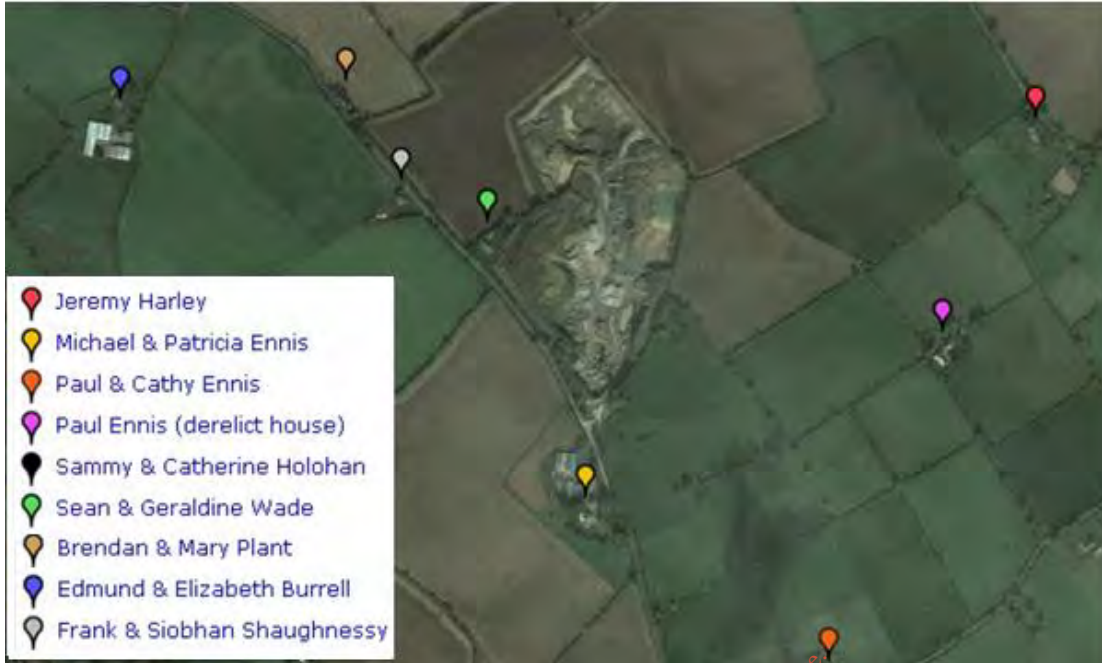
If we look at the proposed phase for year 1 above and the greatest concentration of nearby residences it is obvious that by phase 10 below the development has been progressively moving further away from the bulk of the closest sensitive residences.

This was simply the point being made in section 3.4 of the original EIS.

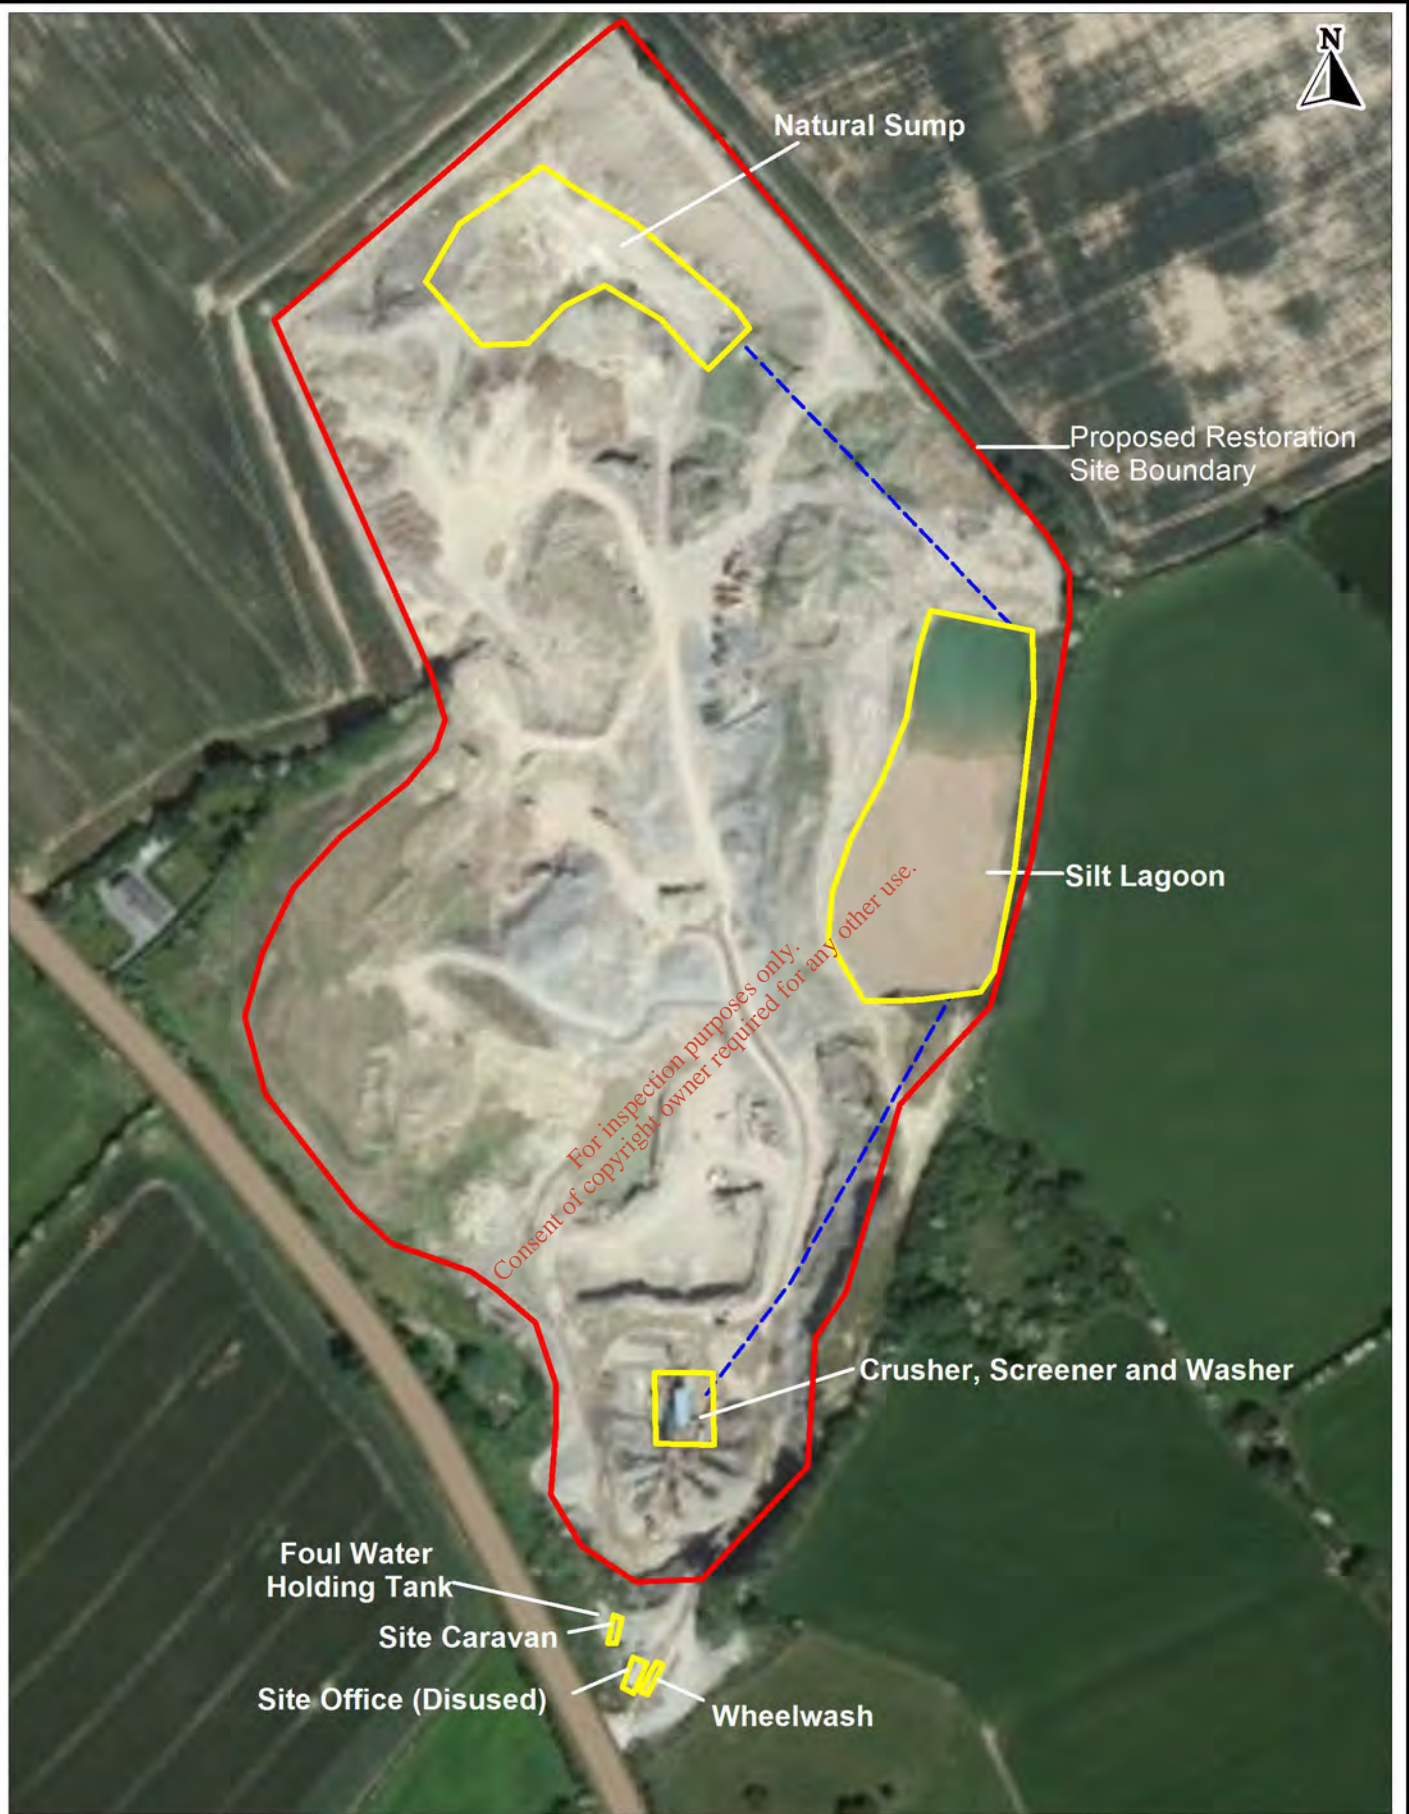
***Drawing No. IE1105-007-A***

<b>Project Title:</b> Hydrogeological Assessment					
<b>Project Address:</b> Boherkill, Rathangan, Co. Kildare					
<b>Client:</b> Kildare Architects & Design Ltd					
<b>Dwg. Title:</b> Site Layout					
<b>Dwg. Scale:</b>	<b>Date:</b>	<b>Dwg. No.:</b>	<b>Job No.:</b>	<b>Revision:</b>	<b>Dwg. By:</b>
NTS	20/10/16	IE1105-002	IE1105	B	ÁMcE

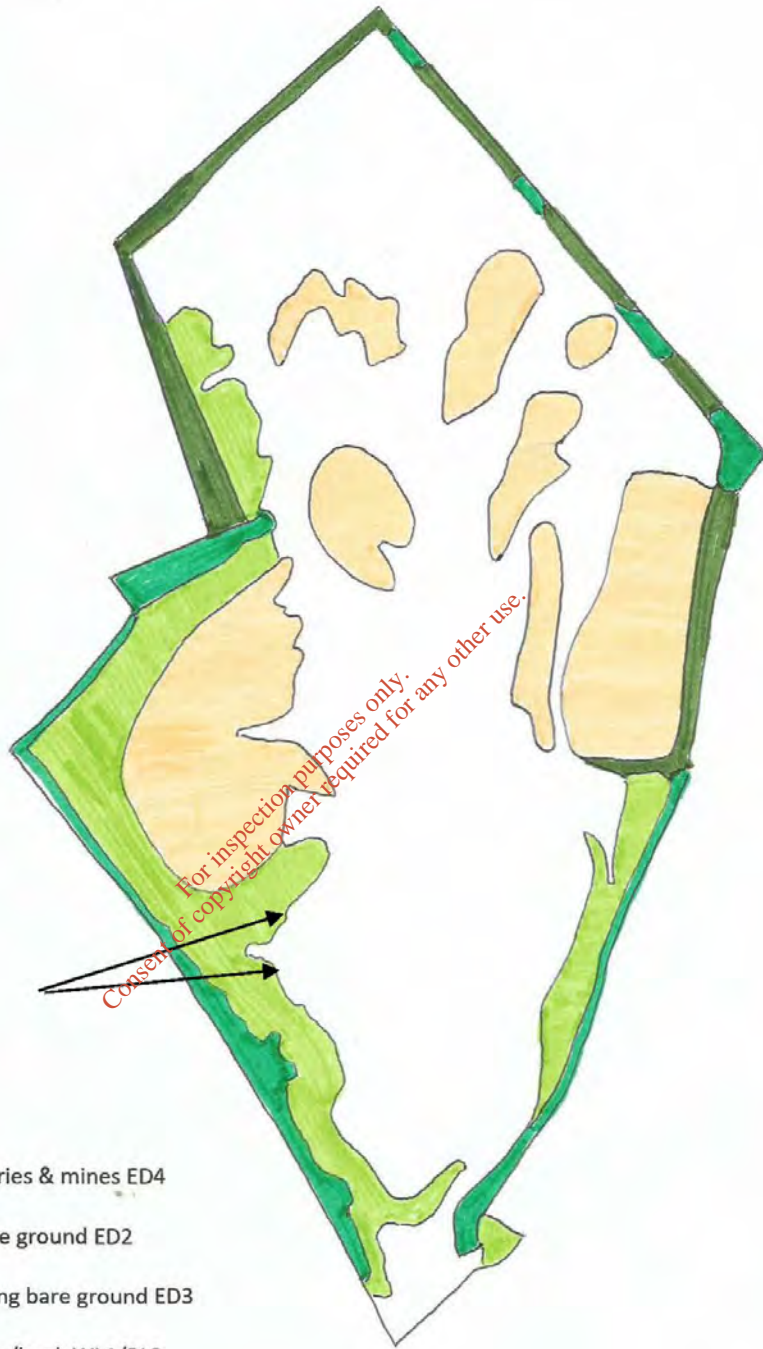
- Active quarries & mines ED4
- Spoil & bare ground ED2
- Recolonising bare ground ED3
- Low hedge/bank WL1/BL2
- Hedgerow with trees WL1

Simplified habitat map of Boherkill Quarry with sand martin colony arrowed
