Re: Kealanine Landfill - Notice in accordance with Regulation 7(4) of the Waste Management (Certification of Historic Unlicensed Waste Disposal and Recovery Activity) Regulations, 2008

Kealanine Landfill Site

Review of Tier 1, Draft Tier 2 and Tier 3 Risk Assessment

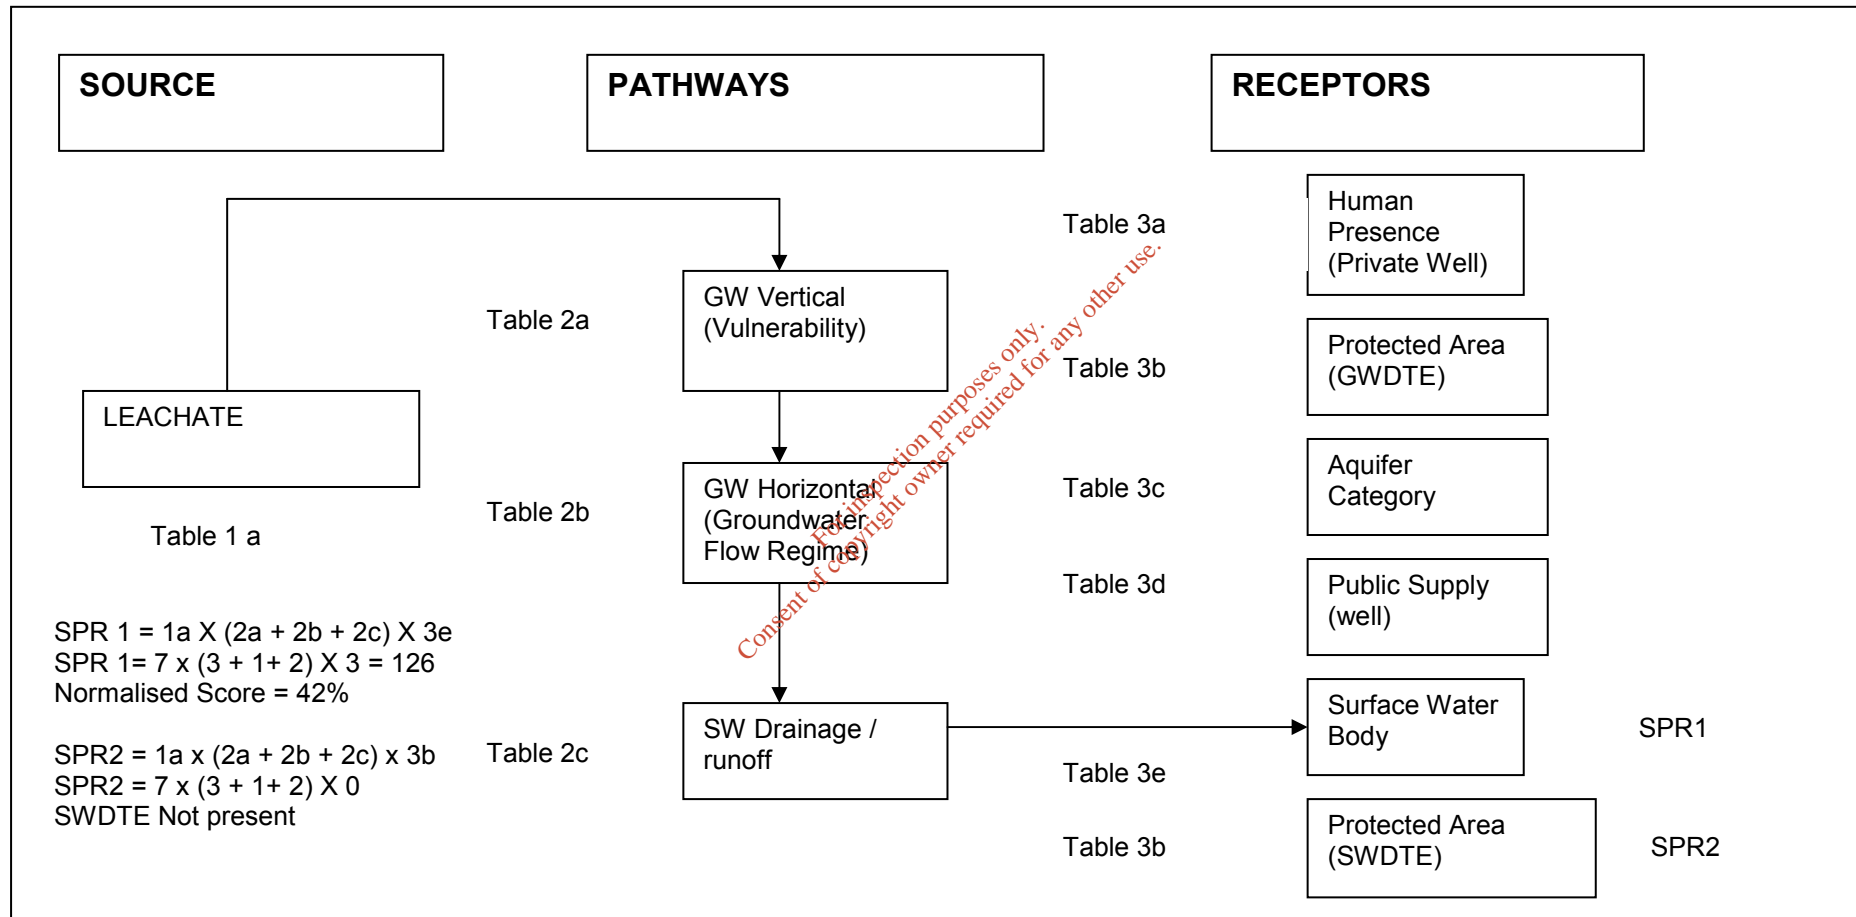
Figure No. 1: Network Diagram For Leachate Migration Through Combined Groundwater & Surface Water Pathways

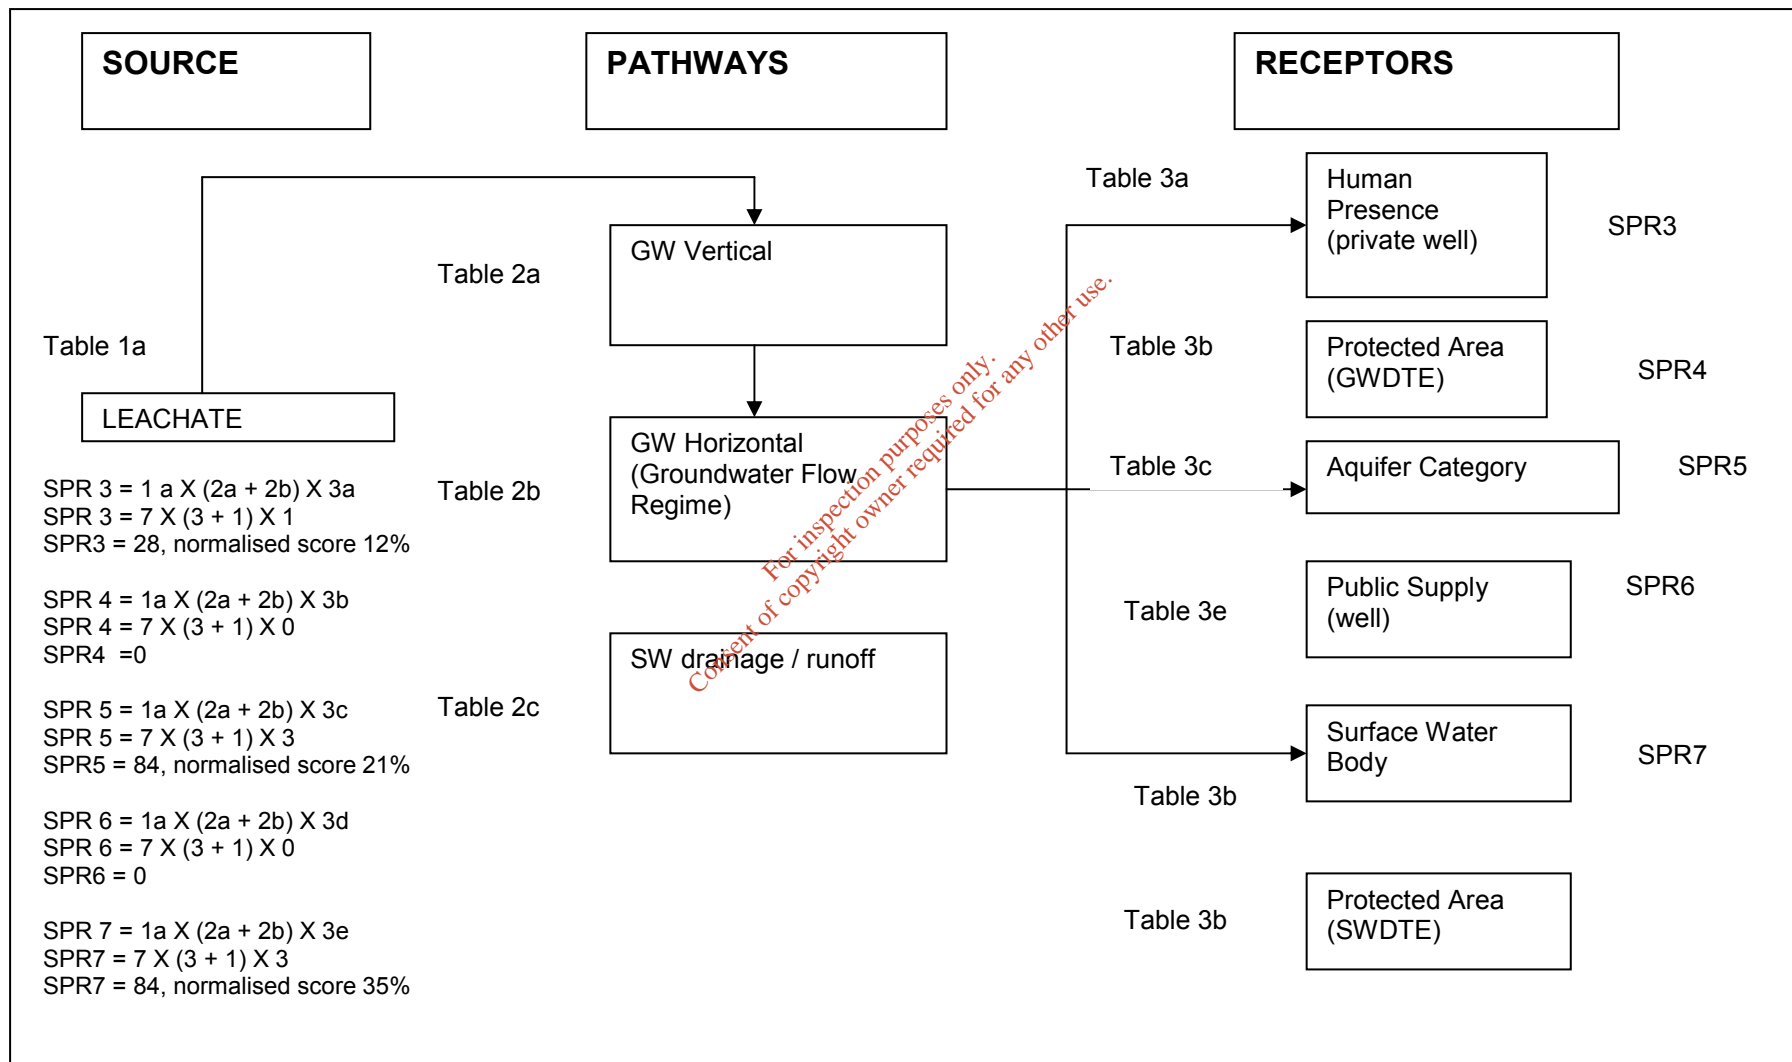
Figure No. 2: Network Diagram For Leachate Migration Through Groundwater Pathways

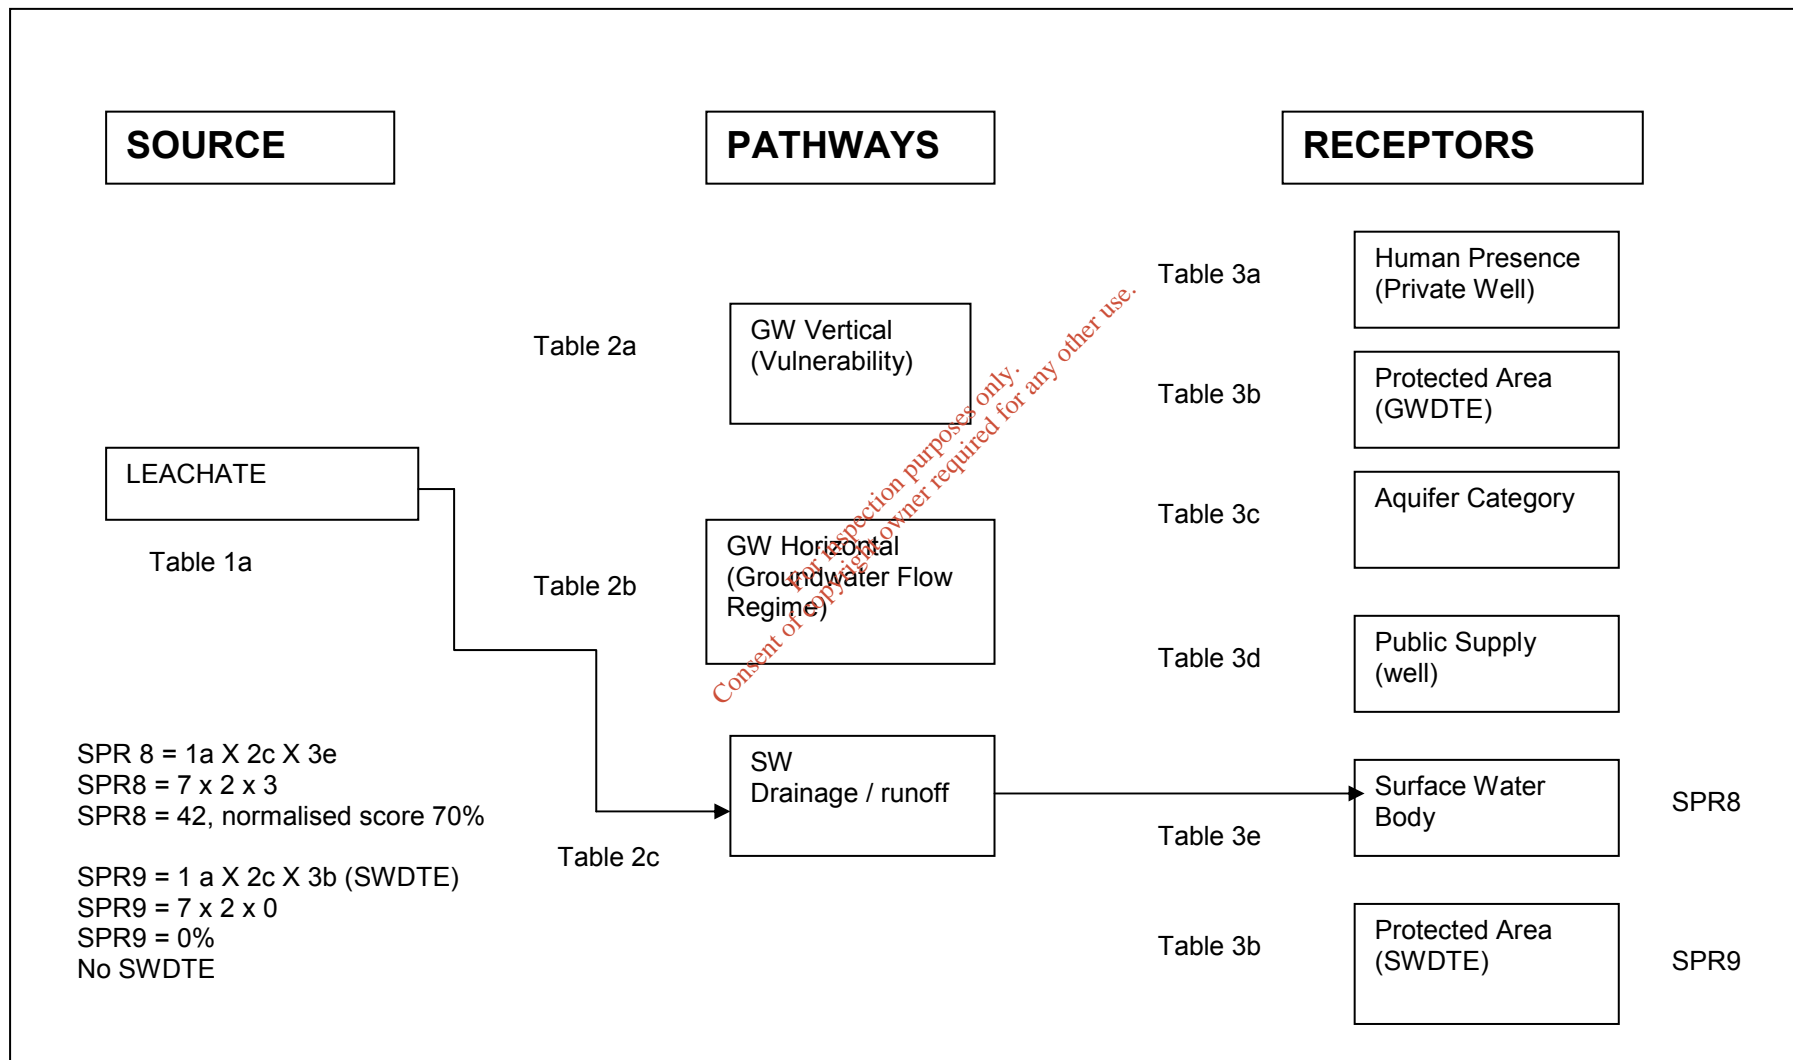
Figure No. 3: Network Diagram For Leachate Migration Through Surface Water Pathway

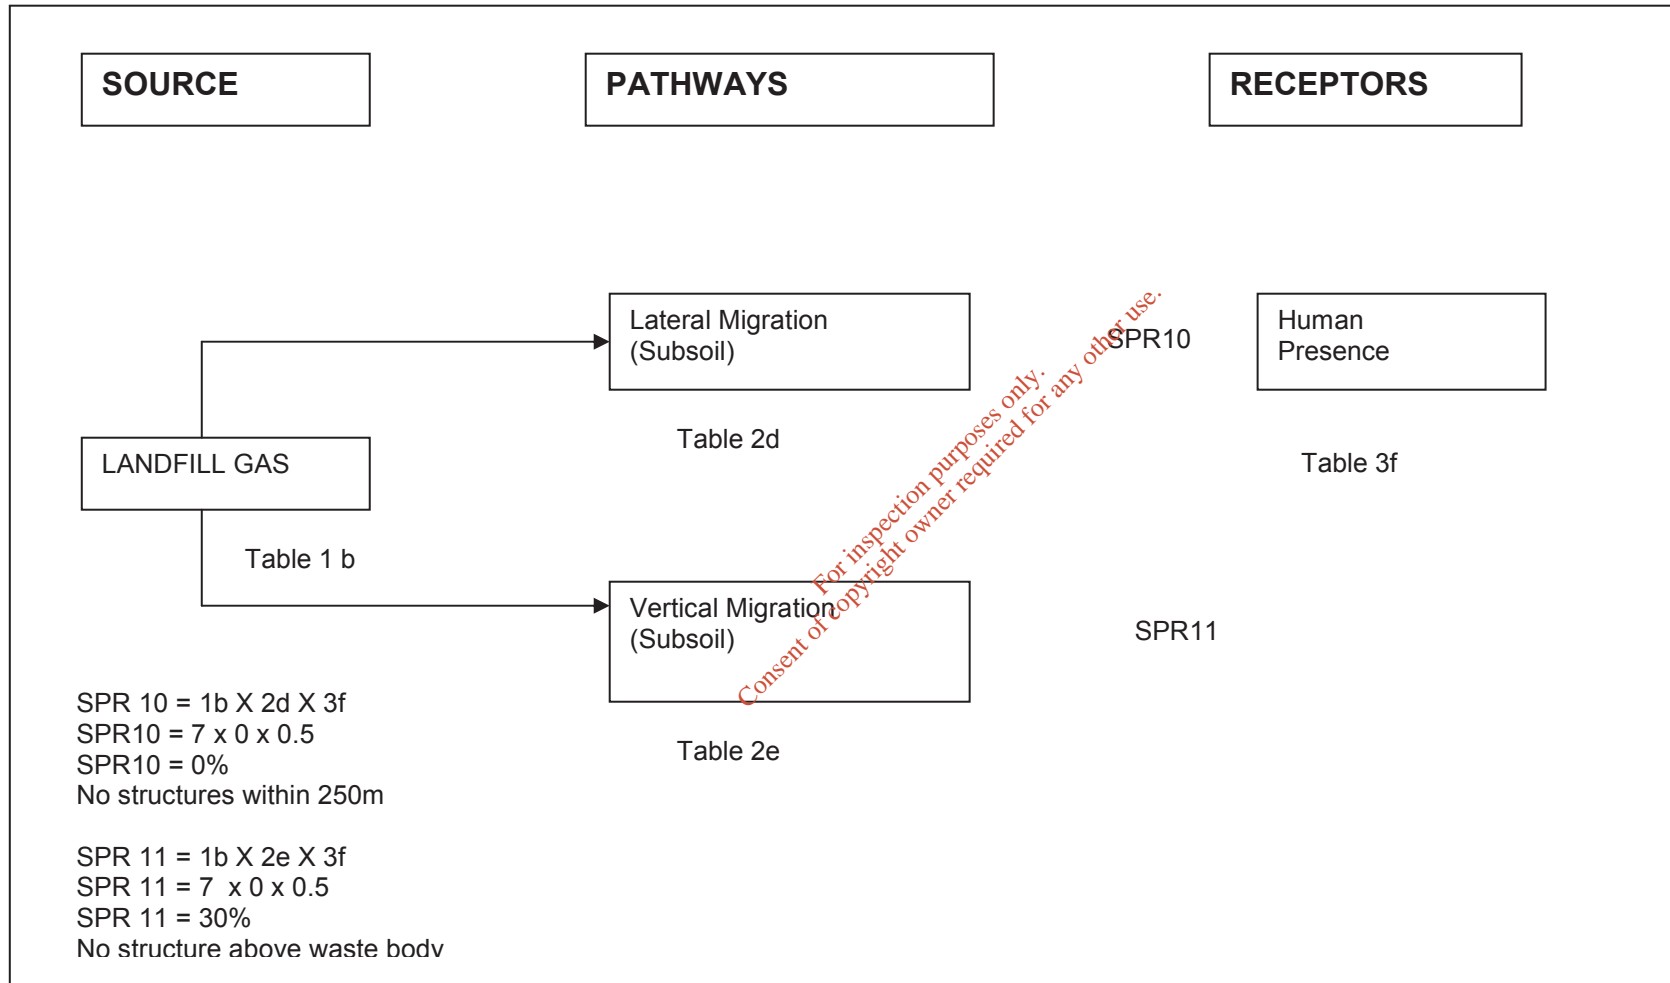
Figure No. 4: Network Diagram For Landfill Gas Migration Pathways (Lateral & Vertical)
