PADRAIG THORNTON WASTE DISPOSAL LTD

THORNTONS RECYCLING CENTRE

Waste Licence Reg. No W0044-02

ANNUAL ENVIRONMENTAL REPORT 2016

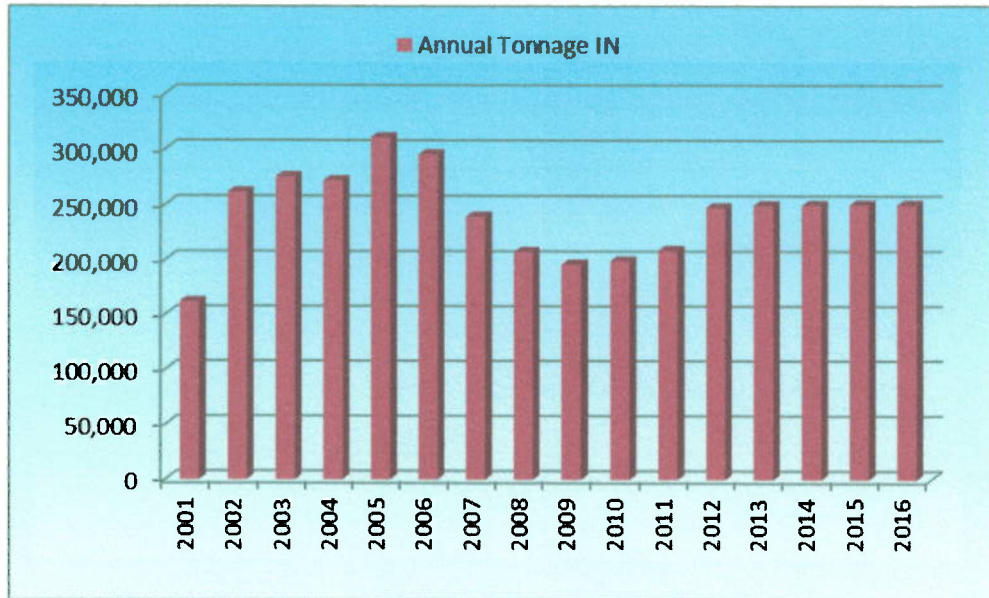
Figure 2 - Quantities of waste received at the facility (2001 – 2016)

A total of 249,729.52 tonnes of waste was received at the facility in the reporting period of 2016. Details of which are contained in Appendix 2 of this report. Figure 1 illustrates the trend in waste received at the facility between the periods 2001 to 2016.

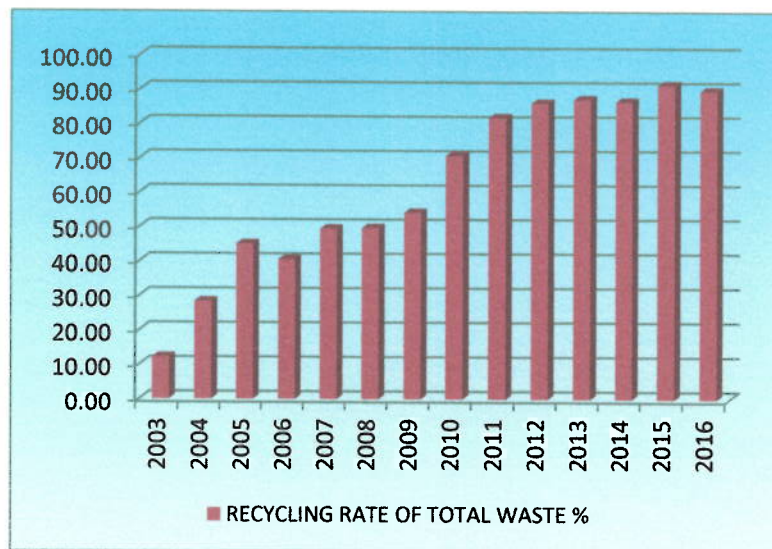
Figure 4 - Recycling Rate trends (2003 - 2016)

The total quantity of waste recovered or recycled has increased steadily at the facility. PTWDL process, sort and segregate all skip waste and now MSW material at Thorntons

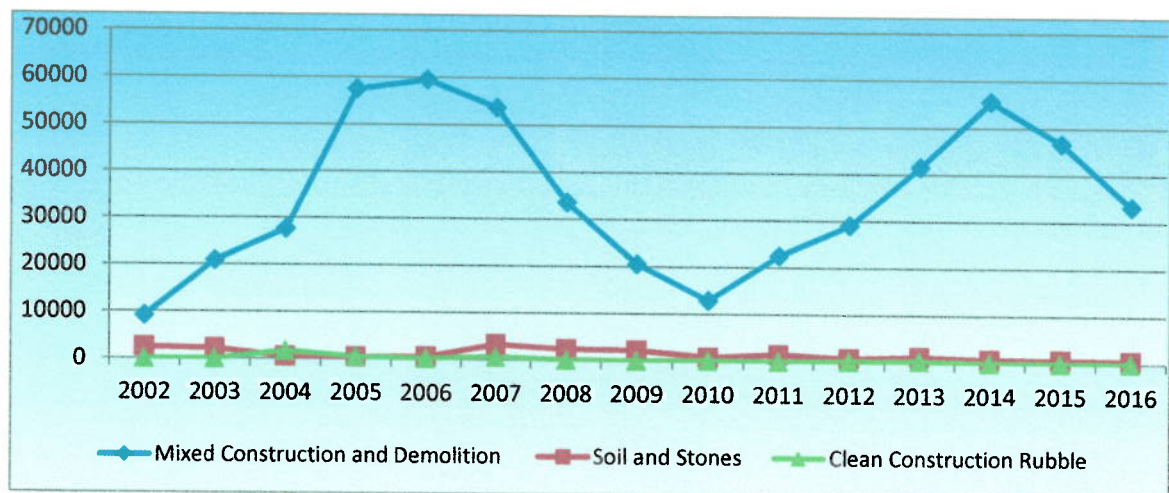
Figure 5 - Recovery of C&D waste (2002 - 2016)

Under National and European waste policies, Ireland was expected to recycle 85% of Construction and Demolition Waste by 2013. Mixed Construction and Demolition materials received at the facility had increased steadily between 2003 and 2006. However, 2007 to 2010 showed a decrease in the quantity of this material accepted from 60,214 tonnes in 2006 13,824 tonnes in 2010. Between the years 2011 and 2014 the volumes of C&D waste accepted on site for processing increased, but decreased in 2016 to 33,317.72 tonnes from 47,337.03 tonnes in 2015. Thorntons Recycling have utilised the Dunboyne Facility since the latter half of 2015 to divert some C&D materials and to enable us to accept more materials suitable for SRF production at the Killeen Road facility.

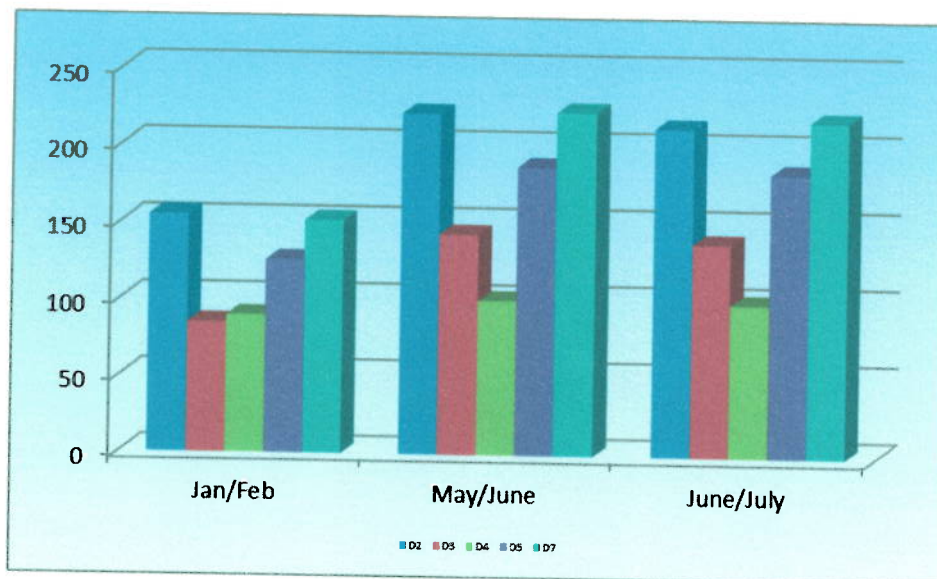
Figure 7 - Dust Monitoring Results 2016

Monitoring Locations	Sample 1 Jan/Feb	Sample 2 May/June	Sample 3 June/July	ELV mg/l
D2	155	222	214	350
D3	85	144	139	350
D4	90	101	100	350
D5	126	188	185	350
D7	152	224	219	350

A new mist air dust suppression system was erected in 2013 in Building 2. In 2013 an extended roofed area between building 3 and building 5 was erected. Upon completion, a dust curtain was erected in addition to a mist air system, to further militate against dust emissions. Dust curtains on site in 2015 were replaced where necessary. An air curtain was installed on the outer side of the automatic fast roller door on the exit from building 1 in 2016. This prevents both dust and odours escaping from this building. In an effort to further reduce dust emissions Thorntons Recycling also uses a road sweeper which is used at least twice daily in the facility. This is also used on the Killeen Road and Kylemore Park North to assist in reducing dust levels due to passing traffic and upwind contributors.

PTWDL recognise the importance of maintaining dust levels below the emission limit level of 350mg/m²/day and are fully committed to maintaining compliant emissions from the facility in 2016.
