Appendix 2 Trial Pit records

Appendix 3 Laboratory Test Results

SWS Group Limited
Compliance with Waste Licence W0211-01
Site Investigatory Work
Report on site investigation at the Foxhole waste facility, Youghal, Co. Cork
MEL Work Item A1
MEL Doc. Ref: 1906-068 (Final)
Date: Wednesday, April 18, 2007

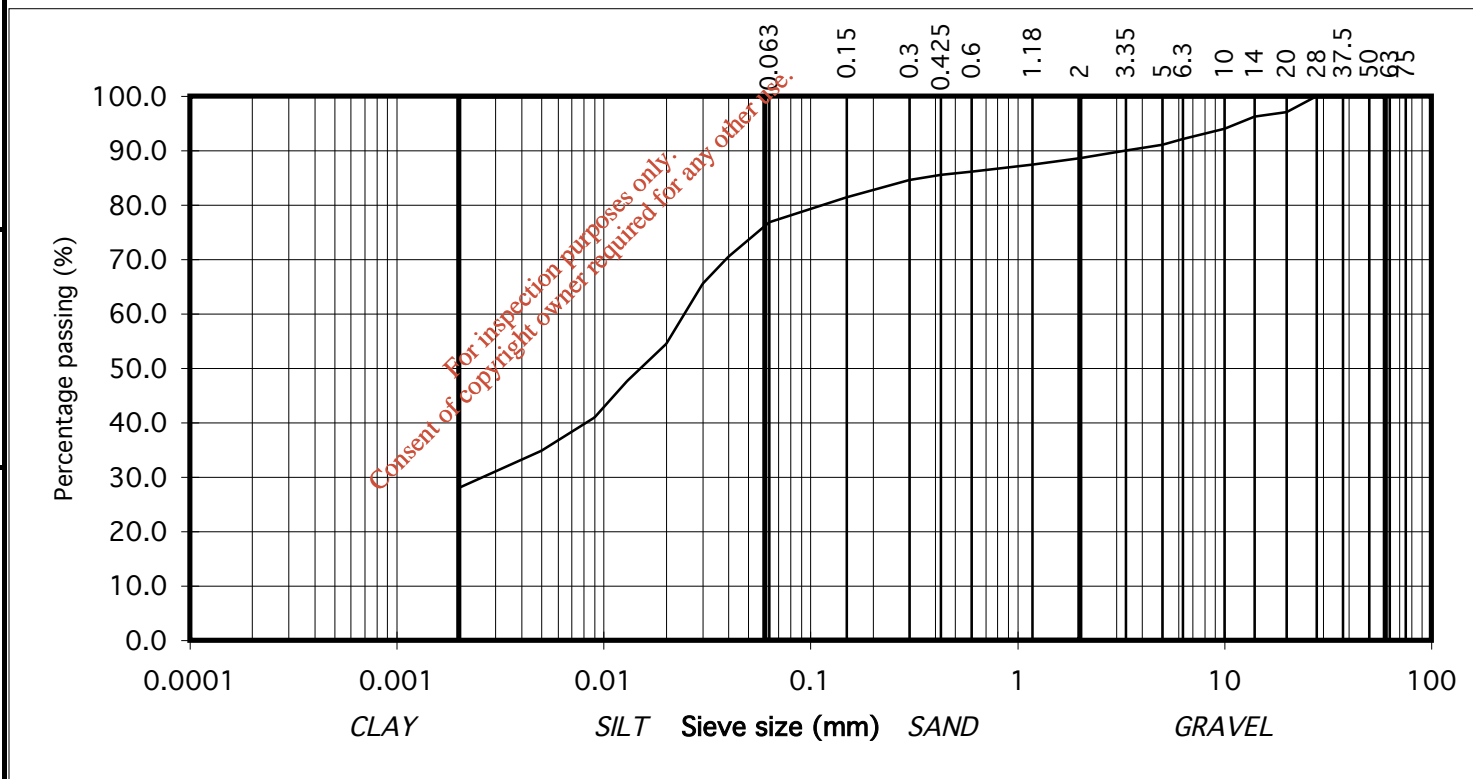
Determination of Particle Size Distribution

Contract No: 11303
 Contract: FOXHOLE YOUGHAL CO.CORK
 BH/TP No: BH 7
 SAMPLE No.: 3329
 DEPTH (m): 12.00
 TEST METHOD: Wet sieve and hydrometer
 DESCRIPTION: Brown slightly sandy, slightly gravelly, CLAY

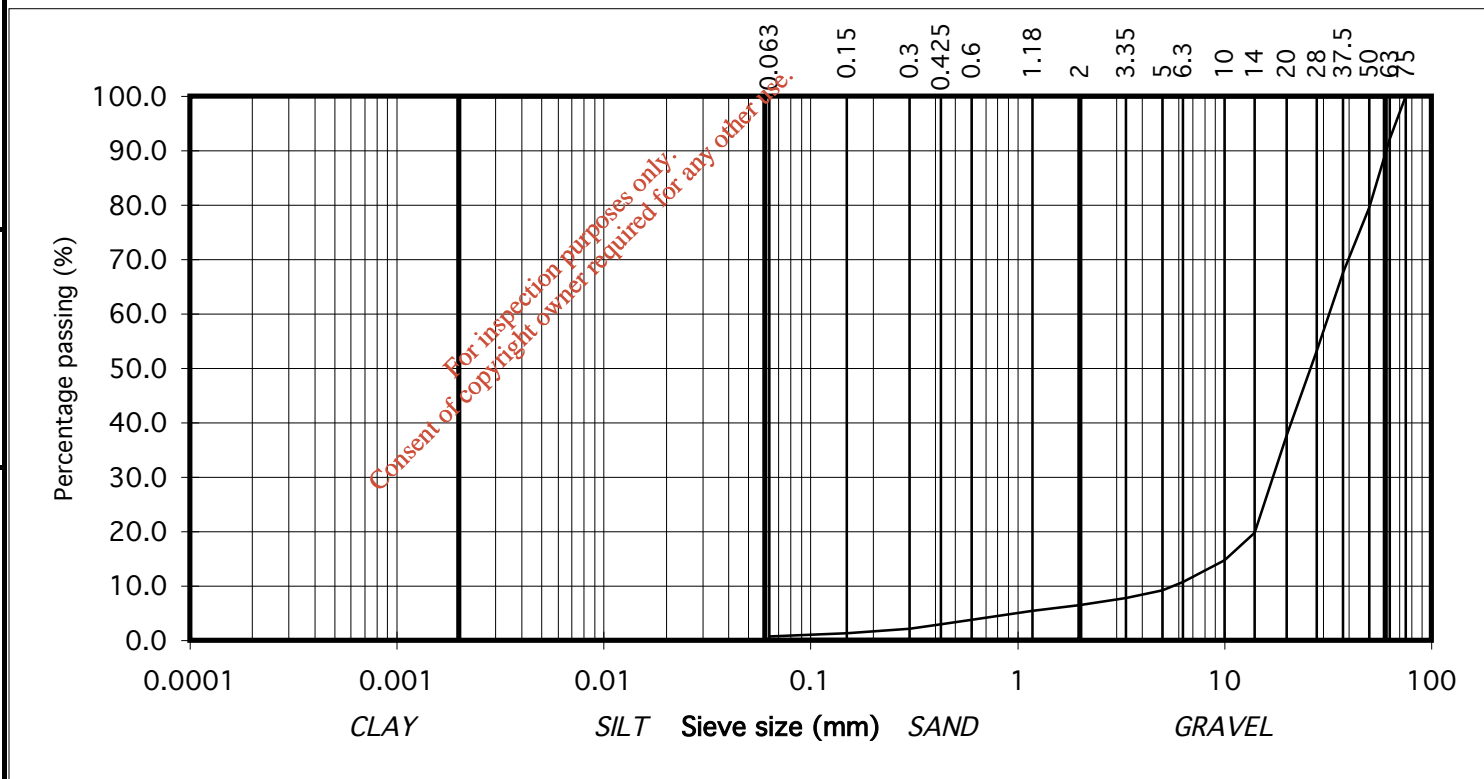
Determination of Particle Size Distribution

Contract No: 11303
 Contract: FOXHOLE YOUGHAL CO.CORK
 BH/TP No: BH 6
 SAMPLE No.: 3394
 DEPTH (m): 7.00
 TEST METHOD: Wet sieve
 DESCRIPTION: Grey brown slightly clayey/silty, sandy, GRAVEL with some cobbles
