## ***Kerry County Council***

Waste Licence Ref No. W0001-04

### ***› Annual Environmental Report for North Kerry Landfill 2016 ‹***

January 2016 – December 2016

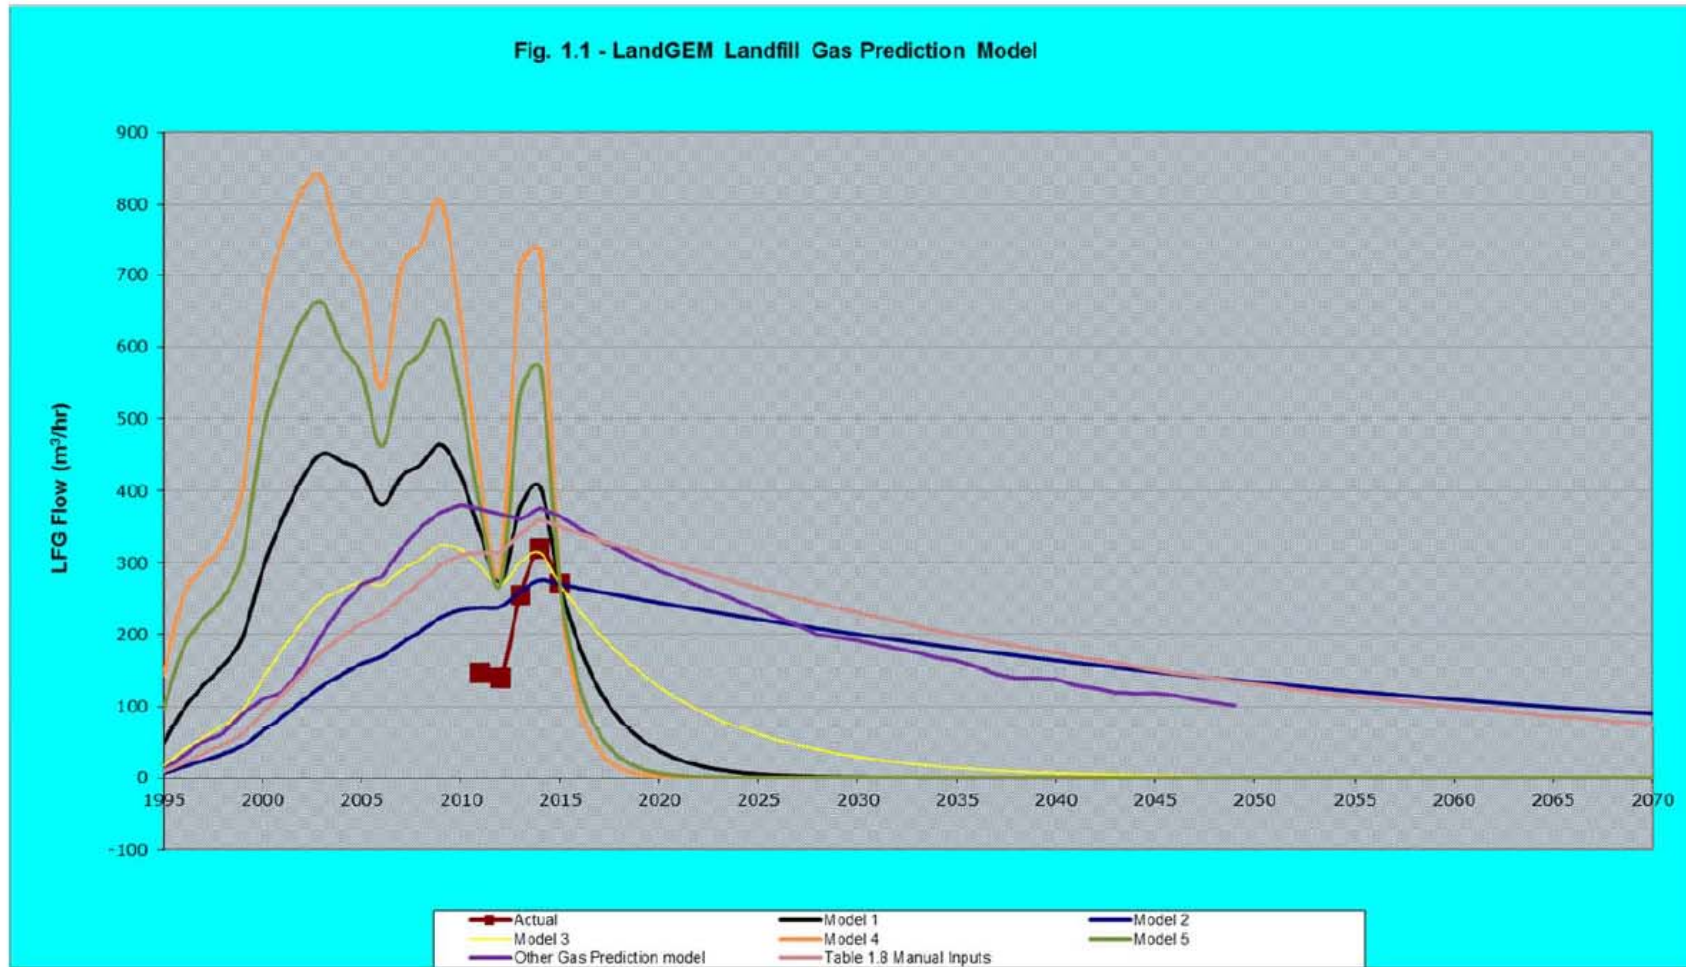
Model 2 shows a scenario of a long flat curve, created by wet waste conditions. The curve which is likely the best fit, is called '[Table 1.84 Model Inputs.](#)'

Models 1, 4 and 6 use input parameters which are closer to the default settings in Landgem, but as can be seen do not predict generation as high as would have been predicted in the period 2010-2013 in the AERs on file.

**Figure 3-8: Calibrated Landfill Gas Prediction Models**

FT advises that whilst it is not possible to accurately estimate the future gas production flow rates it is unlikely that these rates will increase significantly year on year given that leachate dissipation within perched bodies will most likely be a function of secondary consolidation.

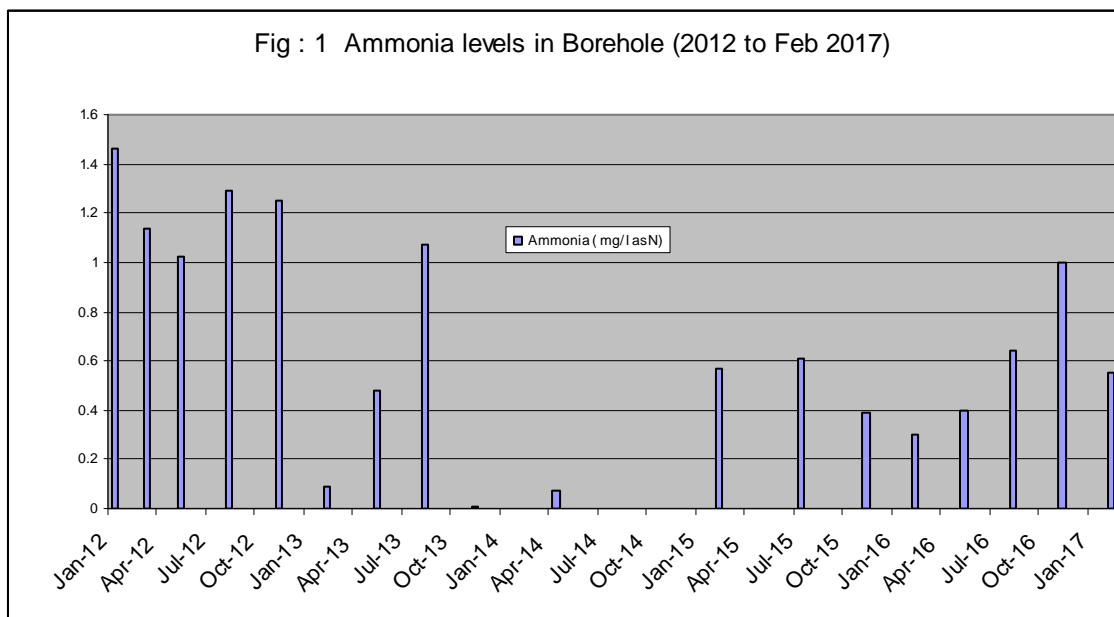
Borehole 5 continues pattern of other years i.e. high Ammonias coupled with highest levels of colour and molybdate reactive Phosphorous *see Fig 1* . However in last two years there is also increasing evidence of above background levels of cyanide and Arsenic. This may point to contamination from Landfill source and thus requires further investigation.

Fig 1 Ammonia levels in Borehole 5 2012 to 2017

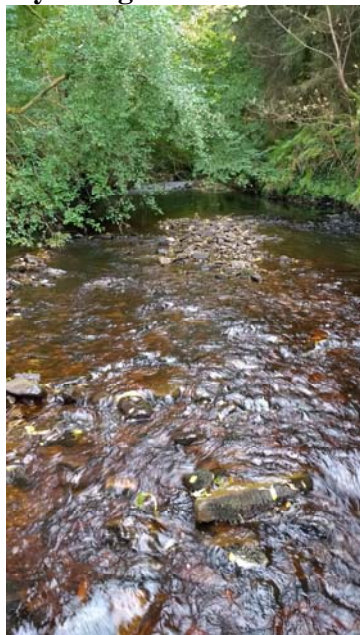
### **Ivy Bridge:**

The Glashoreag River at Ivy Bridge is further downstream of G2 and upstream of the confluence with the River Smearlagh. It scores a biological Q rating of 4 indicating good water quality and unpolluted conditions

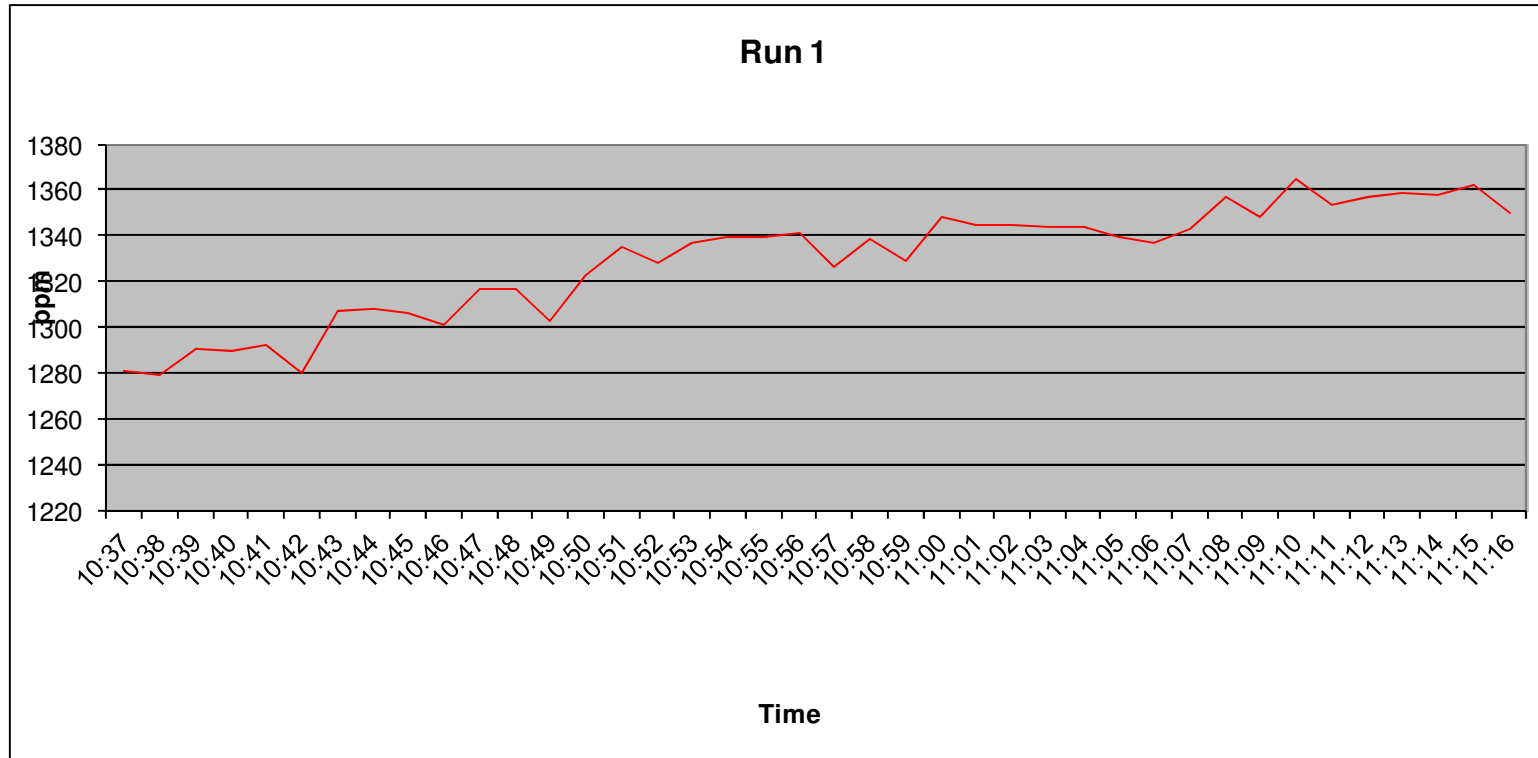
**Carbon Monoxide Trend**

<b>Units</b>	<b>Run 1</b>
Measured Quantities		
Certified Range of Analyser	ppm	1.36 to 1000
Operational Range of Analyser	ppm	2000
Measured Reading	ppm	1328.88
Measured Quantities	<b>Units</b>	<b>Run 1</b>
Nonlinearity	%	0.9
Temperature Dependent Zero drift	%	0.14
Temperature Dependent Span drift	%	-0.12
Cross-sensitivity	%	0.08
Leak	%	0
Calibration Gas Uncertainty	%	<2
<b>Parameter</b>	<b>Units</b>	<b>Run 1</b>
Combined uncertainty	mg.m <sup>-3</sup>	20.94
Expanded uncertainty	mg.m <sup>-3</sup>	41.88
<b>Uncertainty corrected to std conds.</b>	mg.m <sup>-3</sup>	116.55
<b>Expanded uncertainty expressed with a level of confidence of 95%</b>	% of ELV	-
<b>Expanded uncertainty expressed with a level of confidence of 95%</b>	mg.m <sup>-3</sup>	116.55
<b>Expanded uncertainty expressed with a level of confidence of 95%</b>	% of value	7.02
<b>Requirement in standard is for uncertainty to be &lt; 10% at ELV at standard conditions</b>

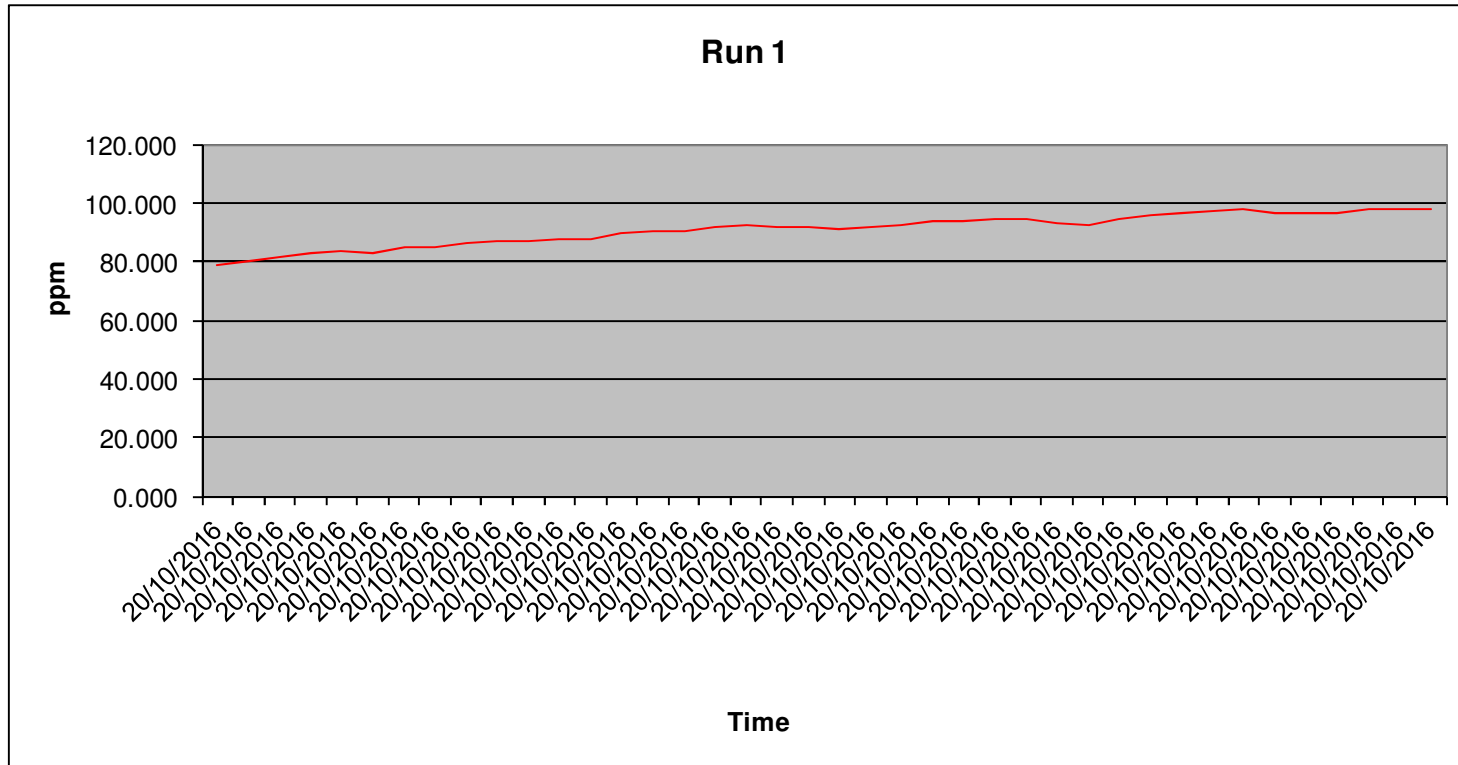
Oxides of Nitrogen Trend

Measured Quantities	Units	Run 1
Nonlinearity	%	1.4
Temperature Dependent Zero drift	%	-0.04
Temperature Dependent Span drift	%	-0.25
Cross-sensitivity	%	0.5
Leak	%	0
Calibration Gas Uncertainty	%	<2
Mass Flow Controllers (Dilution) Uncertainty	%	<1
NOx Converter Efficiency	%	95.3
Parameter	Units	Run 1
Combined uncertainty	mg.m <sup>-3</sup>	5.60
Expanded uncertainty	mg.m <sup>-3</sup>	11.21
<b>Uncertainty corrected to std conds.</b>	mg.m <sup>-3</sup>	17.35
<b>Expanded uncertainty expressed with a level of confidence of 95%</b>	% of ELV	3.47
<b>Expanded uncertainty expressed with a level of confidence of 95%</b>	mg.m <sup>-3</sup>	17.35
<b>Expanded uncertainty expressed with a level of confidence of 95%</b>	% of value	9.31
<b>Requirement in standard is for uncertainty to be &lt; 10% at ELV at standard conditions</b>

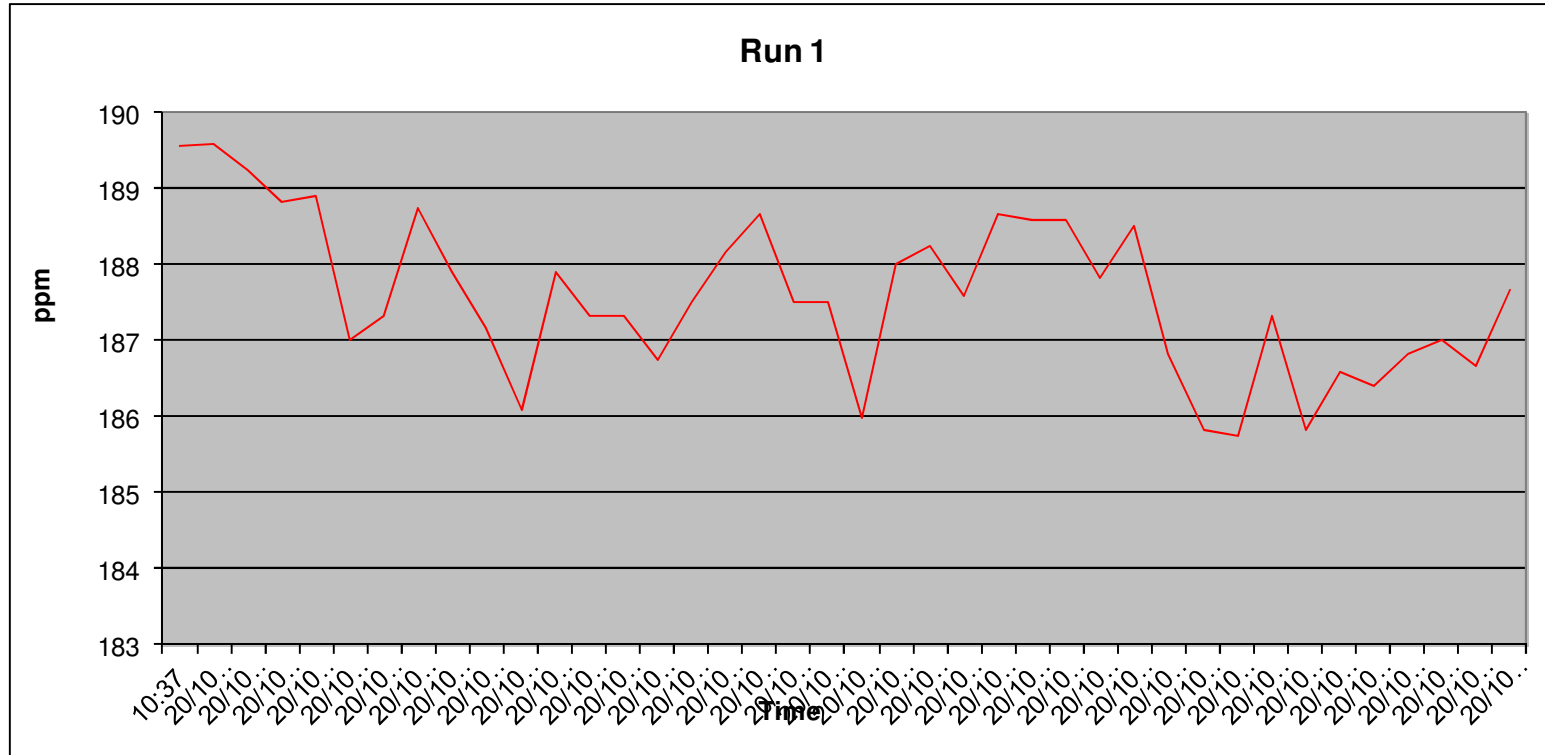
**Sulphur Dioxide Trend**

<b>Units</b>	<b>Run 1</b>
Measured Quantities		
Certified Range of Analyser	ppm	2.14 to 1000
Operational Range of Analyser	ppm	1000
Measured Reading	ppm	187.60
Measured Quantities	<b>Units</b>	<b>Run 1</b>
Nonlinearity	%	0.8
Temperature Dependent Zero drift	%	0.8
Temperature Dependent Span drift	%	2
Cross-sensitivity	%	1.5
Leak	%	0
Calibration Gas Uncertainty	%	<2 %
<b>Parameter</b>	<b>Units</b>	<b>Run 1</b>
Combined uncertainty	mg.m <sup>-3</sup>	7.80
Expanded uncertainty	mg.m <sup>-3</sup>	15.61
<b>Uncertainty corrected to std conds.</b>	mg.m <sup>-3</sup>	38.74
<b>Expanded uncertainty expressed with a level of confidence of 95%</b>	% of ELV	-
<b>Expanded uncertainty expressed with a level of confidence of 95%</b>	mg.m <sup>-3</sup>	38.74
<b>Expanded uncertainty expressed with a level of confidence of 95%</b>	% of value	7.22
<b>Requirement in standard is for uncertainty to be &lt; 10% at ELV at standard conditions</b>

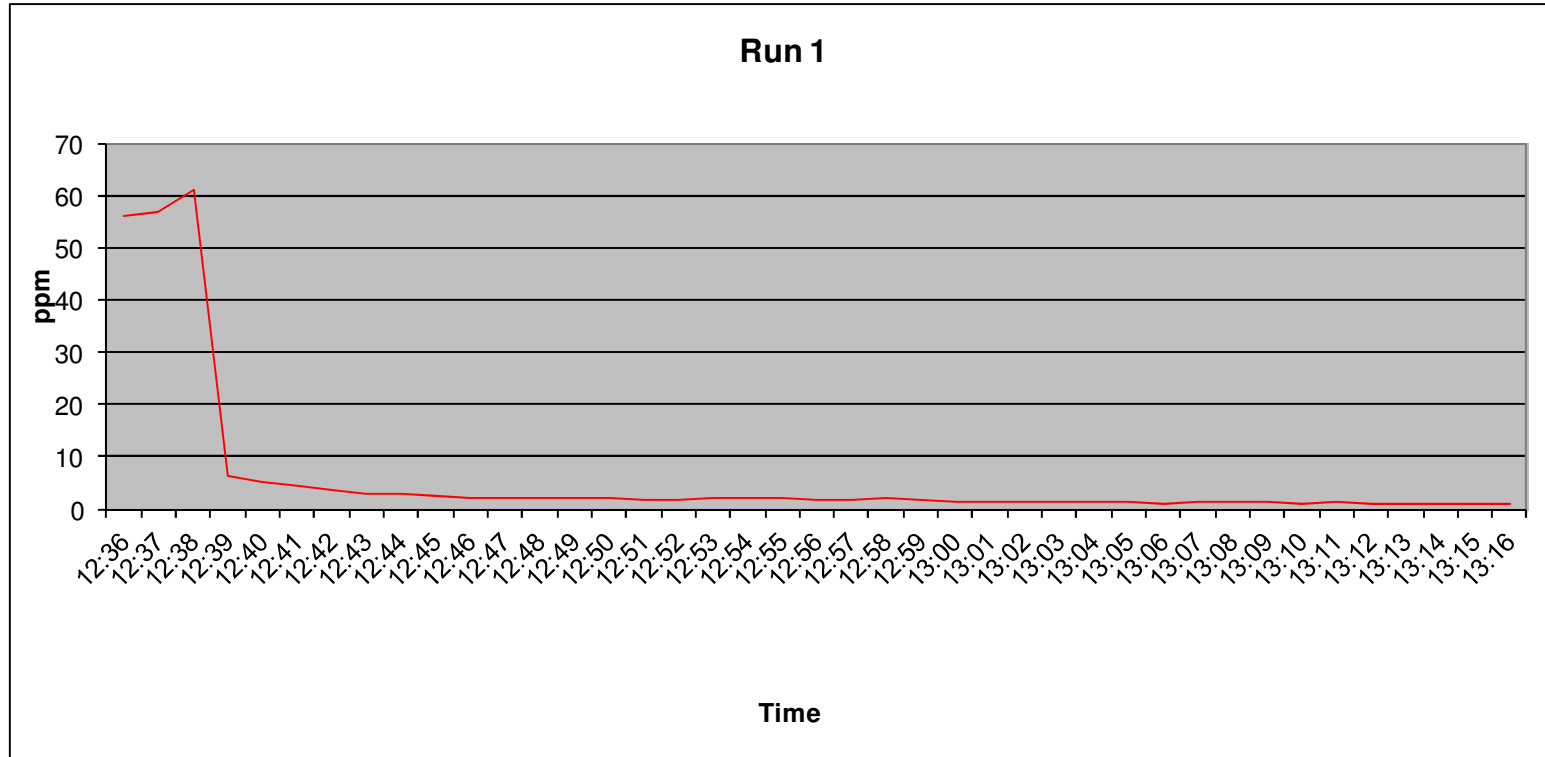
**Carbon Monoxide Trend**

<b>Units</b>	<b>Run 1</b>
Measured Quantities		
Certified Range of Analyser	ppm	1.36 to 1000
Operational Range of Analyser	ppm	200
Measured Reading	ppm	6.08
Measured Quantities	<b>Units</b>	<b>Run 1</b>
Nonlinearity	%	0.9
Temperature Dependent Zero drift	%	0.14
Temperature Dependent Span drift	%	-0.12
Cross-sensitivity	%	0.08
Leak	%	0
Calibration Gas Uncertainty	%	<2
<b>Parameter</b>	<b>Units</b>	<b>Run 1</b>
Combined uncertainty	mg.m <sup>-3</sup>	1.06
Expanded uncertainty	mg.m <sup>-3</sup>	2.12
<b>Uncertainty corrected to std conds.</b>	mg.m <sup>-3</sup>	2.82
<b>Expanded uncertainty expressed with a level of confidence of 95%</b>	% of ELV	-
<b>Expanded uncertainty expressed with a level of confidence of 95%</b>	mg.m <sup>-3</sup>	2.82
<b>Expanded uncertainty expressed with a level of confidence of 95%</b>	% of value	37.16
<b>Requirement in standard is for uncertainty to be &lt; 10% at ELV at standard conditions</b>

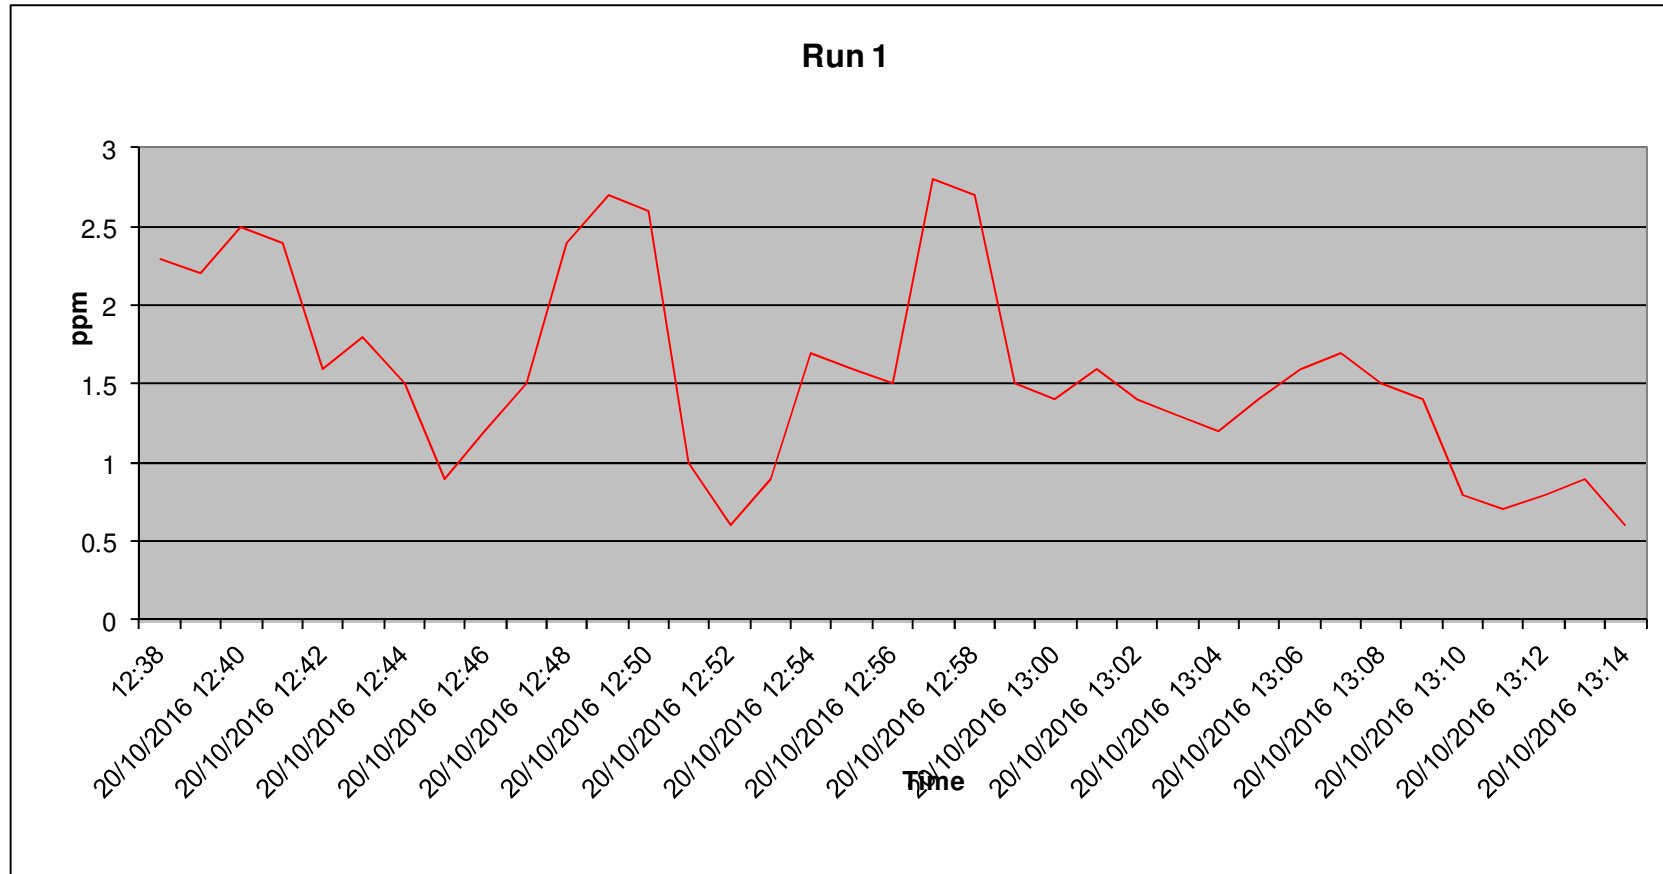
Total Volatile Organic Carbon Trend

<b>Units</b>	<b>Run 1</b>
<b>Measured Quantities</b>		
Certified Range of Analyser	ppm	0.5 to 1000
Operational Range of Analyser	ppm	100
Measured Reading	ppm	1.57
<b>Measured Quantities</b>	<b>Units</b>	<b>Run 1</b>
Nonlinearity	%	0.068
Temperature Dependent Zero drift	%	0.3
Temperature Dependent Span drift	%	0.3
Cross-sensitivity	%	-
Leak	%	<2
Calibration Gas uncertainty	%	<2
<b>Parameter</b>	<b>Units</b>	<b>Run 1</b>
Combined uncertainty	mg.m <sup>-3</sup>	2.80
Expanded uncertainty	mg.m <sup>-3</sup>	0.30
<b>Expanded uncertainty expressed with a level of confidence of 95%</b>	% of ELV	10.63
<b>Expanded uncertainty expressed with a level of confidence of 95%</b>	% of value	21.26
<b>Expanded uncertainty expressed with a level of confidence of 95%</b>	mg.m <sup>-3</sup>	0.60
<b>Requirement in standard is for uncertainty to be &lt; 10% at ELV at standard conditions</b>

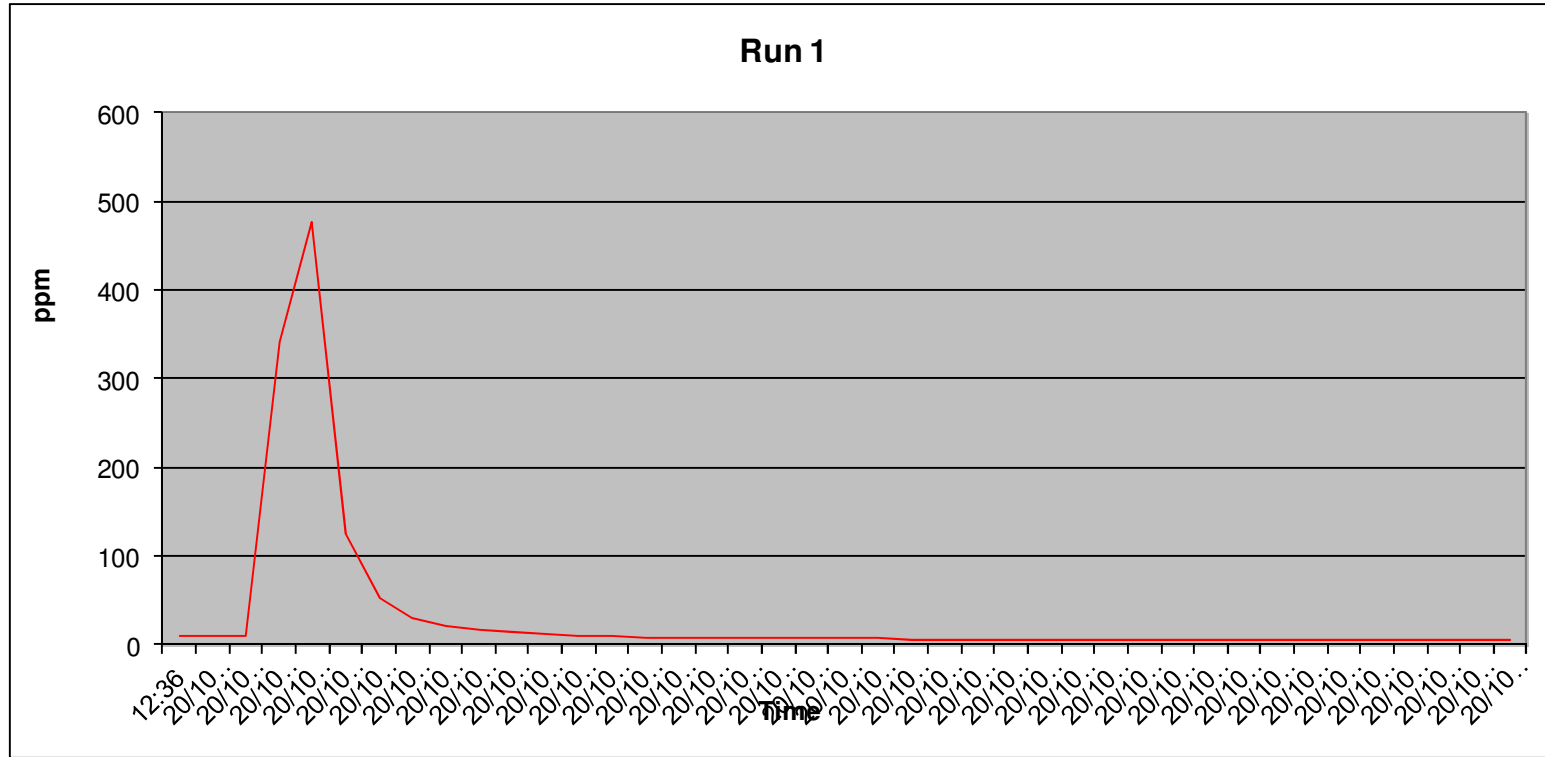
**Sulphur Dioxide Trend**

<b>Units</b>	<b>Run 1</b>
Measured Quantities		
Certified Range of Analyser	ppm	2.14 to 1000
Operational Range of Analyser	ppm	1000
Measured Reading	ppm	32.07
Measured Quantities	<b>Units</b>	<b>Run 1</b>
Nonlinearity	%	0.8
Temperature Dependent Zero drift	%	0.8
Temperature Dependent Span drift	%	2
Cross-sensitivity	%	1.5
Leak	%	0
Calibration Gas Uncertainty	%	<2 %
<b>Parameter</b>	<b>Units</b>	<b>Run 1</b>
Combined uncertainty	mg.m <sup>-3</sup>	3.12
Expanded uncertainty	mg.m <sup>-3</sup>	6.24
<b>Uncertainty corrected to std conds.</b>	mg.m <sup>-3</sup>	10.35
<b>Expanded uncertainty expressed with a level of confidence of 95%</b>	% of ELV	-
<b>Expanded uncertainty expressed with a level of confidence of 95%</b>	mg.m <sup>-3</sup>	10.35
<b>Expanded uncertainty expressed with a level of confidence of 95%</b>	% of value	11.29
<b>Requirement in standard is for uncertainty to be &lt; 10% at ELV at standard conditions</b>

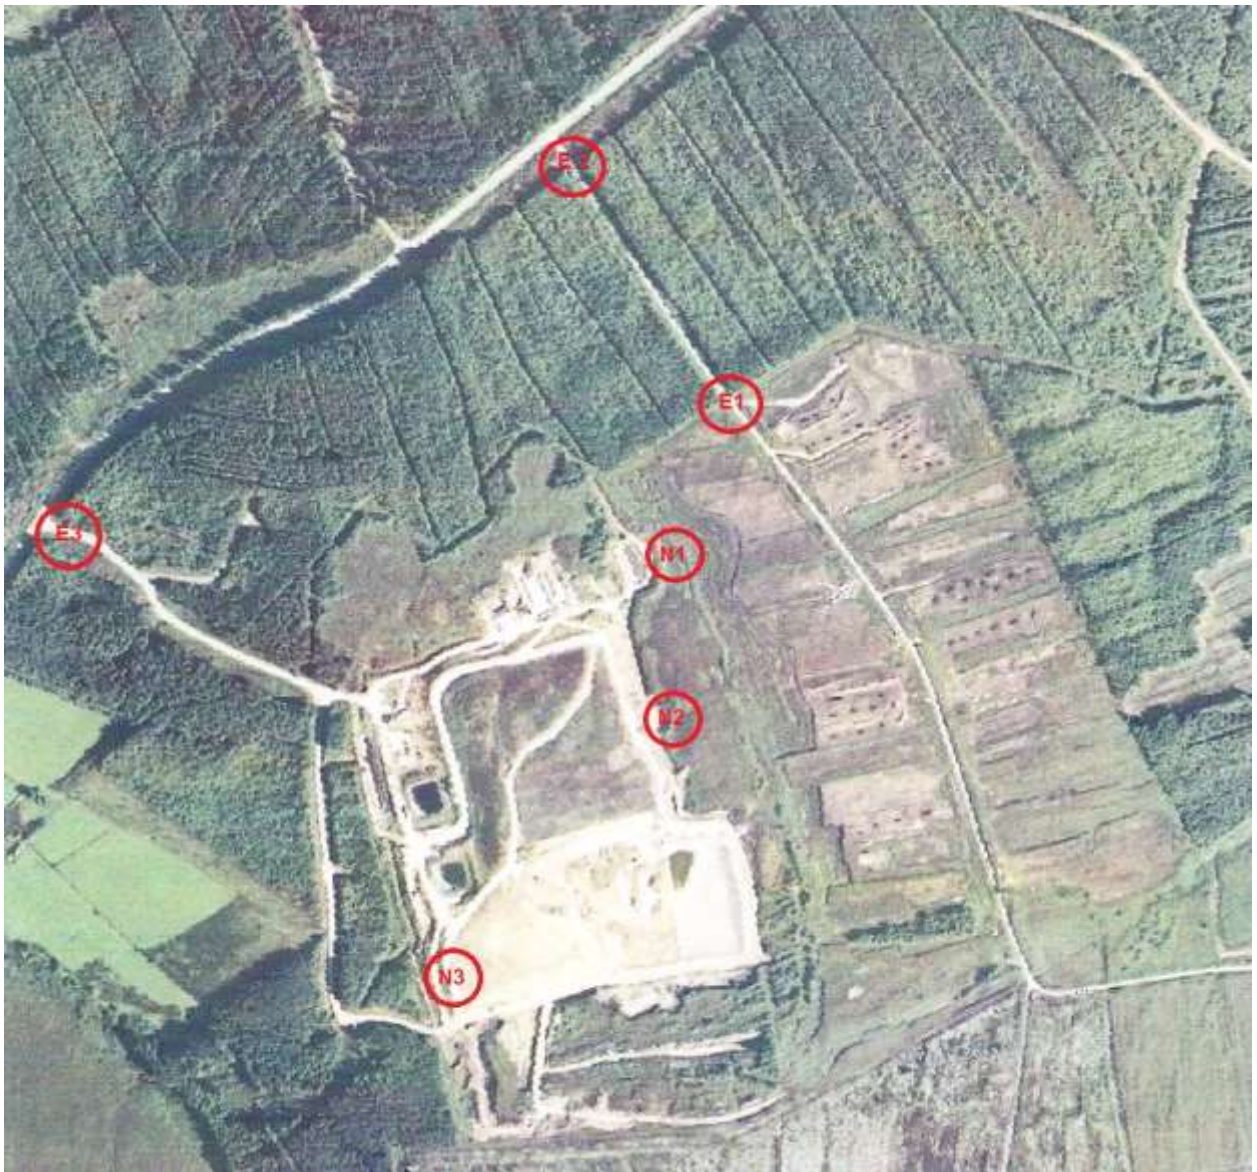
<b>I.D.</b>	<b>Location</b>	<b>Surrounding ground features</b>
N1	Site boundary at lagoon adjacent to public recycling area	Hardcore, lagoon, some earthen mounds
N2	Adjacent to Gas Detection Well No. 8	Hardcore, some earthen mounds
N3	On access road to forestry plantation	Hardcore, some earthen mounds
E1	Access road to windfarm	Rough grass & trees
E2	Junction of access road to windfarm and the public road	Conifer plantation
E3	At entrance to landfill	Roadway, conifer plantation

**Figure 1: Map showing monitoring locations (refer to Table 1 for description)**

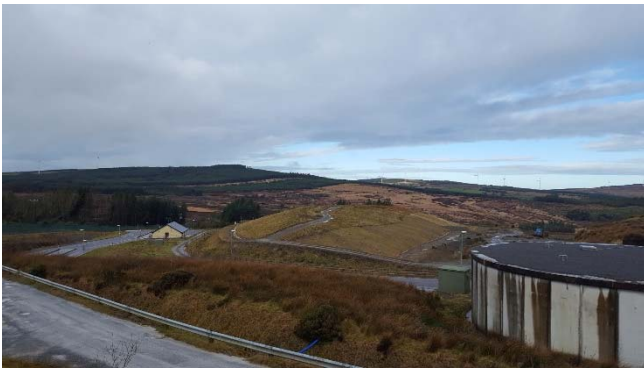
The main slopes were observed to be vegetated by grass, slopes at the north of the cells were sparsely vegetated although grass coverage is developing.

No indications of translational or rotational instabilities were observed. In FT's opinion the slopes are stable.

Photo 1 – Cells 17, 18 & 19

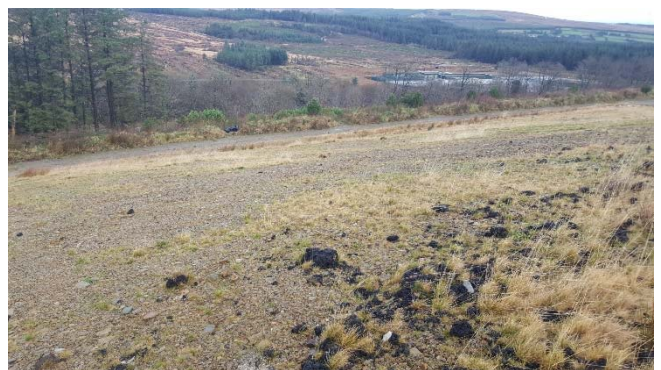
Photo 5 – Northwest Slope

No visibly unstable slopes were observed on the site and no tension cracks were observed in any of the slopes which may have suggested potential instability. Some ponding was noted over cells 1-16 (Photos 5 and 6), particularly in the west of the capped area. Evidence of historical ground movement as highlighted in the previous FT Slope Stability Assessment, March 2016 (Photos 36 – 38) was noted with no evidence of recent movement observed.

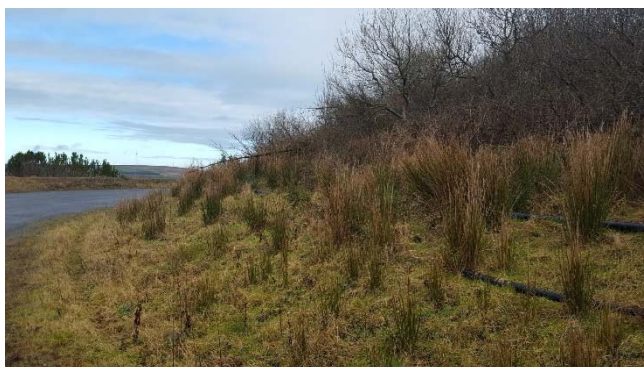
- The capping at Cells 1 – 16 was observed to be heavily vegetated with trees having being established at the northern slopes of the cells (Photos 17 – 18) with the remainder of the capping covered by grasses and rushes.

Photo 17: Northern slope

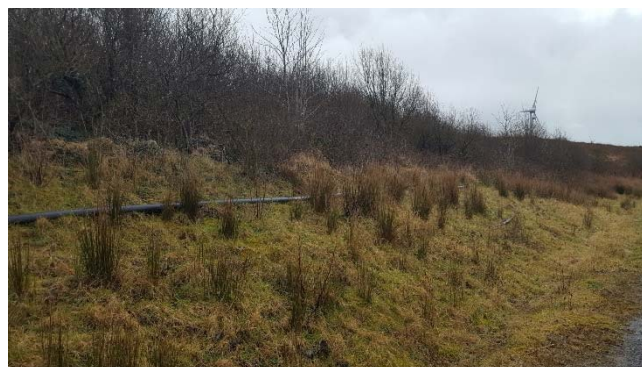
Photo 18: Northern slope

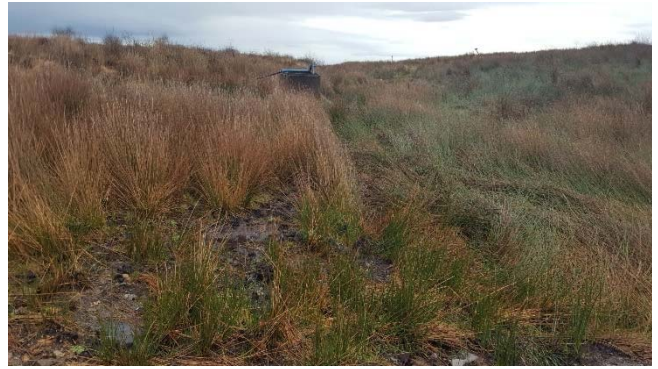
Photo 21: Western Slope

- The capping surface is generally undulating (Photos 21 – 23 and Photos 33 – 34) with localised depressions were noted across the capping in Cells 1 – 16 and may have been caused by settlement following waste degradation or additional surcharge loading caused by the waterlogging of the capping material; and

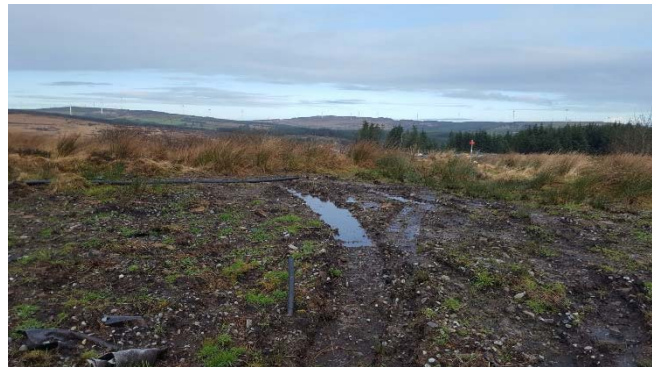
Photo 33: Eastern Slope

- Waterlogging of cap across cells 1 -16 is evident in Photos No 33 to 35 inclusive. FT advises that surface water is being contained in a localised depressions in the ground across the landfill cap across cells particularly in the vicinity of Cells 2 & 6 and Cells 4 and 9 at the central and western portions of the landfill.

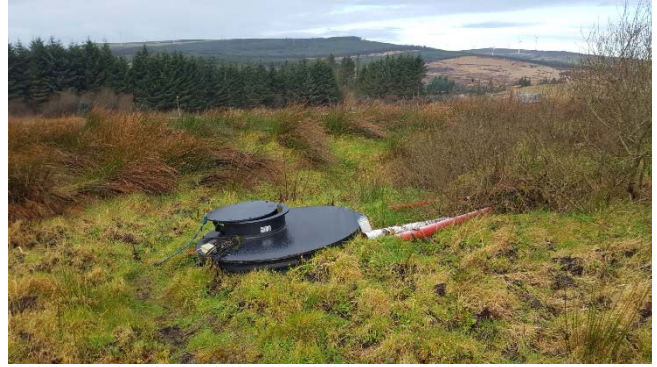
- Evidence of historical ground movement was noted at the western slopes at Cells 4 & 9 (Photos 36 – 38) as noted in the previous FT Slope Stability Assessment (March 2016). No evidence of recent movement was noted during the site walkover

Photo 38: Historical ground movement
