EAST GALWAY LANDFILL

EPA IED LICENCE W0178-02

ANNUAL ENVIRONMENTAL REPORT

JANUARY 2016 - DECEMBER 2016

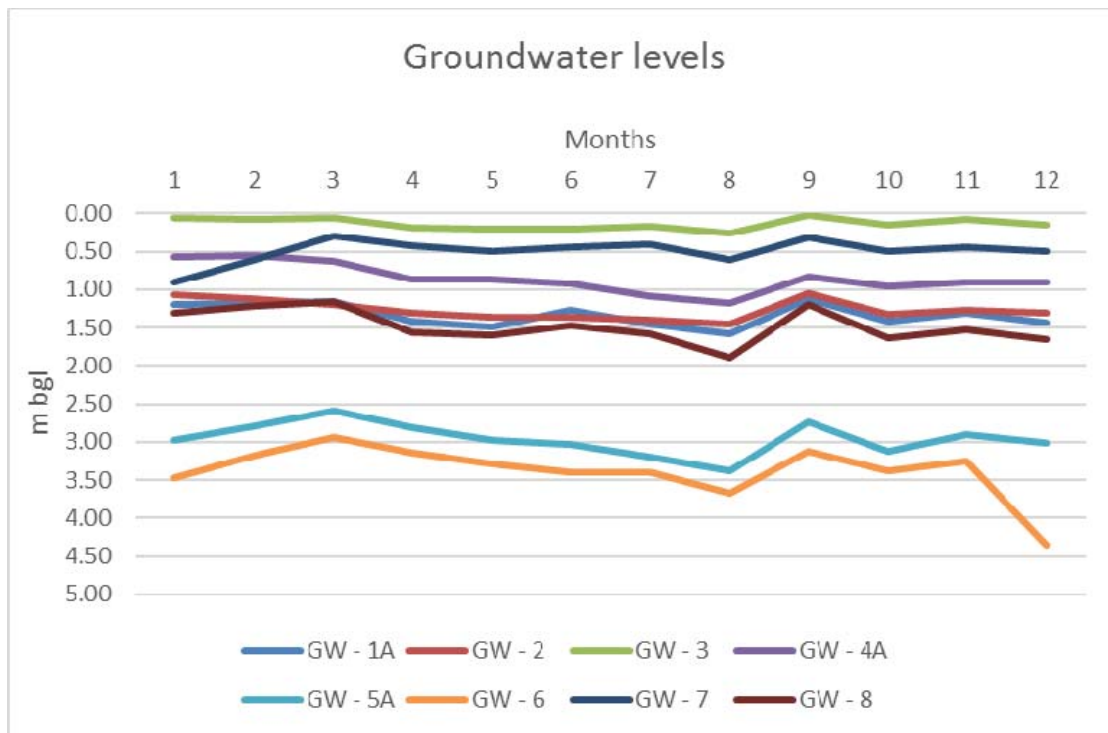
Figure 4.6: Monthly Groundwater Levels – 2016

Groundwater levels were recorded monthly during 2016 and the results are presented in Figure 4.6 below. The recorded water levels remained relatively constant while allowing for seasonal variation during 2016.

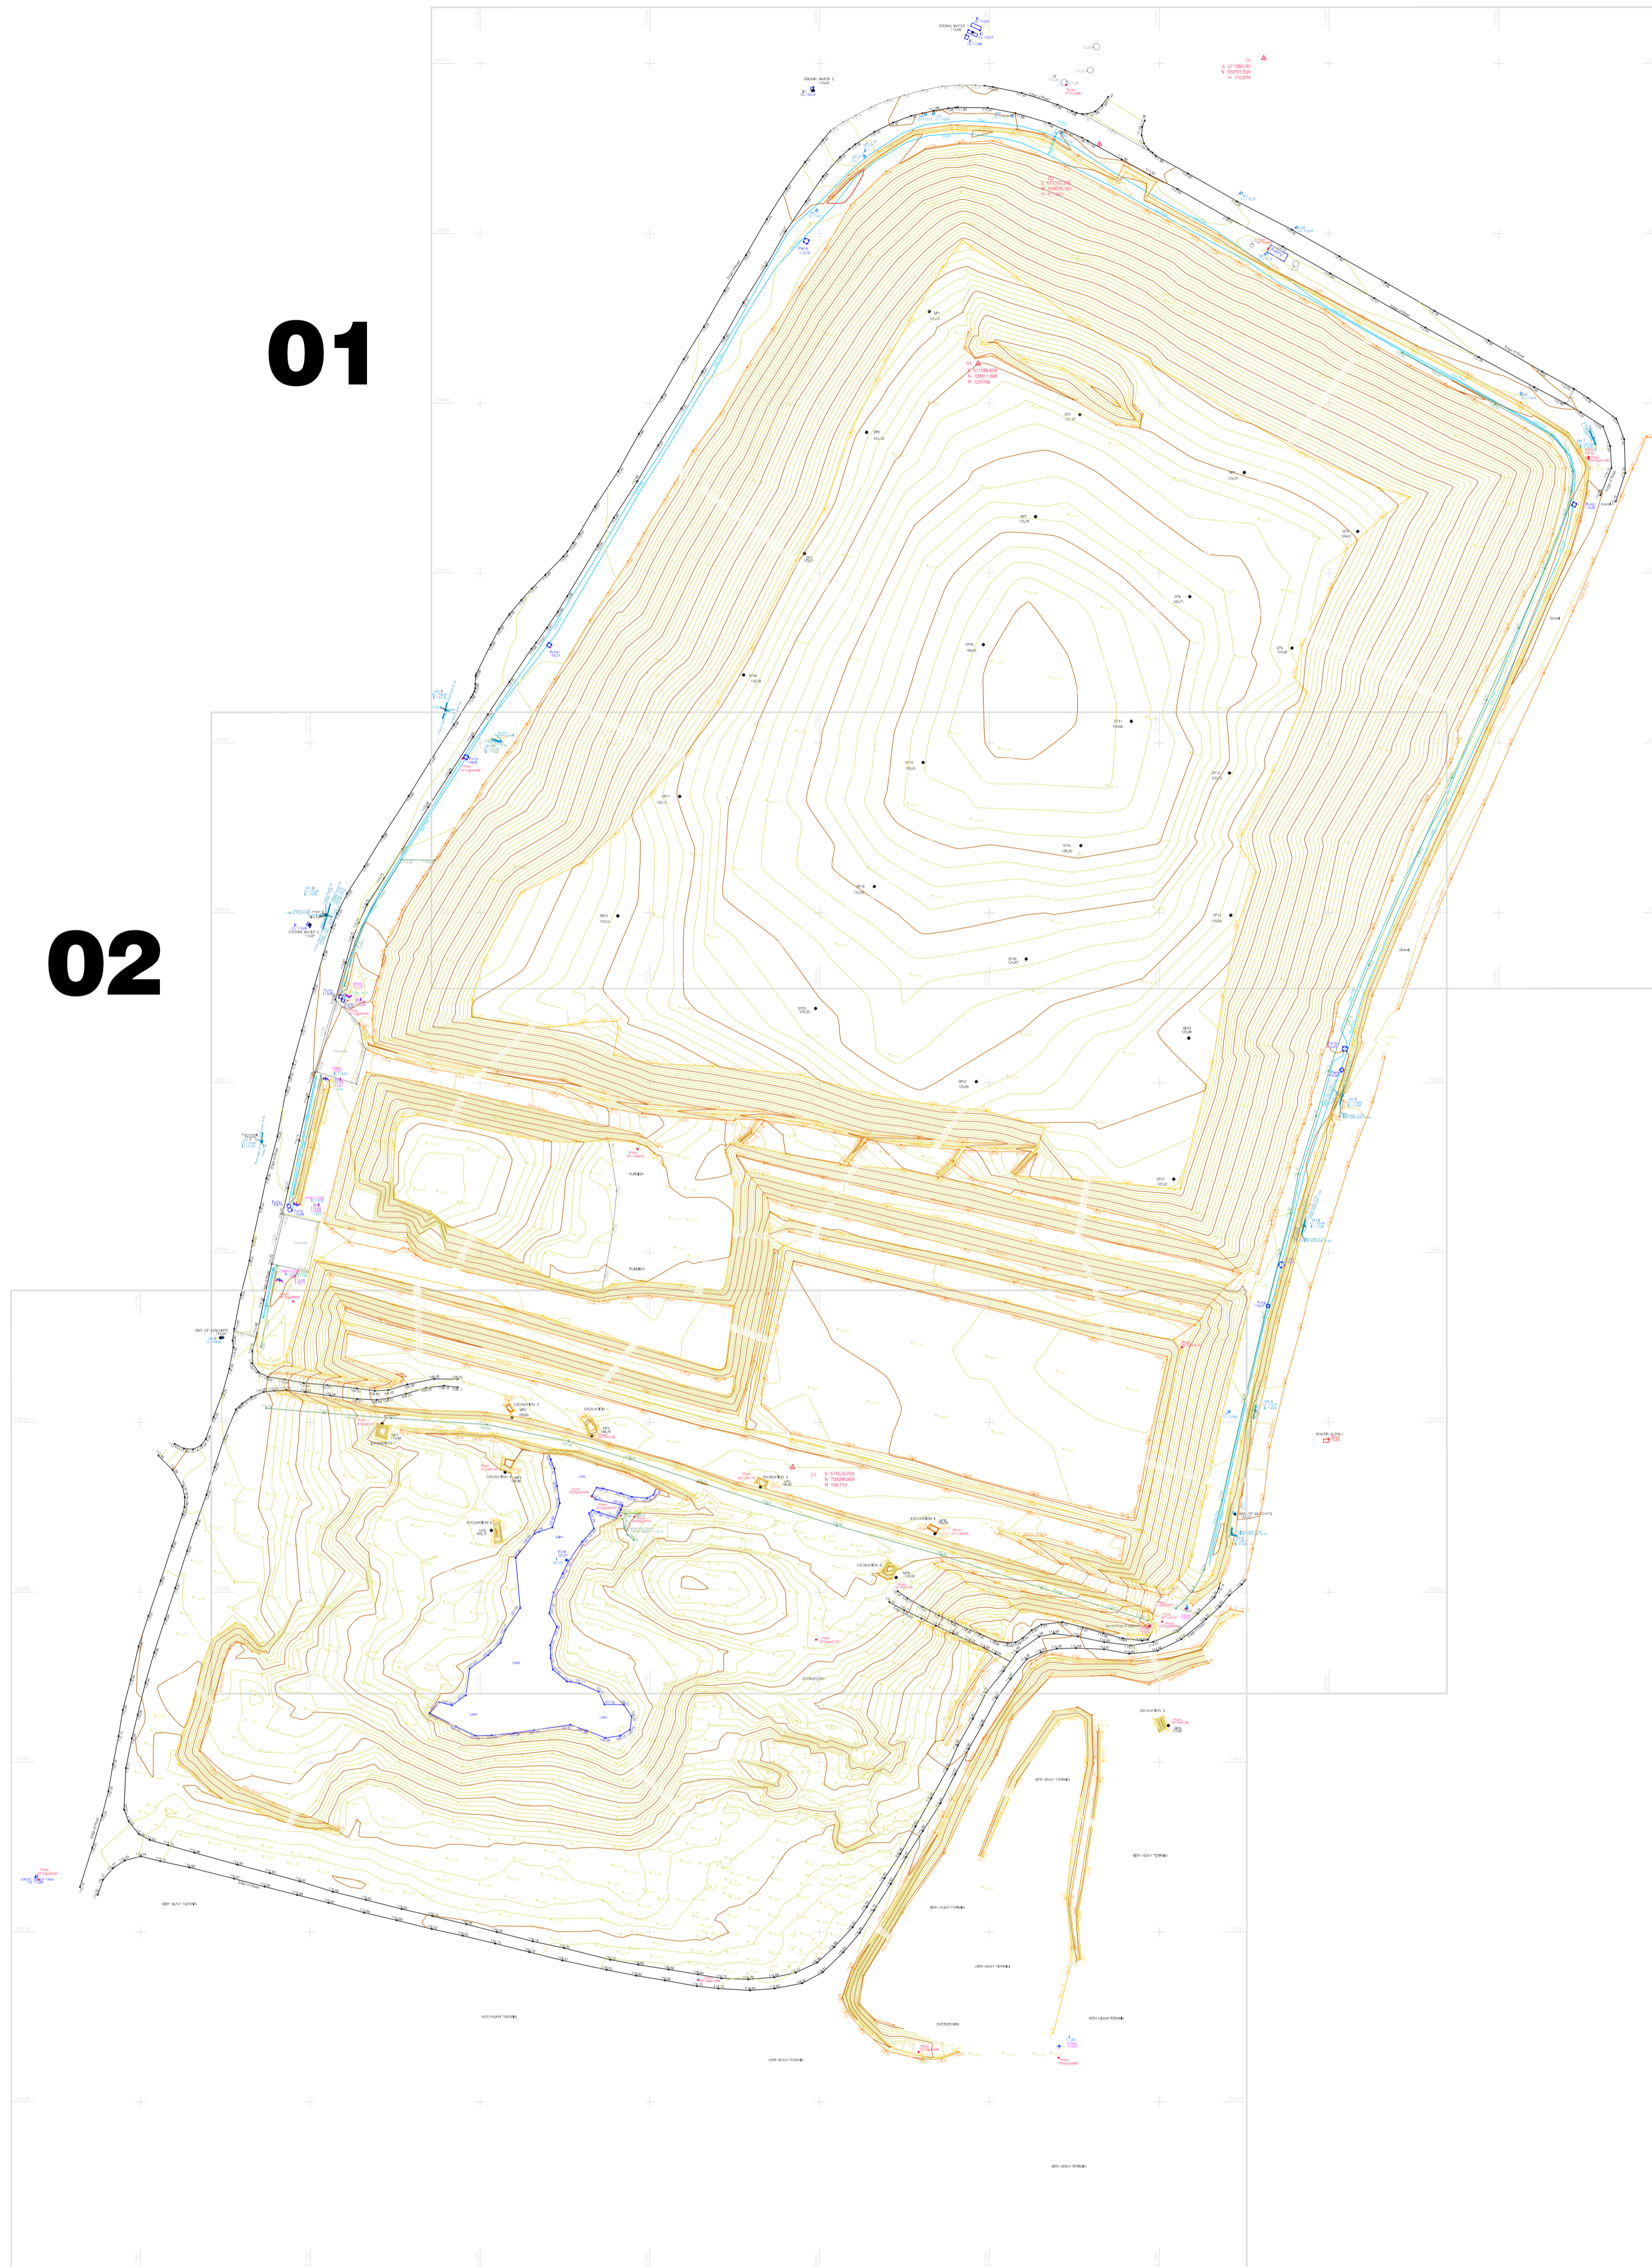
Topographical Survey

As per condition 8.7 of the licence, a survey showing the topography of the facility at the end of the reporting period is included in Appendix C.
