**Facility Information Summary**

AER Reporting Year	2015
Licence Register Number	W0184-
Name of site	01
Site Location	Enva Ireland Limited
NACE Code	Clonminan Industrial Estate, Portlaoise, Co. Loras
Class/Classes of Activity	3832
National Grid Reference (6E, 6 N)	Fourth Schedule - Class 6, Class 7, Class 12, Class 13. 2461 E, 1978 N
<p>A description of the activities/processes at the site for the reporting year. This should include information such as production increases or decreases on site, any infrastructural changes, environmental</p> <p><b>Site Performance:</b> The processing activities onsite include waste oil re-processing, treatment of contaminated soil, repacking of oily contaminated wastes, and paint wastes. The site also stores wastes in packages (barrels, ASPs, IBCs, etc.) prior to transfer off site for recovery or disposal. The company continues to demonstrate its commitment towards HSE management standards - the site maintains ISO14001 and OHSAS 18001. This ensures a standard approach is taking to managing activities from an environmental and safety aspect. There were no issues raised during the reporting period regarding maintenance to the standard.</p> <p><b>EMP

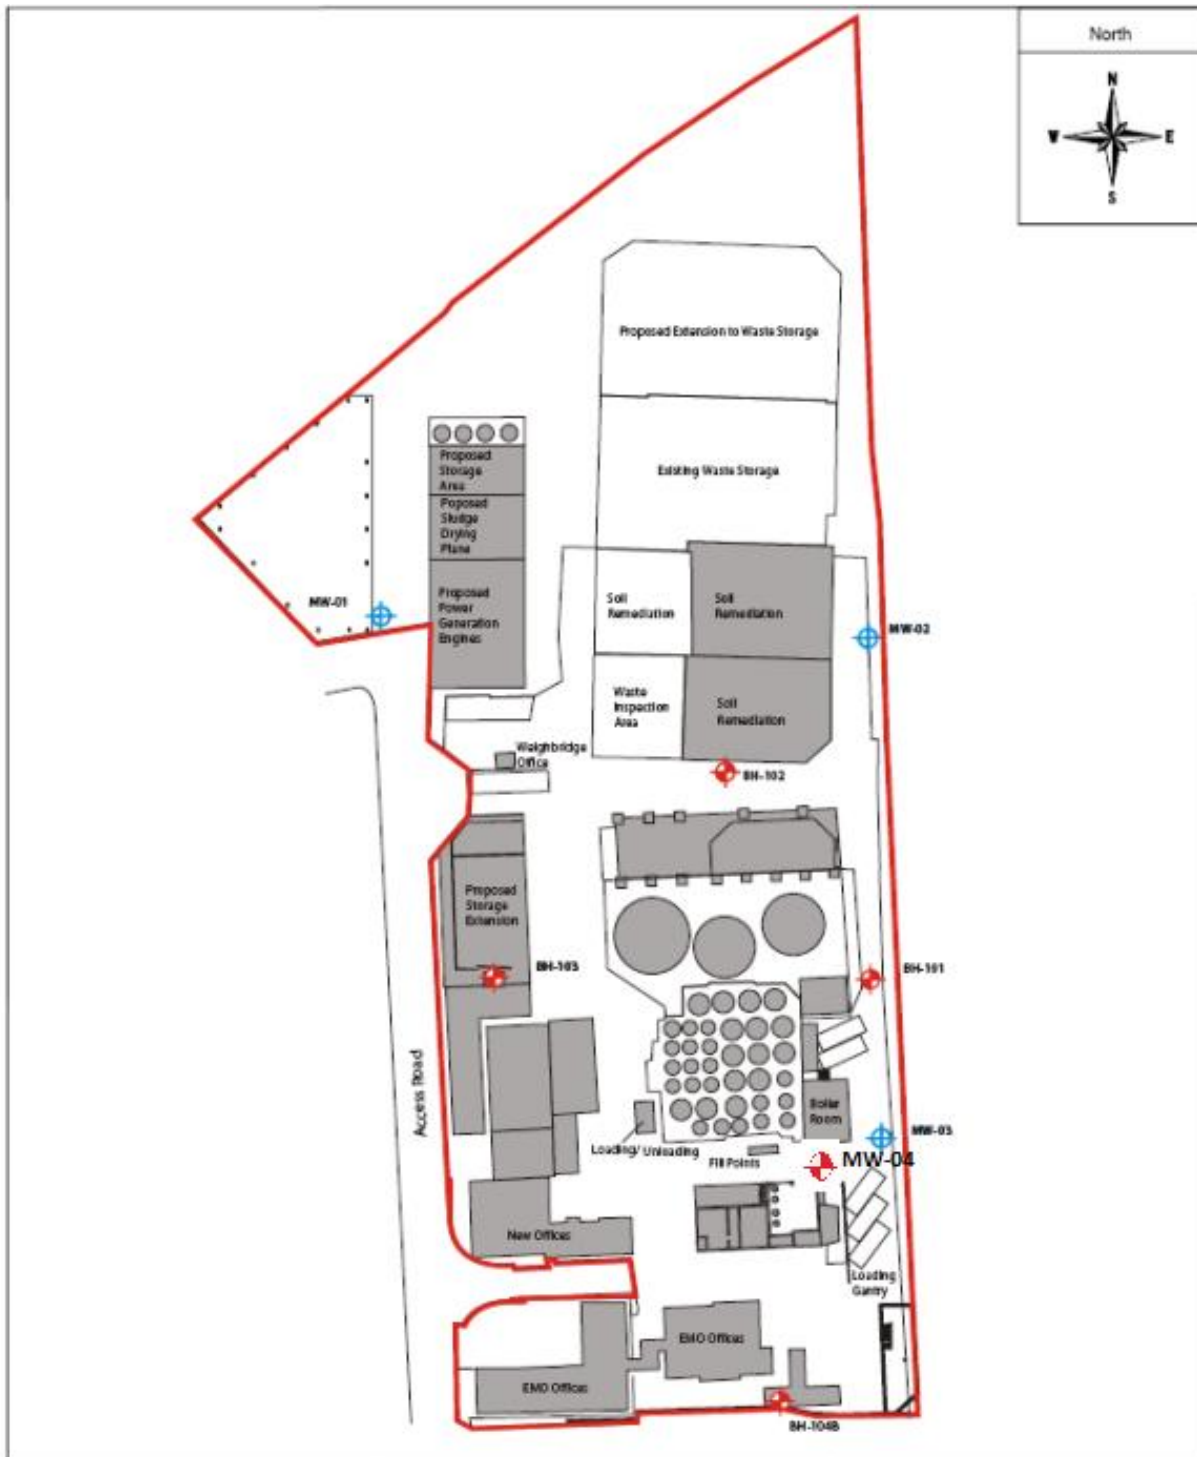
Figure 3.1 – Site Layout Plan with Groundwater Monitoring Locations

- Shallow Monitoring Well locations

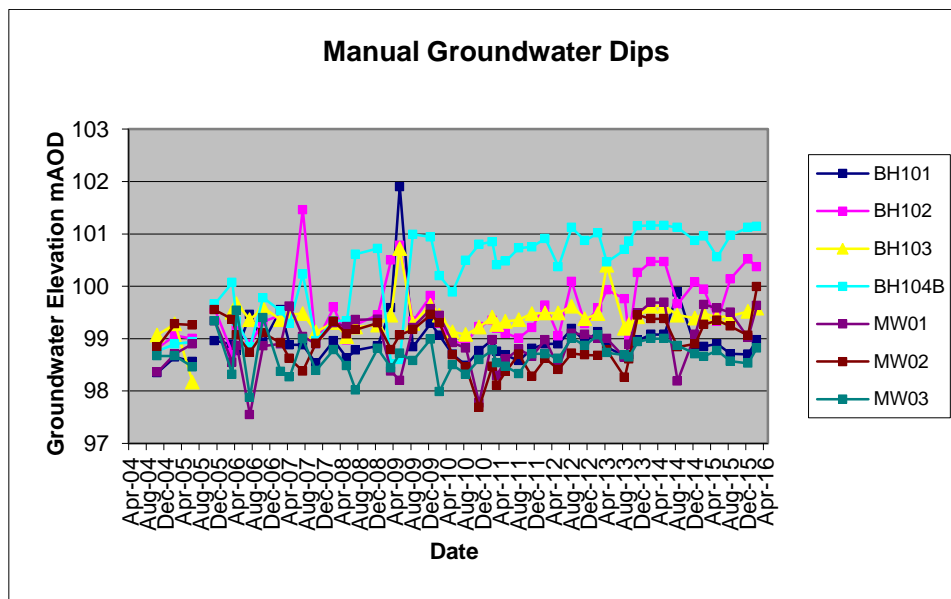
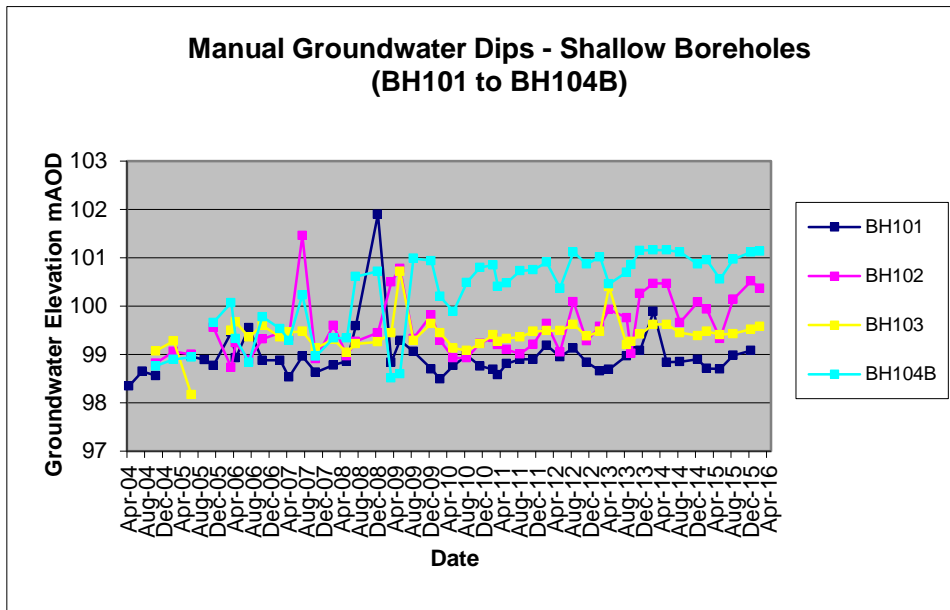
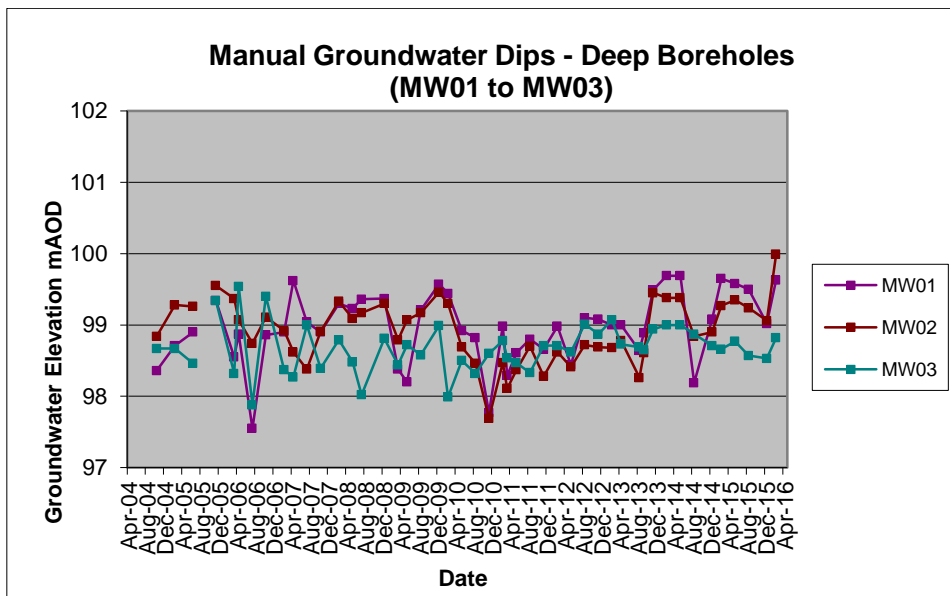
**Figure 6.1 – Ground Elevation (mAOD) in all Monitoring Wells**

Figure 6.2 – Ground Elevation (mAOD) in Shallow Groundwater Monitoring Wells

Figure 6.3 – Ground Elevation (mAOD) in Deep Groundwater Monitoring Wells

The groundwater levels generally show a similar pattern of fluctuation over time indicating a degree of connection between boreholes. The graphs demonstrate that groundwater levels can vary considerably between monitoring rounds; the general direction of flow in the shallow and deeper groundwater bearing unit is in an easterly or north easterly direction however there have been some occasional historic cases of groundwater flowing in a south-easterly direction.

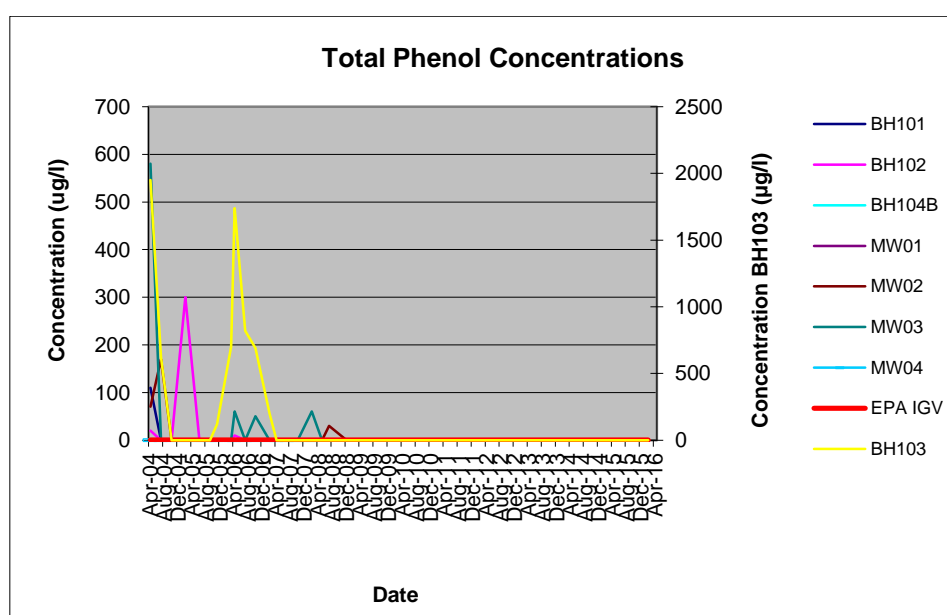
**Figure 6.4 – Phenol Concentrations in all Monitoring Wells**

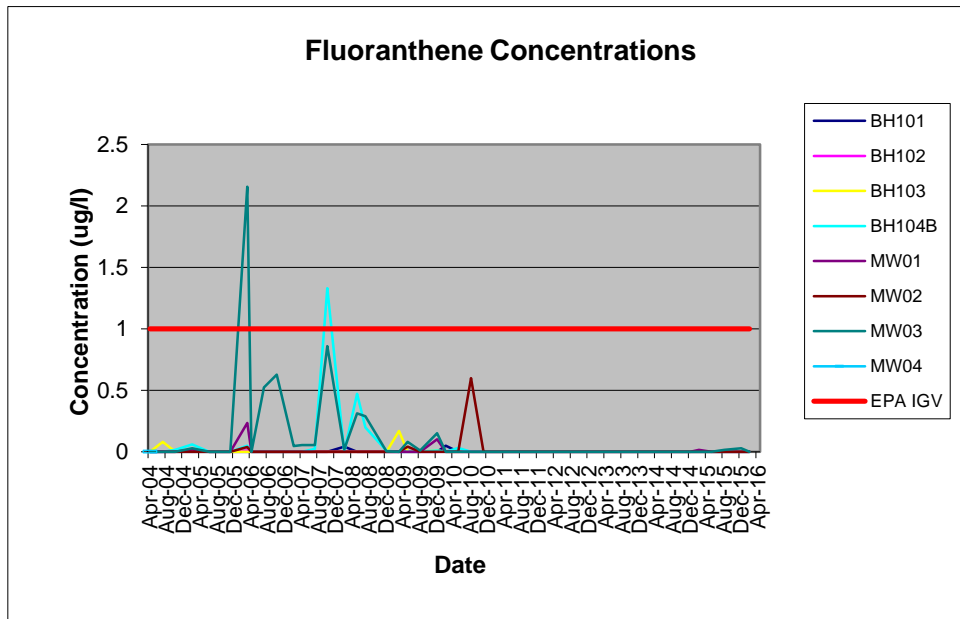
Figure 6.6 – Fluoroanthene Concentrations in all Monitoring Wells

Figure 6.6 illustrates that Fluoroanthene was previously detected above the IGV of 1.0 µg/l in groundwater monitoring wells BH104B (October 2007, 1.33 µg/l) and MW03 (March 2006, 2.158 µg/l) only. The remaining monitoring wells recorded concentrations below the IGV of 1.0 µg/l.

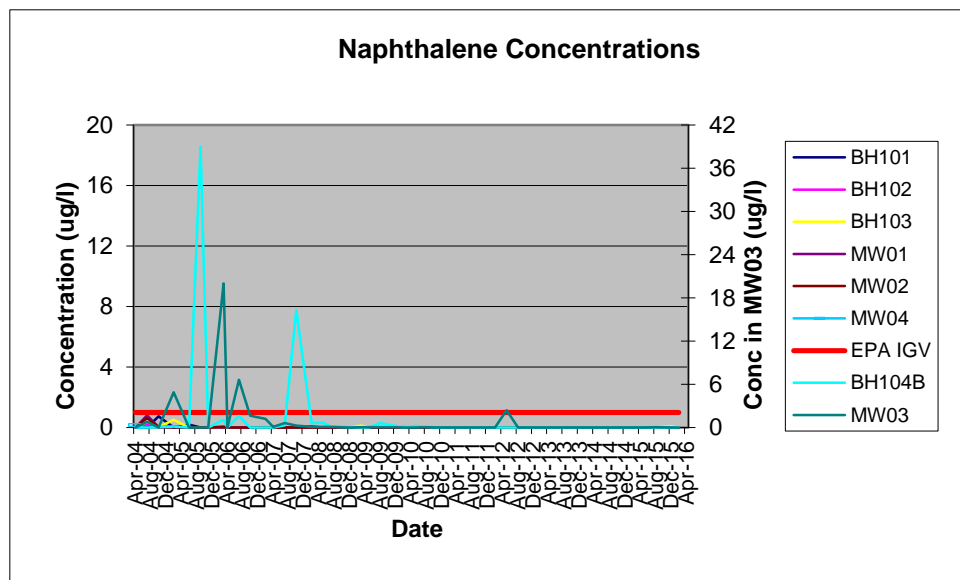
Figure 6.7 – Naphthalene Concentrations in all Monitoring Wells

A similar trend to Fluoroanthene has been noted in Figure 6.7, with concentrations of Naphthalene recorded above the IGV of 1.0 µg/l in BH104B and MW03 only. 4 no. exceedances of the IGV were noted in BH104B in September 2005 (39 µg/l), March 2006 (1.069 µg/l), July 2006 (1.594 µg/l) and October 2007 (16.31 µg/l). Since October 2007, the concentrations in BH104B have decreased below the IGV. There have been 6 exceedances of the IGV of 1.0 µg/l in MW03, with the highest concentration detected in March 2006 (19.986 µg/l) and the most recent being the detected in the Quarter 2 2012 monitoring event (2.4 µg/l). The concentrations detected in August 2010 were slightly above the laboratory limit of detection of 0.01 µg/l at BH104B (0.08 µg/l) and MW03 (0.05

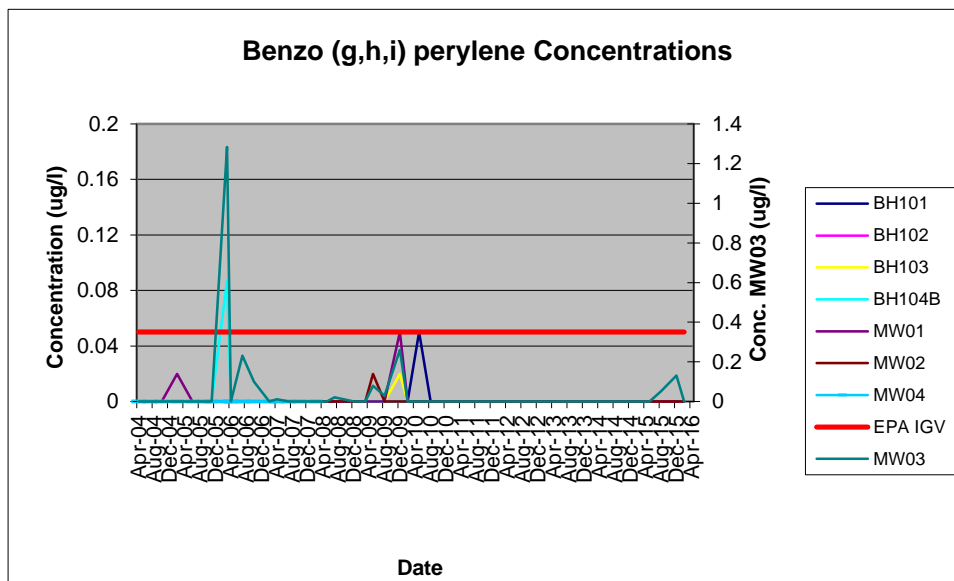
**Figure 6.8 – Benzo (g,h,i) perylene Concentrations**

**Figure 6.8** illustrates the concentrations of **Benzo(g,h,i)perylene** in all monitoring wells over time. Elevated concentrations above the IGV were recorded at BH104B (0.087 µg/l) on one occasion in March 2006.

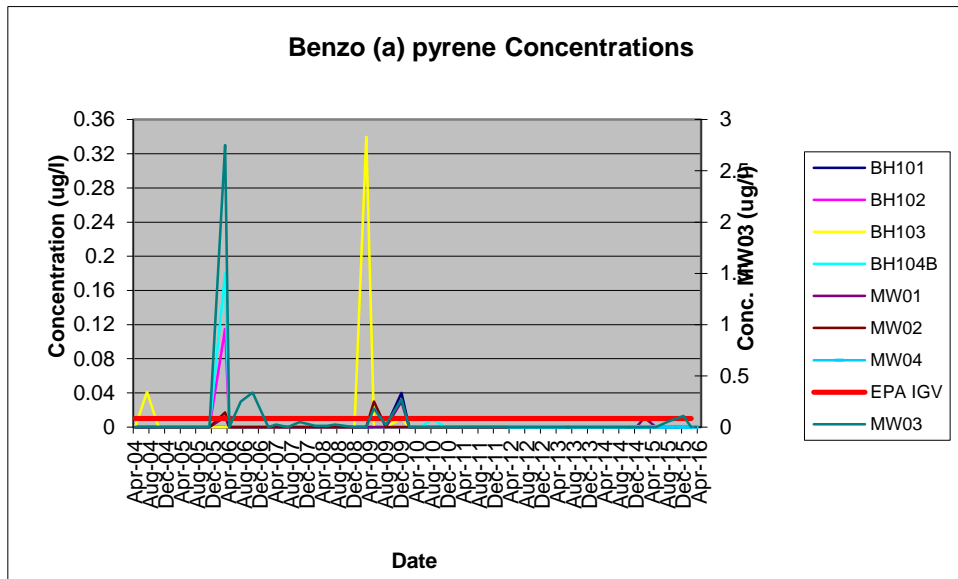
Figure 6.10 illustrates the concentrations of **Benzo(a)pyrene** in all groundwater monitoring wells and indicates that Benzo(a)pyrene has been detected historically in all boreholes above the IGV of 0.01  $\mu\text{g/l}$ . Similarly with the above mentioned trends, the highest concentrations have been detected in MW03 and BH104B. Concentrations have markedly decreased since March 2006 when an elevated concentration of 2.751  $\mu\text{g/l}$  was detected in MW03, however there have been a number of detections above the IGV, with the most recent elevated level detected in December 2009. Elevated concentrations above the IGV were recorded in BH101, BH103 and MW01 during this same period.

Figure 6.10 – Benzo (a) pyrene Concentrations in all Monitoring Wells

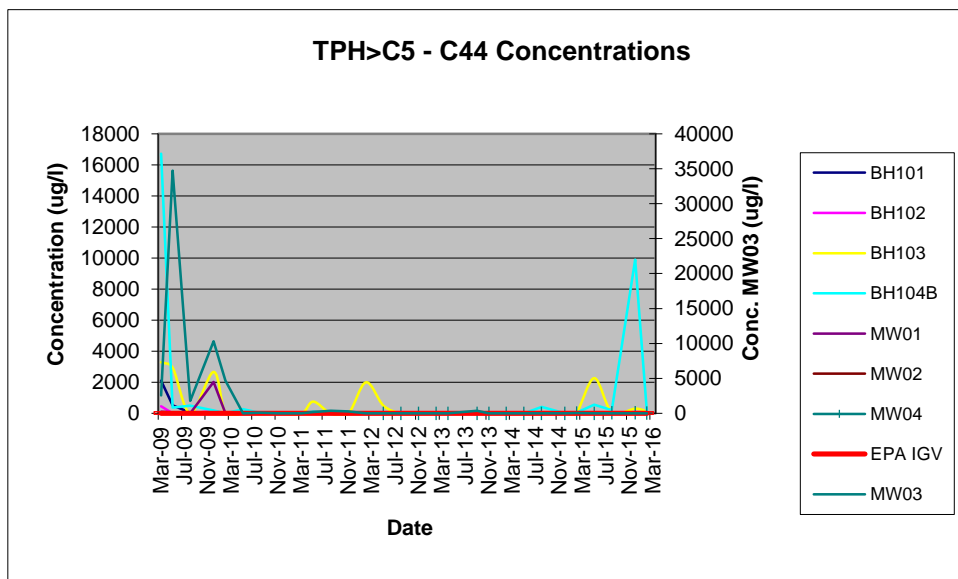
Figure 6.11 – TPH (Carbon Range C5-C44) in all Monitoring Wells

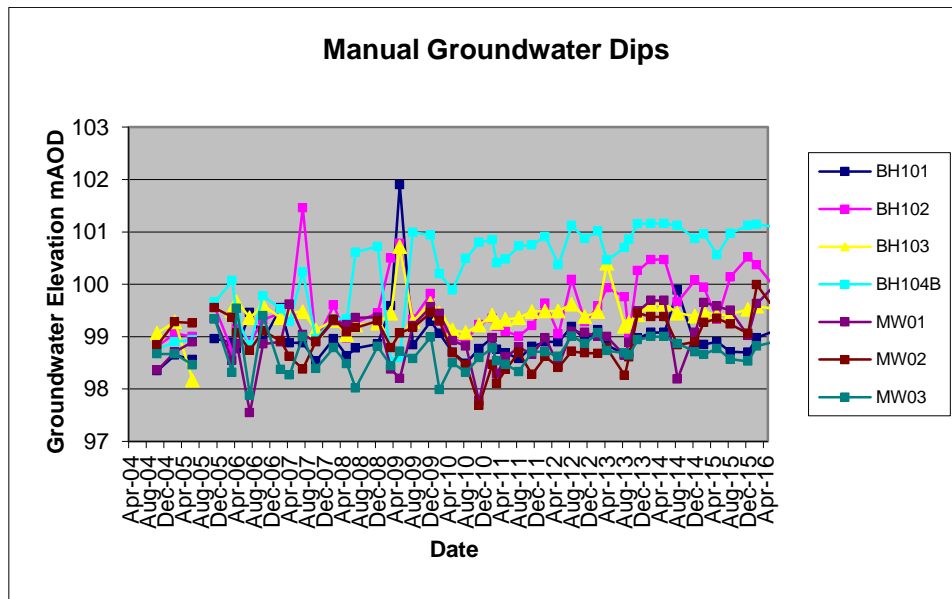
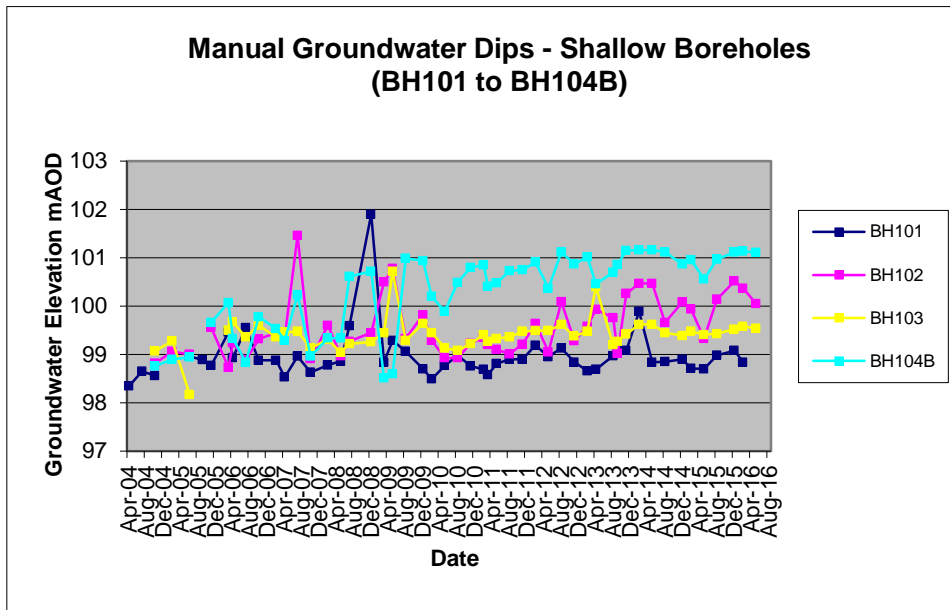
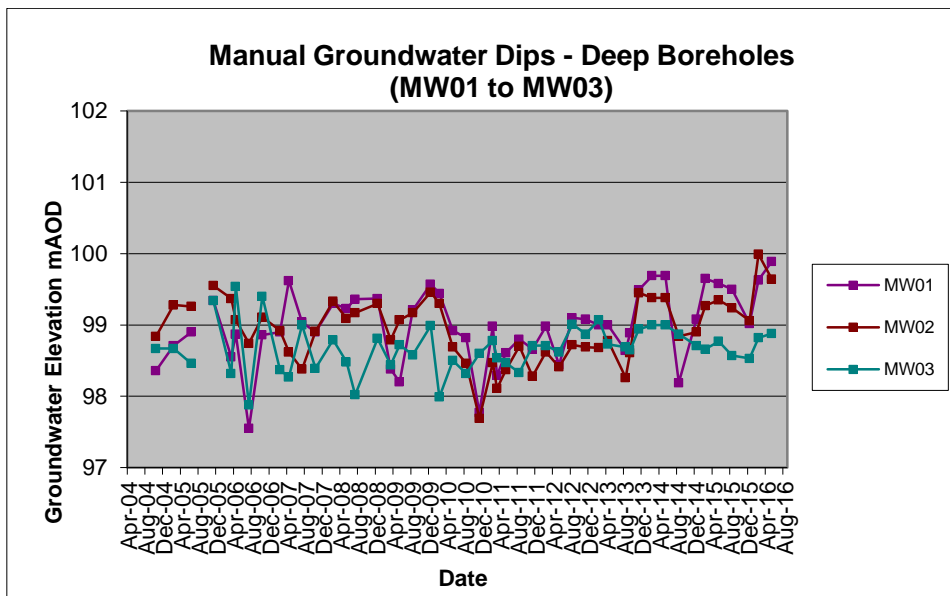
**Figure 6.1 – Ground Elevation (mAOD) in all Monitoring Wells**

Figure 6.2 – Ground Elevation (mAOD) in Shallow Groundwater Monitoring Wells

Figure 6.3 – Ground Elevation (mAOD) in Deep Groundwater Monitoring Wells

The groundwater levels generally show a similar pattern of fluctuation over time indicating a degree of connection between boreholes. The graphs demonstrate that groundwater levels can vary considerably between monitoring rounds; the general direction of flow in the shallow and deeper groundwater bearing unit is in an easterly or north easterly direction however there have been some occasional historic cases of groundwater flowing in a south-easterly direction.

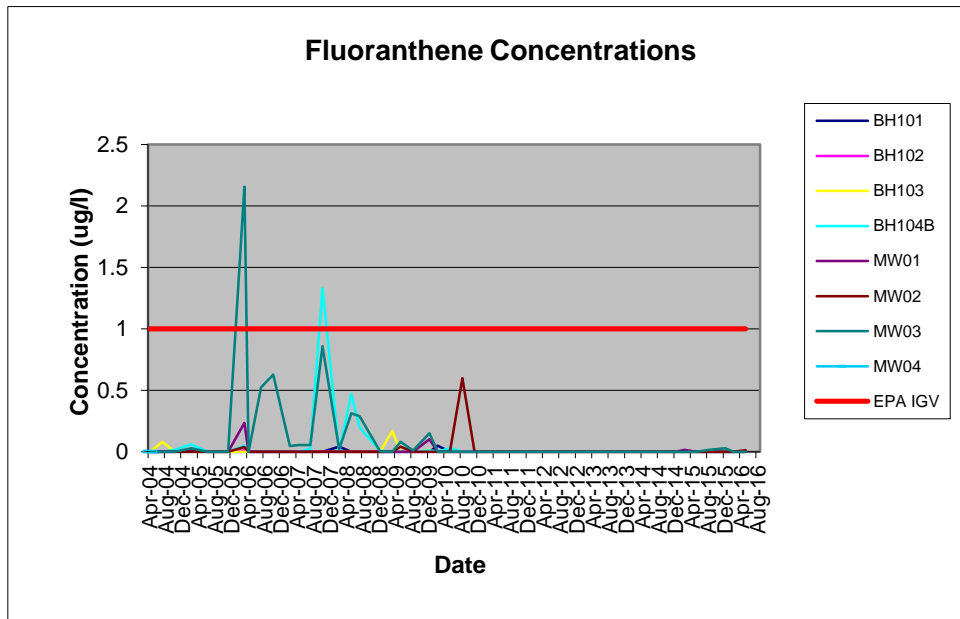
**Figure 6.6 – Fluoranthene Concentrations in all Monitoring Wells**

**Figure 6.6** illustrates that **Fluoranthene** was previously detected above the IGV of 1.0  $\mu\text{g/l}$  in groundwater monitoring wells BH104B (October 2007, 1.33  $\mu\text{g/l}$ ) and MW03 (March 2006, 2.158  $\mu\text{g/l}$ ) only. The remaining monitoring wells recorded concentrations below the IGV of 1.0  $\mu\text{g/l}$ .

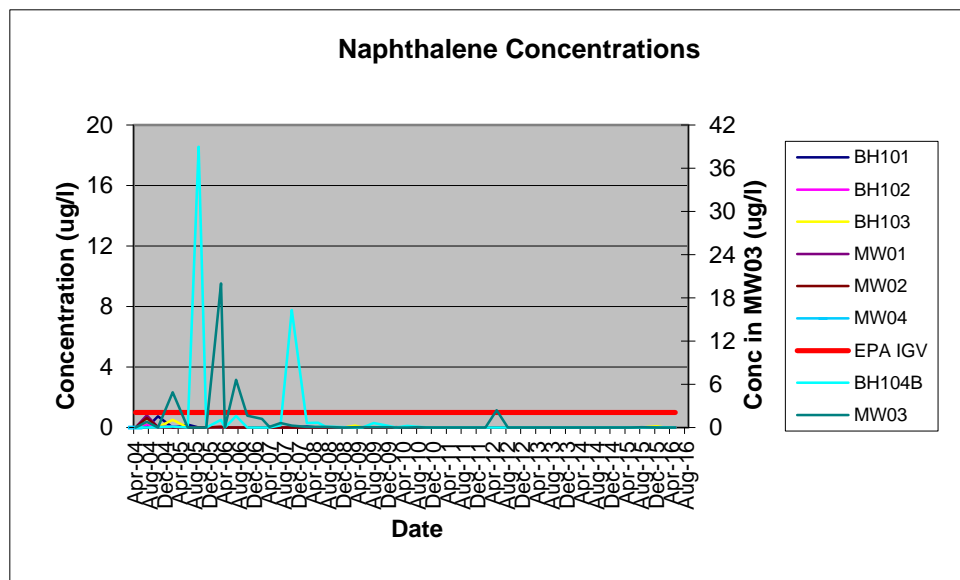
**Figure 6.7 – Naphthalene Concentrations in all Monitoring Wells**

A similar trend to Fluoranthene has been noted in **Figure 6.7**, with concentrations of **Naphthalene** recorded above the IGV of 1.0  $\mu\text{g/l}$  in BH104B and MW03 only. 4 no. exceedances of the IGV were noted in BH104B in September 2005 (39  $\mu\text{g/l}$ ), March 2006 (1.069  $\mu\text{g/l}$ ), July 2006 (1.594  $\mu\text{g/l}$ ) and October 2007 (16.31  $\mu\text{g/l}$ ). Since October 2007, the concentrations in BH104B have decreased below the IGV. There have been 6 exceedances of the IGV of 1.0  $\mu\text{g/l}$  in MW03, with the highest concentration detected in March 2006 (19.986  $\mu\text{g/l}$ ) and the most recent being the detected in the Quarter 2 2012 monitoring event (2.4  $\mu\text{g/l}$ ). The concentrations detected in August 2010 were slightly above the laboratory limit of detection of 0.01  $\mu\text{g/l}$  at BH104B (0.08  $\mu\text{g/l}$ ) and MW03 (0.05

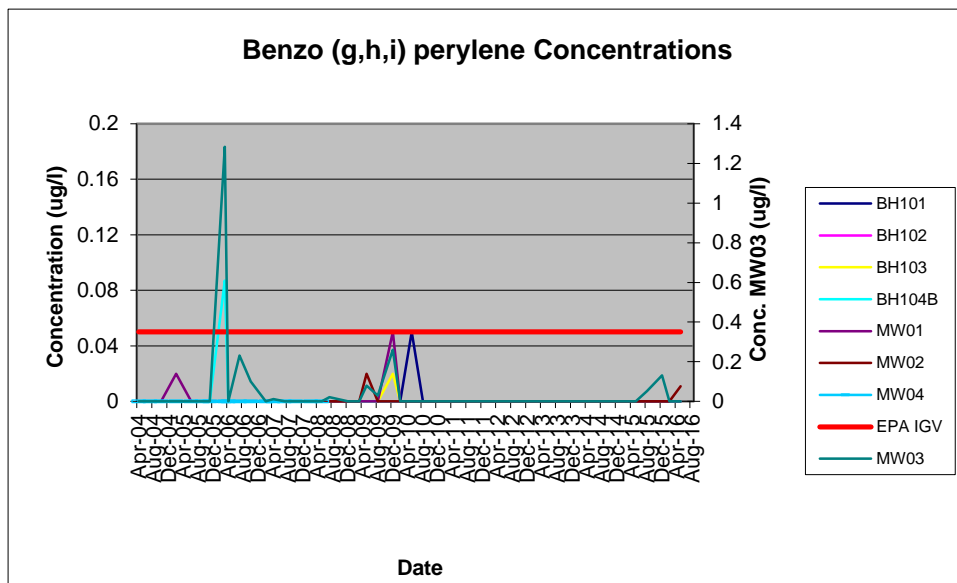
**Figure 6.8 – Benzo (g,h,i) perylene Concentrations**

**Figure 6.8** illustrates the concentrations of **Benzo(g,h,i)perylene** in all monitoring wells over time. Elevated concentrations above the IGV were recorded at BH104B (0.087 µg/l) on one occasion in March 2006.

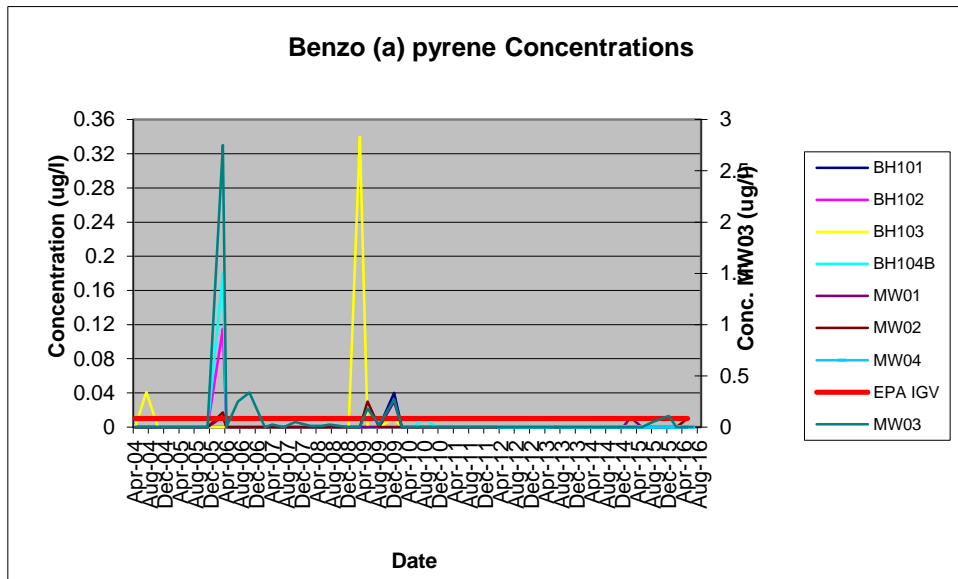
Figure 6.10 illustrates the concentrations of **Benzo(a)pyrene** in all groundwater monitoring wells and indicates that Benzo(a)pyrene has been detected historically in all boreholes above the IGV of 0.01  $\mu\text{g}/\text{l}$ . Similarly with the above mentioned trends, the highest concentrations have been detected in MW03 and BH104B. Concentrations have markedly decreased since March 2006 when an elevated concentration of 2.751  $\mu\text{g}/\text{l}$  was detected in MW03, however there have been a number of detections above the IGV, with the most recent elevated level detected in December 2009. Elevated concentrations above the IGV were recorded in BH101, BH103 and MW01 during this same period.

Figure 6.10 – Benzo (a) pyrene Concentrations in all Monitoring Wells

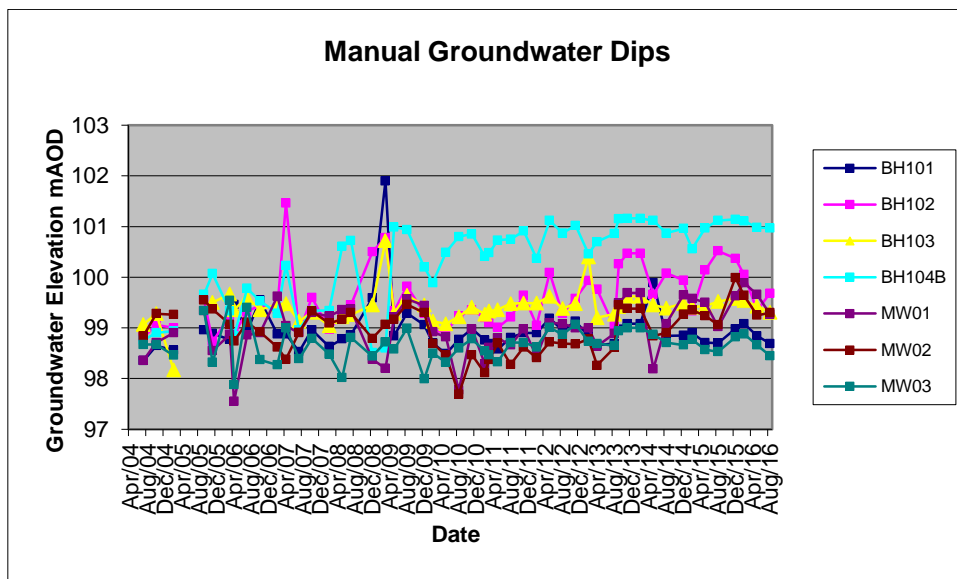
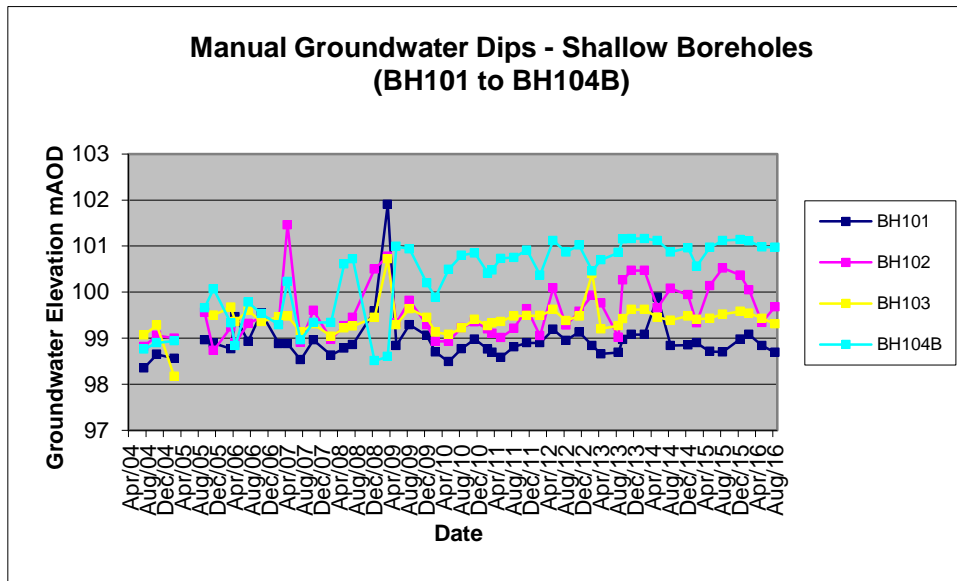
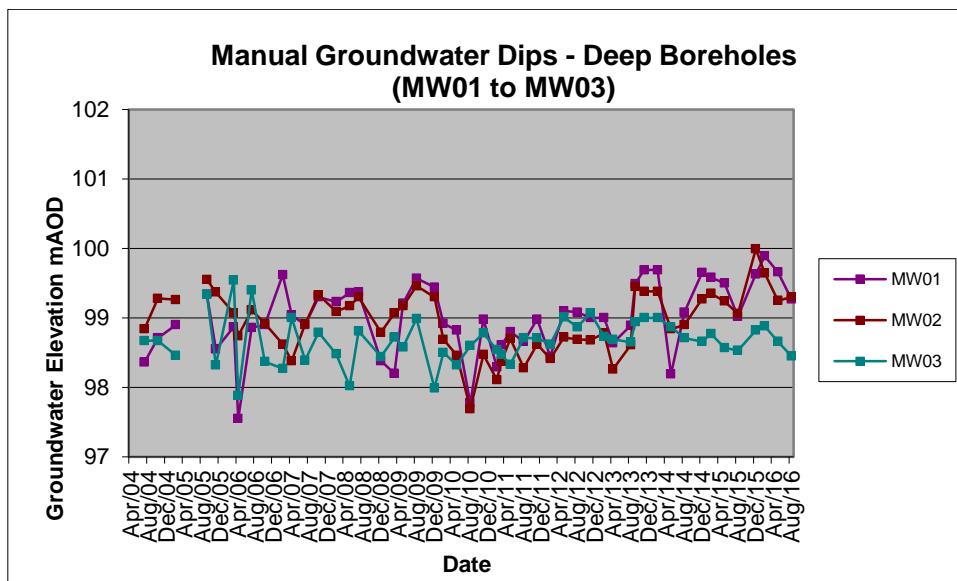
**Figure 6.1 – Ground Elevation (mAOD) in all Monitoring Wells**

Figure 6.2 – Ground Elevation (mAOD) in Shallow Groundwater Monitoring Wells

Figure 6.3 – Ground Elevation (mAOD) in Deep Groundwater Monitoring Wells

The groundwater levels generally show a similar pattern of fluctuation over time indicating a degree of connection between boreholes. The graphs demonstrate that groundwater levels can vary considerably between monitoring rounds; the general direction of flow in the shallow and deeper groundwater bearing unit is in an easterly or north easterly direction however there have been some occasional historic cases of groundwater flowing in a south-easterly direction.

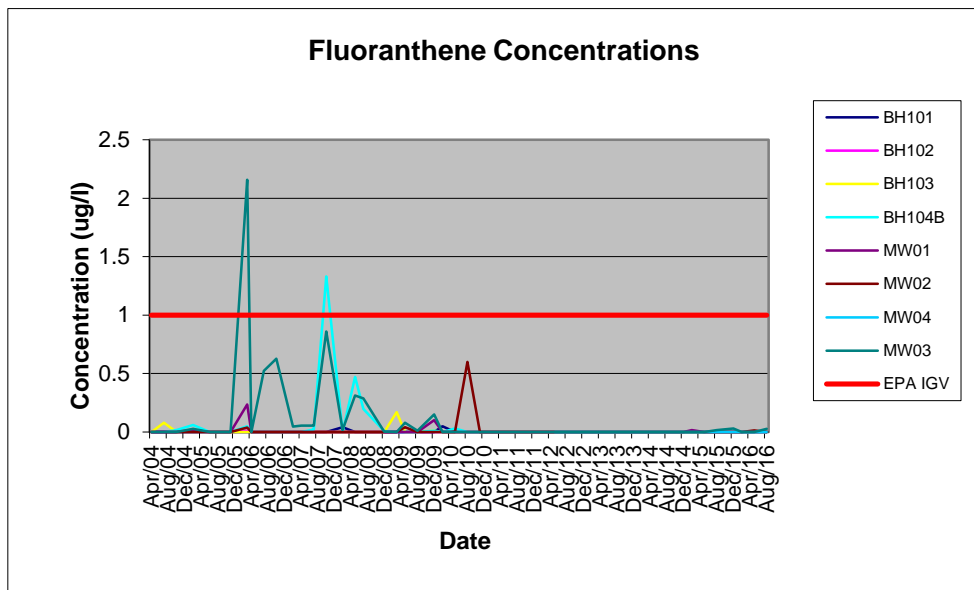
**Figure 6.6 – Fluoranthene Concentrations in all Monitoring Wells**

**Figure 6.6** illustrates that **Fluoranthene** was previously detected above the IGV of 1.0 µg/l in groundwater monitoring wells BH104B (October 2007, 1.33 µg/l) and MW03 (March 2006, 2.158 µg/l) only. The remaining monitoring wells recorded concentrations below the IGV of 1.0 µg/l. During the Quarter 3 2016 monitoring event Fluoranthene was detected above the limit of detection at MW03 (0.026 µg/l) only, this does not exceed the IGV of 1.0 µg/l.

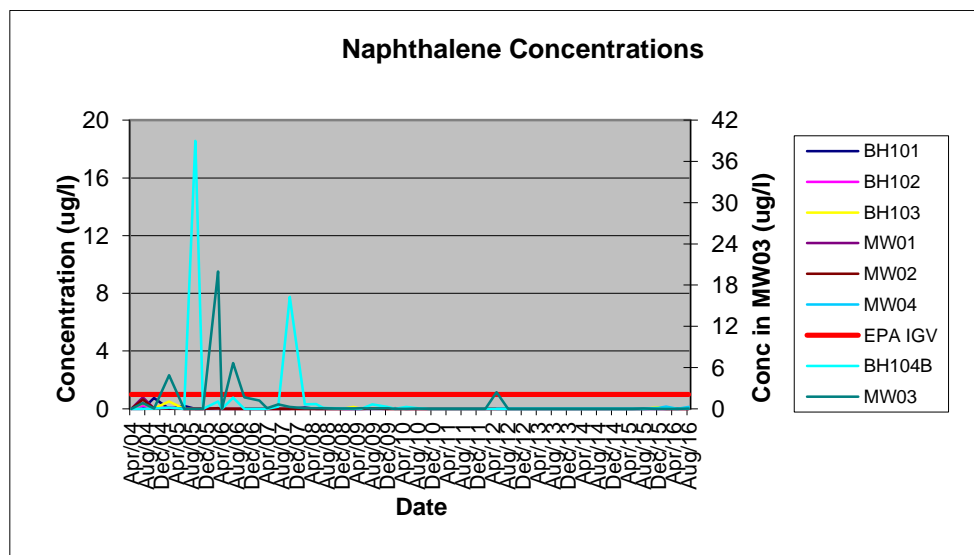
**Figure 6.7 – Naphthalene Concentrations in all Monitoring Wells**

A similar trend to Fluoranthene has been noted in **Figure 6.7**, with concentrations of **Naphthalene** recorded above the IGV of 1.0 µg/l in BH104B and MW03 only. 4 no. exceedances of the IGV were noted in BH104B in September 2005 (39 µg/l), March 2006 (1.069 µg/l), July 2006 (1.594 µg/l) and October 2007 (16.31 µg/l). Since October 2007, the concentrations in BH104B have decreased below the IGV. There have been 6 exceedances of the IGV of 1.0 µg/l in MW03, with the highest concentration detected in March 2006 (19.986 µg/l) and the most recent being the detected in the Quarter 2 2012 monitoring event (2.4 µg/l). The concentrations detected in August 2010 were

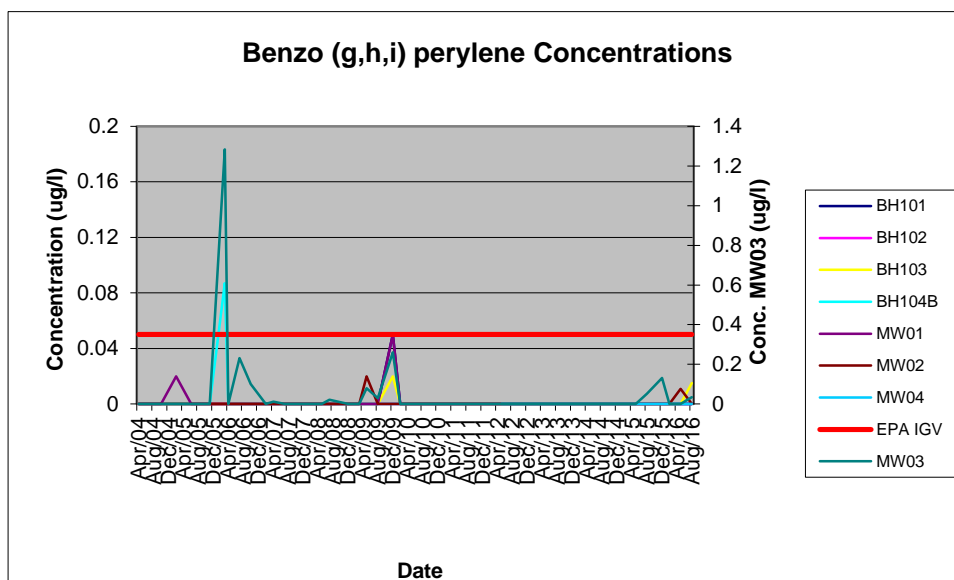
**Figure 6.8 – Benzo (g,h,i) perylene Concentrations**

**Figure 6.8** illustrates the concentrations of **Benzo(g,h,i)perylene** in all monitoring wells over time. Elevated concentrations above the IGV were recorded at BH104B (0.087 µg/l) on one occasion in March 2006.

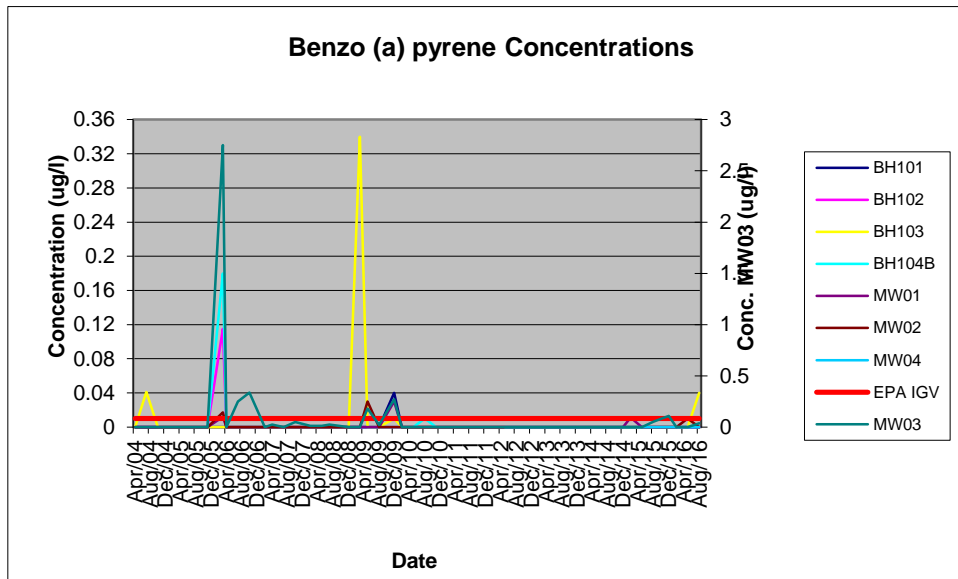
Figure 6.10 illustrates the concentrations of **Benzo(a)pyrene** in all groundwater monitoring wells and indicates that Benzo(a)pyrene has been detected historically in all boreholes above the IGV of 0.01  $\mu\text{g/l}$ . Similarly with the above mentioned trends, the highest concentrations have been detected in MW03 and BH104B. Concentrations have markedly decreased since March 2006 when an elevated concentration of 2.751  $\mu\text{g/l}$  was detected in MW03, however there have been a number of detections above the IGV, with the most recent elevated level detected in December 2009. Elevated concentrations above the IGV were recorded in BH101, BH103 and MW01 during this same period.

Figure 6.10 – Benzo (a) pyrene Concentrations in all Monitoring Wells
