**Facility Information Summary**

AER Reporting Year	2015
Licence Register Number	W0184-
Name of site	01
Site Location	Enva Ireland Limited
NACE Code	Clonminan Industrial Estate, Portlaoise, Co. Loras
Class/Classes of Activity	3832
National Grid Reference (6E, 6 N)	Fourth Schedule - Class 6, Class 7, Class 12, Class 13. 2461 E, 1978 N
<p>A description of the activities/processes at the site for the reporting year. This should include information such as production increases or decreases on site, any infrastructural changes, environmental</p> <p><b>Site Performance:</b> The processing activities onsite include waste oil re-processing, treatment of contaminated soil, repacking of oily contaminated wastes, and paint wastes. The site also stores wastes in packages (barrels, ASPs, IBCs, etc.) prior to transfer off site for recovery or disposal. The company continues to demonstrate its commitment towards HSE management standards - the site maintains ISO14001 and OHSAS 18001. This ensures a standard approach is taking to managing activities from an environmental and safety aspect. There were no issues raised during the reporting period regarding maintenance to the standard.</p> <p><b>EMP

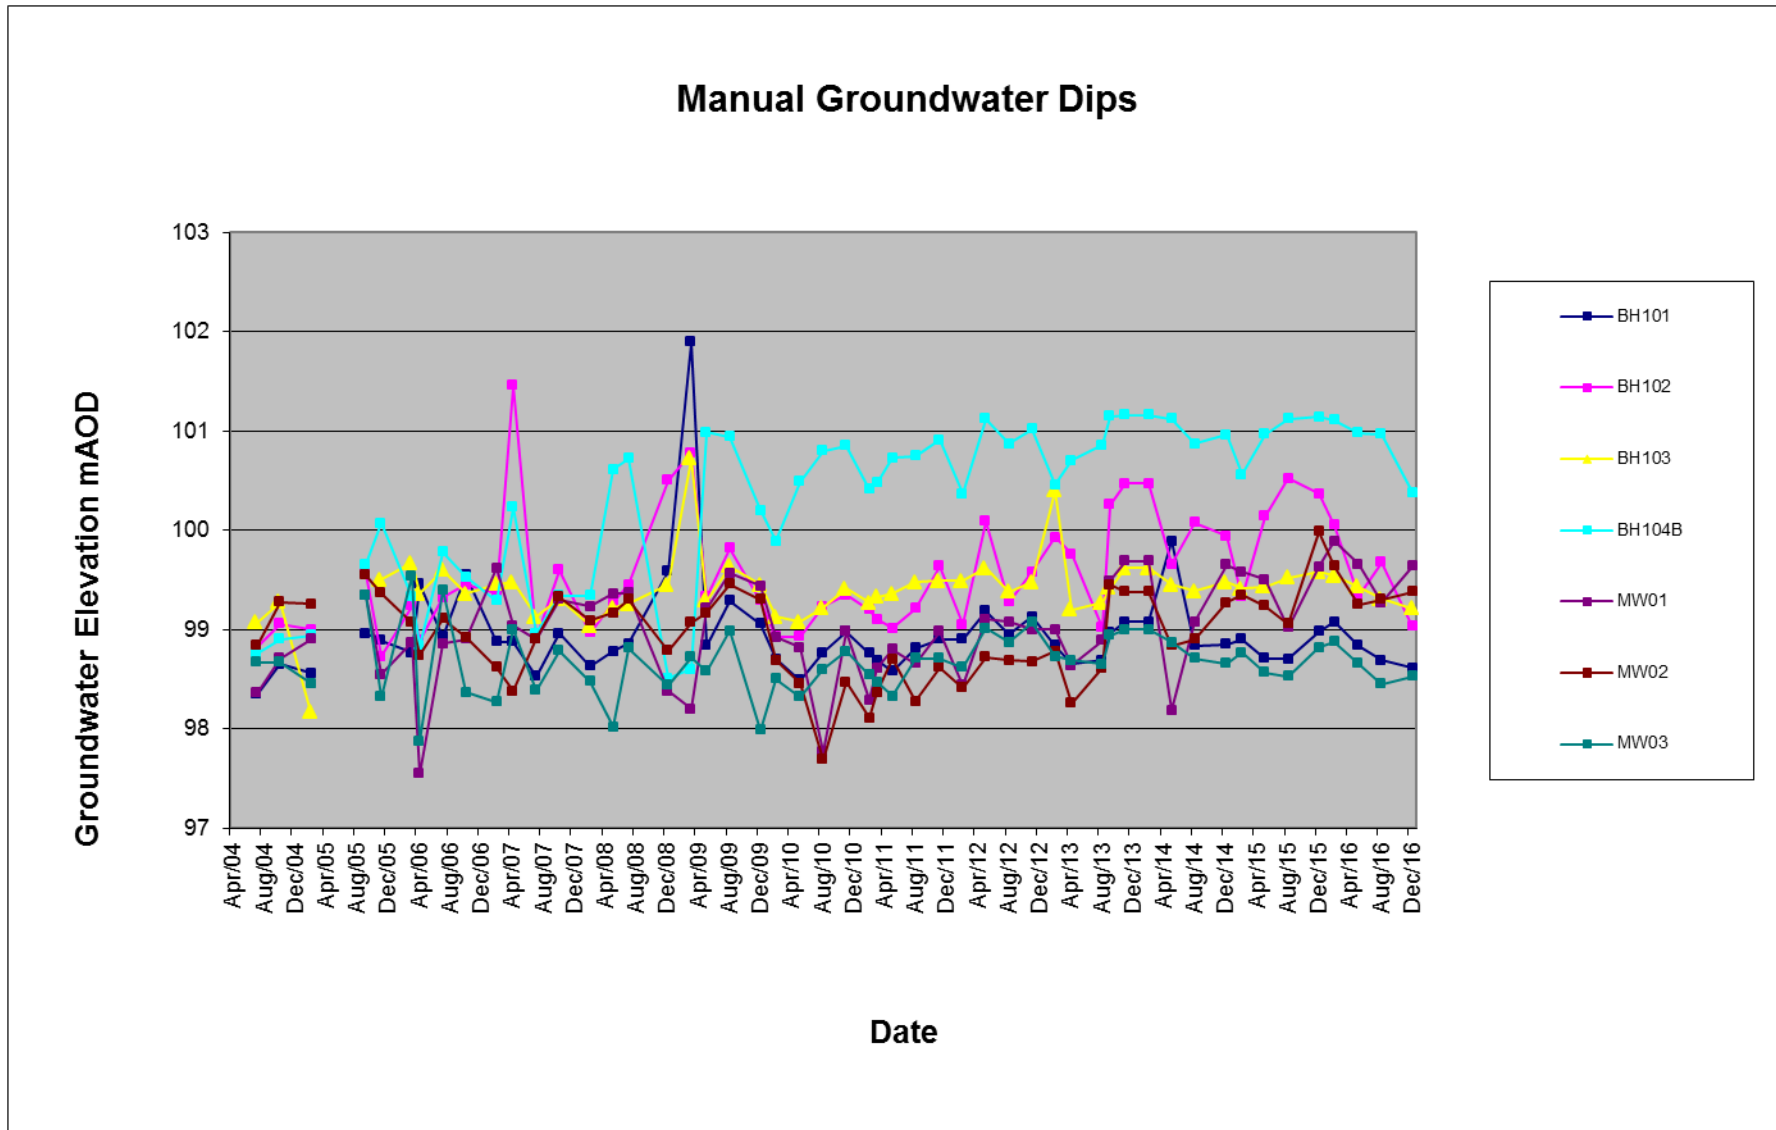
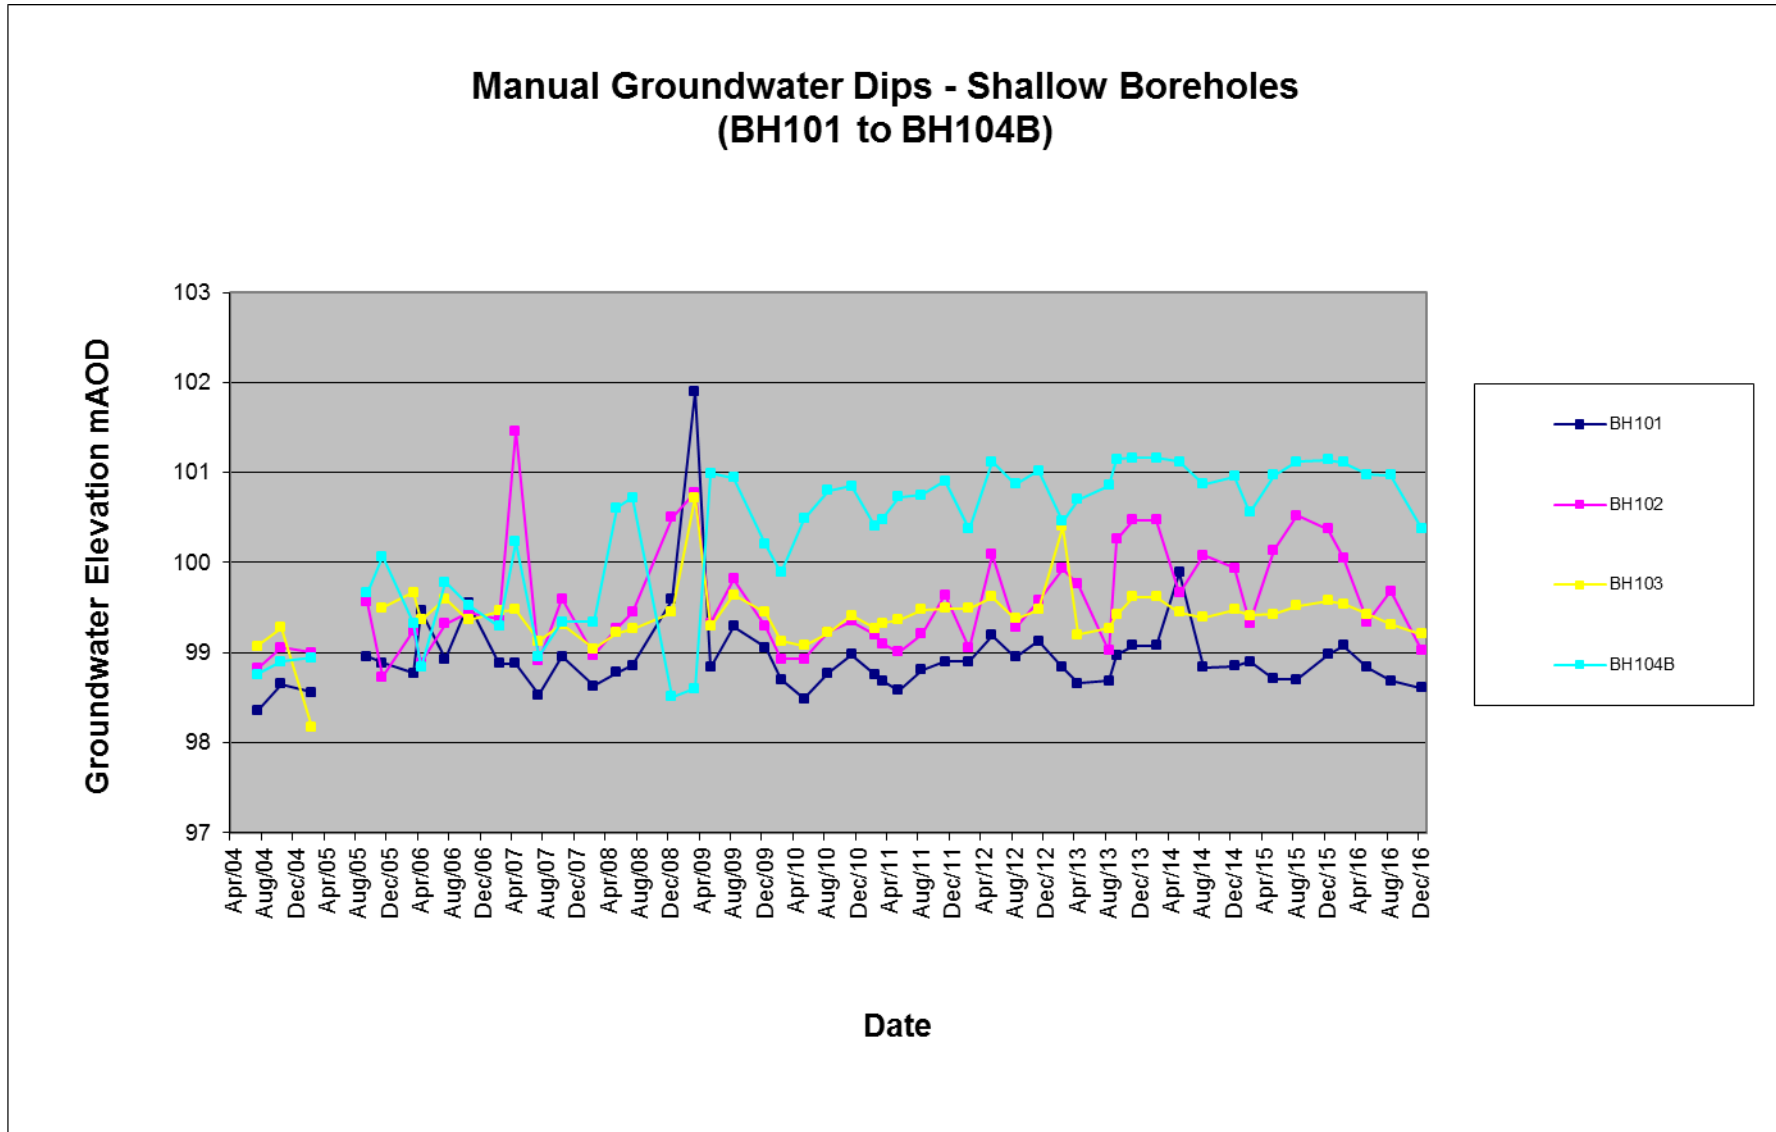
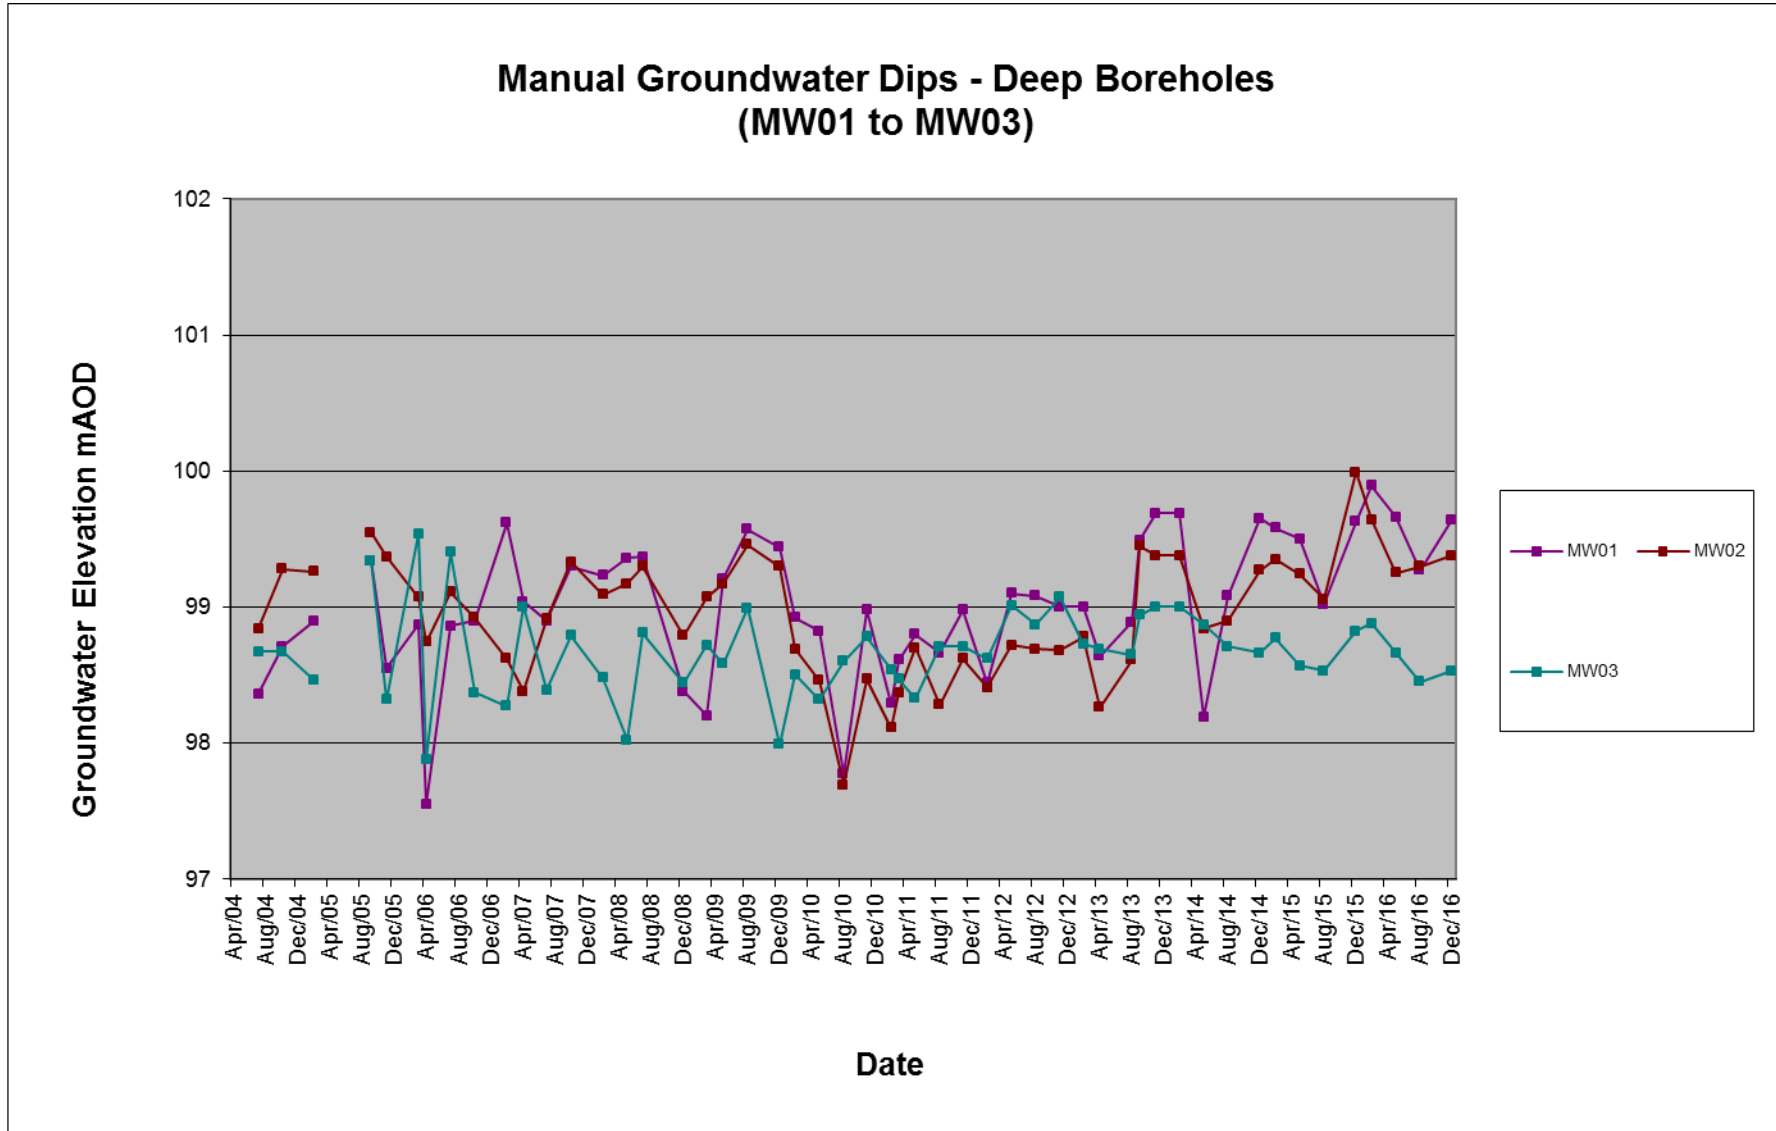
Figure 6.1 – Ground Elevation (mAOD) in all Monitoring Wells

Figure 6.2 – Ground Elevation (mAO) in Shallow Groundwater Monitoring Wells

Figure 6.3 – Ground Elevation (mAOD) in Deep Groundwater Monitoring Wells

The groundwater levels generally show a similar pattern of fluctuation over time indicating a degree of connection between boreholes. The graphs demonstrate that groundwater levels can vary considerably between monitoring rounds; the general direction of flow in the shallow and deeper groundwater bearing unit is in an easterly or north easterly direction however there have been some occasional historic cases of groundwater flowing in a south-easterly direction.

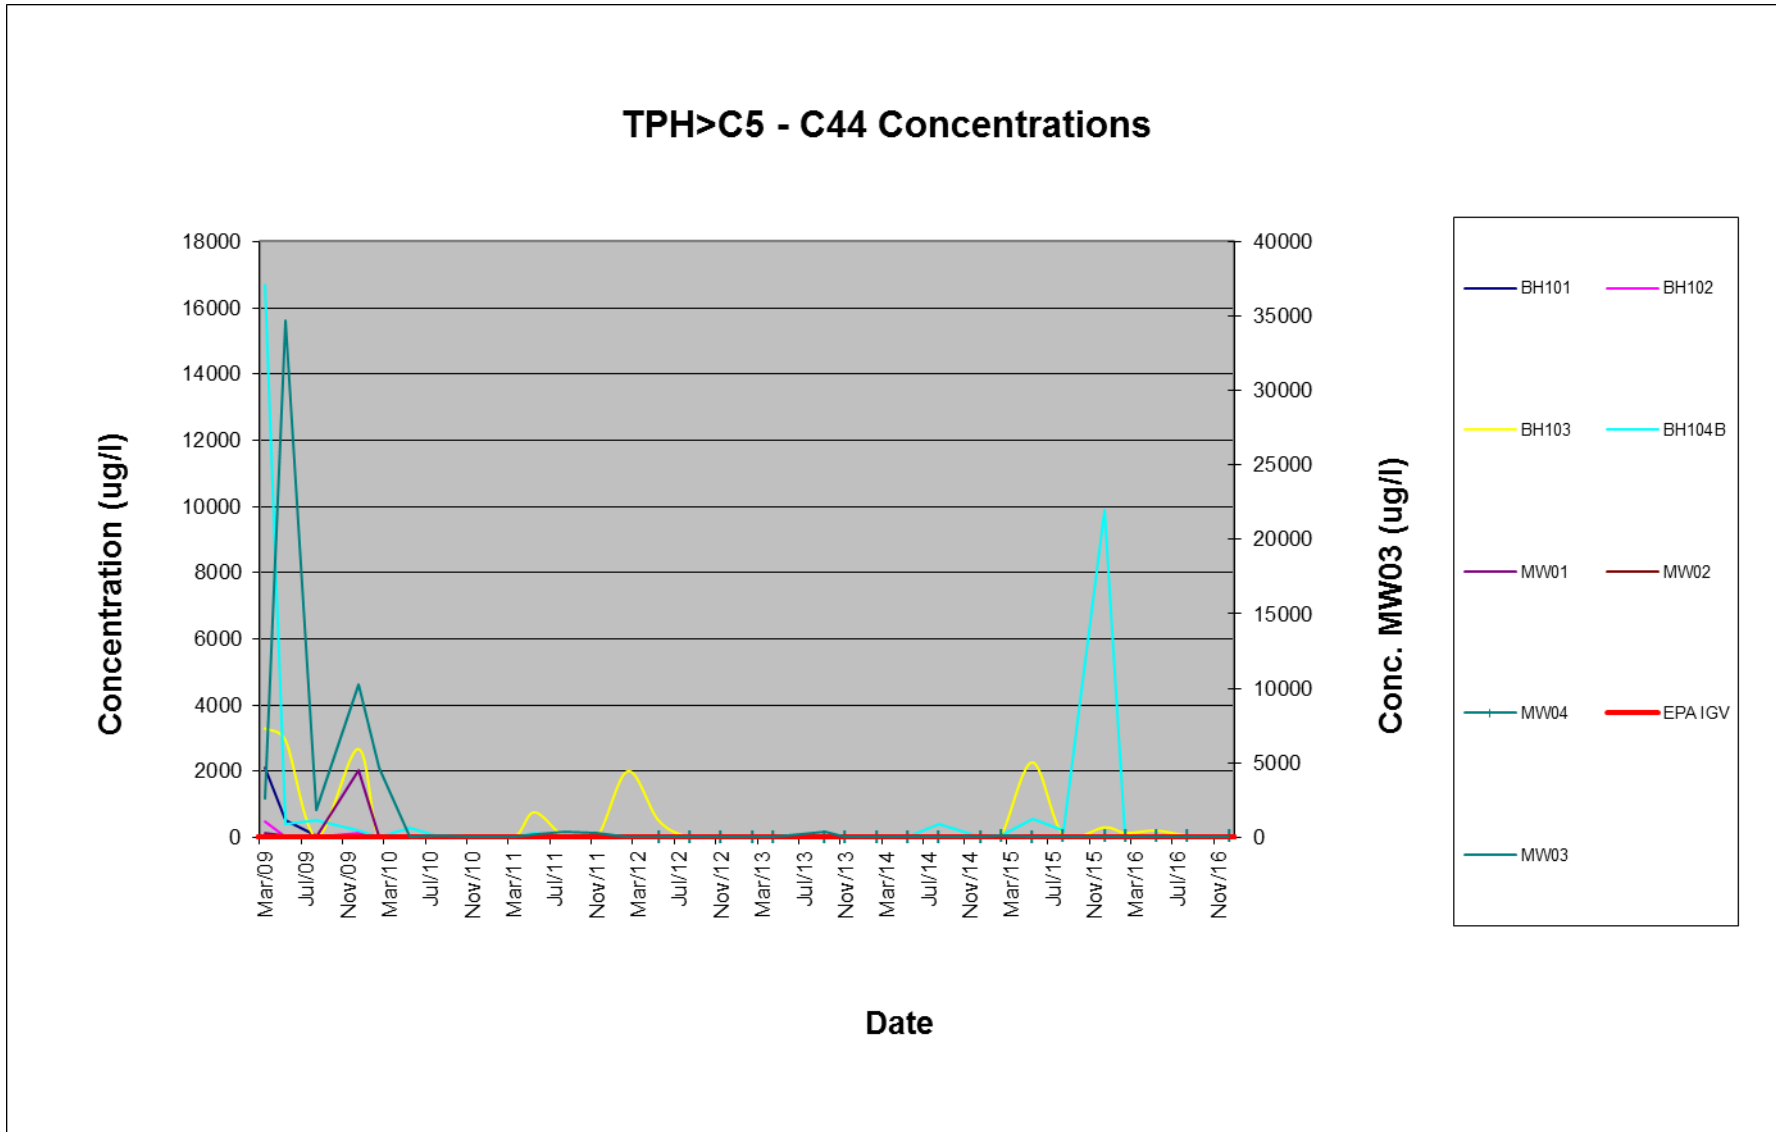
Figure 6.11 – TPH (Carbon Range C10-C44) in all Monitoring Wells

During the Quarter 1 2015 monitoring event, hydrocarbons were detected in MW03, MW04, BH103 and BH104B. The predominant aromatic carbon range comprised C21-C35 (14 µg/l) in BH103, C12-C16 (27 µg/l) and C16-C21 (15 µg/l) in BH104B, C12-C16 (14 µg/l) in MW03 and C12-C16 (15 µg/l) in MW04. Aliphatic hydrocarbons were detected in the ranges C16-C35 (54 µg/l) in BH103, C16-C35 (11 µg/l) in BH104B and C16-C35 (46 µg/l) and C35-C44 (12 µg/l) in MW03.

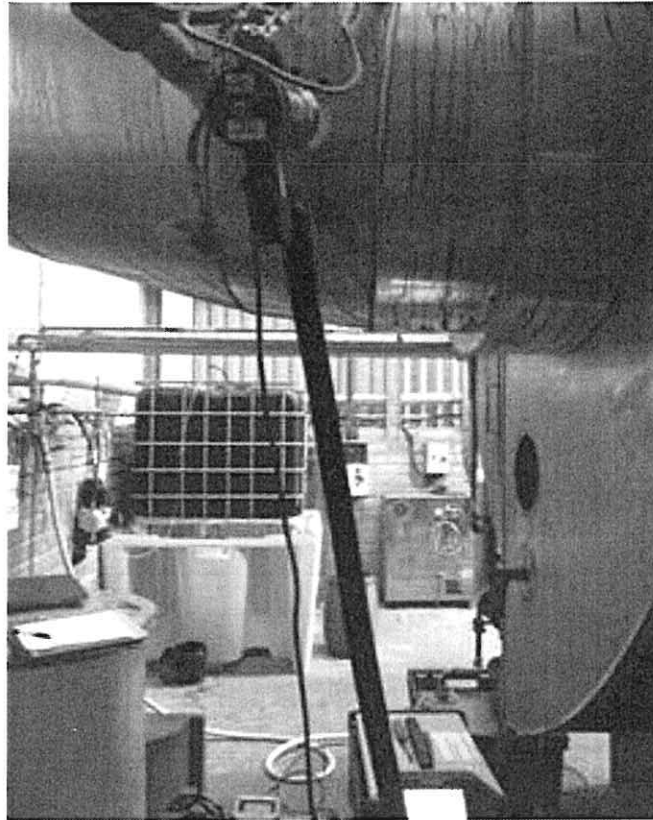
**Stack Diagram**

**Figure 1: Boiler 1**
