**Re: 2016 Annual Environmental Report for W0277-01, Huntstown Inert Waste Recovery Facility**

This is a summary of the activities for W0277-01, week beginning 1<sup>st</sup> January 2016 to 31<sup>st</sup> December 2016 at Huntstown, Finglas, Dublin 11.

**CLOSURE, RESTORATION AND  
AFTERCARE MANAGEMENT PLAN (CRAMP)**

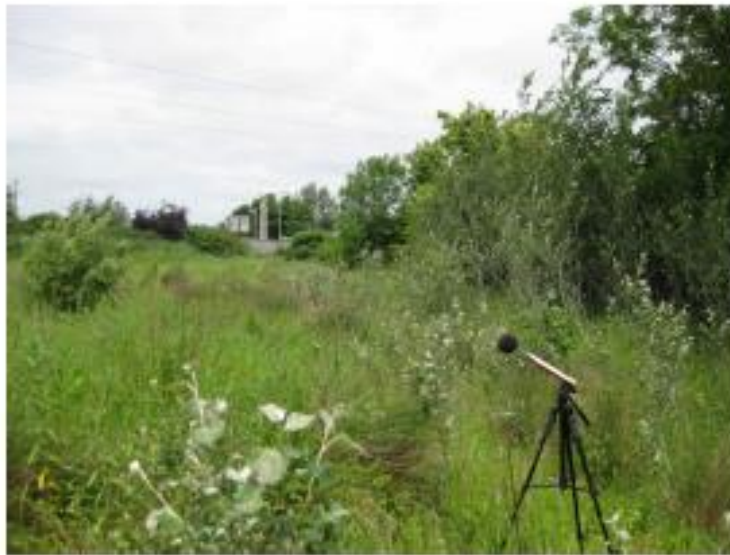
**Noise monitoring equipment at Monitoring Location N1**

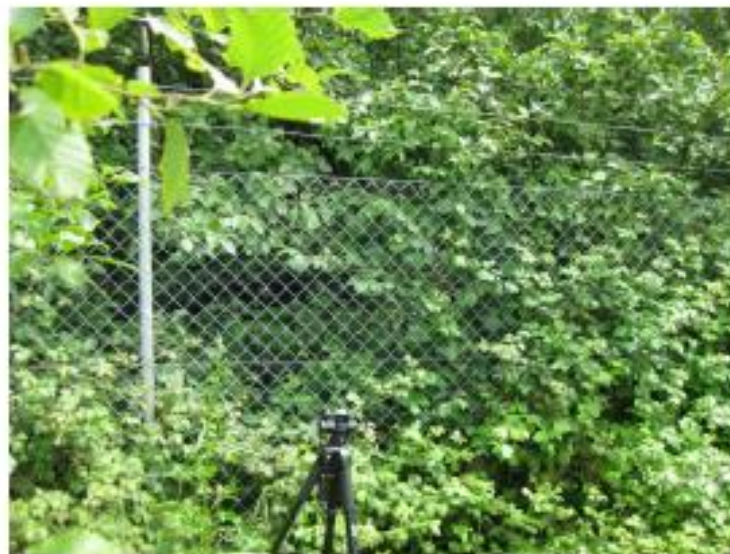
**Noise monitoring equipment at Monitoring Location N2**

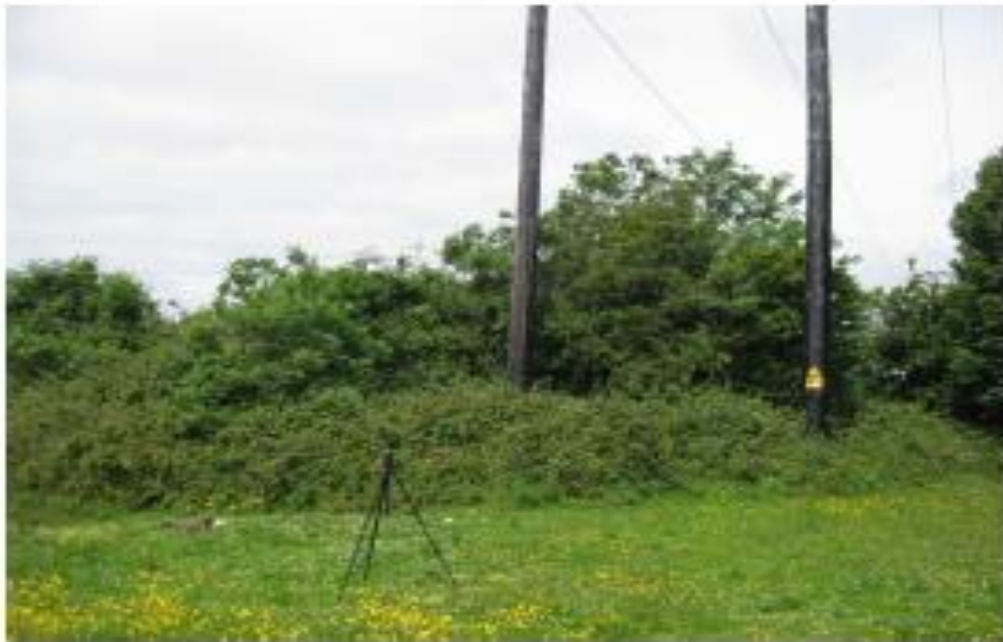
**Noise monitoring equipment at Monitoring Location N3**

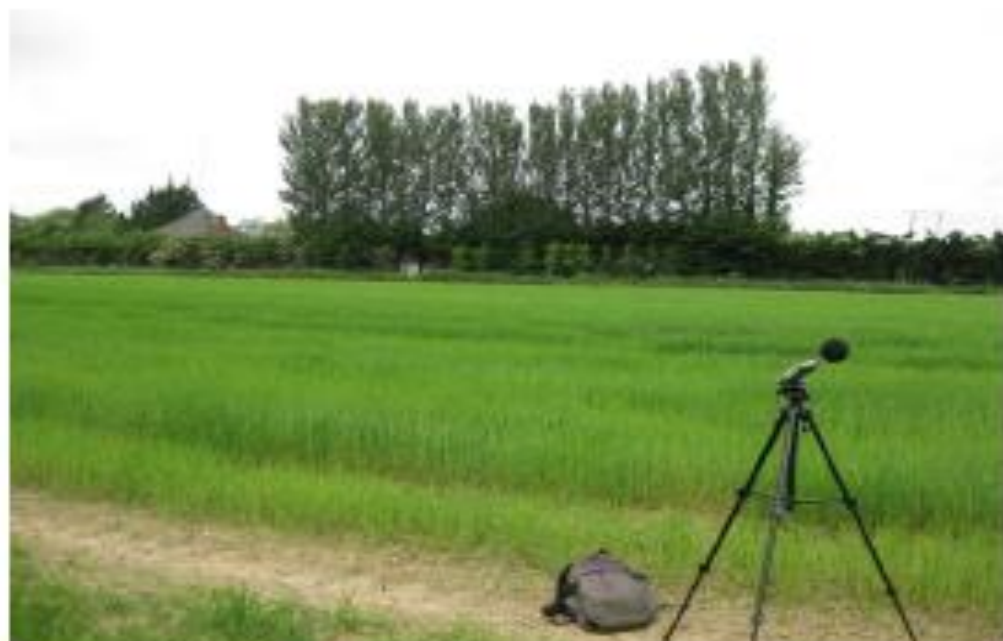
**Noise monitoring equipment at Monitoring Location N4**

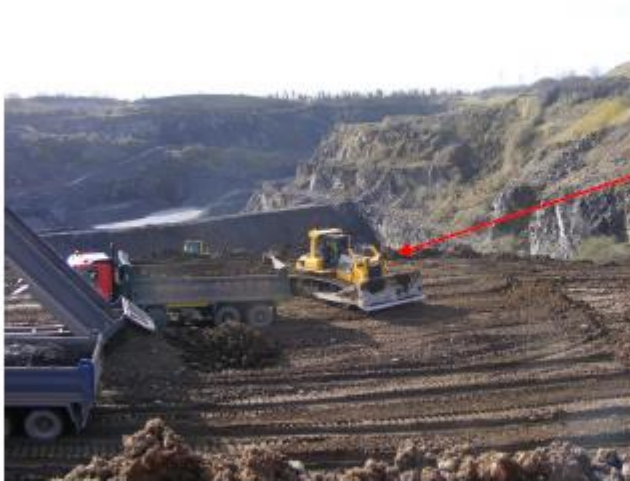
Plate 1 – Mobile Plant working at the Location

KPI Data should be developed for the Dozers and can be used for Projects, Internal Training and Communication.

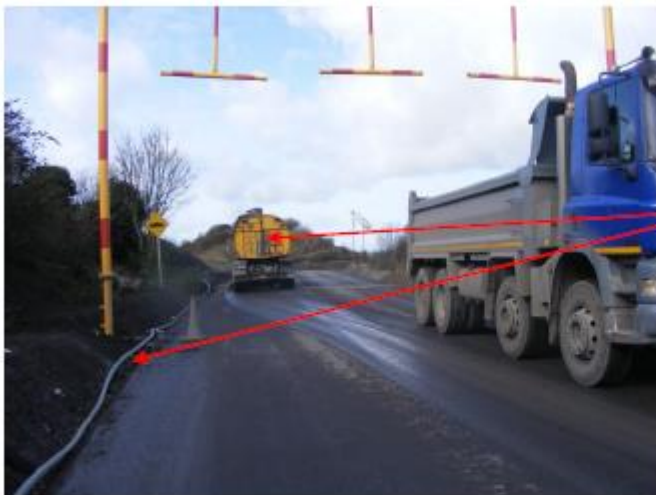
Plate 2 – Road Sweeper and Sprinklers under Construction

The Road Sweeper was operating at the Location. Once sprinklers are operation the bowser hrs may be reduced.

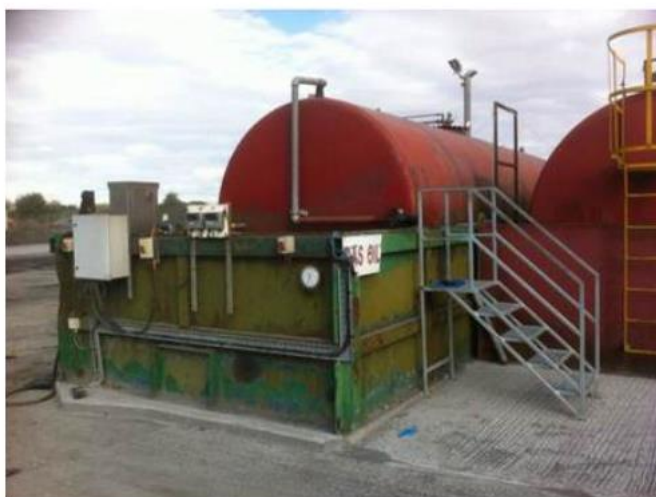
**Figure 1 Bund identification**

Aspect	Value/Finding	Comment
Date of Assessment	9-Oct 15	
Bund type	Local	
Bund construction	Steel	
Capacity	Sufficient	
Defects	None	
Assessment result	Pass

Aspect	Value/Finding	Comment
Bund protected from rain?	No (Fail)	Best practice is to protect from rain.
Maximum quantity of rainwater marked?	No (Fail)	Best practice is to mark maximum allowable level of rain water.
Is rainwater discharged by gravity?	Yes (Fail)	Outlet plug observed. Best practice is not for gravity discharge.
Is rainwater discharge point securely locked?	No (Fail)	Best practice is to securely lock access to discharge point.
Are tank filling points within bund?	Yes (Pass)	Best practice is for tank filling points to be within the bund.
Do pipes pass through bund wall?	N/A as bund of steel construction	Only applicable for masonry bunds
Is bund protected from vehicle strikes?	N/A as bund of steel construction	Only applicable for block and plastic bunds.

Aspect	Value/Finding	Comment
Associated refuelling area?	Yes	
Impermeable ground?	Yes	
Interceptor?	Yes	
Defects	None

- Roof bund or mark maximum level rain water

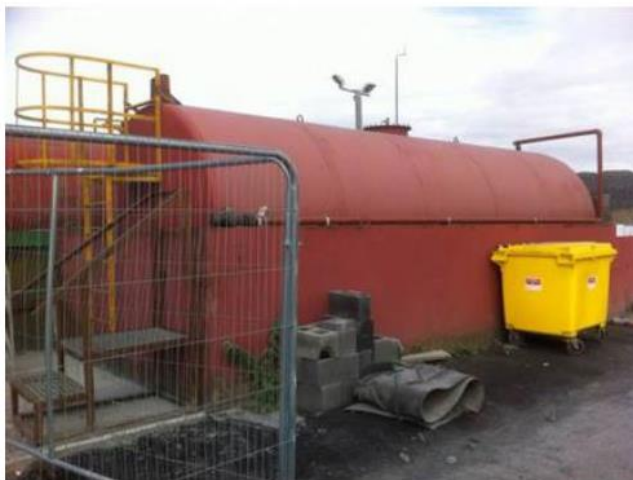
Figure 2 Bund identification

Aspect	Value/Finding	Comment
Date of Assessment	9-Oct 15	
Bund type	Local	
Bund construction	Steel	
Capacity	Sufficient	
Defects	None	
Assessment result	Pass

Aspect	Value/Finding	Comment
Bund protected from rain?	No (Fail)	Best practice is to protect from rain.
Maximum quantity of rainwater marked?	No (Fail)	Best practice is to mark maximum allowable level of rain water.
Is rainwater discharged by gravity?	Yes (Fail)	Outlet plug observed.  Best practice is not for gravity discharge.
Is rainwater discharge point securely locked?	No (Fail)	Best practice is to securely lock access to discharge point.
Are tank filling points within bund?	Yes (Pass)	Best practice is for tank filling points to be within the bund.
Do pipes pass through bund wall?	N/A as bund of steel construction	Only applicable for masonry bunds
Is bund protected from vehicle strikes?	N/A as bund of steel construction	Only applicable for block and plastic bunds.

Aspect	Value/Finding	Comment
Associated refuelling area?	Yes	
Impermeable ground?	Yes	
Interceptor?	Yes	
Defects	None
