Annual Environmental Report 2016 for Crystalhill Inns Ltd T/A CHI  
Environmental Grannagh, Kilmacow, Co. Kilkenny licence number  
W0260-01

This Annual Environmental Report provides information on environmental compliance at the CHI Environmental Soil Recovery Facility, Grannagh, Kilmacow, Co. Kilkenny.

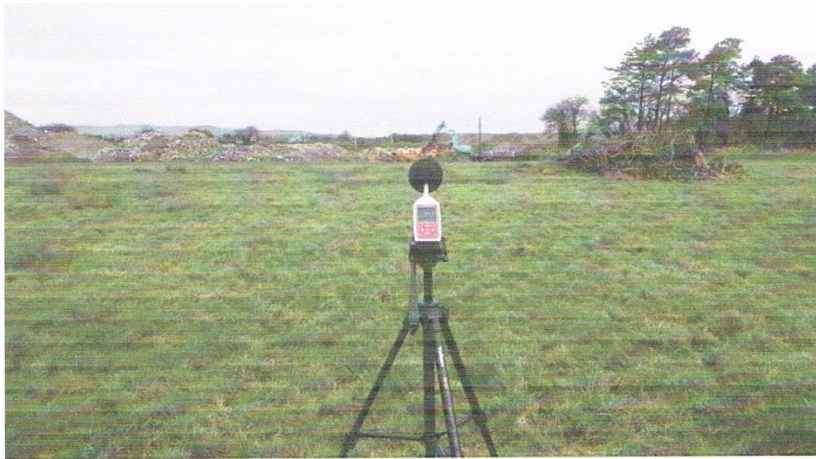
Noise monitoring location NSL3

As can be seen in section 4.1,  $L_{Aeq}$  levels at the noise monitoring locations are less than the day time limit of 55dB at all locations except NSL3 for reading two and three. The crusher was operating during this monitoring period and was audible at 50-55dBA. It was noted that there was very little difference in reading one compared to reading two and three. In reading one, the crusher was not operational. The main noise source at this location as traffic noise in the range of 50-60dBA and up to 65dBA at times.
