ENERGY AUDIT
PANDA WASTE SERVICES
RATHDRINAGH
NAVAN, COUNTY MEATH
WASTE LICENCE NO. W0140-03

October 2012

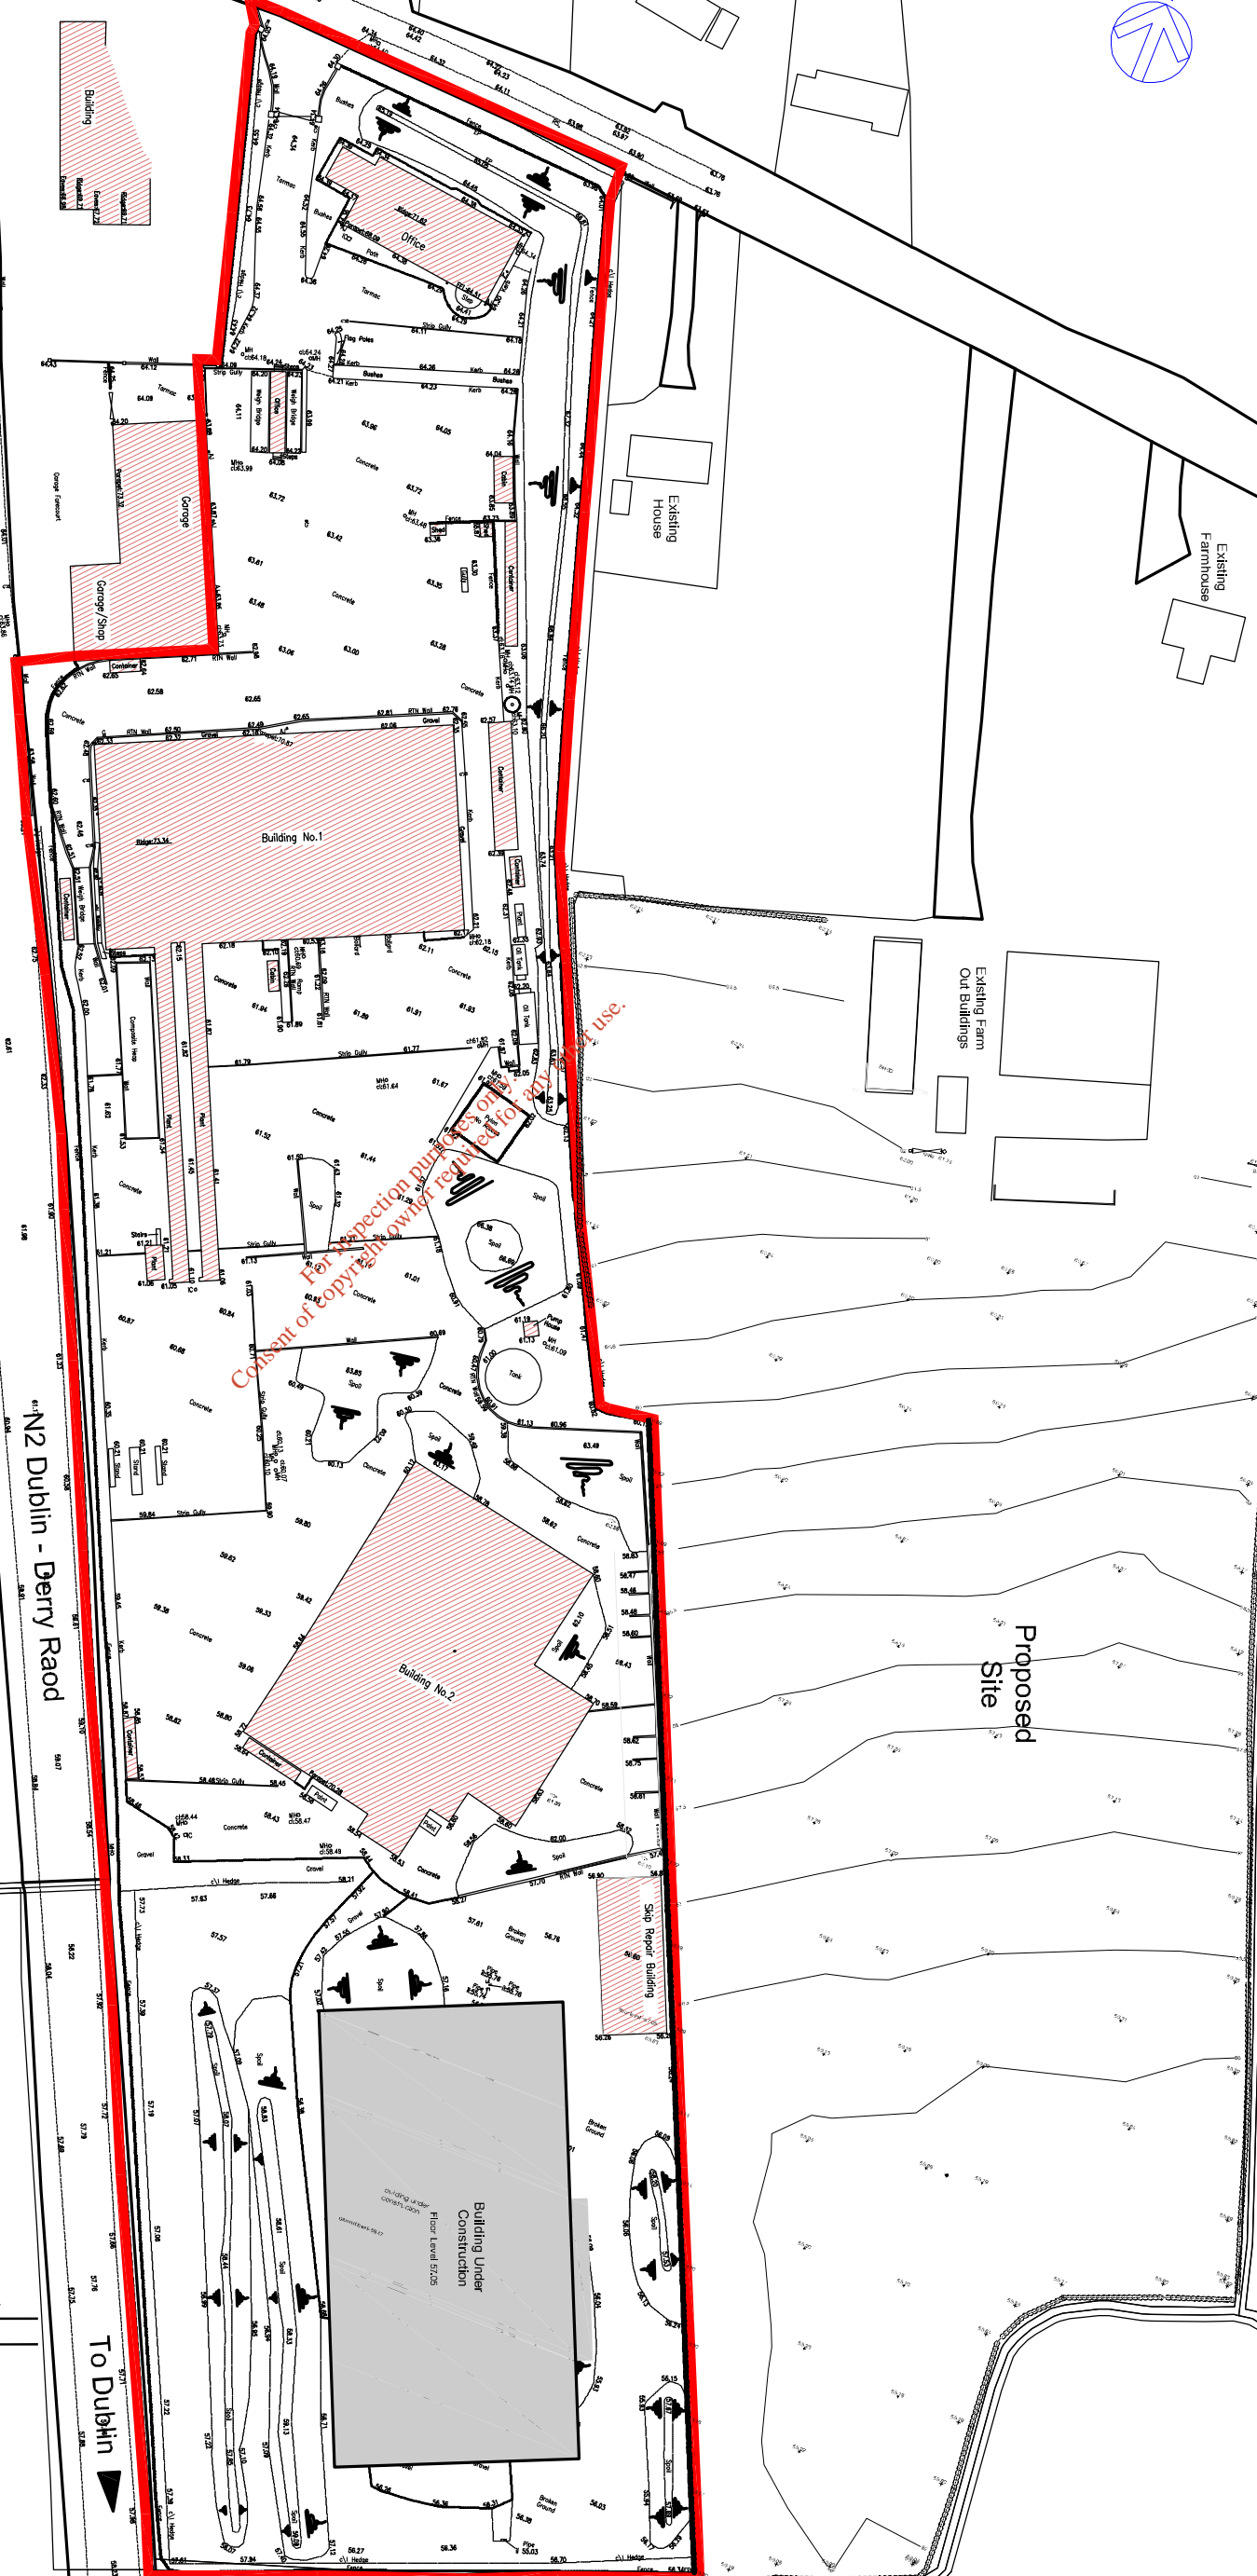
Drawing 101-102

The current licensed area is 4.7 hectares and the site layout is shown on Drawing No 101-102 in Appendix 1, with details of the infrastructure presented in Table 2.1. Buildings 1 & 2 were operational for the entire 12 month period (2011). Building 3 was constructed in 2010 and 2011 and only began operations in September 2011.
