Wexford County Council

Killurin Landfill
W0016-02

Annual Environmental Report 2016

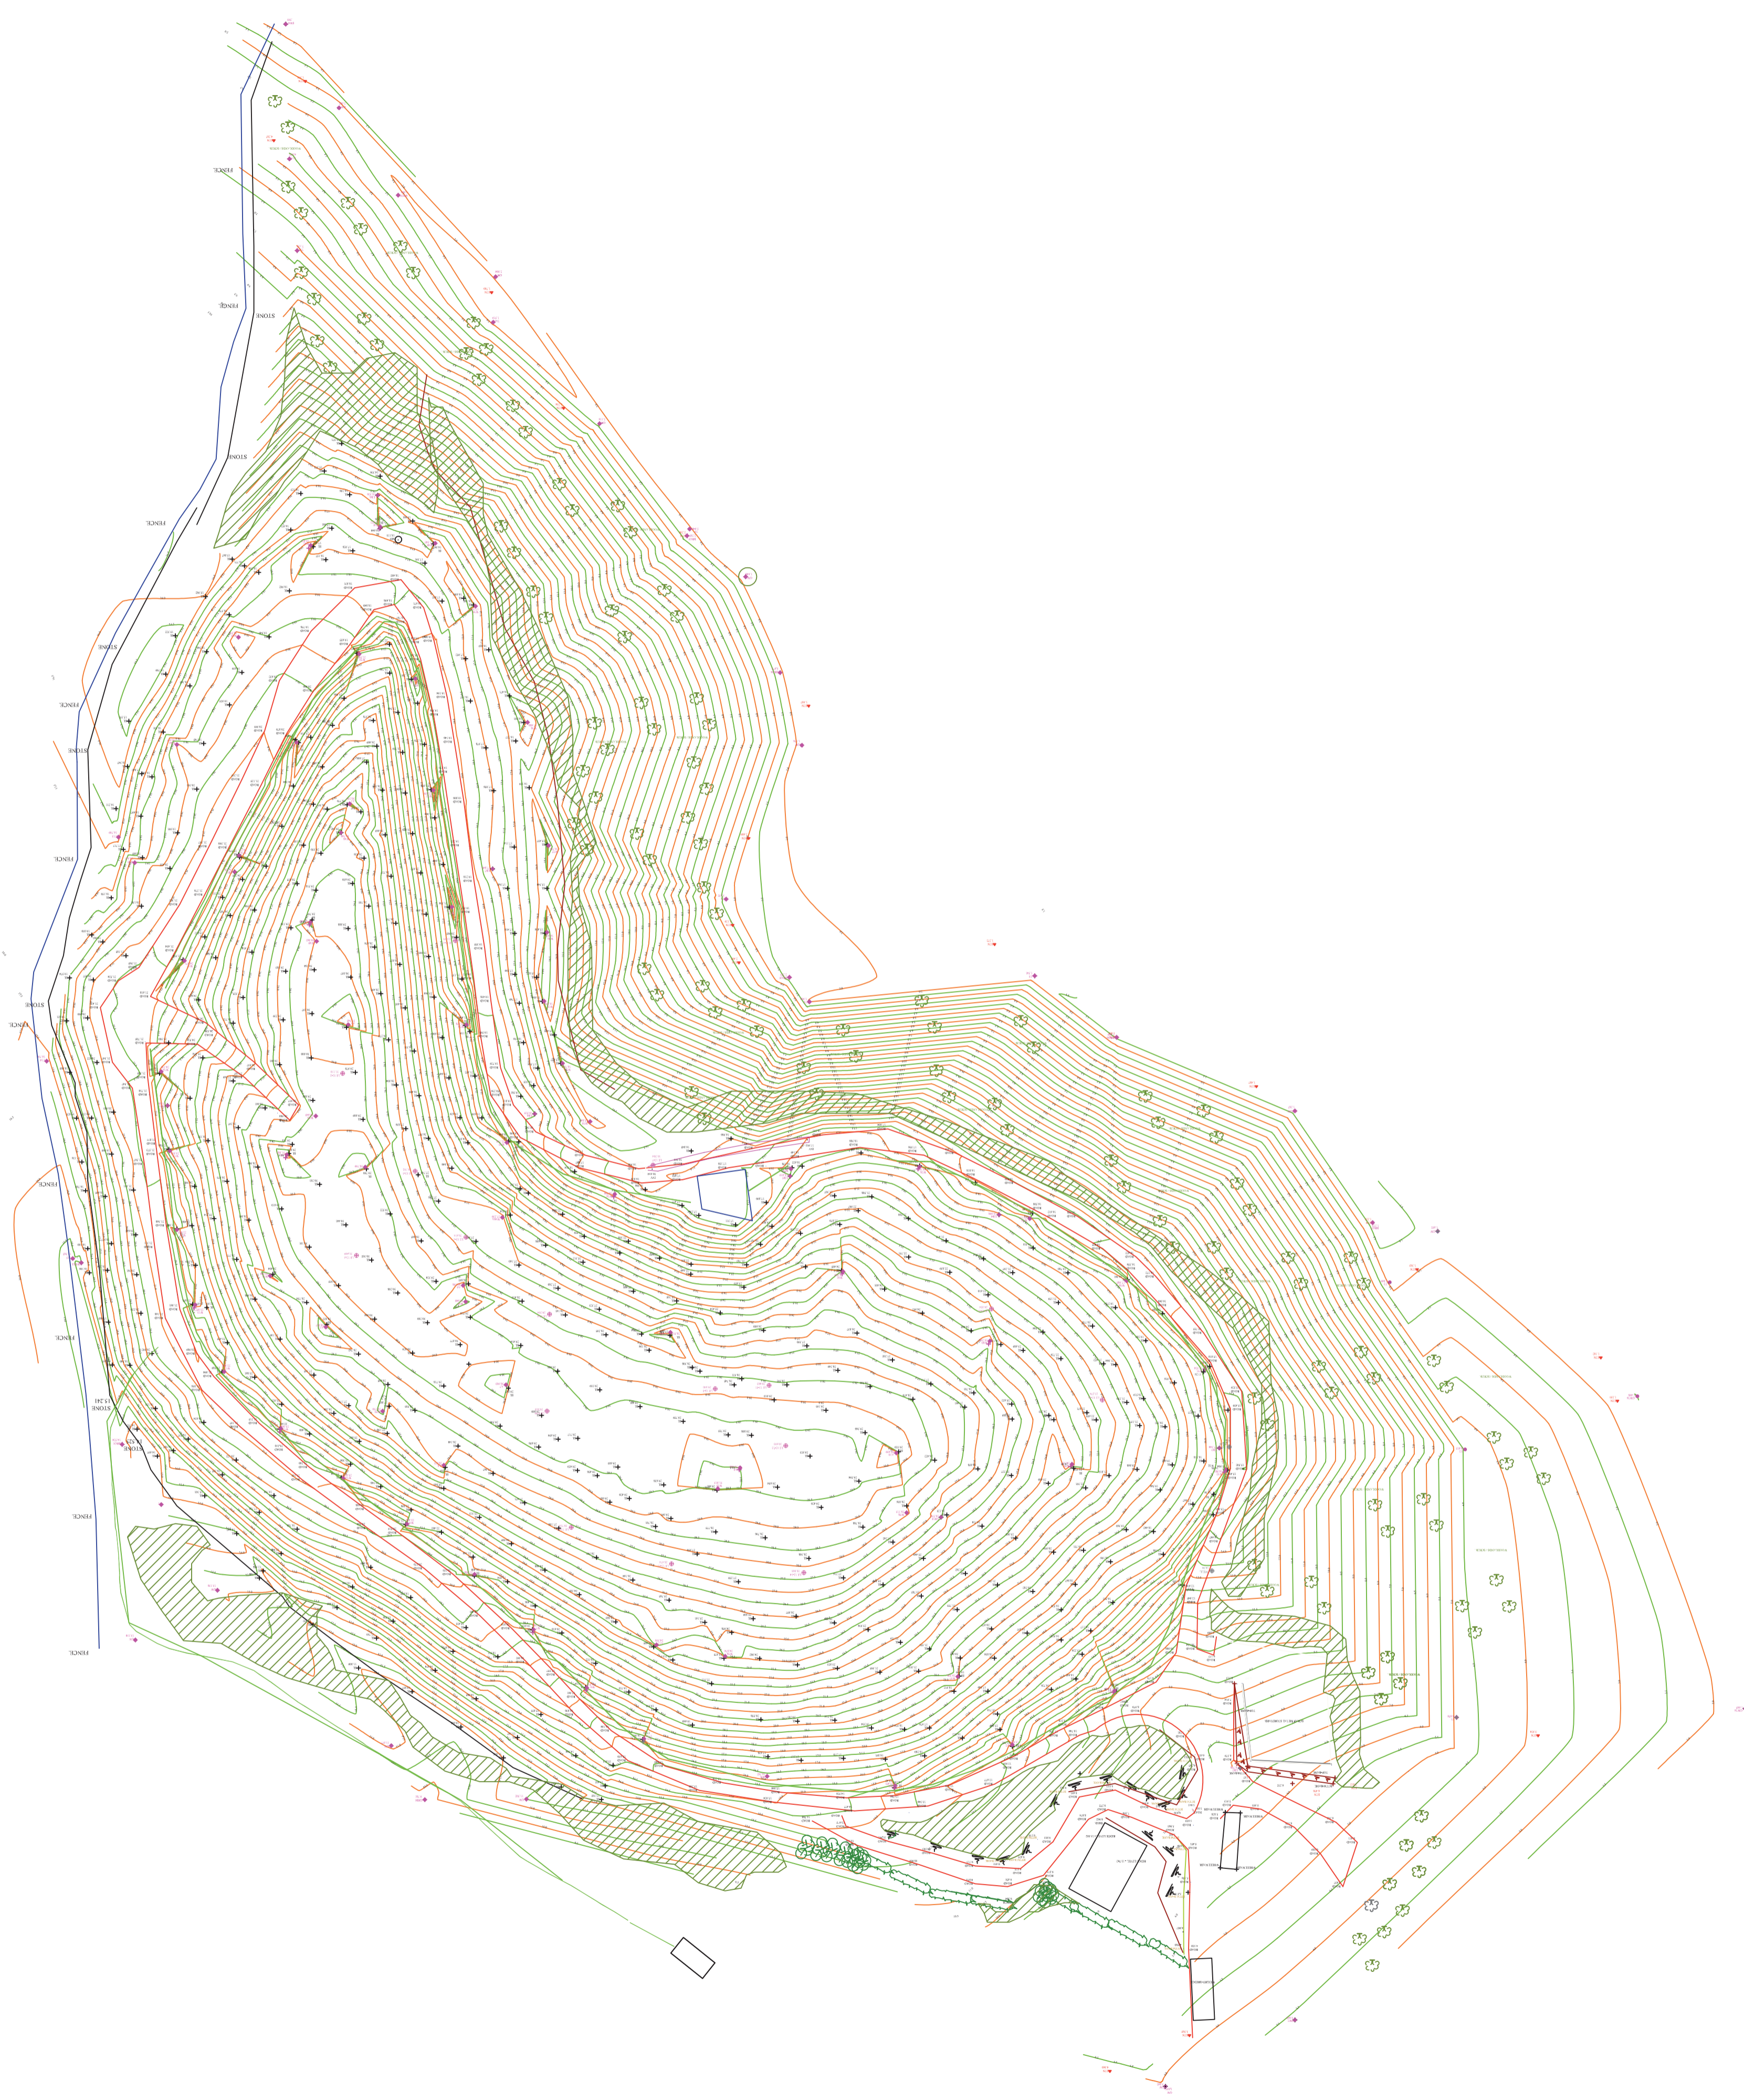
Scale : 1 : 500	Date : Nov 14	Job no : 12-77	Dwg no : 12-77/1	Dr By : J.K.	Rev : A
Project : Killurin Land Fill Top Survey.		Client : Frab Hobbs, Wexford County Council Homestown Land Fill Facility, Homestown, Co Wexford.		Dwg Title : Site Plan.	
  Land Surveyors & Civil Engineers.		  ENGINEERS IRELAND		  CHARTERED SURVEYORS	
Brakesstown, Taghmon, Co. Wexford. Phone: (053) 34218 or (087) 6857464 email : info@capitalsurveys.ie www : www.capitalsurveys.ie

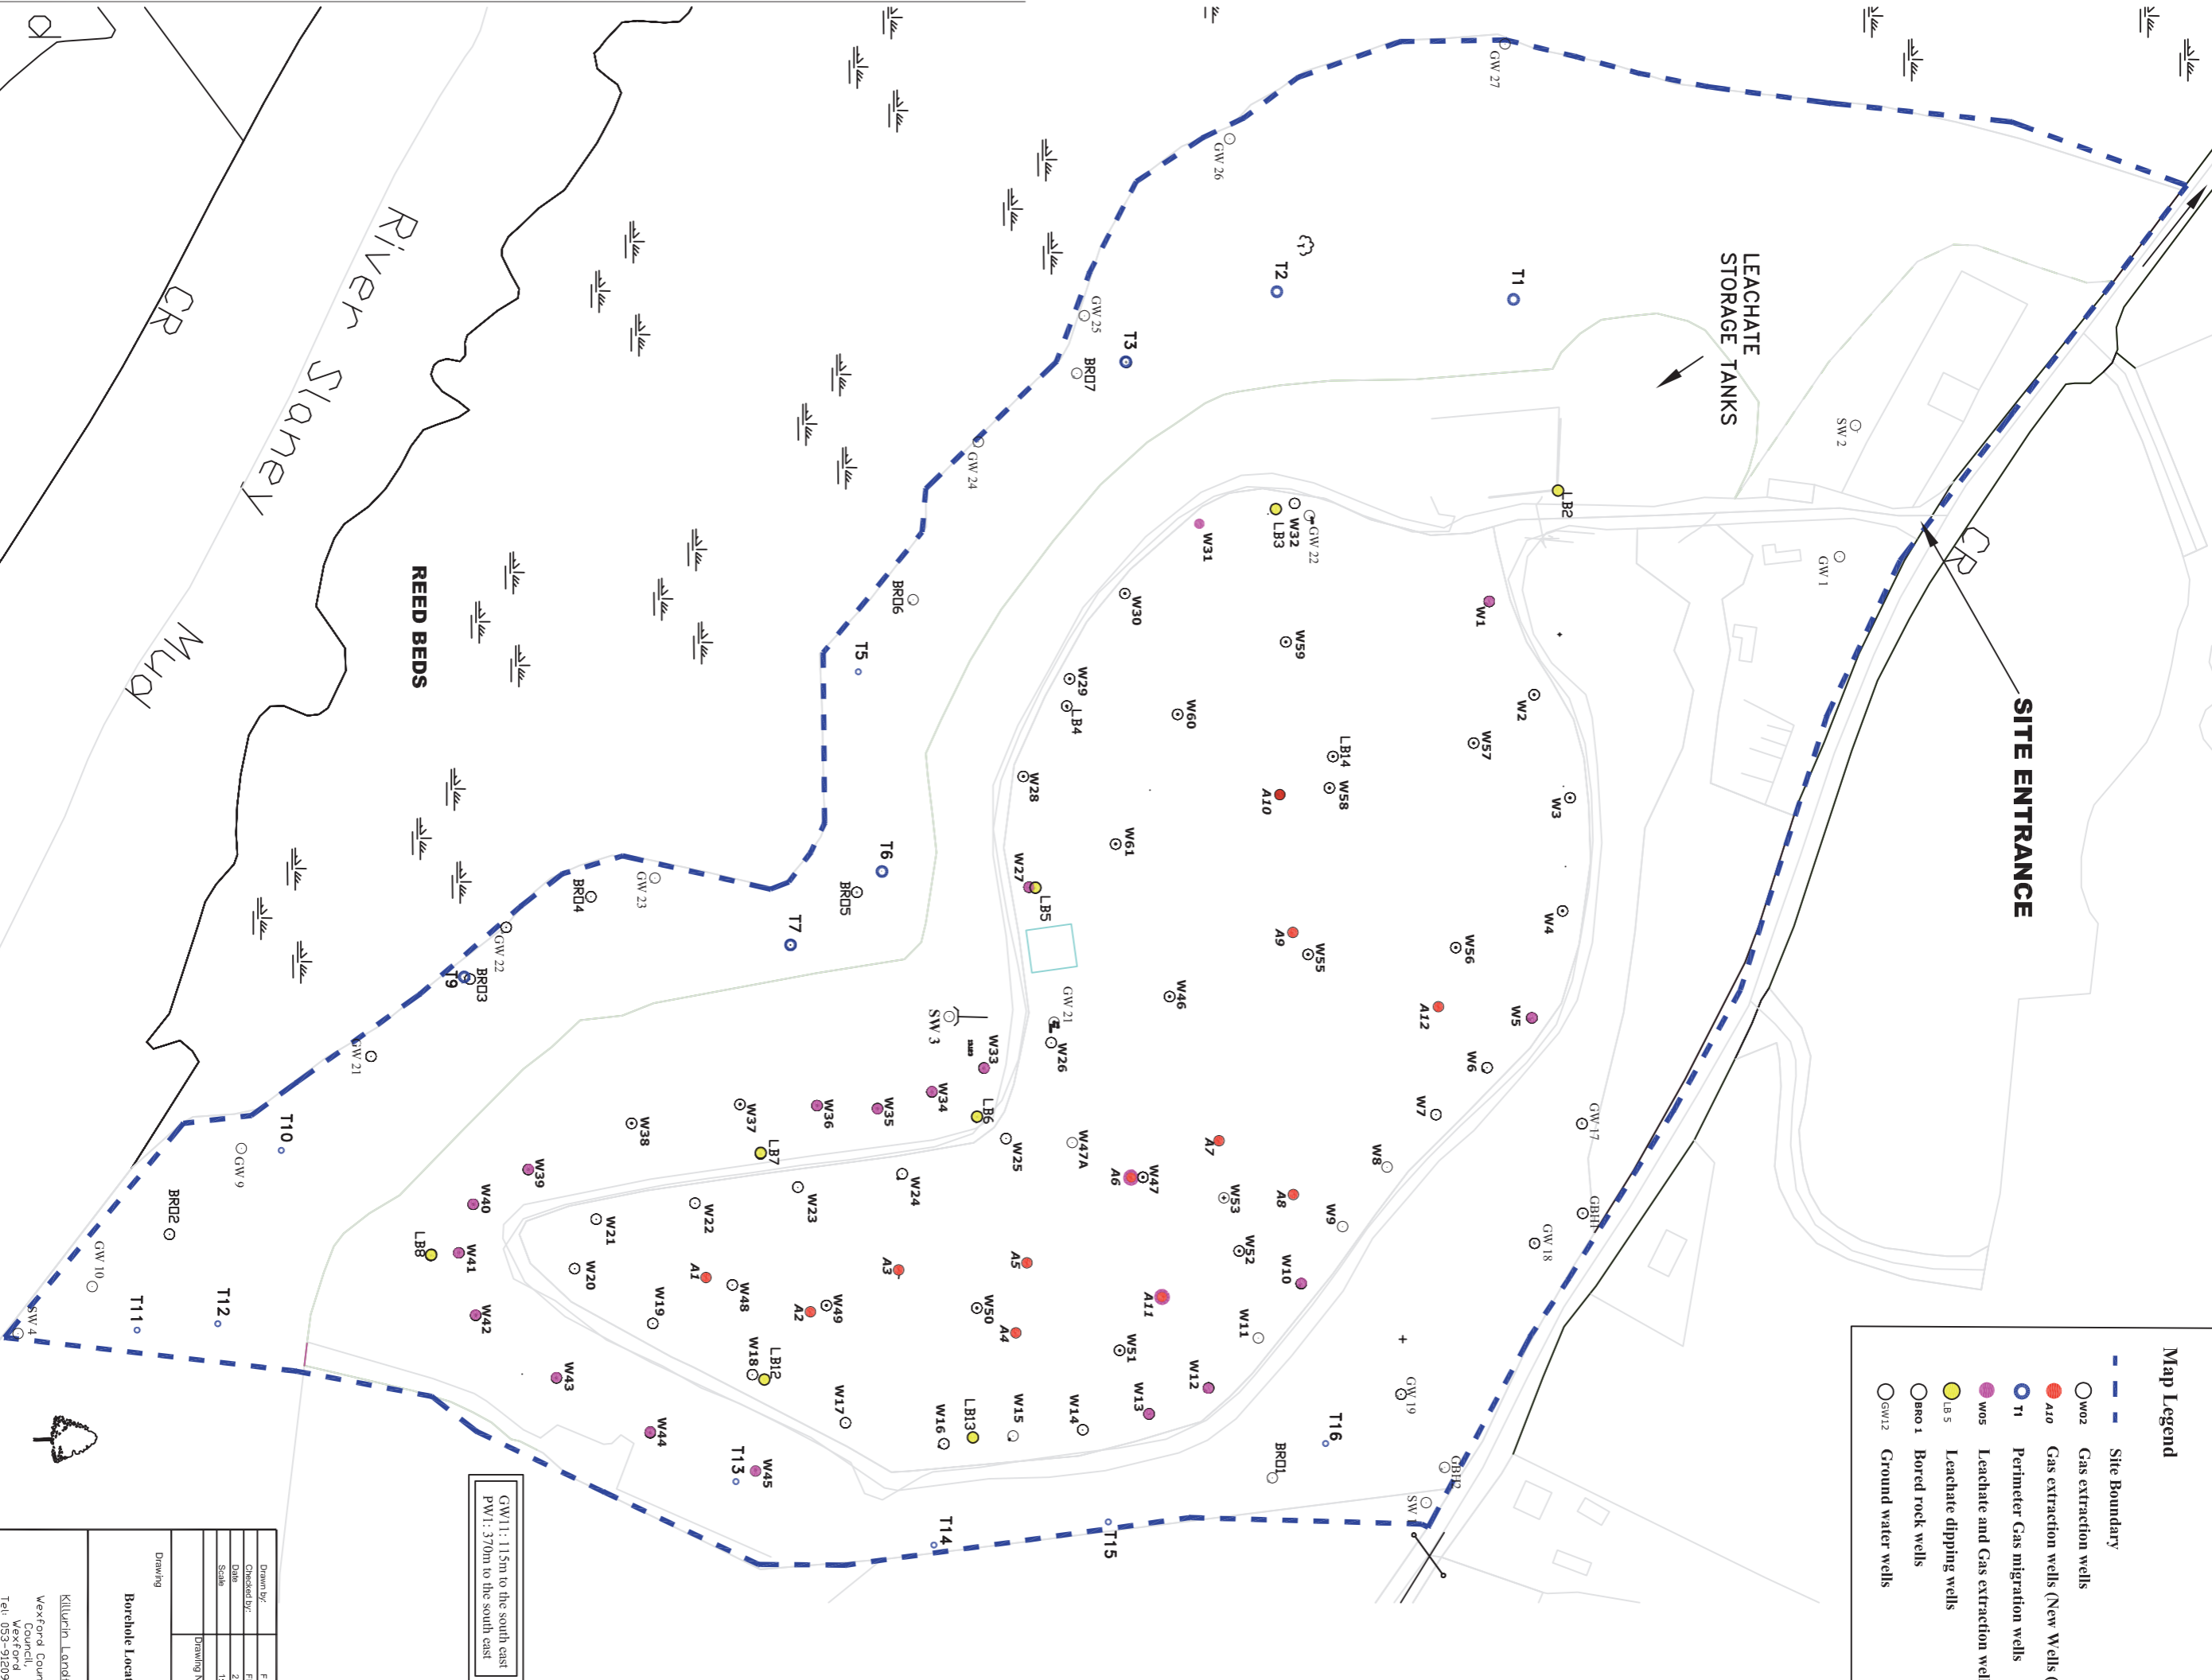
- Site Boundary
- Gas extraction wells
- Gas extraction wells (New Wells (2010))
- Perimeter Gas migration wells
- Leachate and Gas extraction wells
- Leachate dipping wells
- Bored rock wells
- Ground water wells

GW1: 11.5m to the south east
 PVI: 370m to the south east
