# SOIL AND GEOLOGY 5

- 5.1 This Chapter of the Environmental Impact Statement evaluates the regional and local geological conditions prevailing at the established construction and demolition (C&D) waste recovery facility at the Central Quarry at Huntstown and the location of the planned long-term replacement facility to be located at the north-eastern corner of the quarry complex.

- 5.2 This Chapter also assesses the impact of the proposed intensification of C&D waste recovery activity at the Central Quarry in the near-term (next 2-3years) and at the planned replacement facility over the longer term thereafter. The extent of the application site to which this application applies is shown in Figure 5-1.

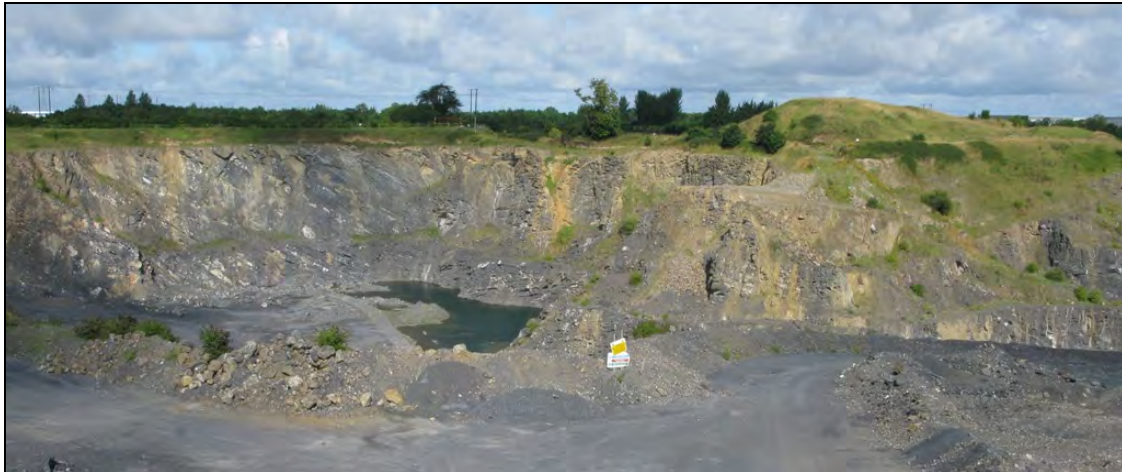
Plate 5-1 Limestones Exposed in Western Face of the North Quarry.  
Note steep dip to north-west and well-bedded nature of the limestones.

- 5.23 The South Quarry at Huntstown is developed within limestones of the Malahide Formation which dip steeply to the north in the eastern part of the quarry and to the north-west in the western part of the quarry. The limestones are dominated by well-bedded limestones.

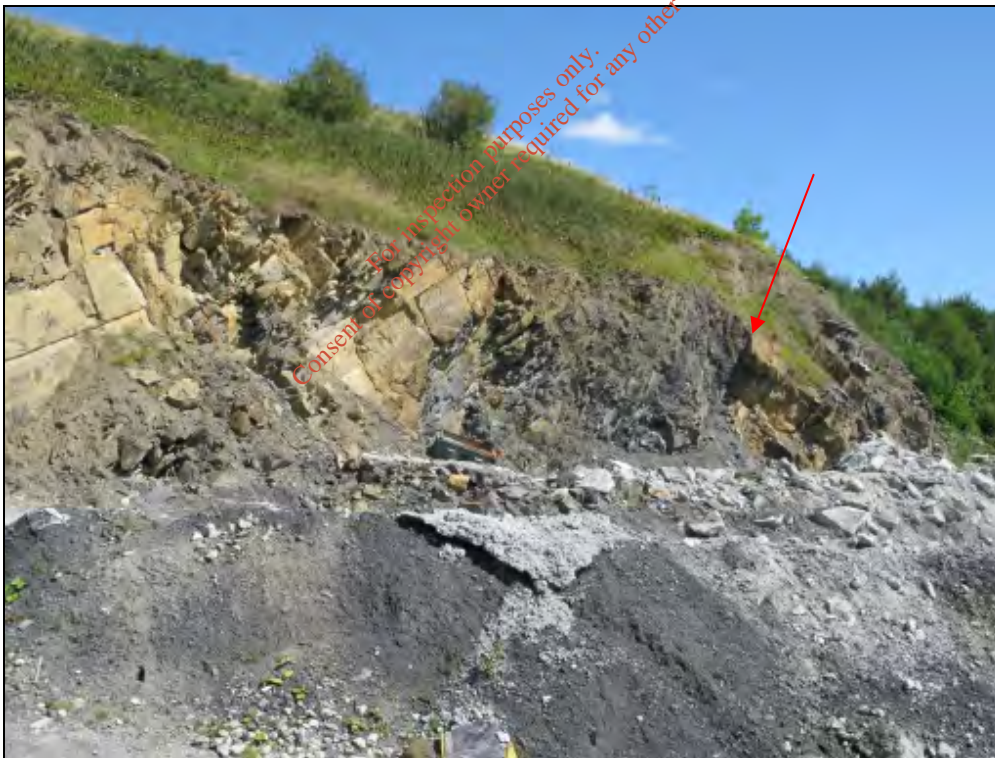
Plate 5-2 Exposure of the Geological Contact in Huntstown Central Quarry.  
between the Waulsortian Limestones of the Feltrim Limestone  
Formation (to right) and Tober Colleen Formation (to left). Contact  
marked by arrow. Unprocessed C&D waste in foreground.

- 5.25 The Waulsortian Limestones at the Central Quarry are overlain to the north and north-northwest by argillaceous limestones and mudstones / shales of the Tober Colleen Formation which dip steeply to the north-northwest, above the Waulsortian Limestones. The contact between the Waulsortian limestones and the Tober Colleen Formation is exposed in the sides of the roadway leading down into the Central Quarry.

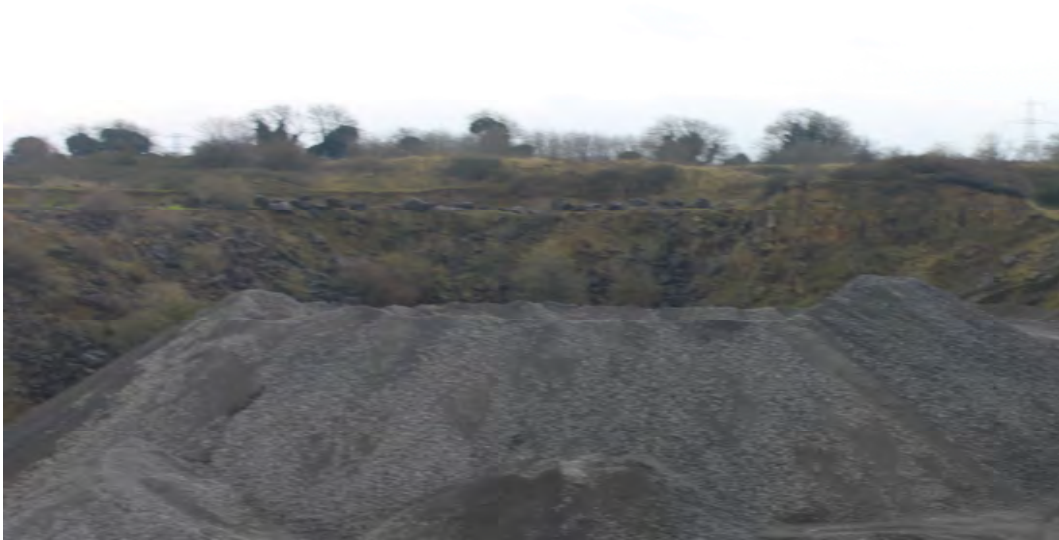
Plate 5-3 View to South-East across Central Quarry with processed C&D waste / recycled aggregate stockpiled in foreground

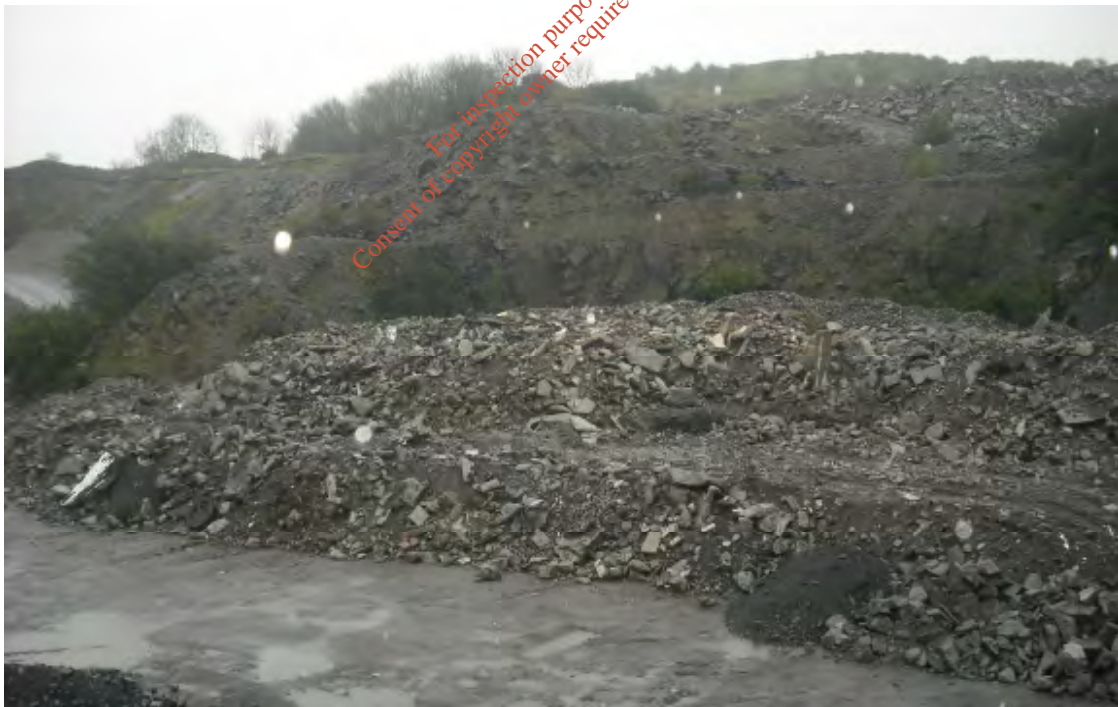
Plate 5-4 View to South across Central Quarry with unprocessed C&D waste stockpiled in foreground
