***MONTHLY DUST MONITORING***  
***AT THE***  
***MILLTOWN COMPOST SITE,***  
***MILLTOWN MOR, FETHARD,***  
***CO. TIPPERARY.***  
***JULY 2017***  
***W0270-01***

**Ref: Dust Monitoring 2017**

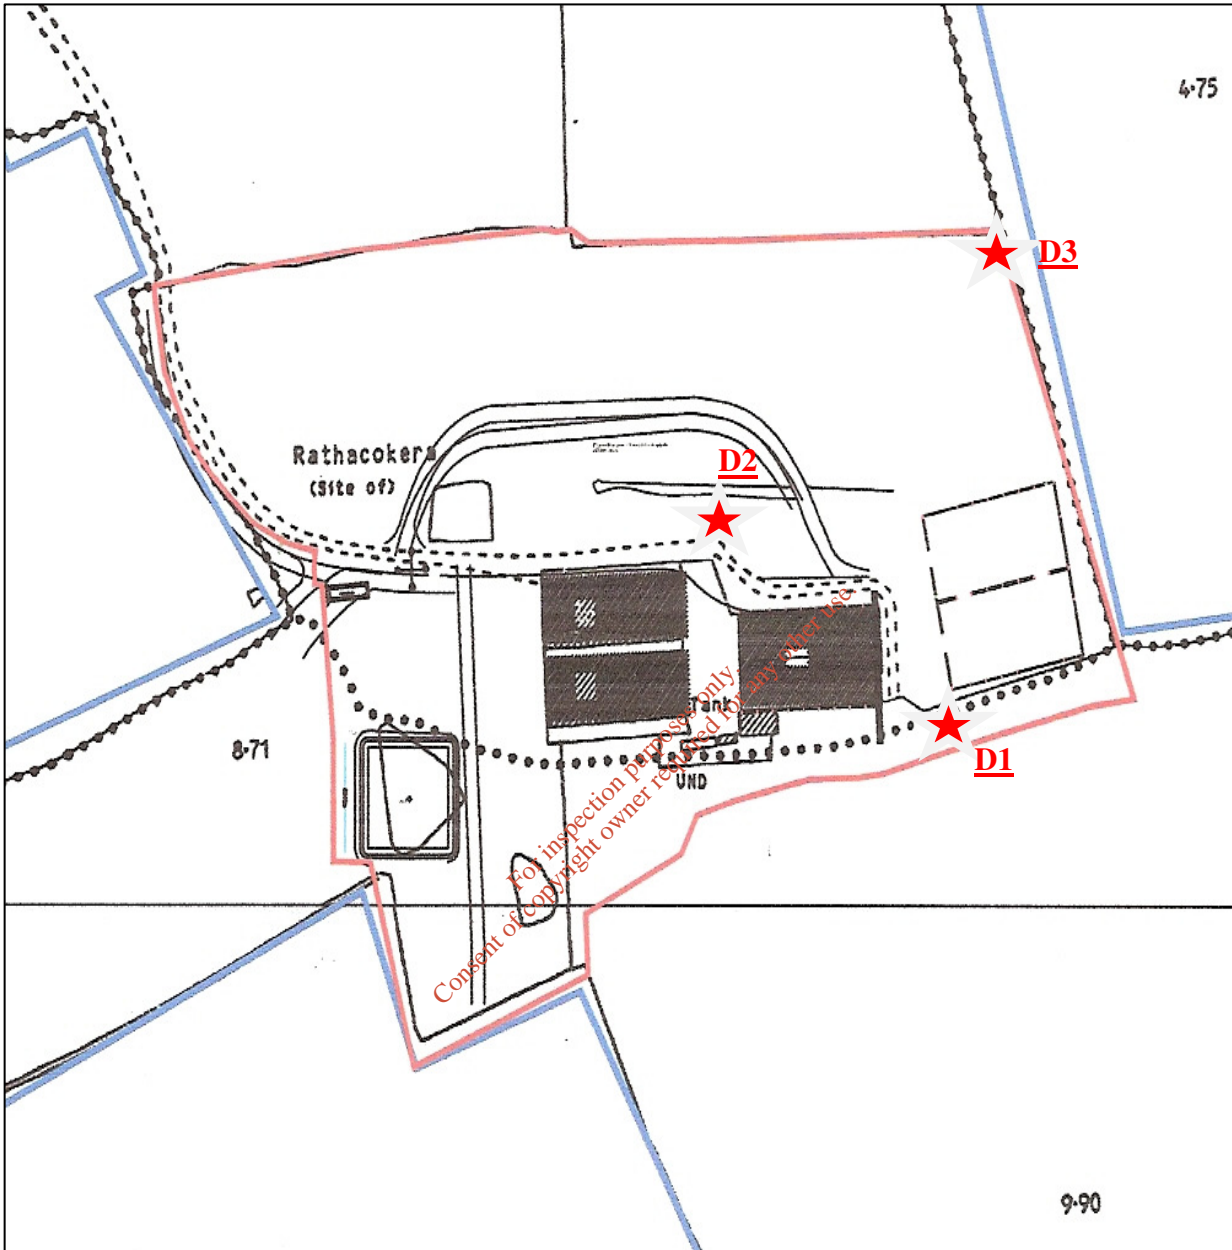
**Appendix 1**  
**Dust Monitoring Location Map**

Measurement No.	Location
D1	On ditch south of the main processing area.
D2	Opposite site offices.
D3	On northeastern boundary of site.
