SNC
Environment

**Scariff Civic Amenity Centre - Independent Closure Audit
Report for Waste Licence W0150-01**

22nd February 2016

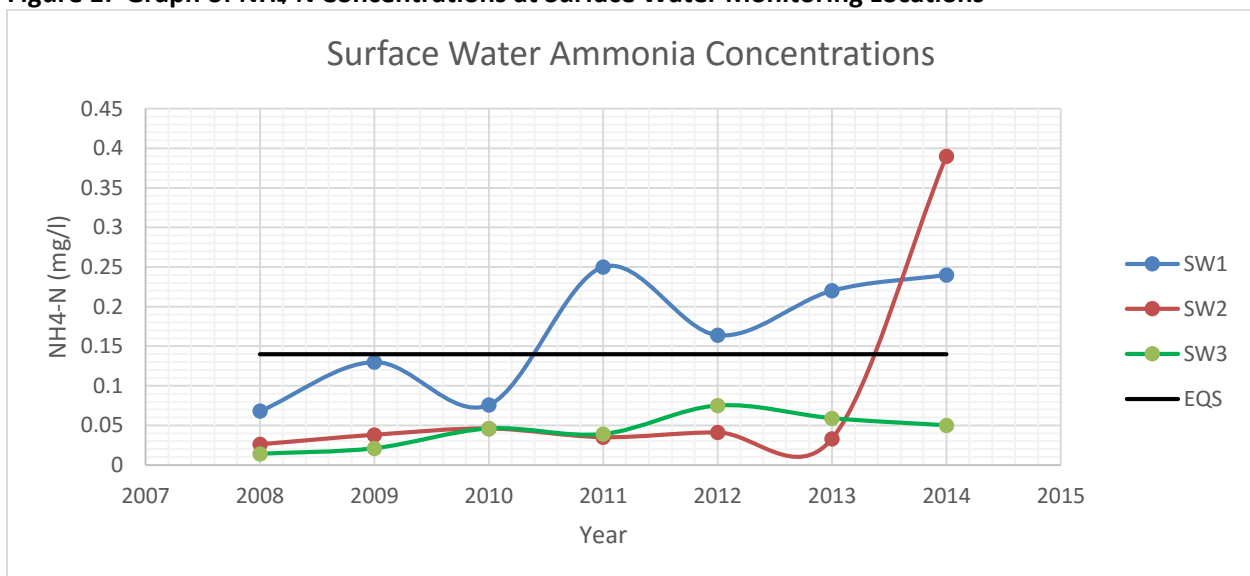
Figure 1: Graph of NH₄-N Concentrations at Surface Water Monitoring Locations

The sample results indicated that although the concentrations of NH₄-N were slightly elevated at the site discharge between 2008 and 2014 it was not having an impact on downstream water quality at SW3 where NH₄-N concentrations were consistently less than the regulatory limit, see Figure 1. The only potential source of NH₄-N from onsite activities would be from the compactor but the site layout design indicates that leachate runoff from the compactor should enter the drain into the septic tank system. SW2 (Upstream) did show an increase in NH₄-N concentration in 2014, this may be due to runoff from other sources upstream of the site.

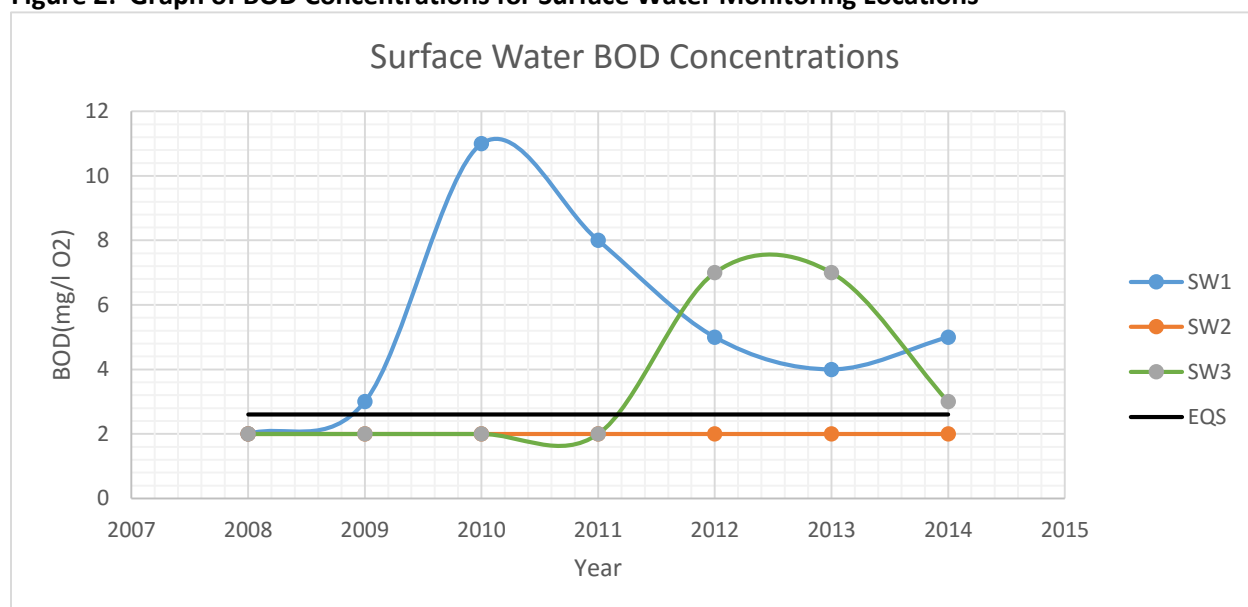
Figure 2: Graph of BOD Concentrations for Surface Water Monitoring Locations

BOD concentrations greater than the Environmental Objectives (Surface Water) Regulations, 2009 value of 2.6 mg/l were observed at SW1 (2009-2014) and SW2 (2012-2014). The downstream location (SW3) contained concentrations of BOD less than the laboratory method detection limit of 2 mg/l O₂. The BOD concentrations trends from 2008 to 2014 at all surface water sampling locations are outlined on Figure 2 below.

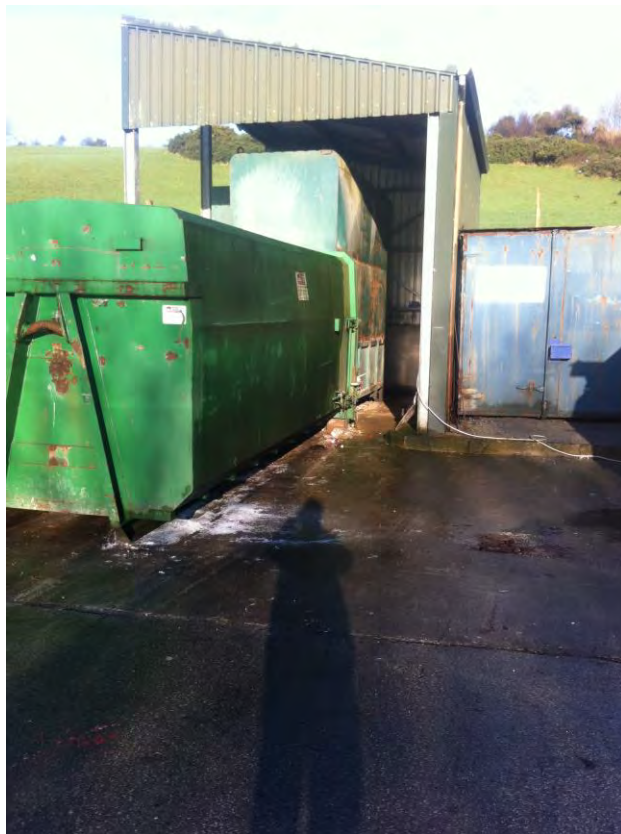
Photograph 4: Compactor Unit with associated Road Gully.

During the site walk over and closure audit the site was inspected for litter control and cleanliness. The site was generally clean with some windblown paper etc. there was no staining observed under the compactor. A black residue was observed on the concrete floor of the lower yard which appears to be melted bitumen. Photos of the site conditions during the site walkover are provided in Attachment 1.

The waste water drainage system was observed and the flow identified as outlined in Drawing No. 01 in Attachment 2. The system collects water from the site office and the road gully at the site compactor unit. The sample analysis results from December 2015 and January 2016 did not identify any significant impact to waste water quality prior to discharge to the percolation area. It is recommended that scheduled de-sludging of the septic tank system be completed and annual sampling be completed to ensure optimum system operation. All results should be logged and filed on site.

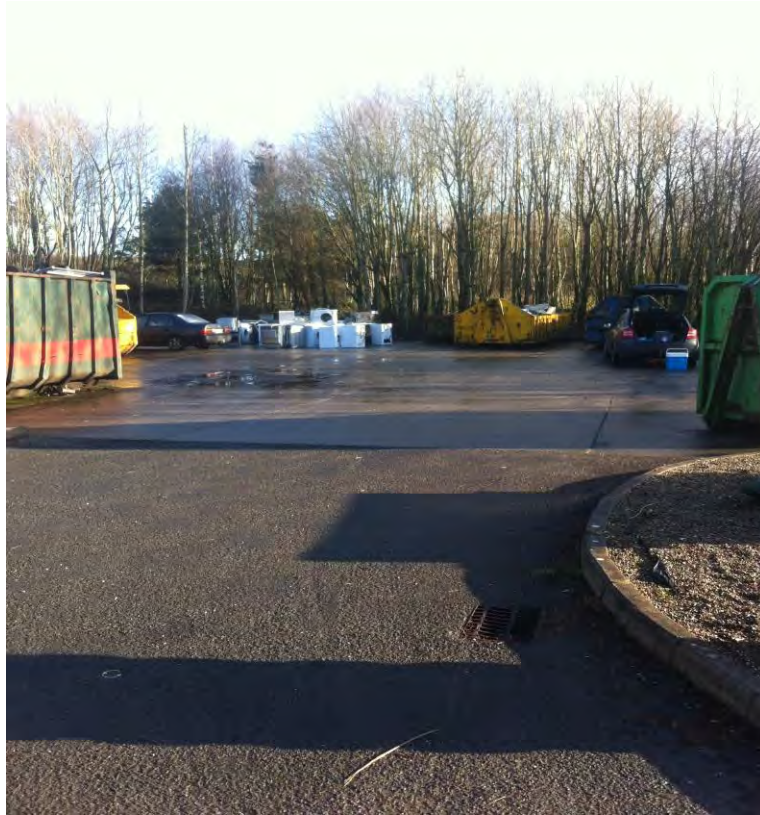
Photograph 5: Lower yard Area – White Goods & WEEE Storage

During the site visit in December 2015 it was observed that there were white goods stored in close proximity to the storm water drains. As a result the surface water sample from SW1 were tested for metals and concentrations of all parameters were less than the applicable regulatory limits and guideline values. Additionally the surface water sample was analysed for hydrocarbons, BOD and COD. The results were all less than the surface water regulatory limits and guideline values. The sampling event on December 8th indicated that surface water discharge from the Scariff site was not having a negative impact on surface water receptors.

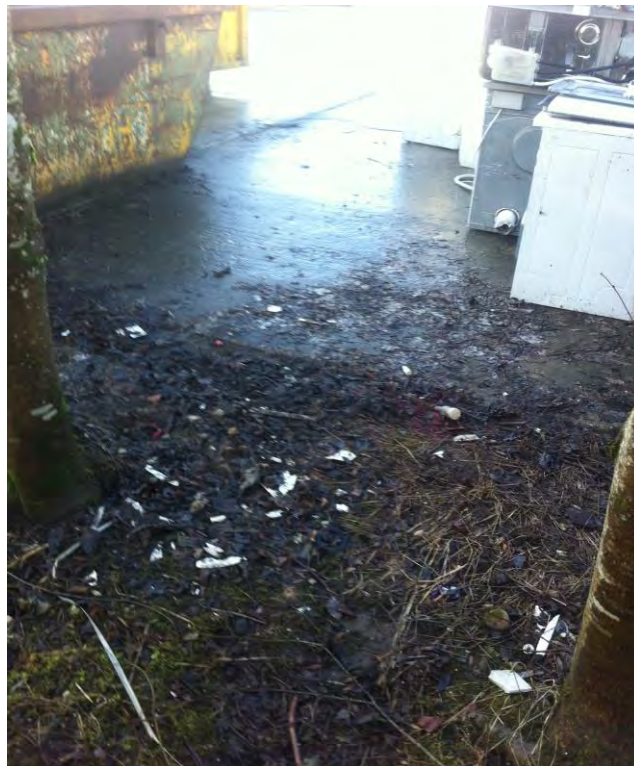
Photograph 6: Soil Sample Location at Edge of Missing Curbing on East Boundary

The results indicated that all metals concentrations in the surface soil sample collected east of the missing curbing on the eastern perimeter of the yard in December 2015 and January 2016 were all significantly less than the Dutch Action limits, with some metals concentrations (i.e., arsenic, cadmium, copper, mercury and nickel) also less than the Dutch Optimum Limits.

Soil samples collected in December 2015 from the wooded area immediately to the east of the missing curbing indicated extractable petroleum hydrocarbon (EPH) concentrations (i.e., 1,644 mg/kg in SS-01 and 341 mg/kg in SS-02) greater than the Dutch Optimum Limit but less than the Dutch Action Limit. To assess if the concentrations of EPH may have been influenced by natural organic interference a second round of soil sampling was completed at the same locations in January 2016 with silica gel clean-up applied as part of the analysis. The results indicated that surface soil to the south contained EPH concentrations (i.e., 49 mg/kg) less than the Dutch Optimum Limit of 50 mg/kg and surface soil to the east contained EPH concentrations (i.e., 61 mg/kg and 57 mg/kg) marginally greater than the Dutch Optimum Limit of 50 mg/kg but significantly less than the Dutch Action Limit of 5,000 mg/kg.

It was also observed that there was curbing missing at the eastern and southern boundaries of the yard close to WEE and white goods storage areas. Surface soil sampling results indicated that soil quality was not impacted and the concentrations of contaminants of concern were significantly less than the Dutch Action Limits and most parameters were less than the Dutch Optimum Limits indicating that surface water runoff in the vicinity of the missing curbs had not impacted soil quality. It is recommended that the curbing be repaired and sealed to prevent surface water migration from the concrete surface to ground.

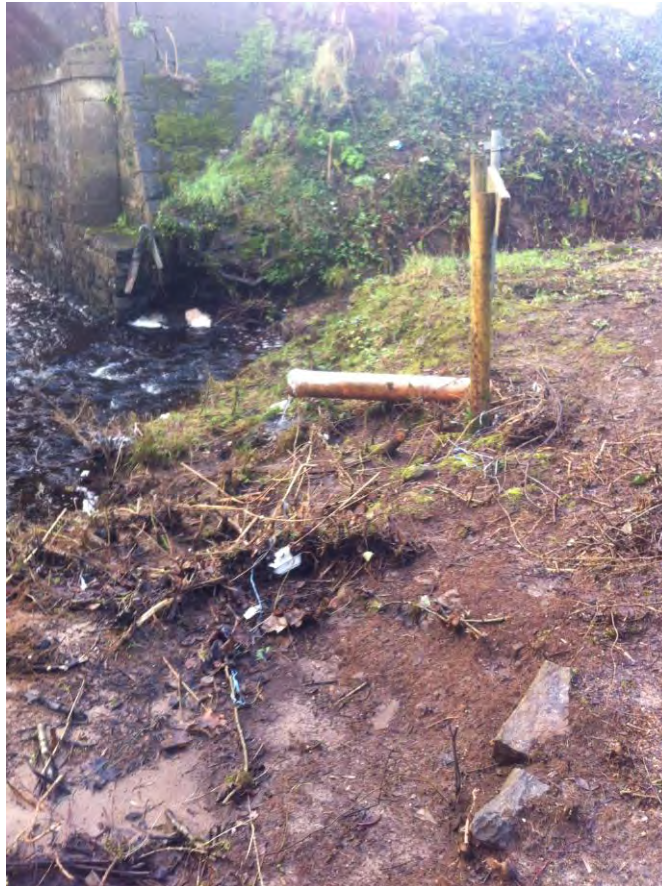
Photograph 8: Surface Water Discharge at SW1

Surface water is directed to one central manhole before discharging to the surface water receptor at SW1. As part of the site visit/closure audit surface water samples were collected on December 7th 2015 and January 19th 2016 to assess surface water quality discharge from the site (SW1) and surface water quality upstream and downstream of the site (SW2 and SW3). It should be noted that sampling at SW2 and SW3 could not be completed in December 2015 as the Cappaghabaun River was flooded and the sample for SW1 was collected from a surface water manhole located immediately up gradient from SW1.) The samples collected in December 2015 from the SW1 outlet was submitted for metals and hydrocarbons analysis to assess concentrations in surface water runoff from the site. Samples collected from SW1, SW2 and SW3 in January 2016 were submitted for analysis for parameters required under Schedule D.3 of the site Waste Licence. The results for the sampling completed in December 2015 are presented in Table 4-A and the results for the sampling completed in January 2016 are presented in Table 4-B. All samples were submitted to an accredited laboratory for analysis.

The surface water drainage system was observed and the flow identified as outlined in Drawing No. 01 in Attachment 2. However, no oil/water interceptor was found on site as required under the licence conditions. Although the historical surface water sample results and the results of the sampling completed in December 2015 and 2016 did not identify any significant impact to surface water quality

from surface water discharge from the site it is recommended that a bypass interceptor system that meets EN 858 be installed in the surface water drainage system prior to SW1.

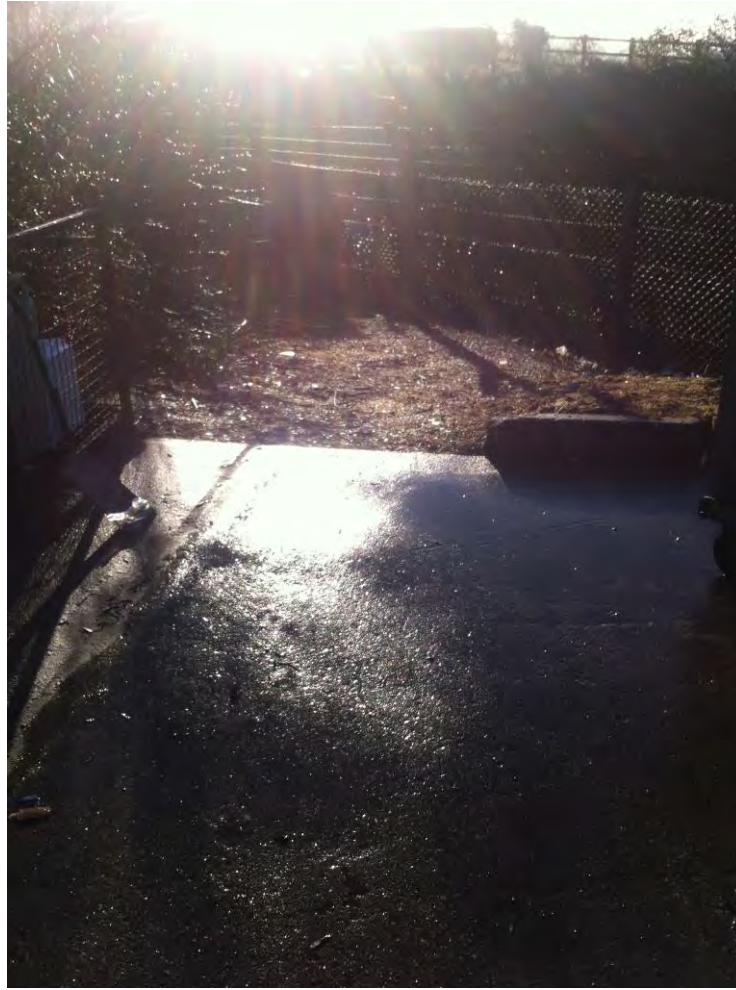
Photograph 9: Soil Sample Location at Missing Curbing at South Boundary

The results indicated that all metals and hydrocarbon concentrations in the surface soil sample collected south of the missing curbing on the southern perimeter of the yard (SS16-S01-South) were less than the Dutch Optimum Limits.

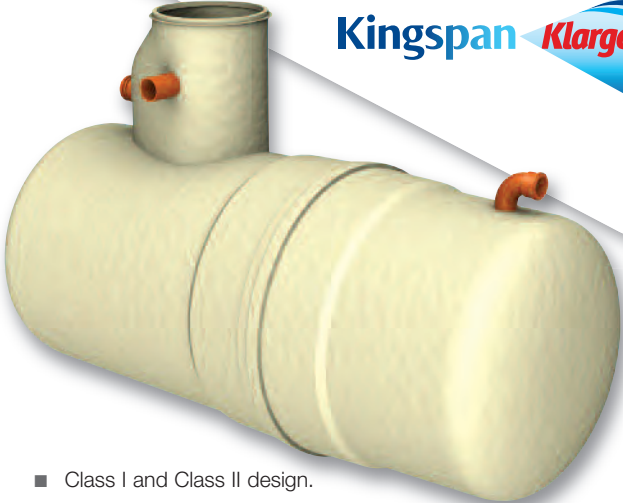
Forecourt

The forecourt separator is designed for installation in petrol filling station forecourts and similar applications. The function of the separator is to intercept hydrocarbon pollutants such as petroleum and oil and prevent their entry to the drainage system, thus protecting the environment against hydrocarbon contaminated surface water run-off and gross spillage.
