**DUNSINK LANDFILL, DUNSINK LANE, FINGLAS, CO. DUBLIN**

**ANNUAL ENVIRONMENTAL REPORT 2017**

**WASTE LICENCE REG. NO. W0127-01**

**MARCH 2018**

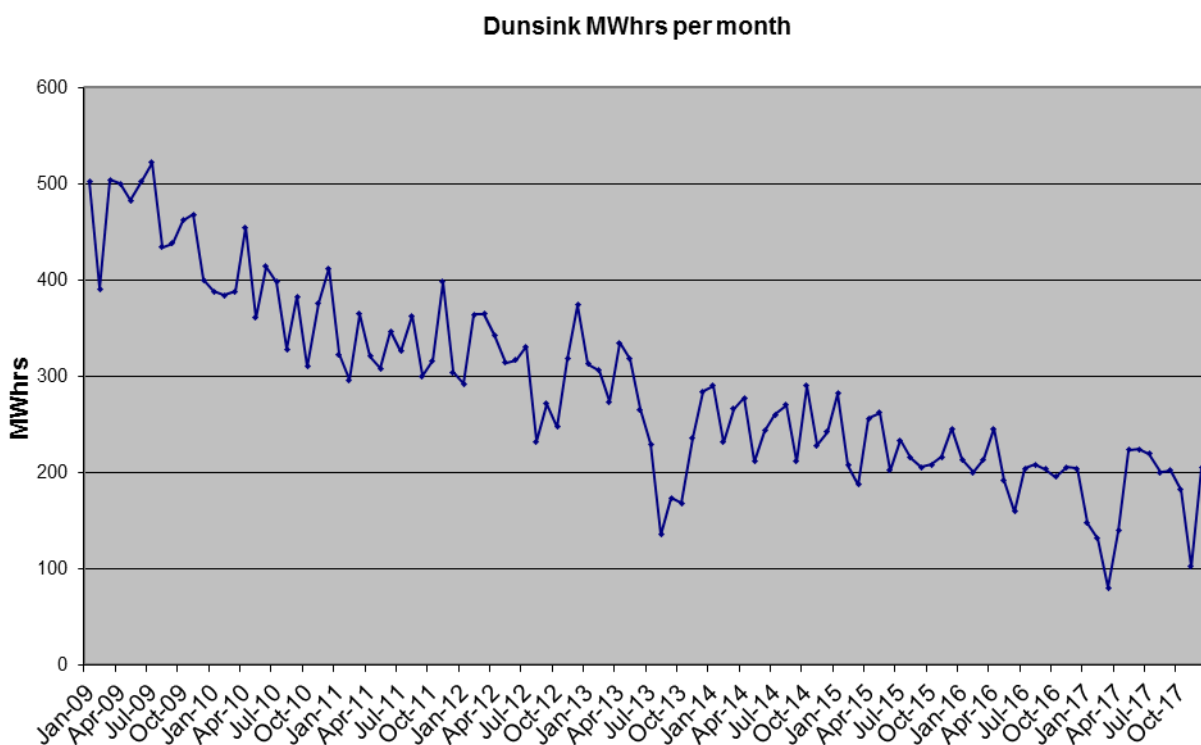
**Figure 12.1: Dunsink Landfill Gas Utilisation Plant**

Figure 12.1 shows the electricity production from landfill gas at Dunsink since 2009 and Table 12.2 shows the resources used and generated by the landfill gas utilisation plant.

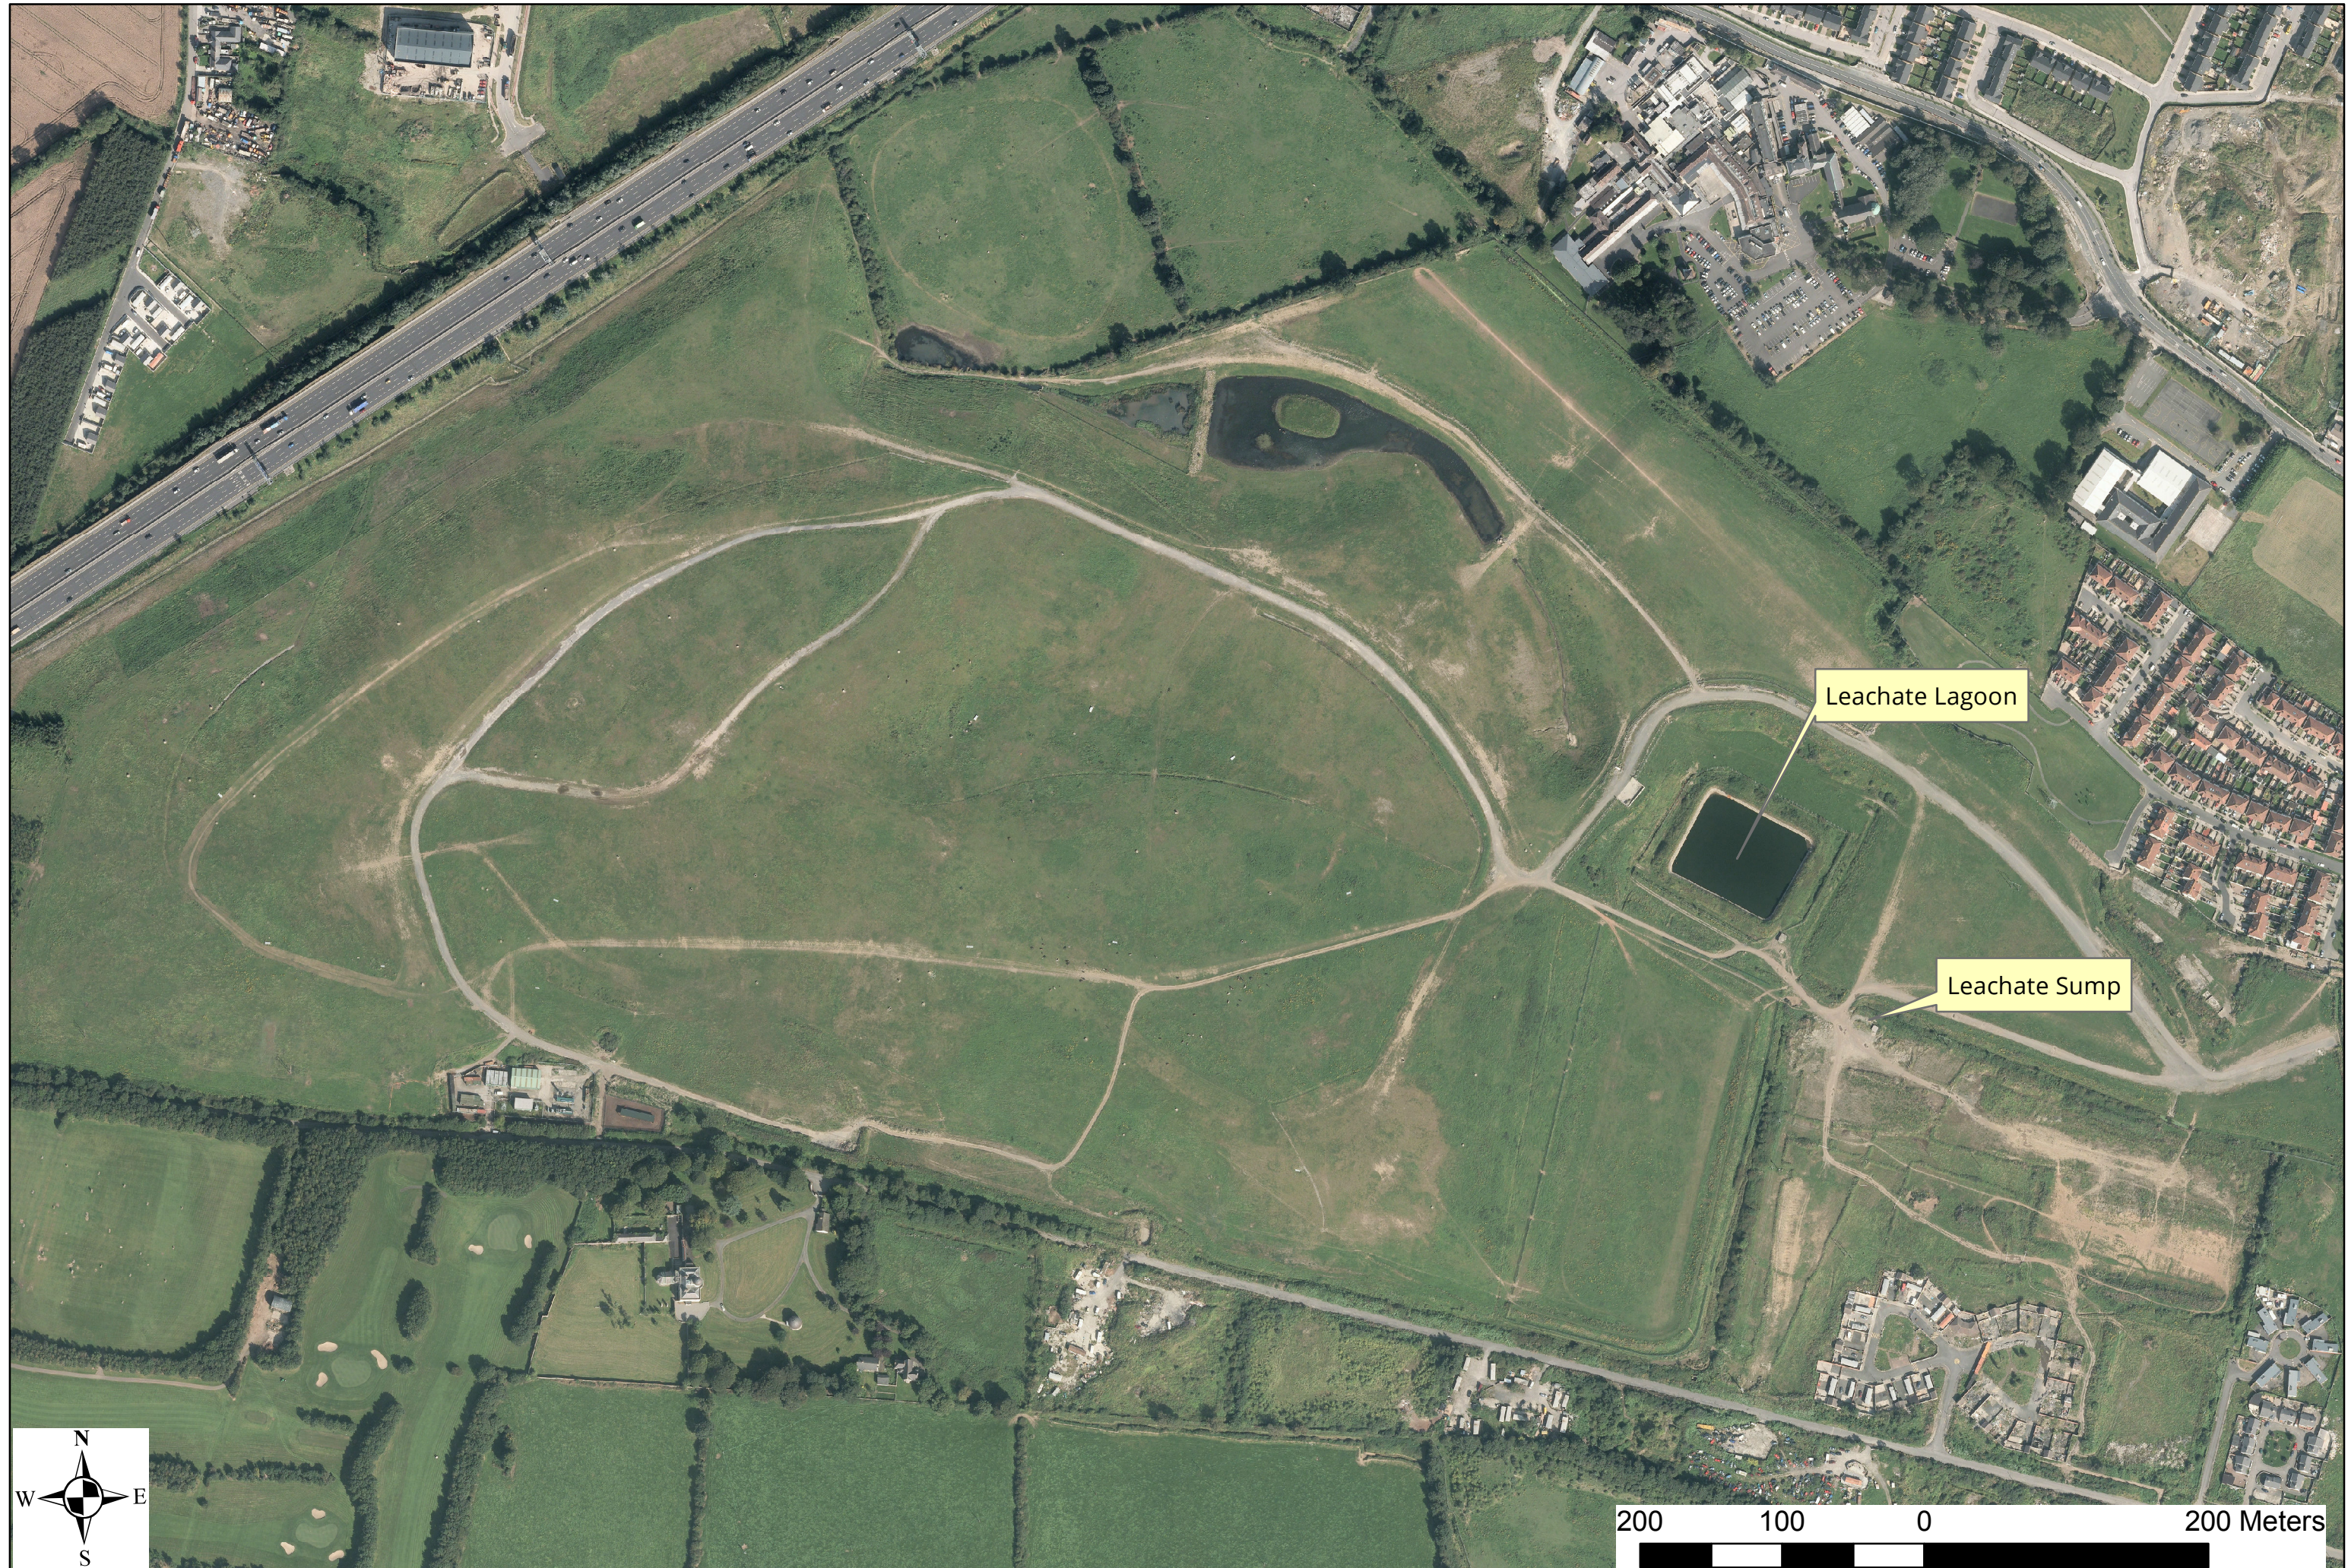
# Leachate Monitoring Locations at Dunsink Landfill

Leachate Lagoon

Leachate Sump
