**ANNUAL ENVIRONMENTAL REPORT FOR
ARTHURSTOWN LANDFILL, KILL, CO. KILDARE**

1ST JANUARY 2017 – 31ST DECEMBER 2017

WASTE LICENCE NO: W0004-04

Client: South Dublin County Council

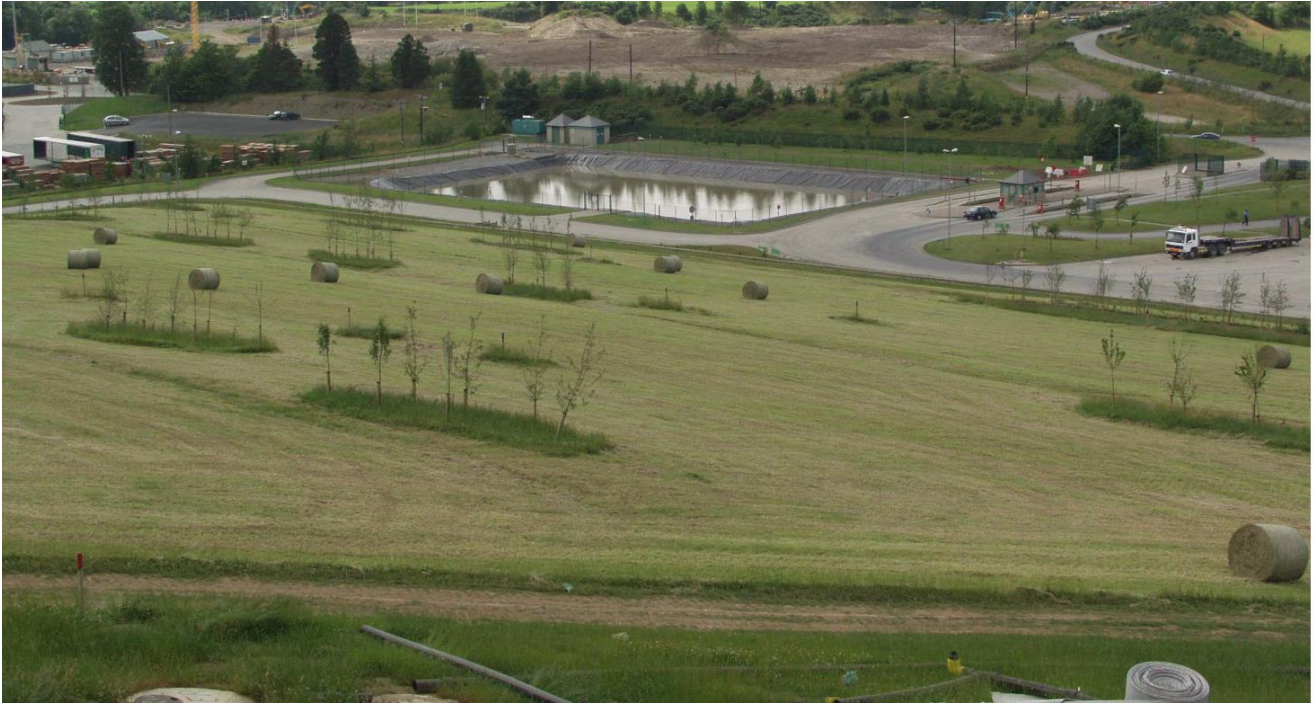
Final capping is now complete and this was achieved during the final quarter of 2013.

Figure 2-1: Completed Landfill Cap at Arthurstown

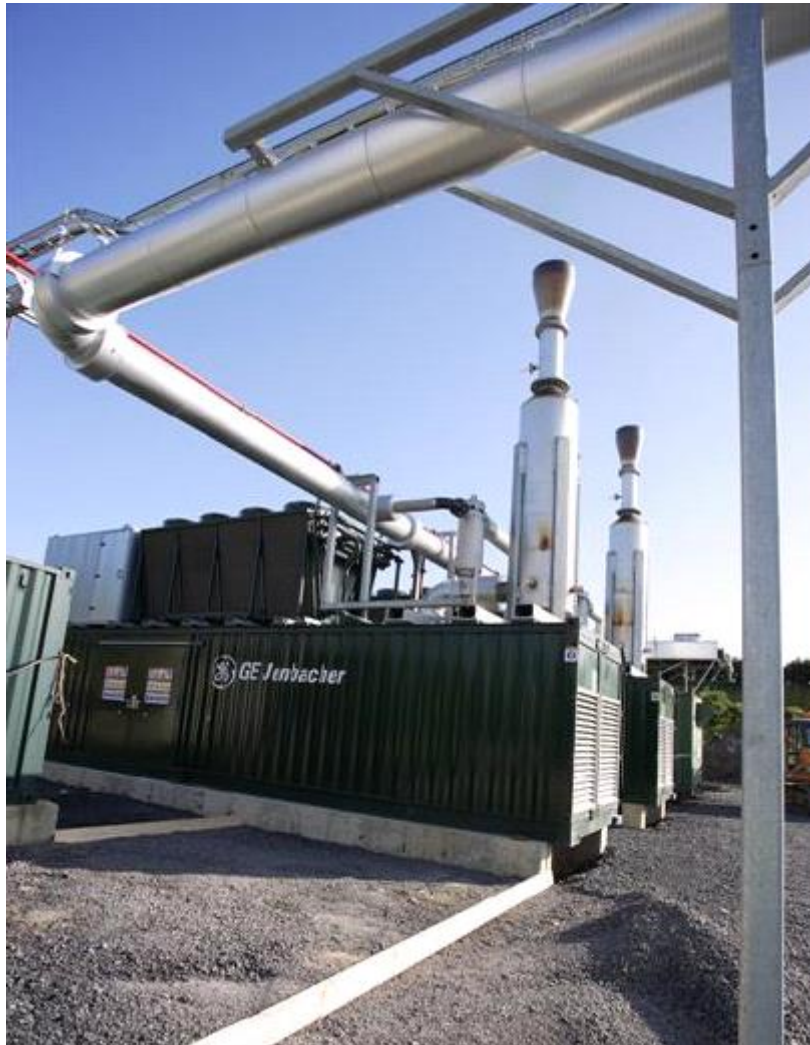
The Landfill Gas Utilisation Plant commenced operations April 2004 with three no. Jenschacher landfill gas engines. Over time, 4 no. enclosed flares were installed and a further 8 no. engines. This accommodated the peak gas capture in 2007 of 13,500 m³/hr. In 2017 there were 5 no. operational engines with 2 back up flares. There are an additional 2 no. enclosed flares on site. The 5 engines do not run continuously, generally 3 of the 5 engines running full time and 2 engines in maintenance. By the end of 2017, the number of operational engines on site reduced to 4 (1.4 MW). Therefore, stack emissions testing was carried out on the 2 flares and 4 engines that were operational on the day of sampling.

Figure 3-2: Landfill Gas Utilisation Plant at Arthurstown

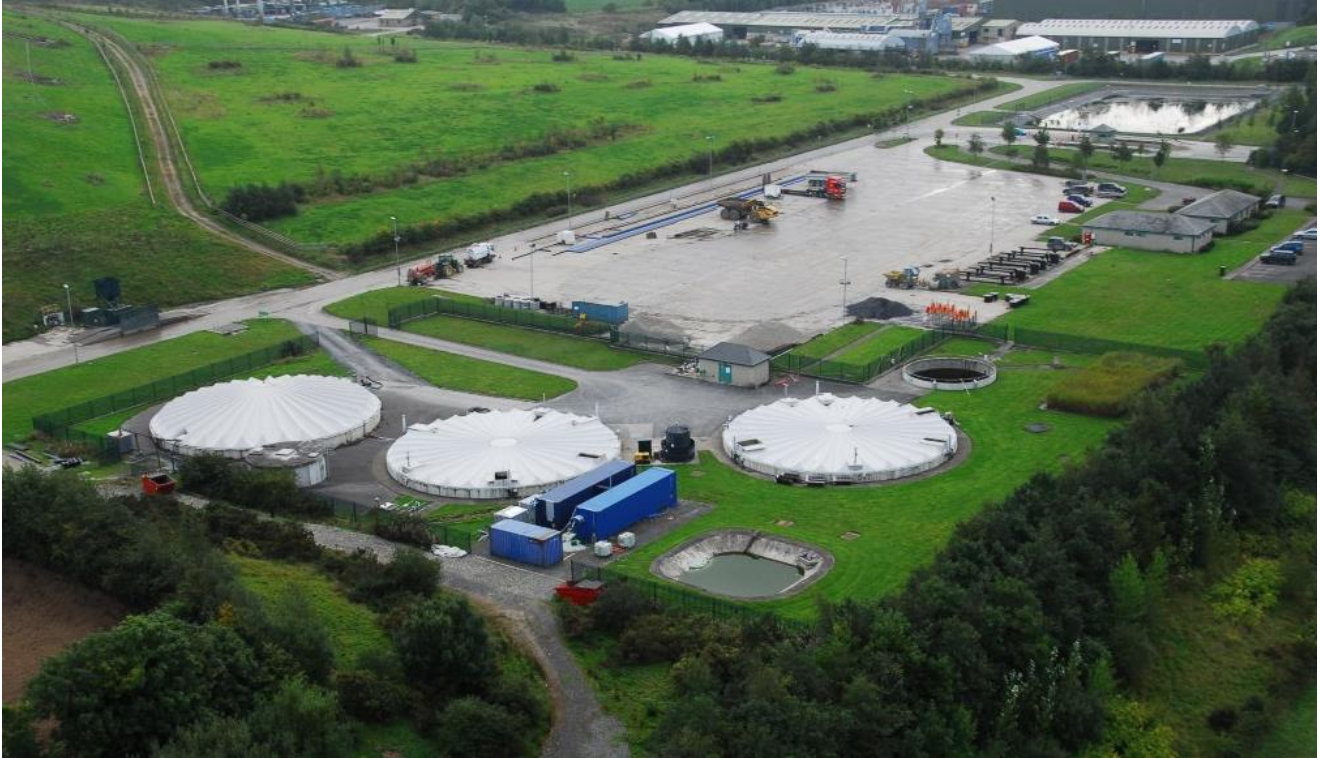
In 2017, leachate was collected from the waste cells and pumped to the leachate tanks on site. Following this, treated leachate was discharged via the local sewer to Osberstown WWTP with the permission of Kildare County Council and the Agency.

Figure 4-1: Leachate Treatment Plant

General maintenance of the site continues a regular basis including the maintenance of leachate pumps, the leachate treatment plant and all ancillary infrastructure and the landfill gas collection infrastructure.
