BALLEALLY LANDFILL, BALLEALLY, LUSK, CO. DUBLIN

ANNUAL ENVIRONMENTAL REPORT 2017

IED LICENCE REF. NO. W0009-03

MARCH 2018

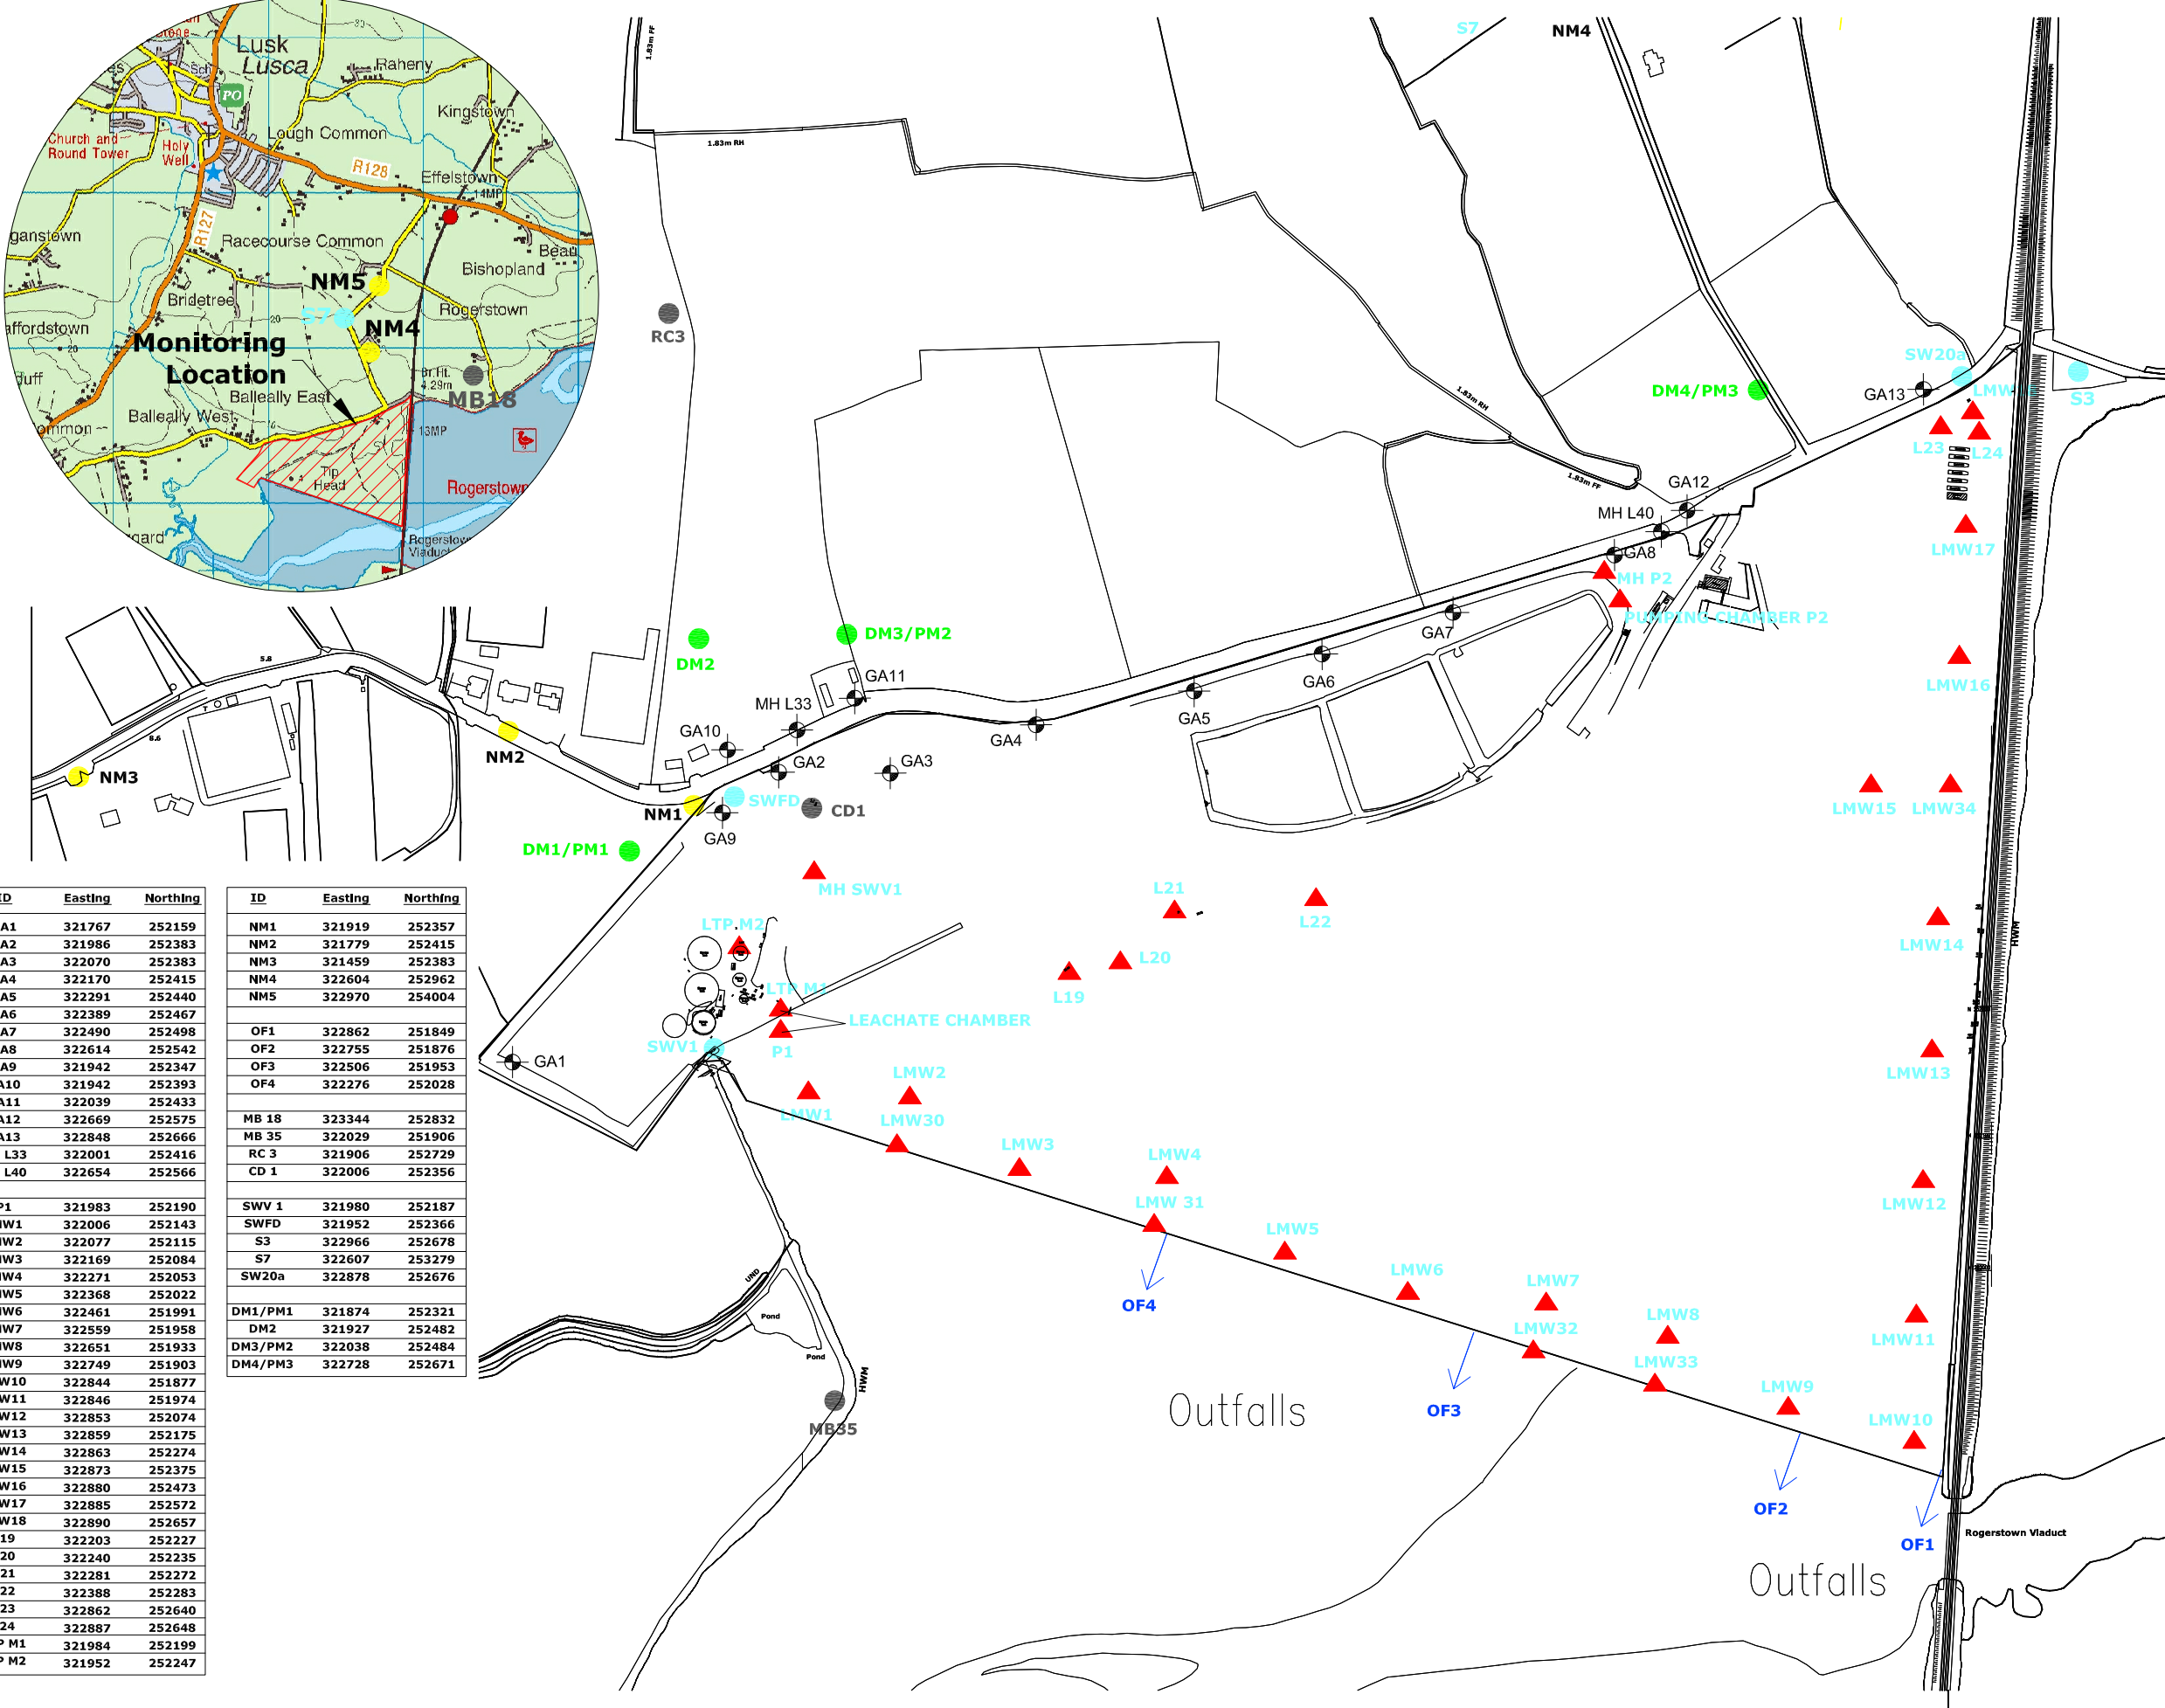
- KEY**
- NSL1 Noise Monitoring Location
 - AD1 Dust Monitoring Location
 - OF1 Outfall Location
 - 3d Groundwater Monitoring Location
 - SW1 Surface Water Monitoring
 - MG1 Gas Well Monitoring Locations
 - ▲ LM1 Leachate Monitoring Locations

Drawing Monitoring Locations (Figure 1) in Appendix 1 is a map of the facility and the monitoring locations.

The landfill site covers approximately 50 ha in total. The east face of the landfill is bordered by the Dublin-Belfast railway line and the southern boundary is the Rogerstown Estuary. See Figure 1, Drawing DE07-164-03-001, Appendix 1.

Dust monitoring was carried out at 4 locations in accordance with Schedule D of the licence. The locations of these monitoring points are shown on Balleally Monitoring Locations Map, Appendix 1.

The licence requires monthly monitoring of perimeter gas boreholes/vents/wells. The location of the 13 no. monitoring positions is shown on Balleally monitoring Locations Map, Appendix 1.

The sample locations can be seen in Drawing Balleally Monitoring Locations Map, Appendix 1. There are 5 no. surface water monitoring locations.
