**EAST GALWAY LANDFILL**

**EPA IED LICENCE W0178-02**

**ANNUAL ENVIRONMENTAL REPORT**

**JANUARY 2017 - DECEMBER 2017**

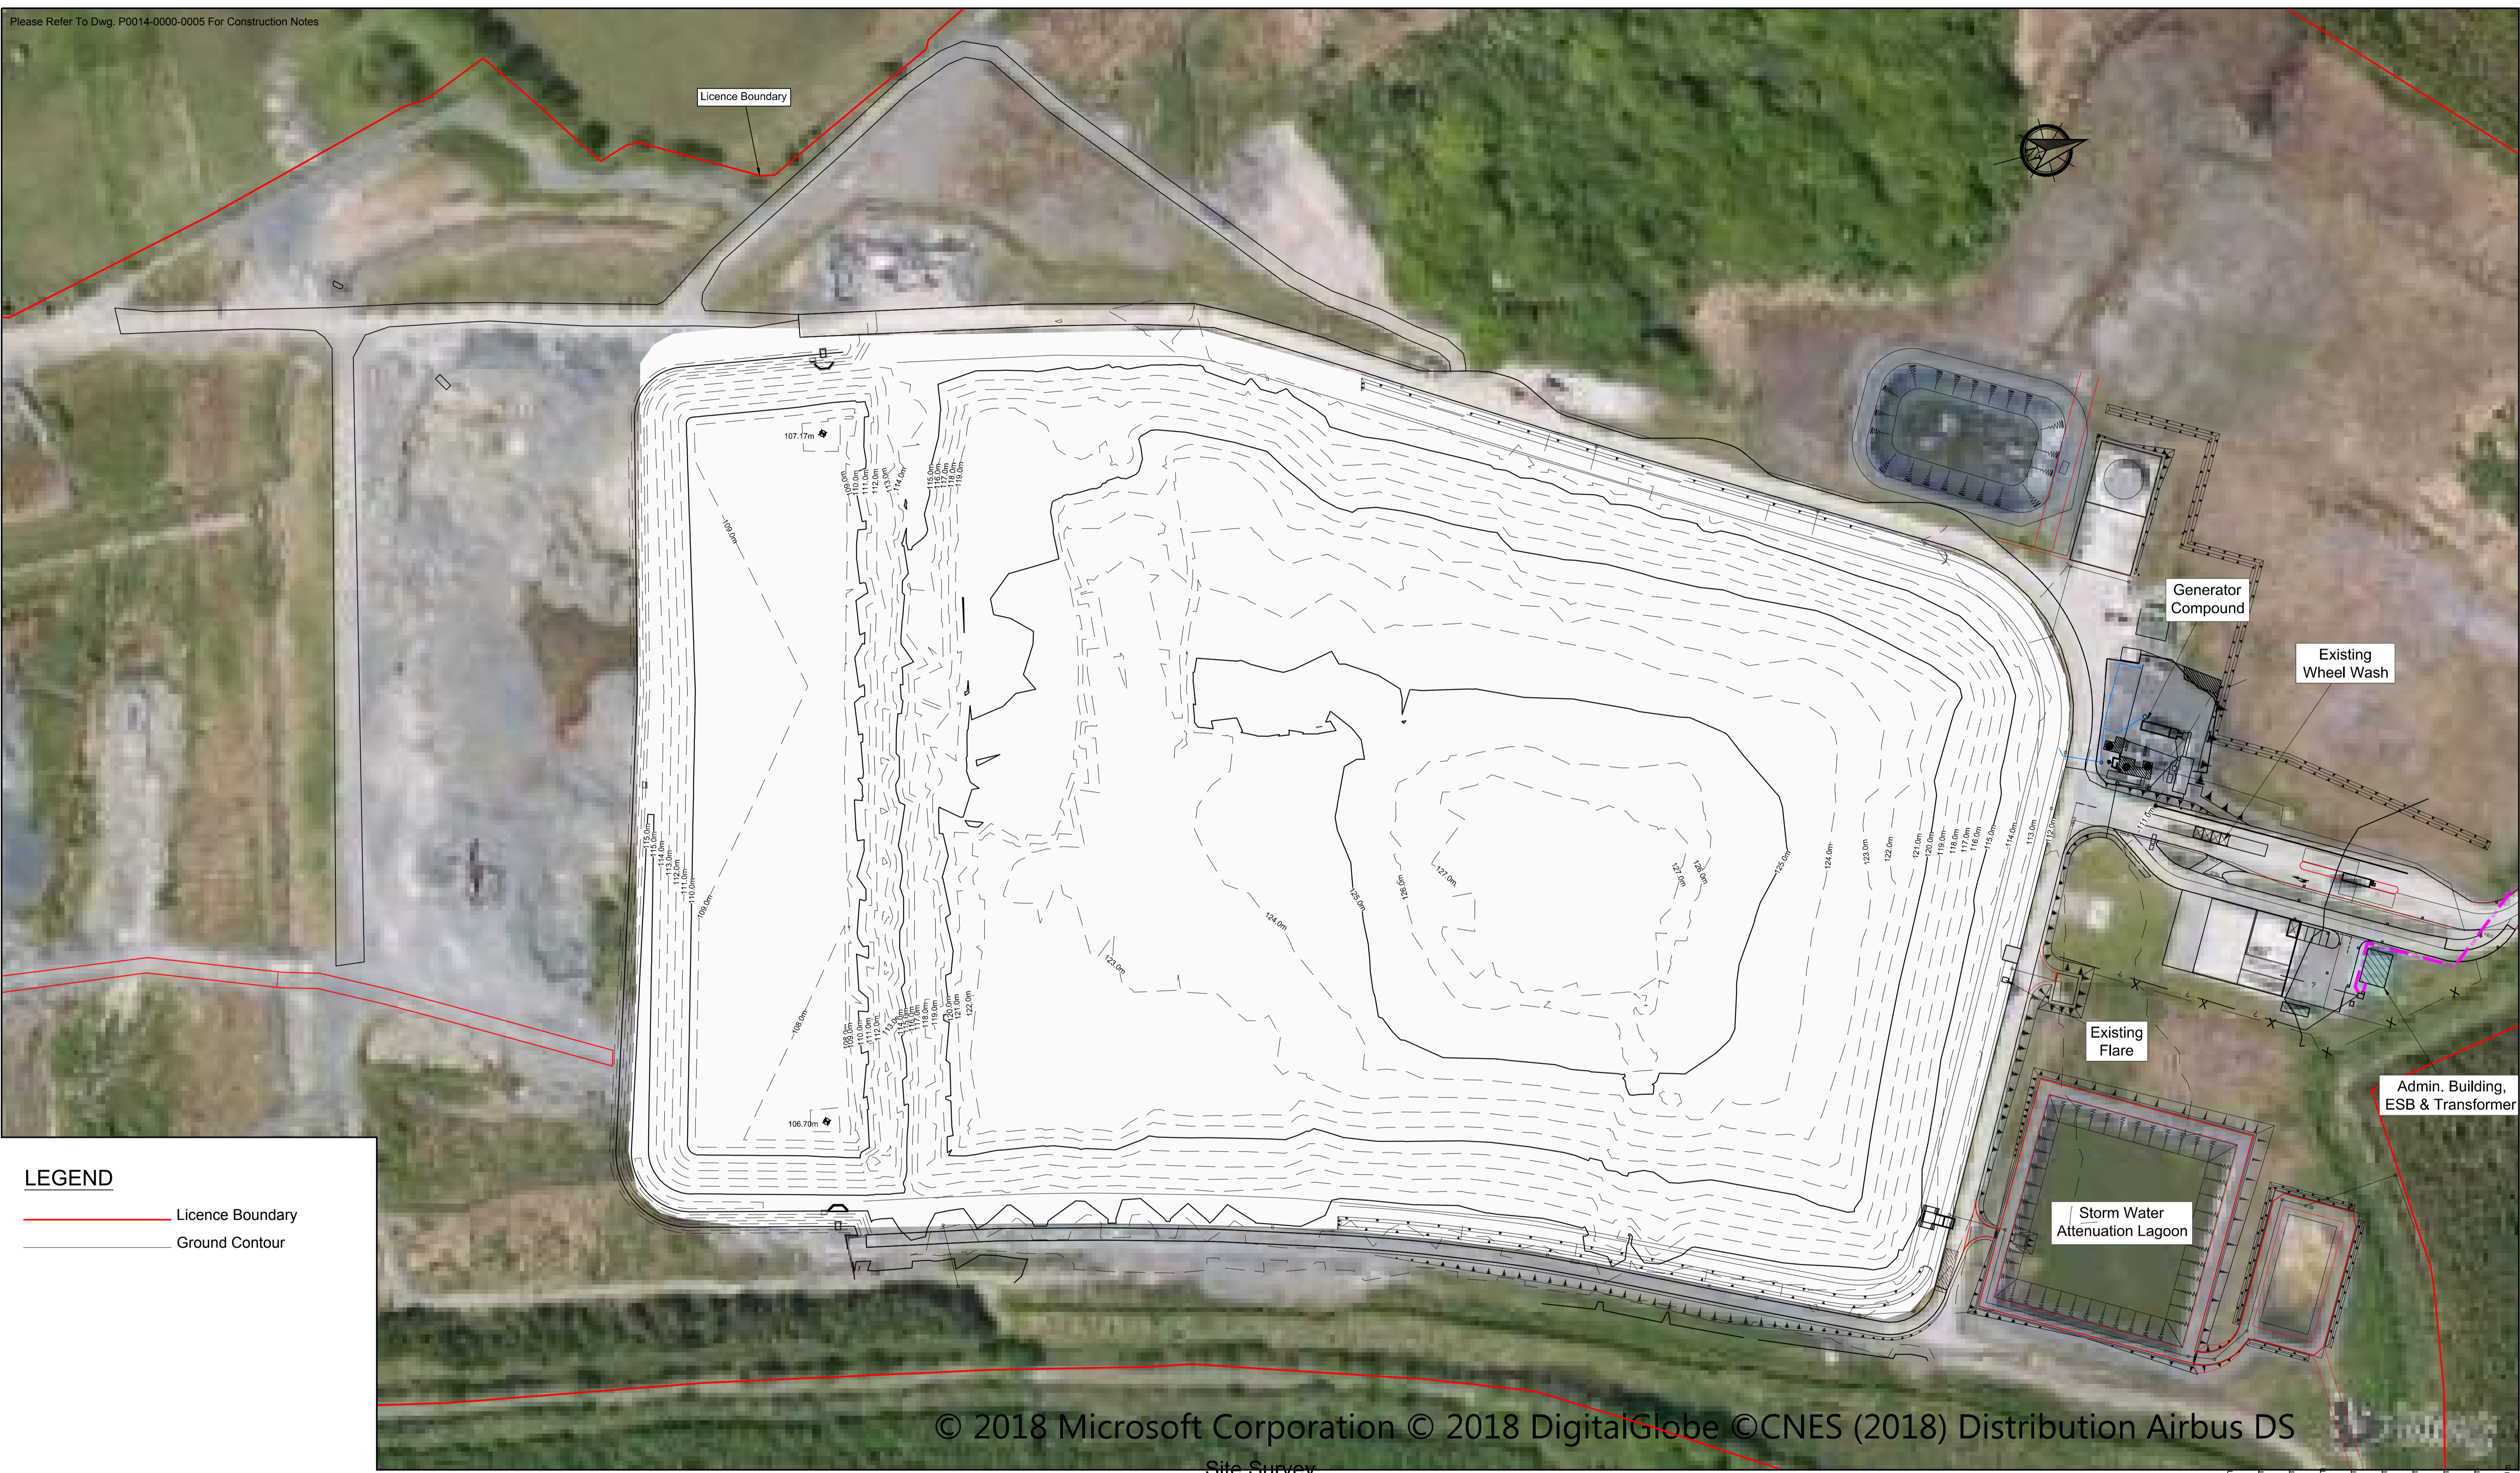
## Topographical Survey

As per condition 8.7 of the licence, a survey showing the topography of the facility at the end of the reporting period is included in Appendix C.
