# Corranure Landfill W0077-04 Annual Environmental Report 2017

<b>Authors::</b>	Michelle Cass	Enviroguide Consulting
<b>Checked by::</b>	Jim Dowdall	Enviroguide Consulting
<b>Approved by:</b>	Cavan County Council	
<b>Document No:</b>		
<b>Version:</b>	00 Draft 1	
<b>Date:</b>	30 <sup>th</sup> January 2018

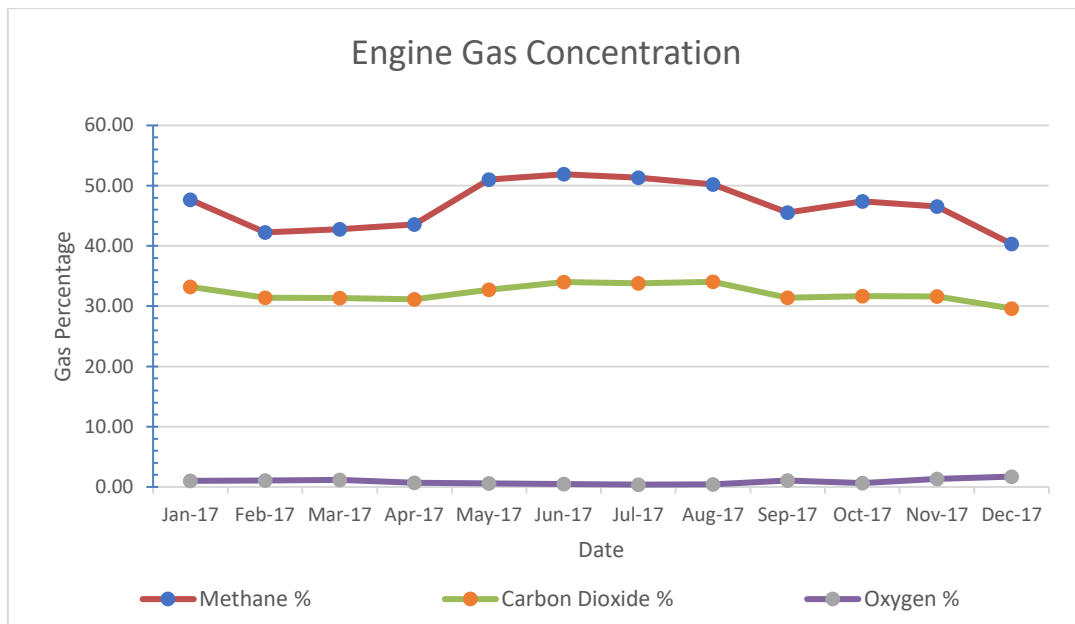
Figure 2: Gas Monitoring at Engine 2017

Average monthly concentrations for the flare and the engine are shown in Figures 2 and 3 below.

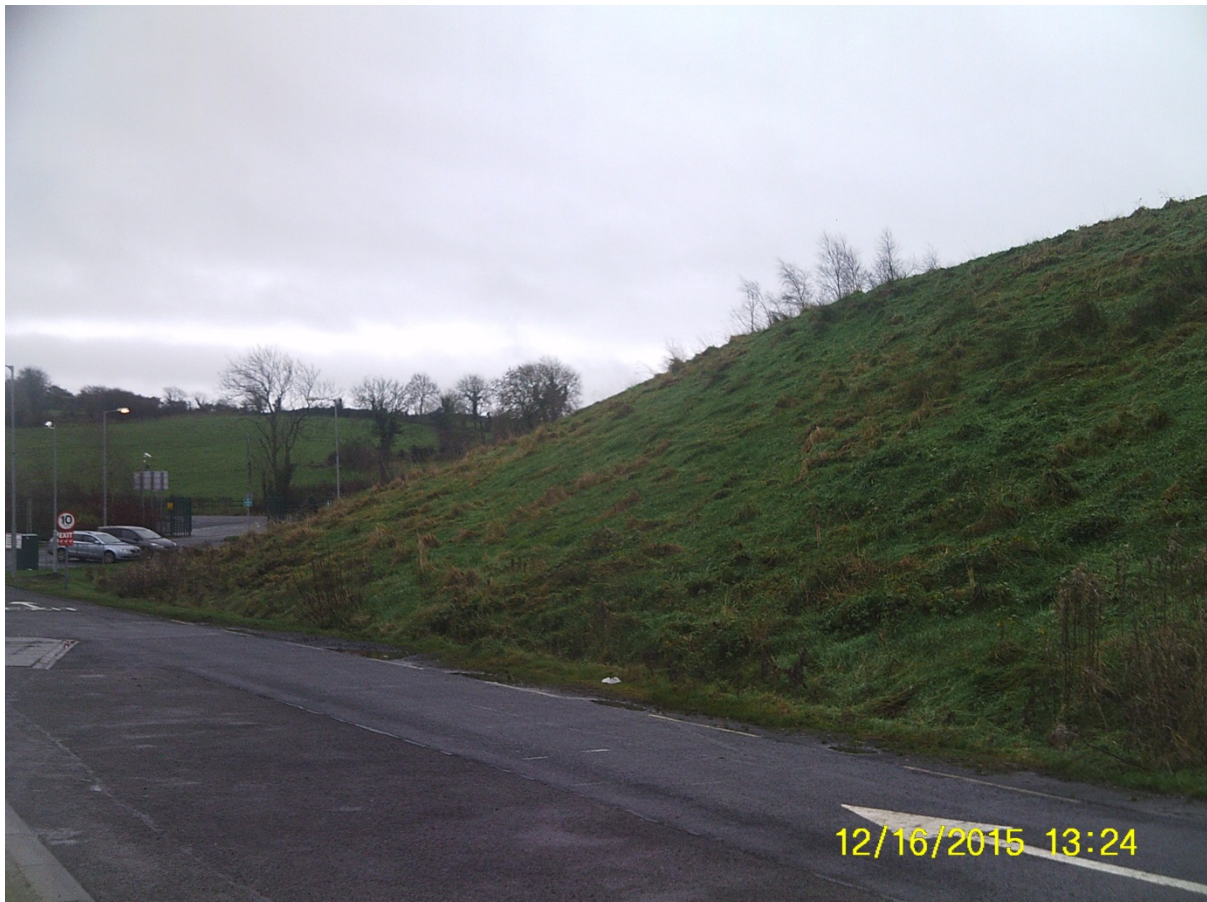
**Figure 1 – East Slope of Cell 0 (facing south from the recycling depot carpark)**

This slope, shown in **Figure 1**, is at an angle of about 1V:2H and is located adjacent to the site entrance. It is well vegetated with grass, rushes and gorse. A drainage channel at the toe of the slope appears to be operational and there were no obvious signs of ponding. There are no obvious signs of movement or distress visible at the surface of this slope.

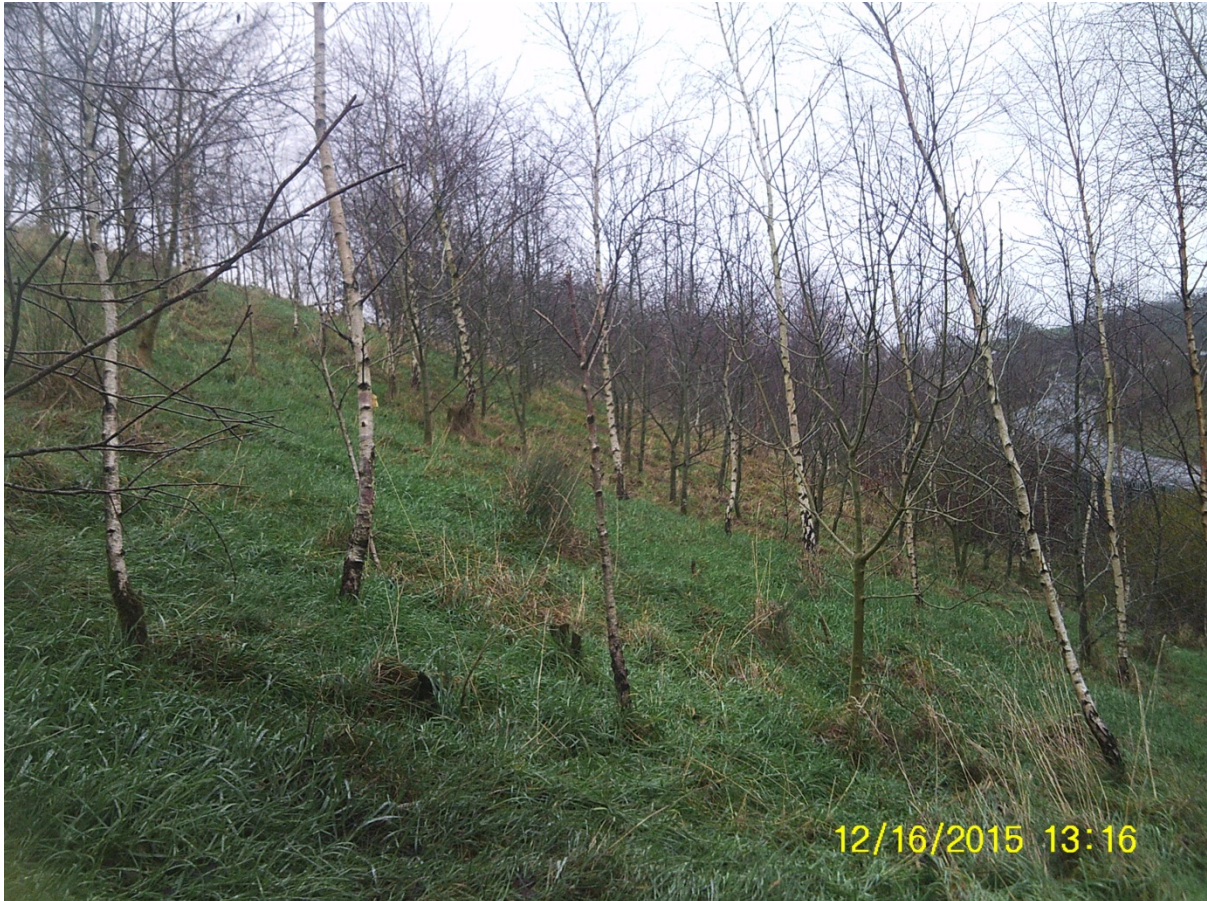
**Figure 2 – Southeast Slope of Cell 0 (facing northeast)**

The Southeast Slope is bounded by the R188 at the southeast edge of the landfill (refer **Figure 2**). The slope stands at an angle of approximately 1V:2.5H. It is well-vegetated with grass, rushes, gorse and small to medium sized trees. The drain at the toe of the slope appears to be functional but there was some minor ponding within the drain as a result of the recent heavy rainfall. There are no obvious signs of movement or distress visible at the surface of this slope.

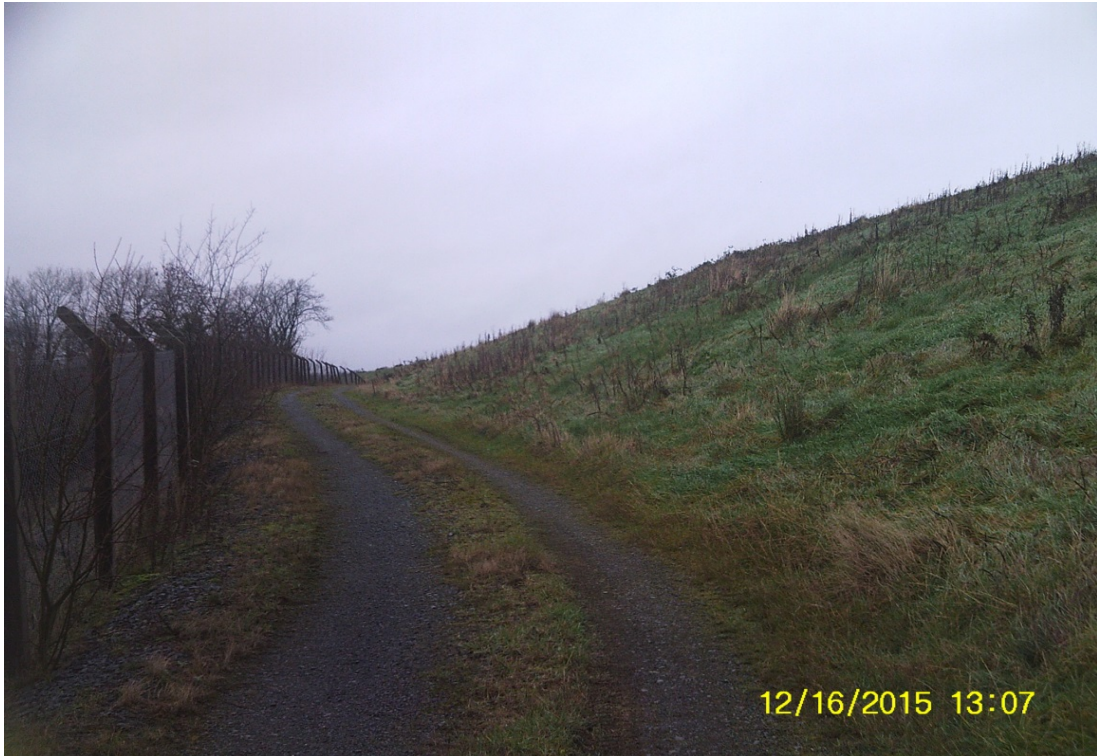
Figure 3 – Southwest Slope of Cell 0 (facing northwest from the southwest corner of the landfill)

The Southwest Slope, shown in **Figure 3**, is at an angle of approximately 1V:2H. The slope is well-vegetated with grass and rushes and it is hummocky in places. A haul road is located at the base of this slope. There is also a drainage channel on the downslope side of the haul road, between the road and the landfill boundary. The drain at the toe of the slope appears to be functional but there was some ponding within the drain as a result of the recent heavy rainfall (shown in **Figure 4**). There are no obvious signs of movement or distress visible at the surface of this slope.

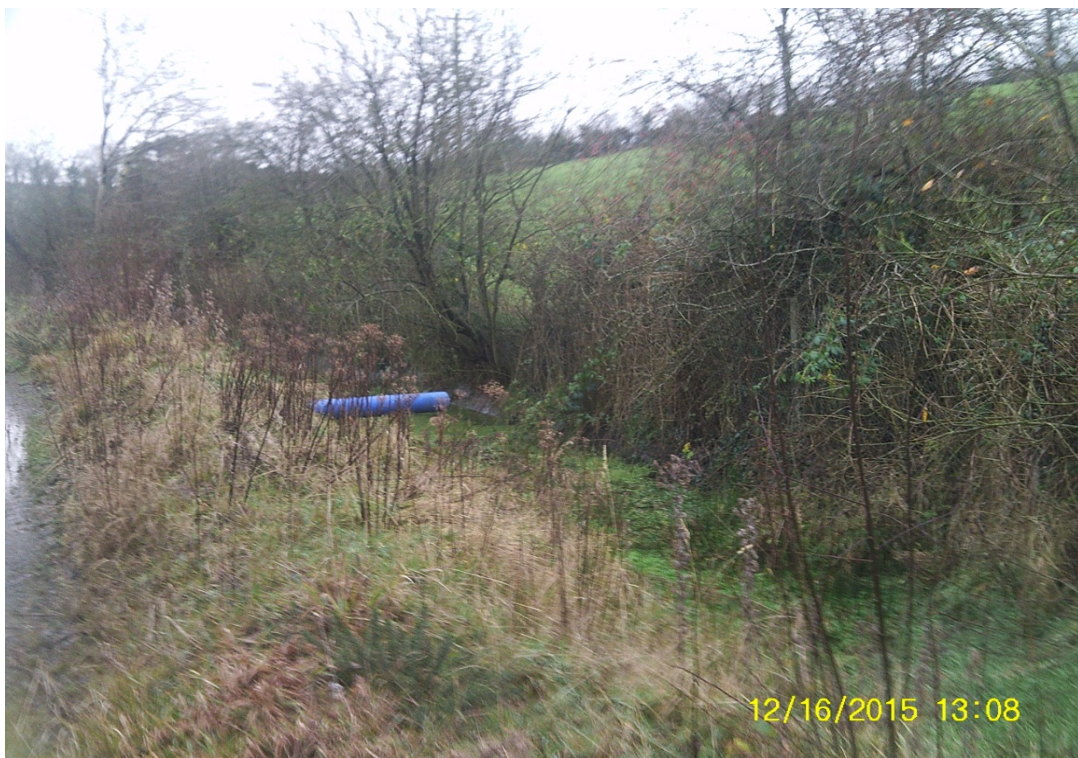
Figure 4 – Ponding in channel at the toe of the Southwest Slope of Cell 0 (facing southwest)

Ponding water was observed in a number of toe drains around the perimeter of the landfill. The ponding is likely the result of very heavy rainfall in the week preceding the site visit. Drains must be well maintained so that they can continue to allow water to efficiently flow away from the slopes. During any cleaning or other maintenance operations care must be taken not to excavate soil or vegetation from the toe of the slopes as this material may be providing additional support to the slope.

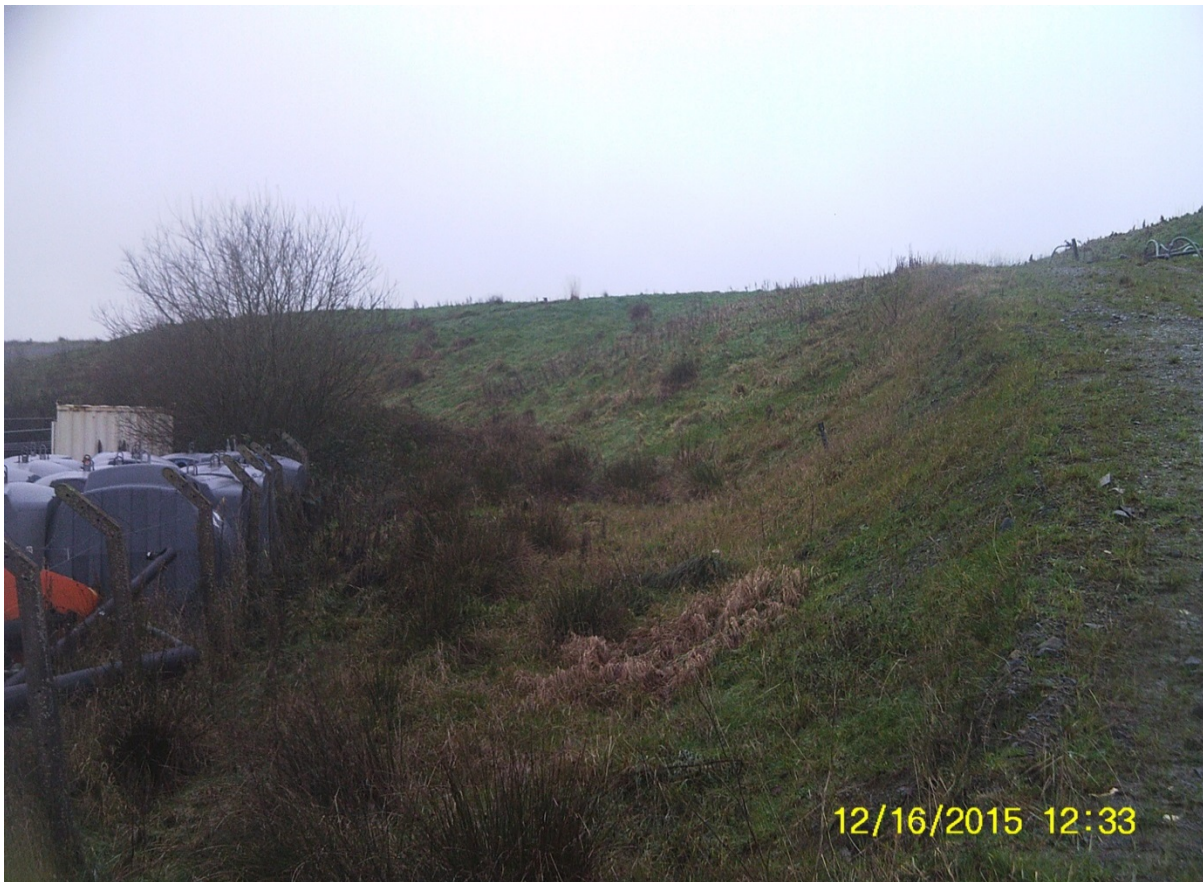
**Figure 5 – Northeast Slope of Cell 1 (facing southwest from the base of the access track)**

The gradient of this slope varies between approximately 1V:3H at the northern end (shown in **Figure 5**) and approximately 1V:2H at southern end (shown in **Figure 6**). The southern end was regraded from 1V:3H to 1V:2H in August 2007. An extra layer of liner was placed over the slope and leachate and gas extraction wells were installed. At the northern end of the slope is an access track which ascends to the crest of the landfill. The slope is well-vegetated with grass. There are no obvious signs of movement or distress visible at the surface of this slope.

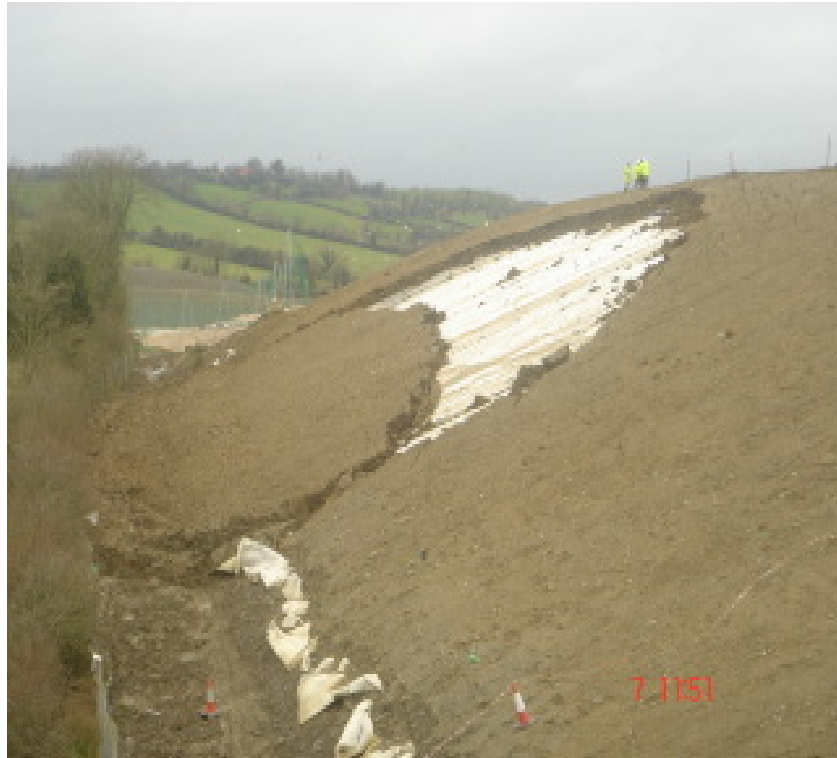
A shallow failure occurred on the Northwest Slope of Cell 1 in early 2006, as shown in **Figure 7**. The weather had generally been dry prior to the failure but the toe of the slope had been left truncated for at least one month to facilitate the installation of a toe drain. This resulted in tensile loading of the liner in excess of its capacity. It was also concluded that leachate streams flowing from the top of the exposed landfill to the western slope contributed to the failure.

**Figure 7 – Northwest Slope of Cell 1 in 2006 following shallow slope failure (facing northwest)**

Following the failure, remediation measures included installing a geogrid and reducing leachate levels. The crest of the slope was also regraded as part of the capping works to reduce the overall slope angle. The slope was then buttressed with a toe bund and was revegetated. The haul road now sits on the toe bund. During capping works, care was taken to ensure that the toe of the slope was not truncated or oversteepened. The vegetation (mainly grass) took a number of years to become re-established (as shown in **Figure 8**, **Figure 9** and **Figure 10**) but the slope is now well-vegetated with green grass. There are no obvious signs of movement or distress visible at the surface of this slope.

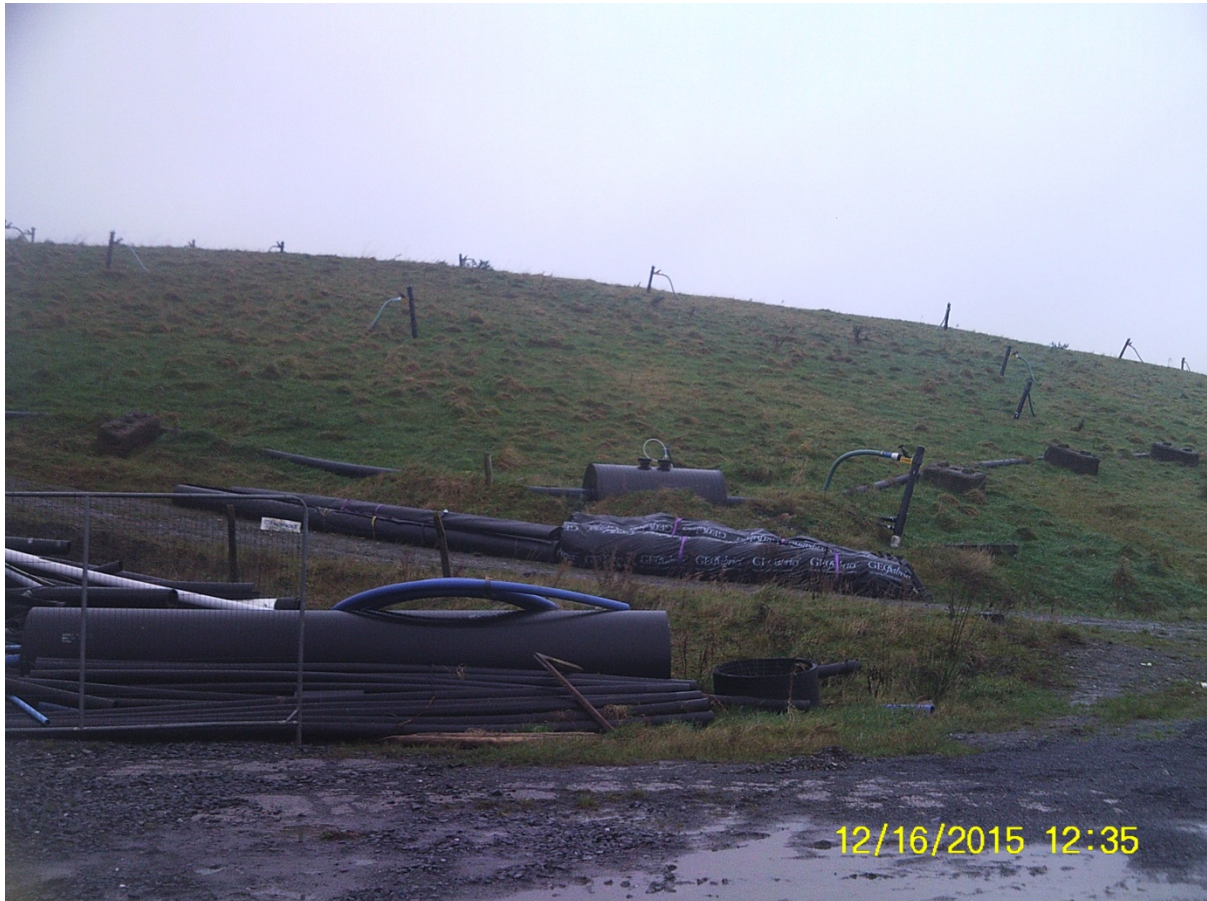
**Figure 11 – Northeast Slope of Cell 2 (facing northwest)**

This slope is well-vegetated with grass and stands at a gradient of approximately 1V:3H as shown in **Figure 11**. Disused farm buildings stand a short distance from the toe of the slope. A haul road runs parallel to the toe of the slope and there is a gravel-lined drain between the toe of the slope and the haul road. There are no obvious signs of movement or distress visible at the surface of this slope.

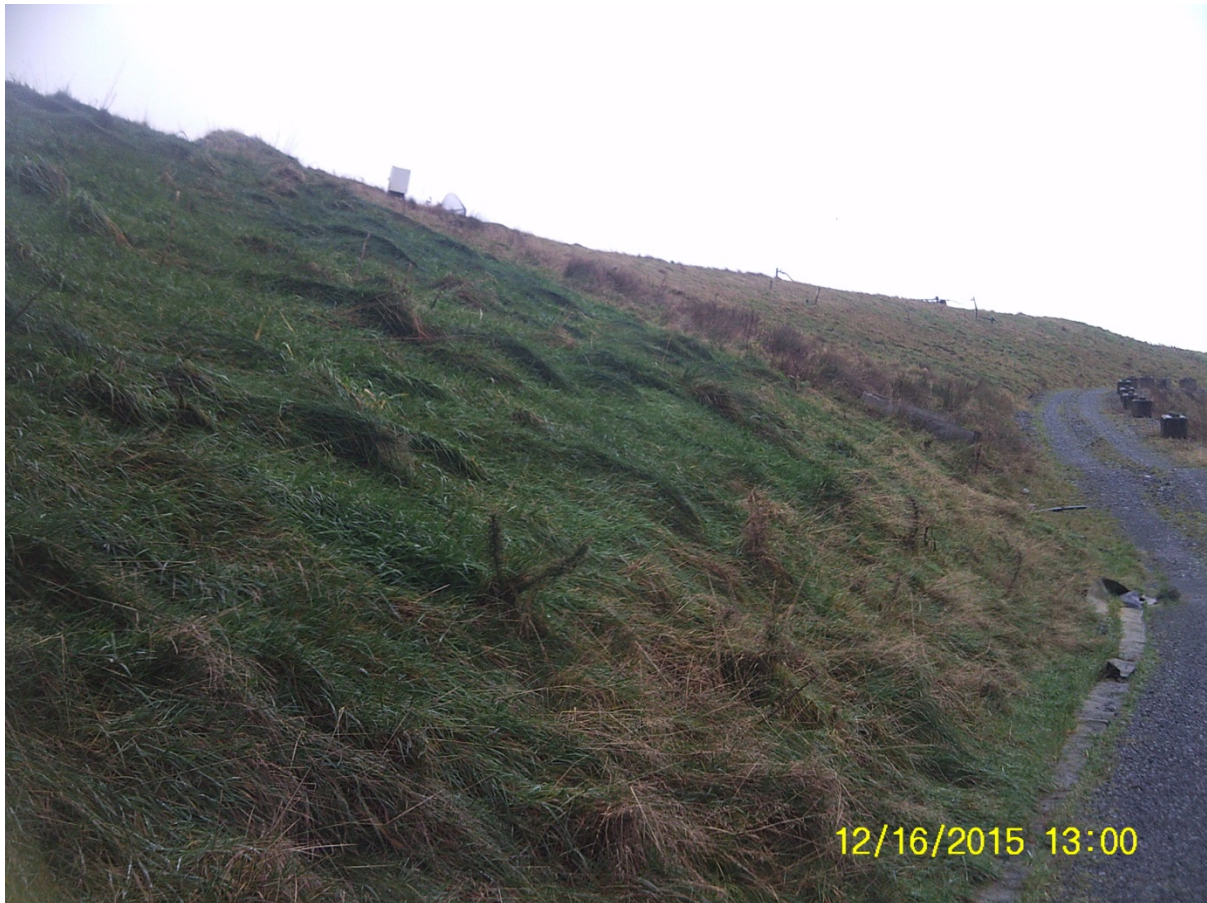
**Figure 12 – Northwest Slope of Cell 2 (facing southeast)**

This slope is well-vegetated with grass and stands at approximately 1V:2H as shown in **Figure 12**. The northern end of the slope was considered to be oversteep during filling but it was regraded to an acceptable gradient during capping. A haul road exists at the toe of the slope on a bund which buttresses the slope. There is a gravel-lined drain between the haul road and the toe of the slope. There is also a larger drainage channel downslope of the haul road which contains ponding water resulting from the recent heavy rainfall. There are no obvious signs of movement or distress visible at the surface of this slope.

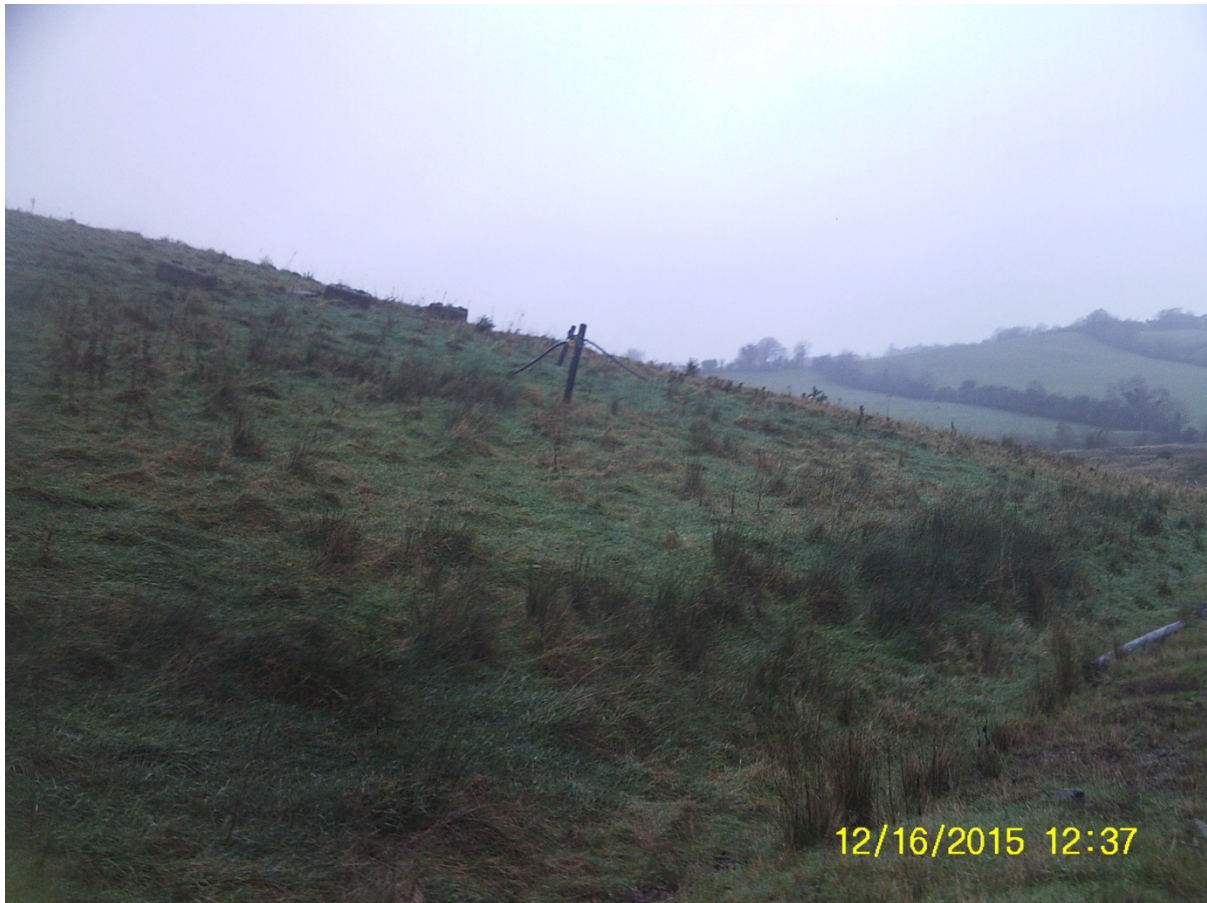
**Figure 13 – Northeast Slope of Cell 3 (facing northwest)**

The Northeast Slope of Cell 3 is well-vegetated with grass and stands at a gradient of approximately 1V:3H as shown in **Figure 13**. This slope was regraded during capping works. A haul road runs parallel to the toe of the slope and there is a gravel-lined drain between the toe of the slope and the haul road. There are no obvious signs of movement or distress visible at the surface of this slope.

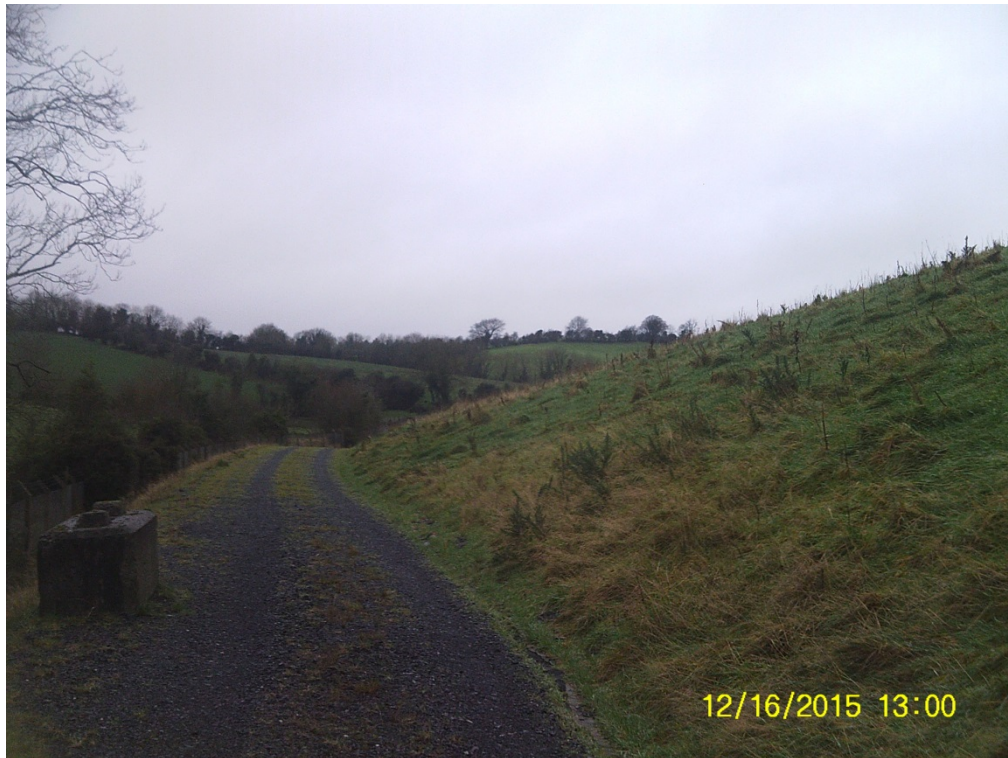
**Figure 14 – Northwest Slope of Cell 3 (facing northwest)**

This slope is well-vegetated with grass and has a gradient of approximately 1V:3H as shown in **Figure 14**. A haul road exists at the toe of the slope on a bund which buttresses the slope. There is a gravel-lined drain between the haul road and the toe of the slope. There is also a larger drainage channel downslope of the haul road which contains ponding water resulting from the recent heavy rainfall (**shown in Figure 15**). There are no obvious signs of movement or distress visible at the surface of this slope.

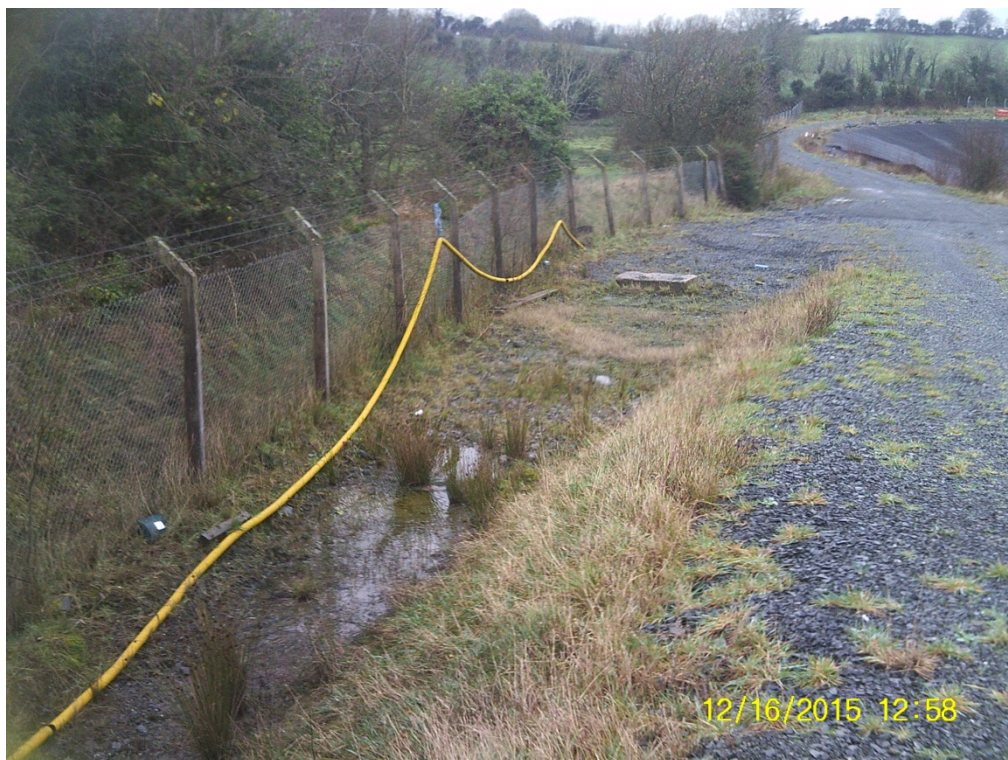
**Figure 15 – Ponding in Drain at Toe of Northwest Slope of Cell 3 (facing northwest)**

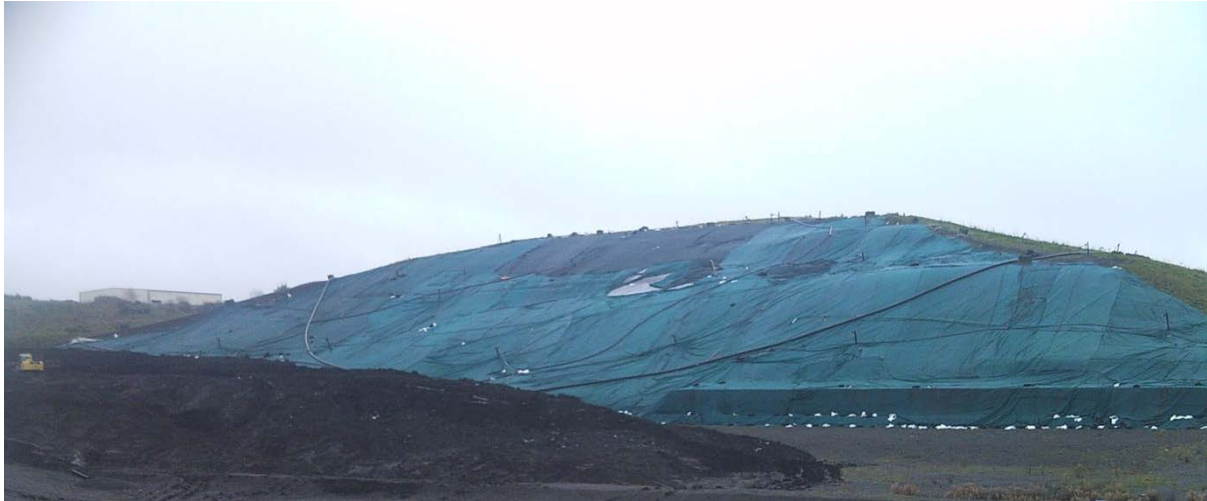
**Figure 16 – North Slope of Cell 4 (facing southeast)**

The surface of the northern end of Cell 3 has not been permanently capped. It is lined with a LLDPE landfill liner and a geofabric overliner as shown in **Figure 16**. An assessment of the underlying soil/waste was not possible during the site visit.

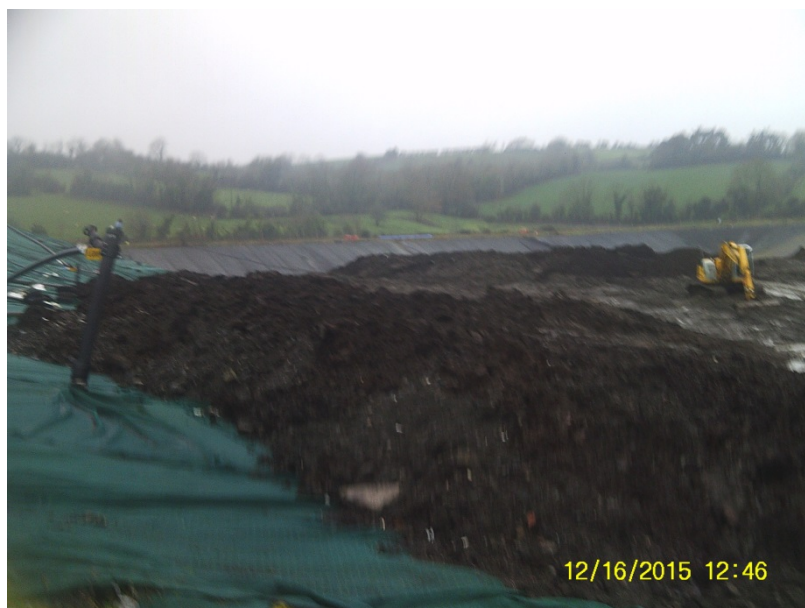
**Figure 17 – Topsoil in Cell 4 (facing west)**

Cell 4 is located directly to the north of Cell 3. Construction of Cell 4 was completed in July 2013. The cell has begun to accept waste which is understood to comprise contaminated topsoil as shown in **Figure 17**. Some ponded water was also observed in the base of the cell as a result of the recent heavy rainfall.

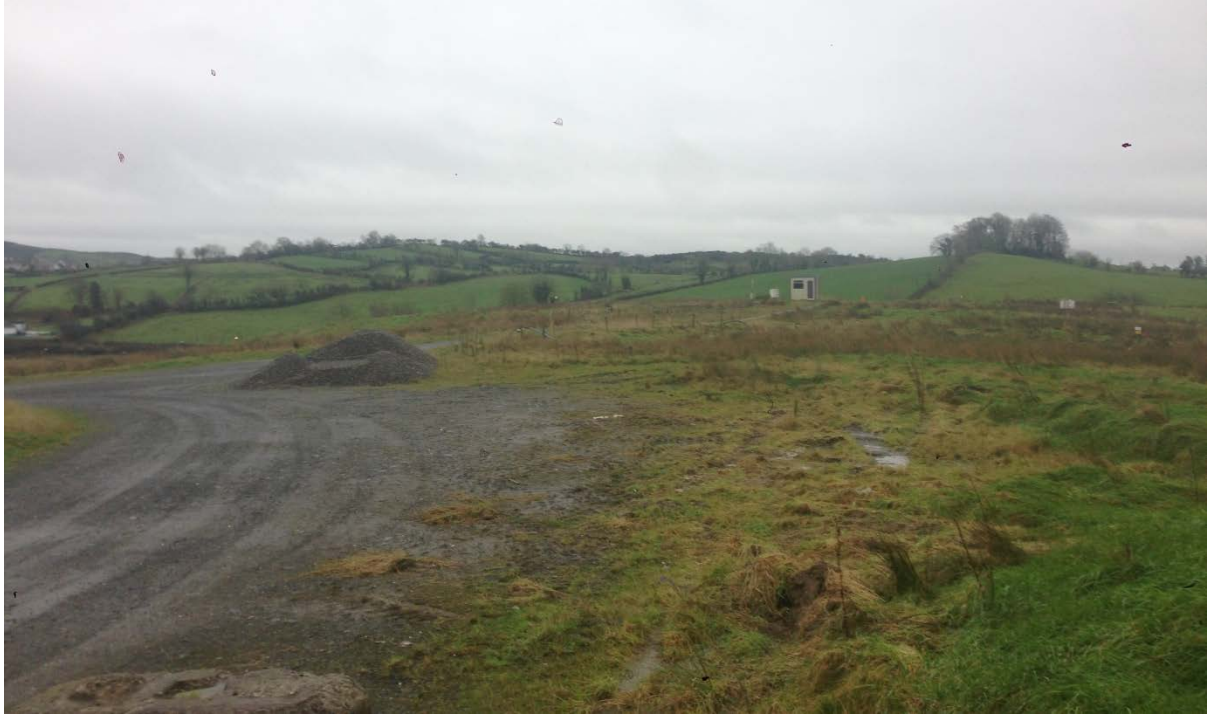
**Figure 18 – Crest of Landfill (facing southeast)**

The area at the top of the capped cells was also assessed as shown in **Figure 18** and **Figure 19**. In 2014, some small settlement cracks were observed at the crest of Cell 3. These were not considered to indicate instability in the slope and they were not observed during the 2015 site visit.

In general, the slopes of the landfill are well-vegetated and appear to be in good condition with no obvious signs of distress. It is recommended that drainage measures are maintained to prevent water from ponding near the crest of the slopes. Water at the crest of slopes can reduce the strength of the soil and result in slope failure. Should depressions form in the crest of the landfill they should be regraded to prevent water ponding.
