Huntstown Inert Clay Facility W0277-02 Annual Environmental Report 2017

This Annual Environmental Report (AER) is prepared for the Huntstown Inert Clay Facility (HICF) operated by Roadstone Limited. This AER covers the period from January 2017 to December 2017.

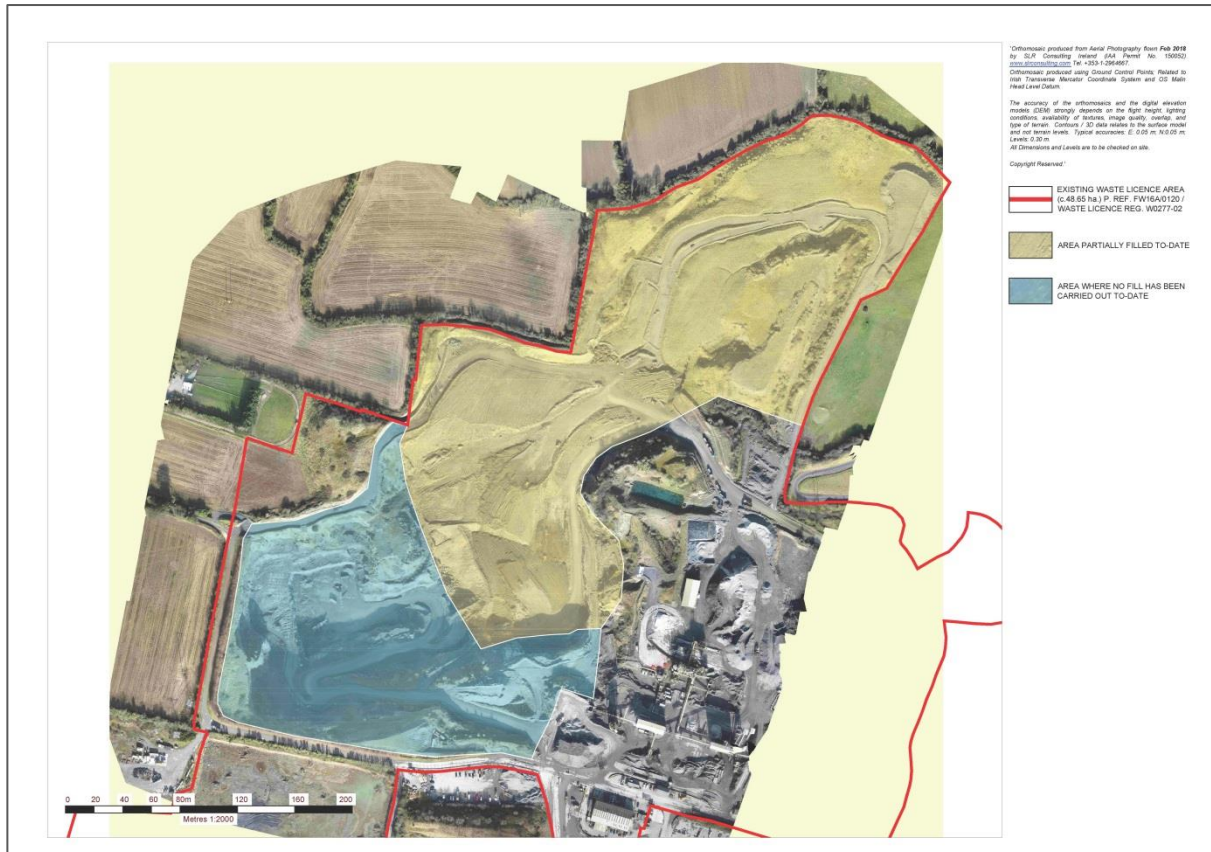
Figure 13: Topographical Monitoring Of Void Space

The annual topographical survey was carried out using drone survey equipment. The survey includes a measurement of the total void space that has been filled and the remaining available void space. This survey has been carried out in accordance with the written instructions issued by the Agency. The output of the survey is shown in Figure 13 below.

For the purposes of calculation of void space in the north quarry the survey has separated into two areas. Those areas which have:

- Been partially filled to date (beige shaded area on Figure 13); and
- Not been filled at all (blue shaded area on Figure 13, and also includes the Western Quarry Capacity).

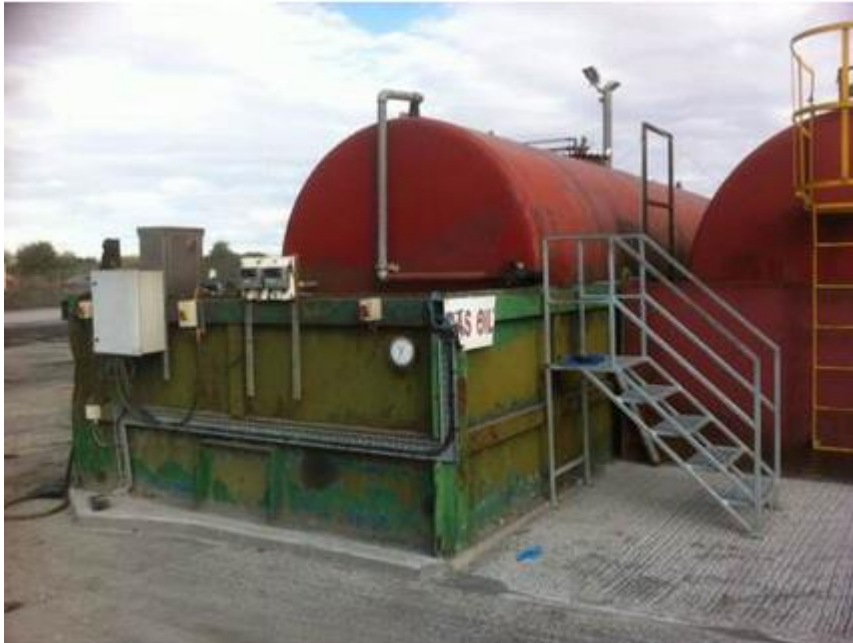
Figure 1 Bund identification

Aspect	Value/Finding	Comment
Date of Assessment	9-Oct 15	
Bund type	Local	
Bund construction	Steel	
Capacity	Sufficient	
Defects	None	
Assessment result	Pass

Aspect	Value/Finding	Comment
Bund protected from rain?	No (Fail)	Best practice is to protect from rain.
Maximum quantity of rainwater marked?	No (Fail)	Best practice is to mark maximum allowable level of rain water.
Is rainwater discharged by gravity?	Yes (Fail)	Outlet plug observed. Best practice is not for gravity discharge.
Is rainwater discharge point securely locked?	No (Fail)	Best practice is to securely lock access to discharge point.
Are tank filling points within bund?	Yes (Pass)	Best practice is for tank filling points to be within the bund.
Do pipes pass through bund wall?	N/A as bund of steel construction	Only applicable for masonry bunds
Is bund protected from vehicle strikes?	N/A as bund of steel construction	Only applicable for block and plastic bunds.

Aspect	Value/Finding	Comment
Associated refuelling area?	Yes	
Impermeable ground?	Yes	
Interceptor?	Yes	
Defects	None

- Roof bund or mark maximum level rain water

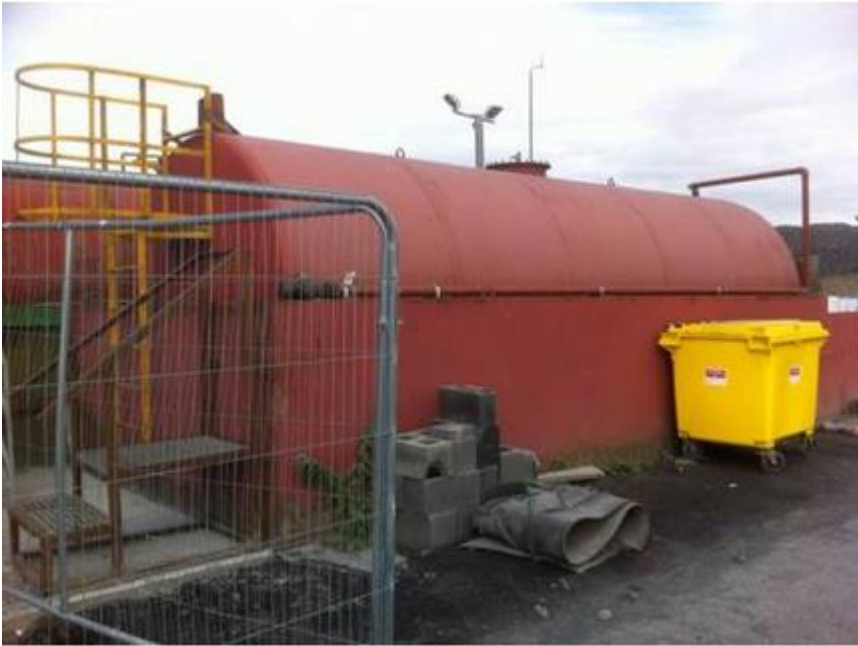
Figure 2 Bund identification

Aspect	Value/Finding	Comment
Date of Assessment	9-Oct 15	
Bund type	Local	
Bund construction	Steel	
Capacity	Sufficient	
Defects	None	
Assessment result	Pass

Aspect	Value/Finding	Comment
Bund protected from rain?	No (Fail)	Best practice is to protect from rain.
Maximum quantity of rainwater marked?	No (Fail)	Best practice is to mark maximum allowable level of rain water.
Is rainwater discharged by gravity?	Yes (Fail)	Outlet plug observed. Best practice is not for gravity discharge.
Is rainwater discharge point securely locked?	No (Fail)	Best practice is to securely lock access to discharge point.
Are tank filling points within bund?	Yes (Pass)	Best practice is for tank filling points to be within the bund.
Do pipes pass through bund wall?	N/A as bund of steel construction	Only applicable for masonry bunds
Is bund protected from vehicle strikes?	N/A as bund of steel construction	Only applicable for block and plastic bunds.

Aspect	Value/Finding	Comment
Associated refuelling area?	Yes	
Impermeable ground?	Yes	
Interceptor?	Yes	
Defects	None

- Roof bund or mark maximum level rain water

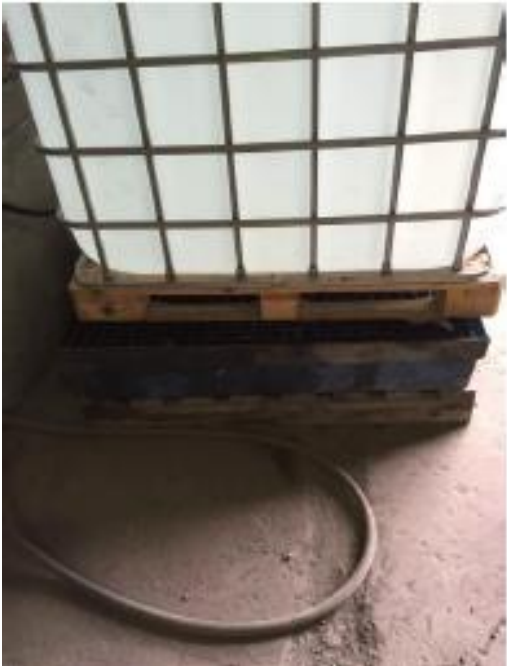
Figure 3 Bund identification

Aspect	Value/Finding	Comment
Date of Assessment	27 April 2016	
Bund type	Local	
Bund construction	Plastic	
Capacity	Sufficient	
Defects	None	
Assessment result	Pass

Aspect	Value/Finding	Comment
Associated refuelling area?	No	
Impermeable ground?	N/A	
Interceptor?	N/A	
Defects	N/A

- Label bund to allow unique identification

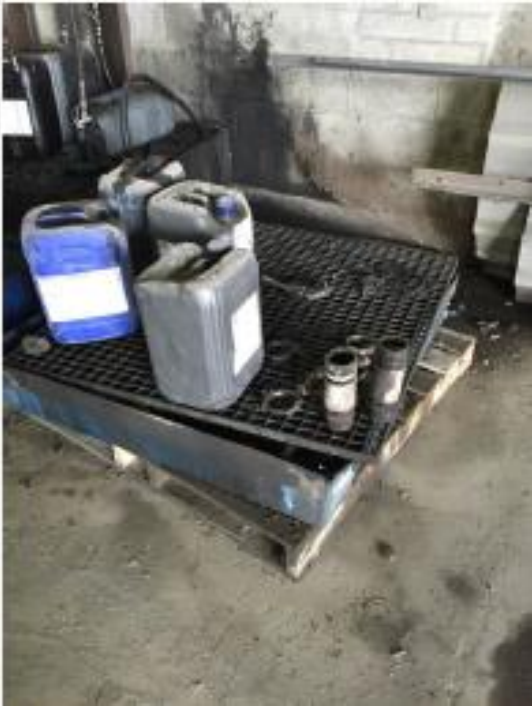
Figure 4 Bund identification

Aspect	Value/Finding	Comment
Date of Assessment	27 April 2016	
Bund type	Local	
Bund construction	Plastic	
Capacity	Sufficient	Sump half full of oil
Defects	None	
Assessment result	Pass

Aspect	Value/Finding	Comment
Associated refuelling area?	No	
Impermeable ground?	N/A	
Interceptor?	N/A	
Defects	N/A

- Label bund to allow unique identification

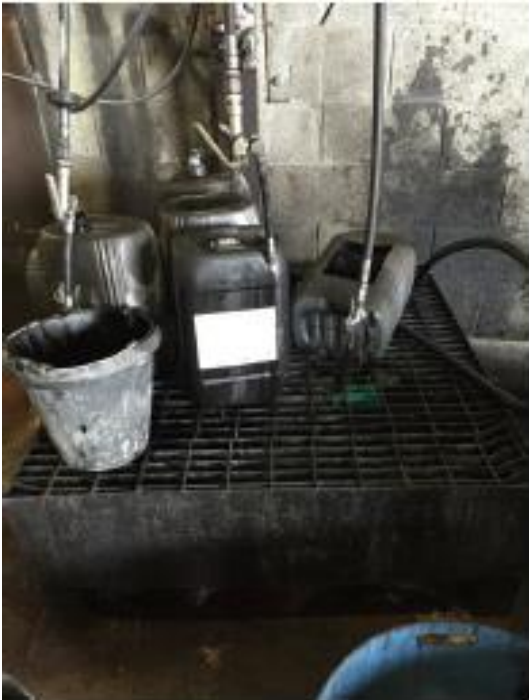
Figure 5 Bund identification

Aspect	Value/Finding	Comment
Date of Assessment	27 April 2016	
Bund type	Local	
Bund construction	Steel	
Capacity	Sufficient	Sump 2/3 full oil
Defects	None	
Assessment result	Pass

Aspect	Value/Finding	Comment
Associated refuelling area?	No	
Impermeable ground?	N/A	
Interceptor?	N/A	
Defects	N/A

- Label bund to allow unique identification

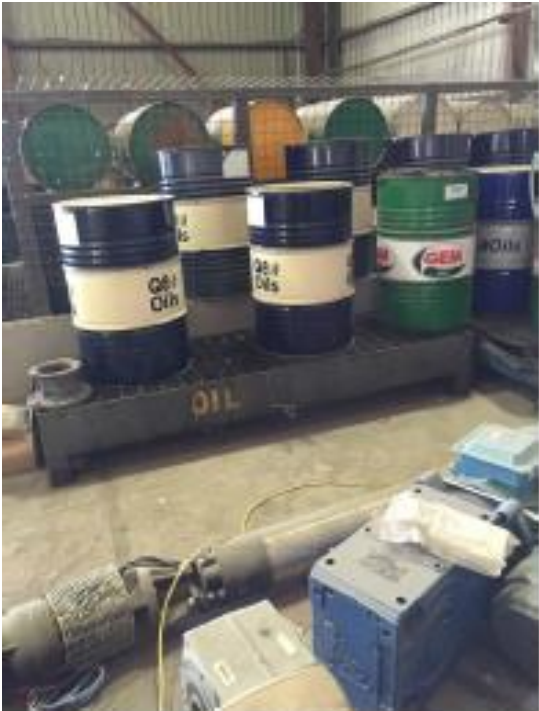
Figure 6 Bund identification

Aspect	Value/Finding	Comment
Date of Assessment	27 April 2016	
Bund type	Local	
Bund construction	Steel	
Capacity	Sufficient	
Defects	None	
Assessment result	Pass

Aspect	Value/Finding	Comment
Associated refuelling area?	No	
Impermeable ground?	N/A	
Interceptor?	N/A	
Defects	N/A

- Label bund to allow unique identification

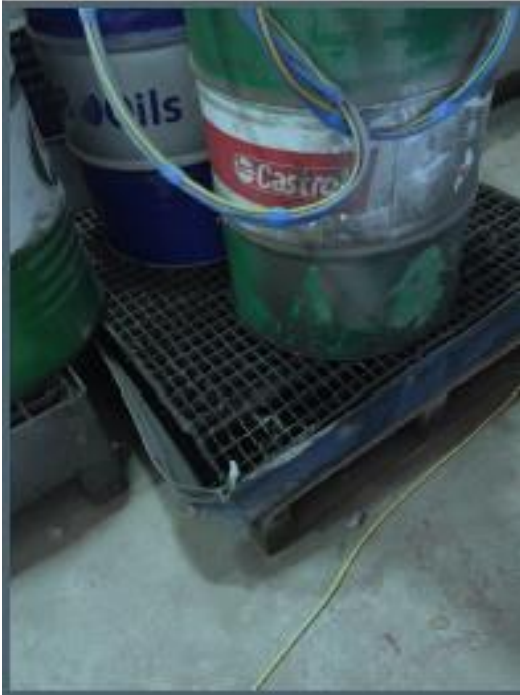
Figure 7 Bund identification

Aspect	Value/Finding	Comment
Date of Assessment	27 April 2016	
Bund type	Local	
Bund construction	Steel	
Capacity	Sufficient	
Defects	Dent	Dent has reduced height of bund resulting in insufficient capacity
Assessment result	Fail	Suggest scrap bund

Aspect	Value/Finding	Comment
Associated refuelling area?	No	
Impermeable ground?	N/A	
Interceptor?	N/A	
Defects	N/A

- Scrap/replace

- Label bund to allow unique identification

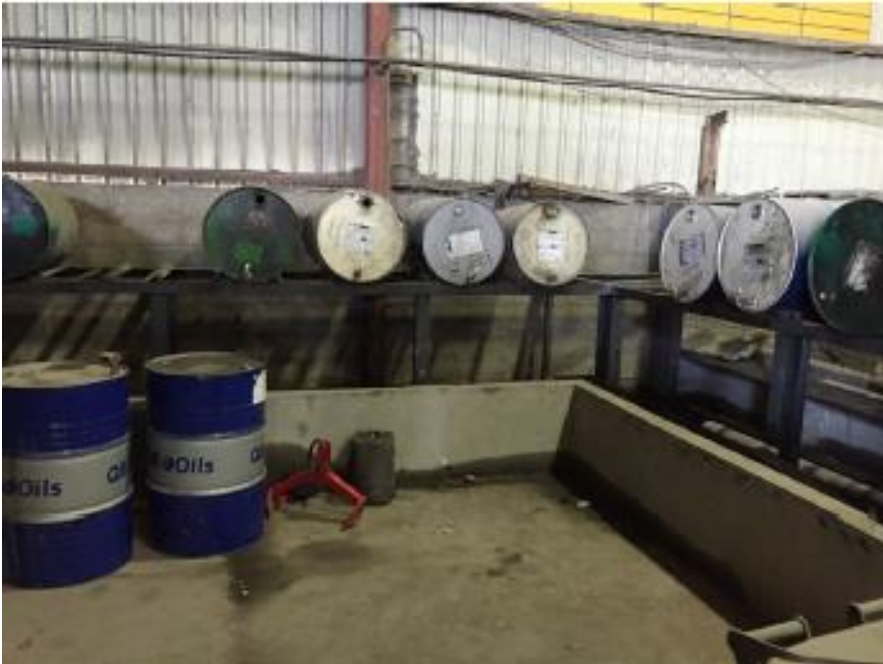
Figure 8 Bund identification

Aspect	Value/Finding	Comment
Date of Assessment	27 April 2016	
Bund type	Local	
Bund construction	Masonry	
Capacity	Sufficient	
Defects	None	
Assessment result	Pass

Aspect	Value/Finding	Comment
Associated refuelling area?	No	
Impermeable ground?	N/A	
Interceptor?	N/A	
Defects	N/A

- None

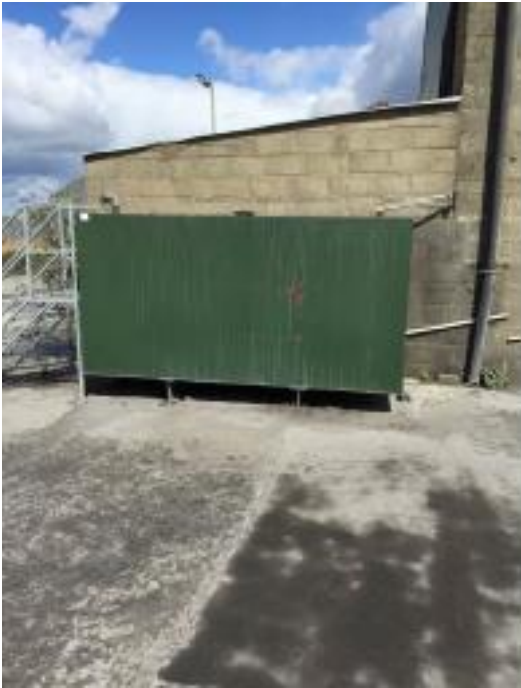
Figure 9 Bund identification

Aspect	Value/Finding	Comment
Date of Assessment	27 April 2016	
Bund type	Local	
Bund construction	Steel double skinned tank	
Capacity	Sufficient	
Defects	None	
Assessment result	Pass

Aspect	Value/Finding	Comment
Associated refuelling area?	No	
Impermeable ground?	N/A	
Interceptor?	N/A	
Defects	N/A

- Label 'for waste oil' or similar wording

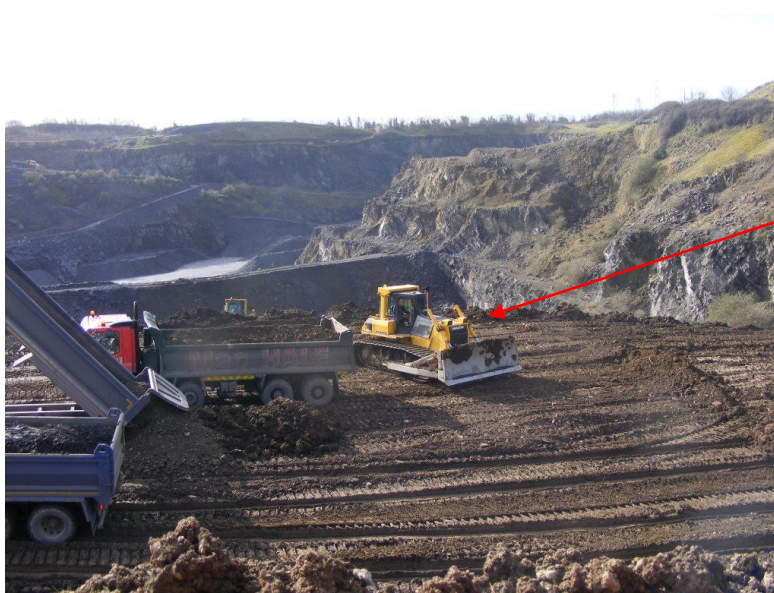
Plate 1 – Mobile Plant working at the Location

KPI Data should be developed for the Dozers and can be used for Projects, Internal Training and Communication.

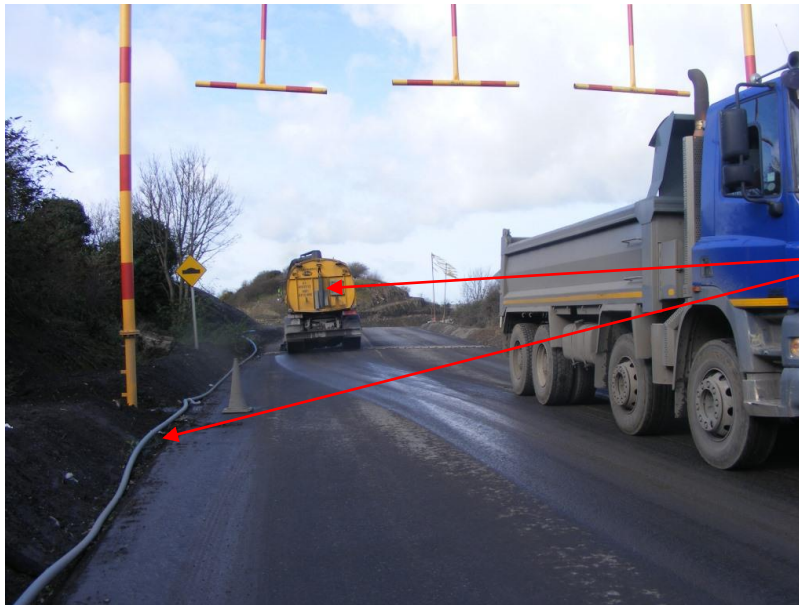
Plate 2 – Road Sweeper and Sprinklers under Construction

The Road Sweeper was operating at the Location. Once sprinklers are operation the bowser hrs may be reduced.

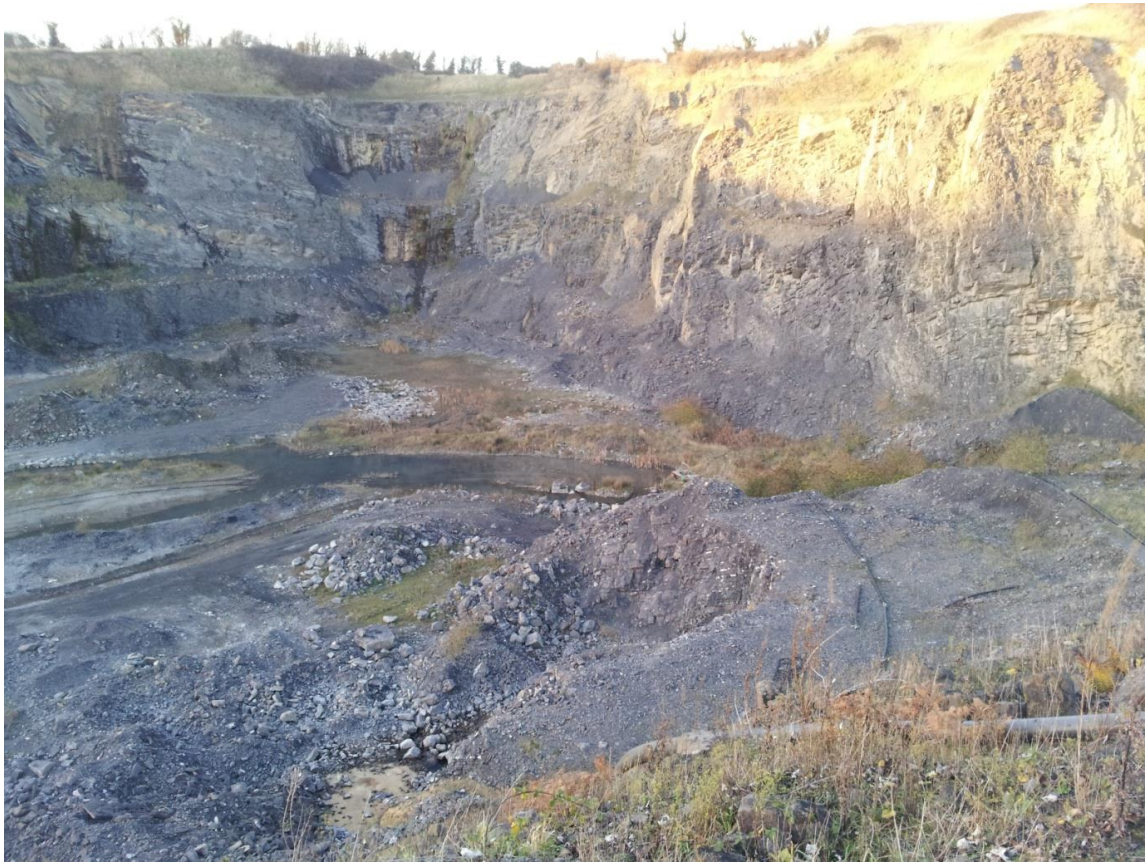
Plate 2
View of North Quarry Void in December 2013

The proposed recovery of inert soils at the North Quarry will provide for complete backfilling of a large open void above the groundwater table, facilitate the restoration of the lands to agricultural use and improve protection to the underlying groundwater resource, which is currently classified as 'extremely vulnerable' due to the absence of any protective soil cover. Plate 2 overleaf shows the quarry void in December 2013.
