# Brownswood Inert Clay Facility W0280-01 Annual Environmental Report 2017

This Annual Environmental Report (AER) is prepared for the Brownswood Inert Clay Facility operated by Roadstone Limited. This AER covers the period from January 2017 to December 2017.

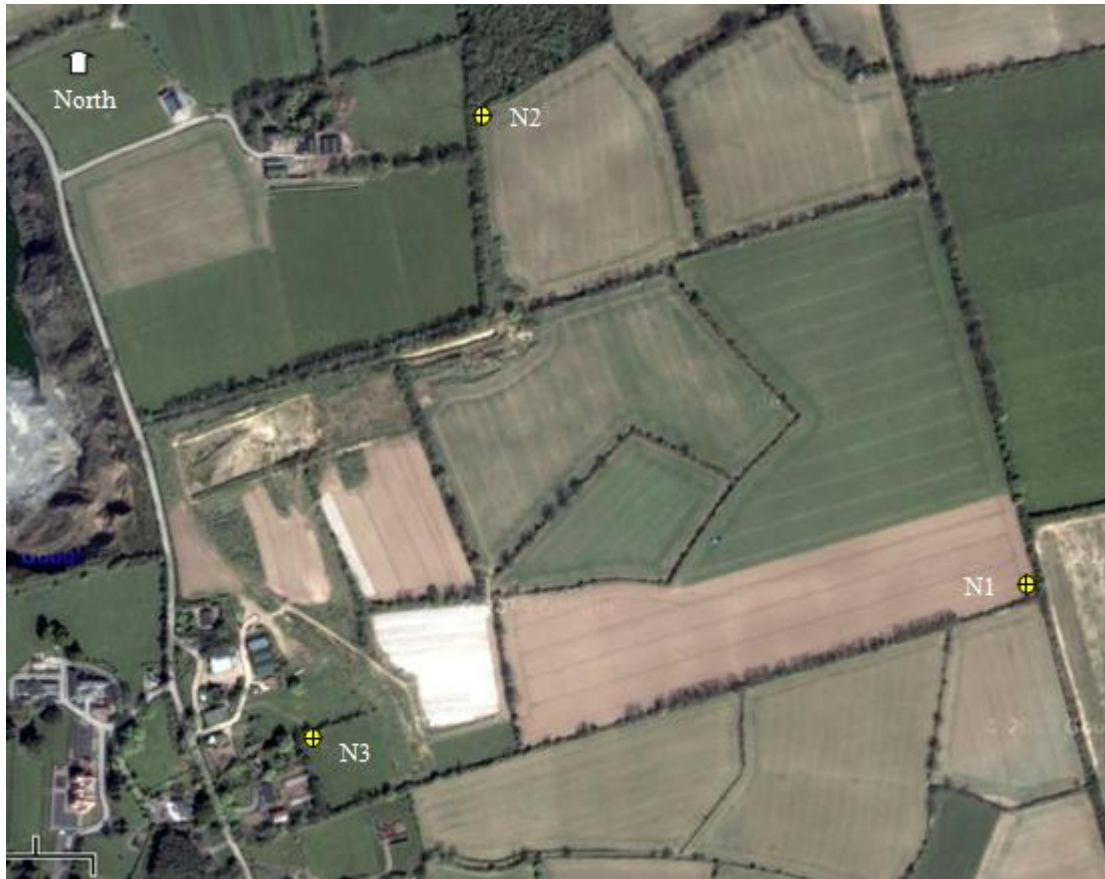
### Site map showing noise monitoring locations

**NOTE:** Noise monitoring locations N1-N3 are from the Roadstonewood Ltd. licence application for an extension of the Brownswood quarry. The map in the EIS deriving the locations is from Nov 2002 and is Figure 3.7.1

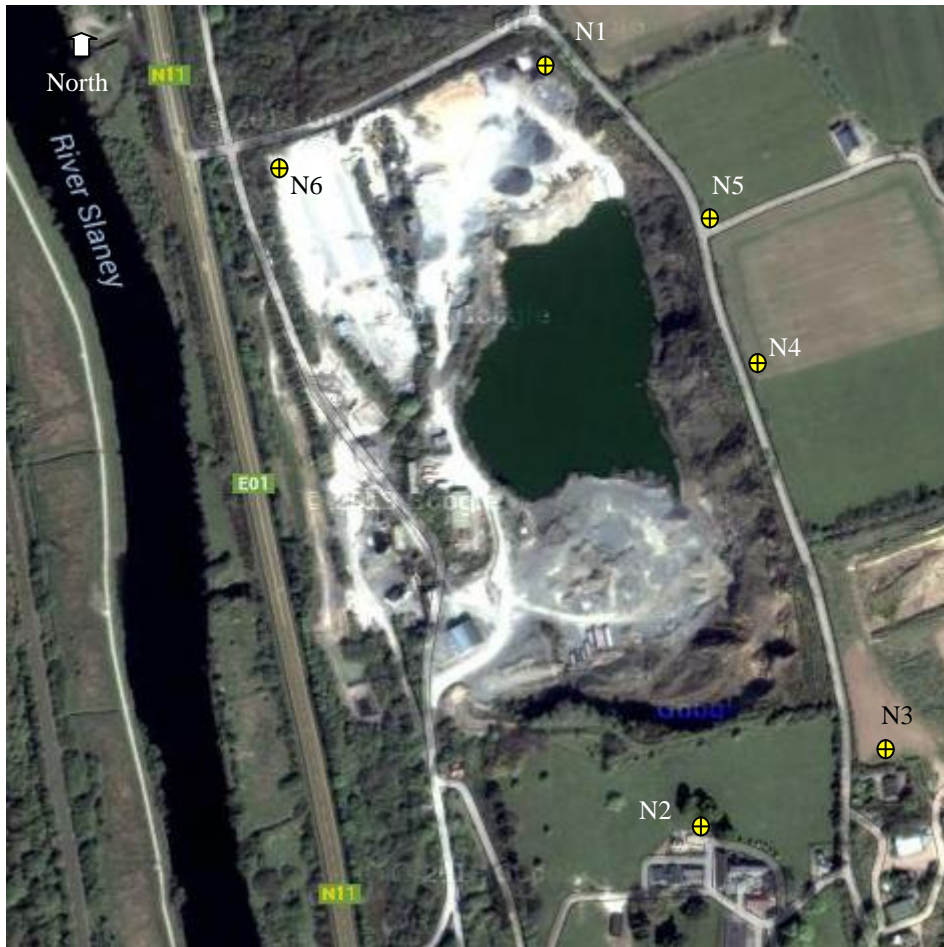
**Map 1:** Site map showing noise monitoring locations N1-N6

**NOTE:** Noise monitoring locations N1-N6 are derived from the Roadstonewood Ltd. waste licence application. The licence is for the waste recovery facility, Brownswood, Co. Wexford. Noise monitoring locations are taken from Figure 8-1, June 2011. The locations N2 and N3 have been moved south towards noise sensitive locations rather than on the boundary as outlined in Figure 8-1 of the application.

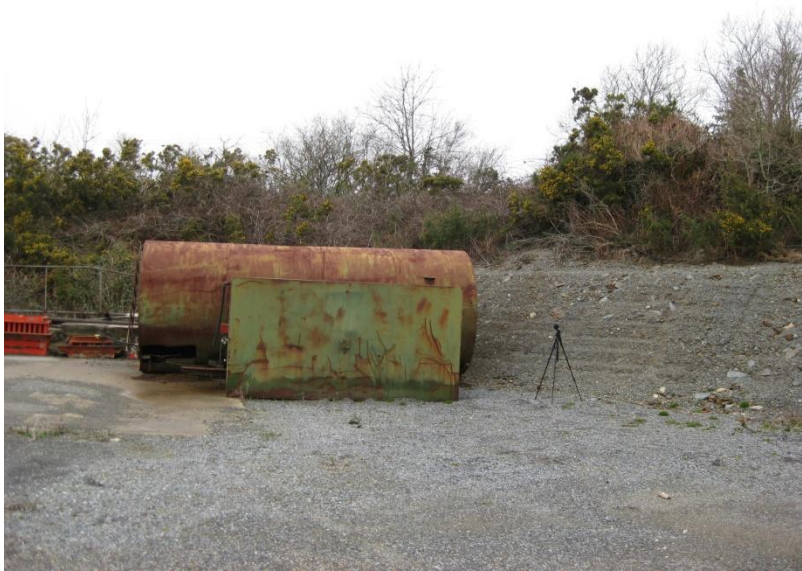
#### Noise monitoring location N1

### Photographs of noise monitoring equipment on-site during monitoring

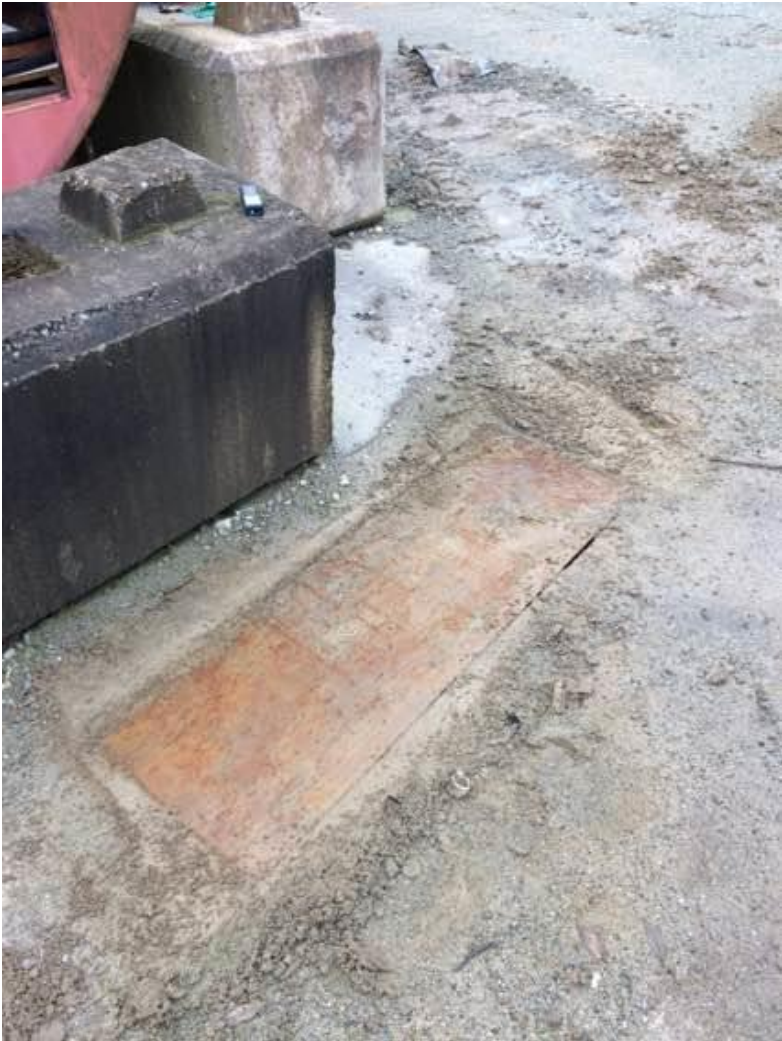
**Figure 1 Interceptor**

Aspect	Value/Finding	Comment
Associated refuelling area?	Yes	
Impermeable ground?	Yes (Pass)	Best practice is for refuelling areas to be impermeable
Interceptor?	Yes (Pass)	Best practice is for refuelling areas to have an interceptor
Defects/Comments	None

- None

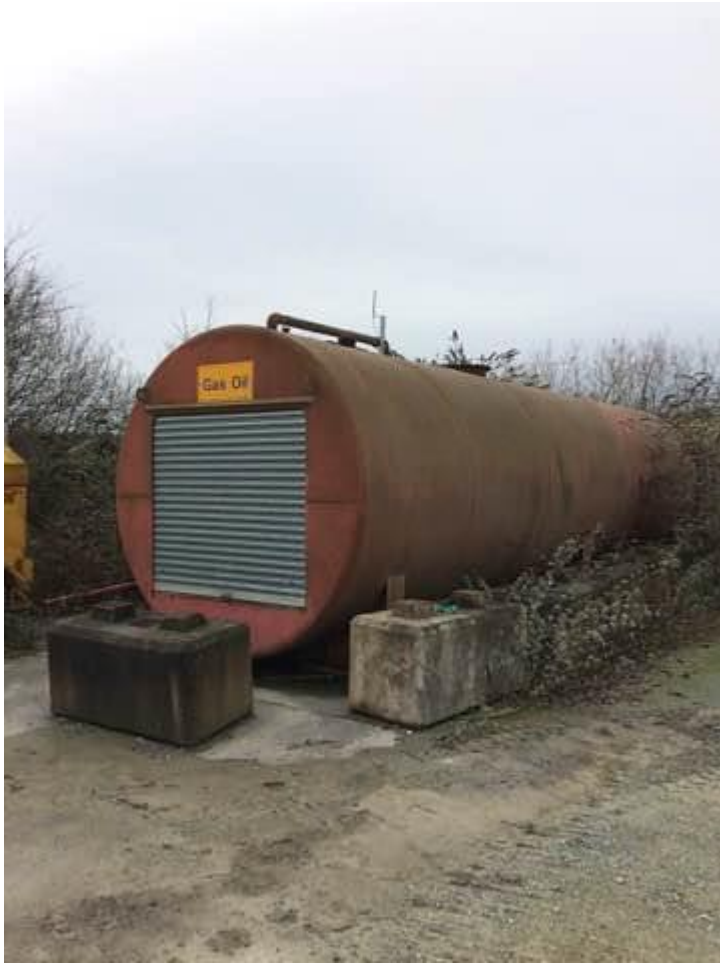
**Figure 2 Self-bunded tank**

Aspect	Value/Finding	Comment
Date of Assessment	20-Dec 16	
Assessment method	Visual	
Location	garage	
Bund type	Local (self banded tank)	
Bund construction	Steel	
Wall integrity defects	walls inspected - no defects	
Base Integrity defects	No defects	
Assessment result	Pass

Is self-test working?	Yes (Pass)	Best practice is for self bunded tanks to have the self-test device regularly tested.
Does self-test device indicate a leak?	No (Pass)	Where a leak is detected in a self bunded tank this may indicate a rupture of the inner skin.

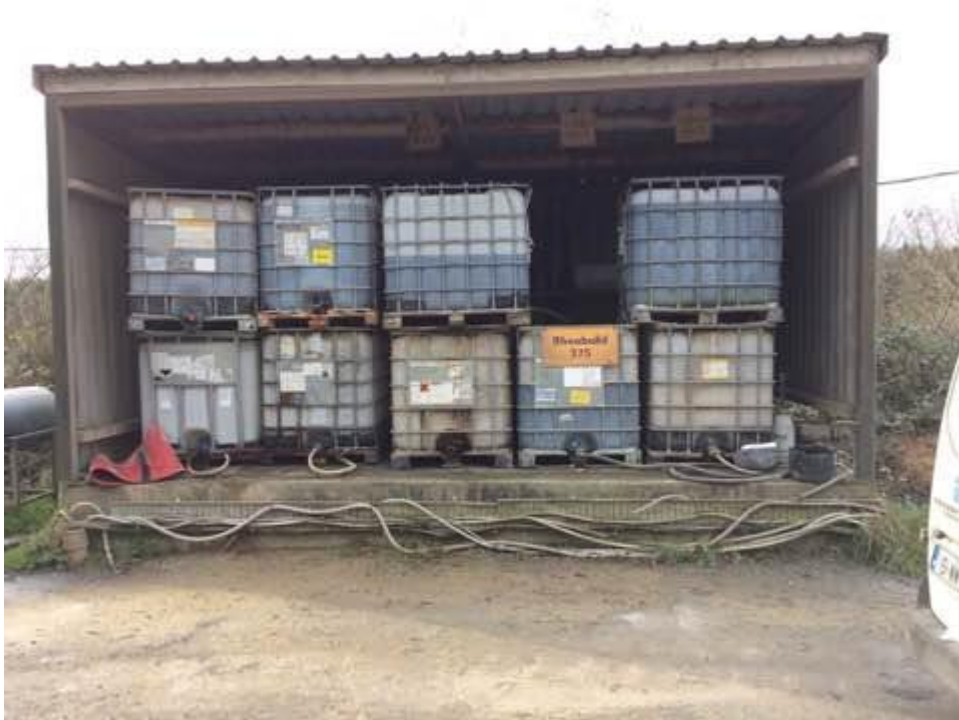
**Figure 3 Additive bund**

Aspect	Value/Finding	Comment
Date of Assessment	20-Dec 16	
Assessment method	Visual	
Location	concrete plant	
Bund type	Local	
Bund construction	RMC	
Wall integrity defects	walls inspected - no defects	
Base Integrity defects	base inspected - no defects	
Assessment result	Pass

- None

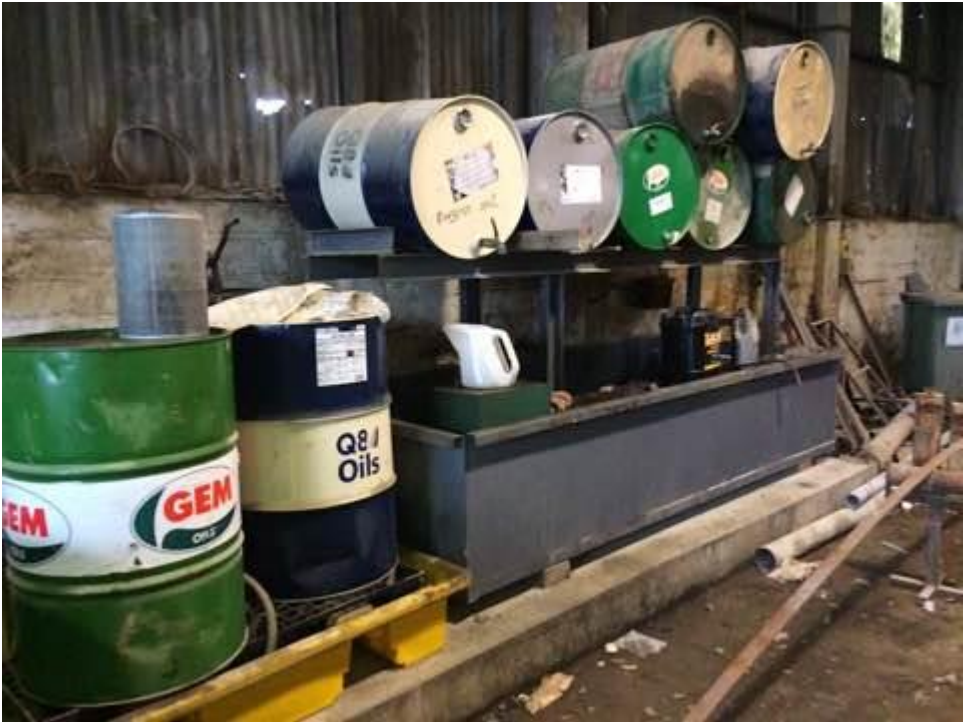
Figure 2 Garage oil bund

Aspect	Value/Finding	Comment
Date of Assessment	20-Dec 16	
Assessment method	Visual	
Location	garage	
Bund type	Local	
Bund construction	Steel	
Wall integrity defects	walls inspected - no defects	
Base Integrity defects	base inspected - no defects	
Assessment result	Pass

- None

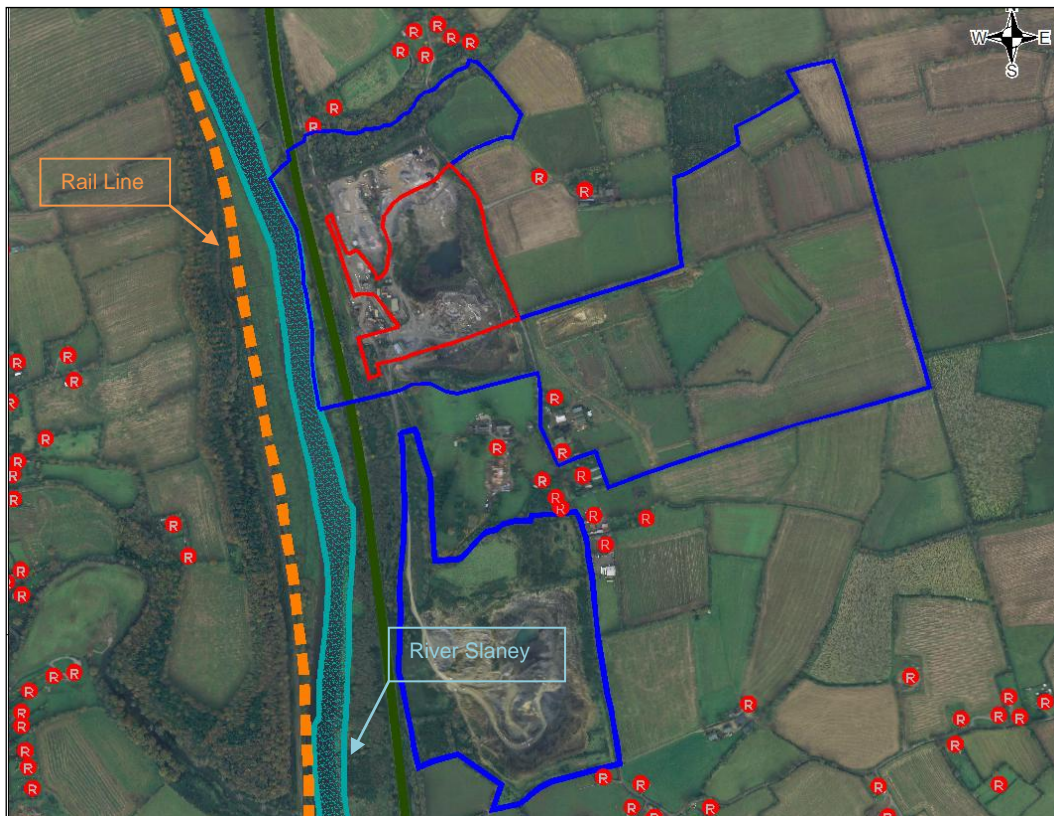
**Figure 2**  
**Aerial View of Licensed Site and Surrounding Land Use**

The site of the proposed inert waste recovery facility, is located within a largely agricultural area. There are approximately 10 No. residential properties clustered amongst agricultural land immediately north of the Old Quarry. The existing N11 National Primary Road and the River Slaney are located immediately beyond the western boundary, while Murphy's Quarry and approximately 7 No. residential properties are located beyond the southern boundary.

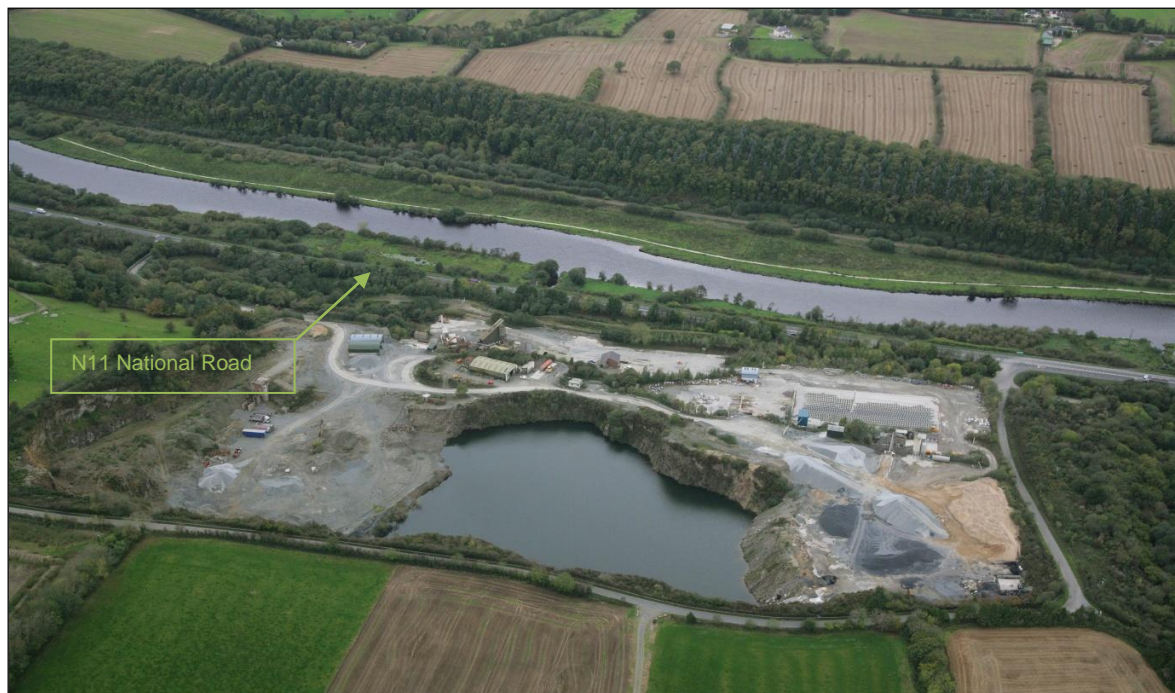
**Figure 3**  
**Oblique Aerial View of Existing Quarry**

Land-use in the vicinity of the facility, including residential and commercial development, is shown on the aerial photograph in Figure 2. An oblique aerial photograph of the existing quarry (taken in 2011), showing its position and setting relative to the Dublin-Wexford rail line, the River Slaney, the N11 National Primary Road is reproduced as Figure 3 below.
