Annual Environmental Report 2017 for Crystalhill Inns Ltd T/A CHI
Environmental Grannagh, Kilmacow, Co. Kilkenny licence number
W0260-01

This Annual Environmental Report provides information on environmental compliance at the CHI Environmental Soil Recovery Facility, Grannagh, Kilmacow, Co. Kilkenny.

ANNUAL SOIL & GROUNDWATER MONITORING REPORT

TEST REPORT 145246

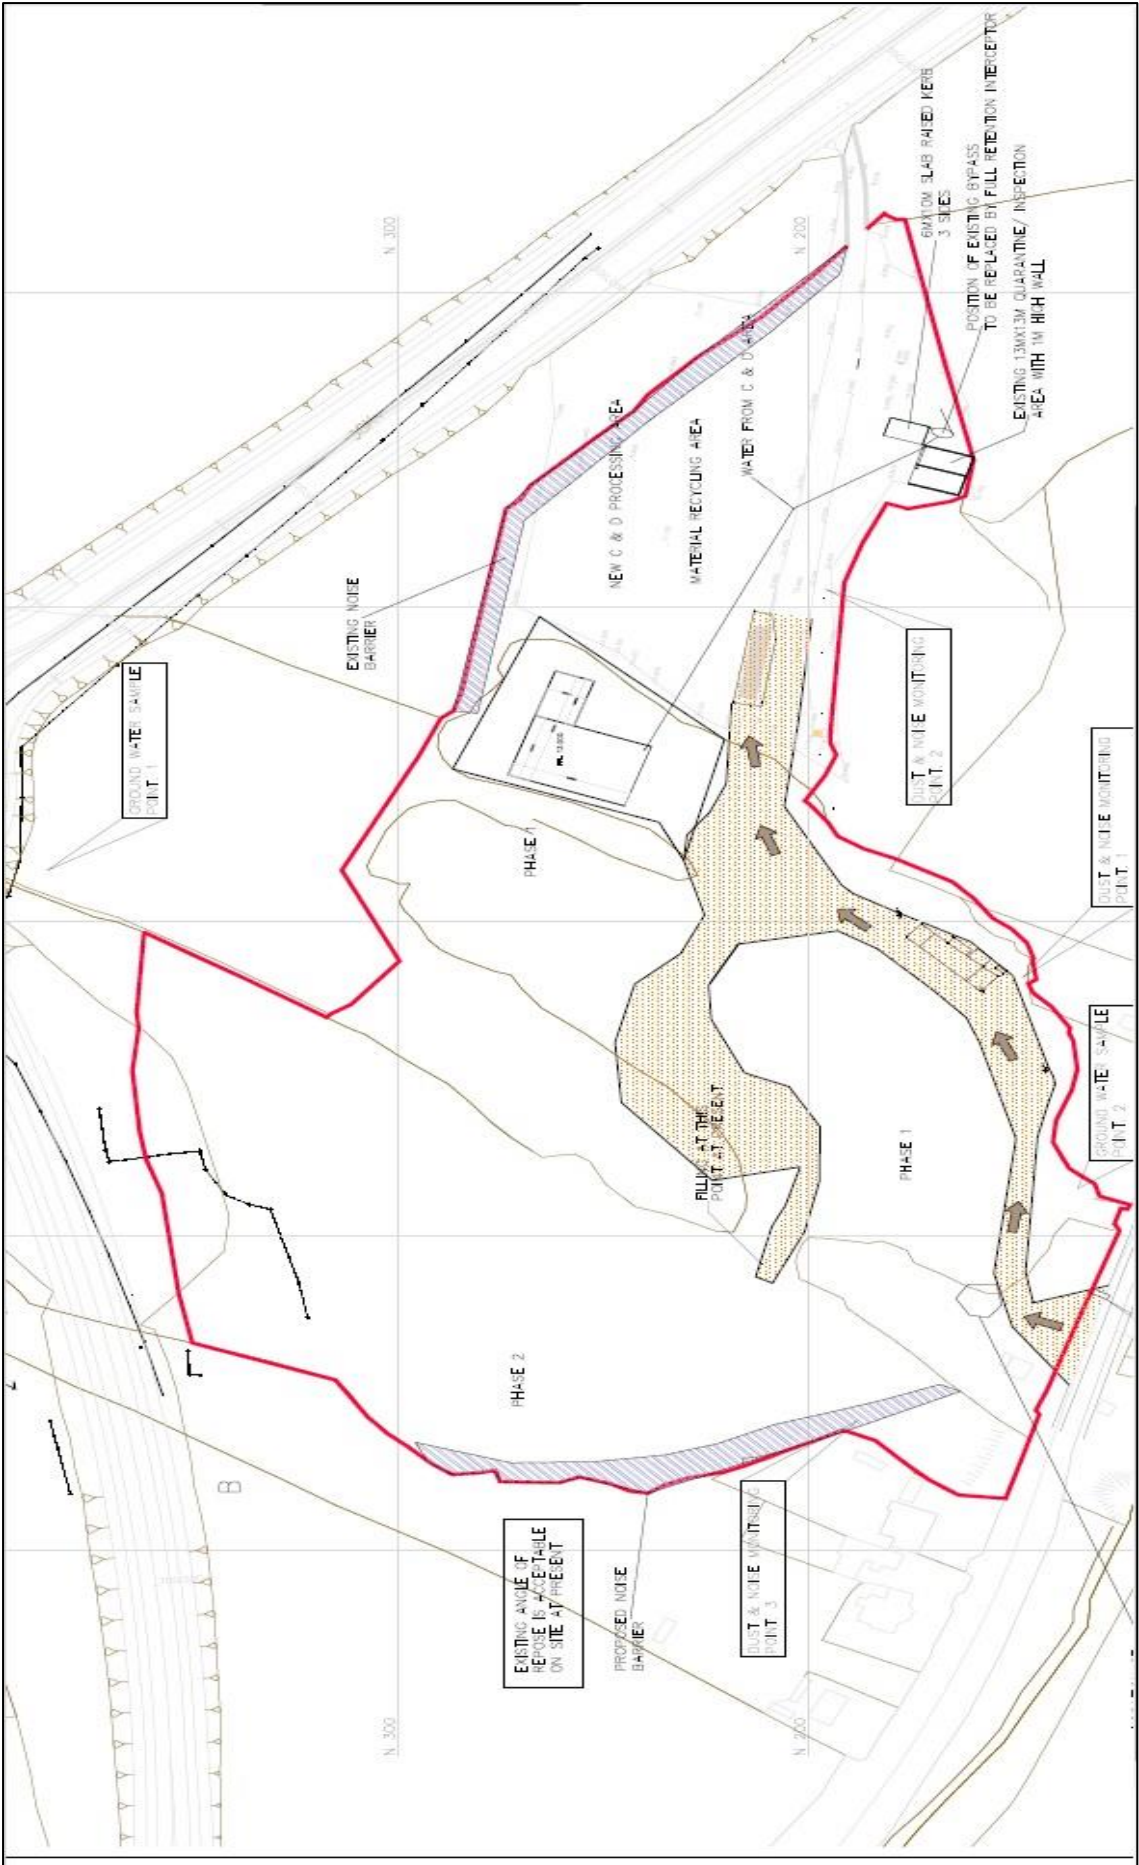
**SITE LAYOUT
FOR CHI ENVIRONMENTAL
AT GRANNACH
CO. NUÉWENY.**

EXISTING SITE LAYOUT

See drawing appendix 1 for site layout.
