TIER 3 ENVIRONMENTAL RISK ASSESSMENT
FORMER MUNICIPAL LANDFILL
MOATE,
COUNTY WESTMEATH

Westmeath County Council,
County Buildings,
Mullingar,
County Westmeath

O' Callaghan Moran & Associates,
Granary House,
Rutland Street,
Cork

18th April 2013

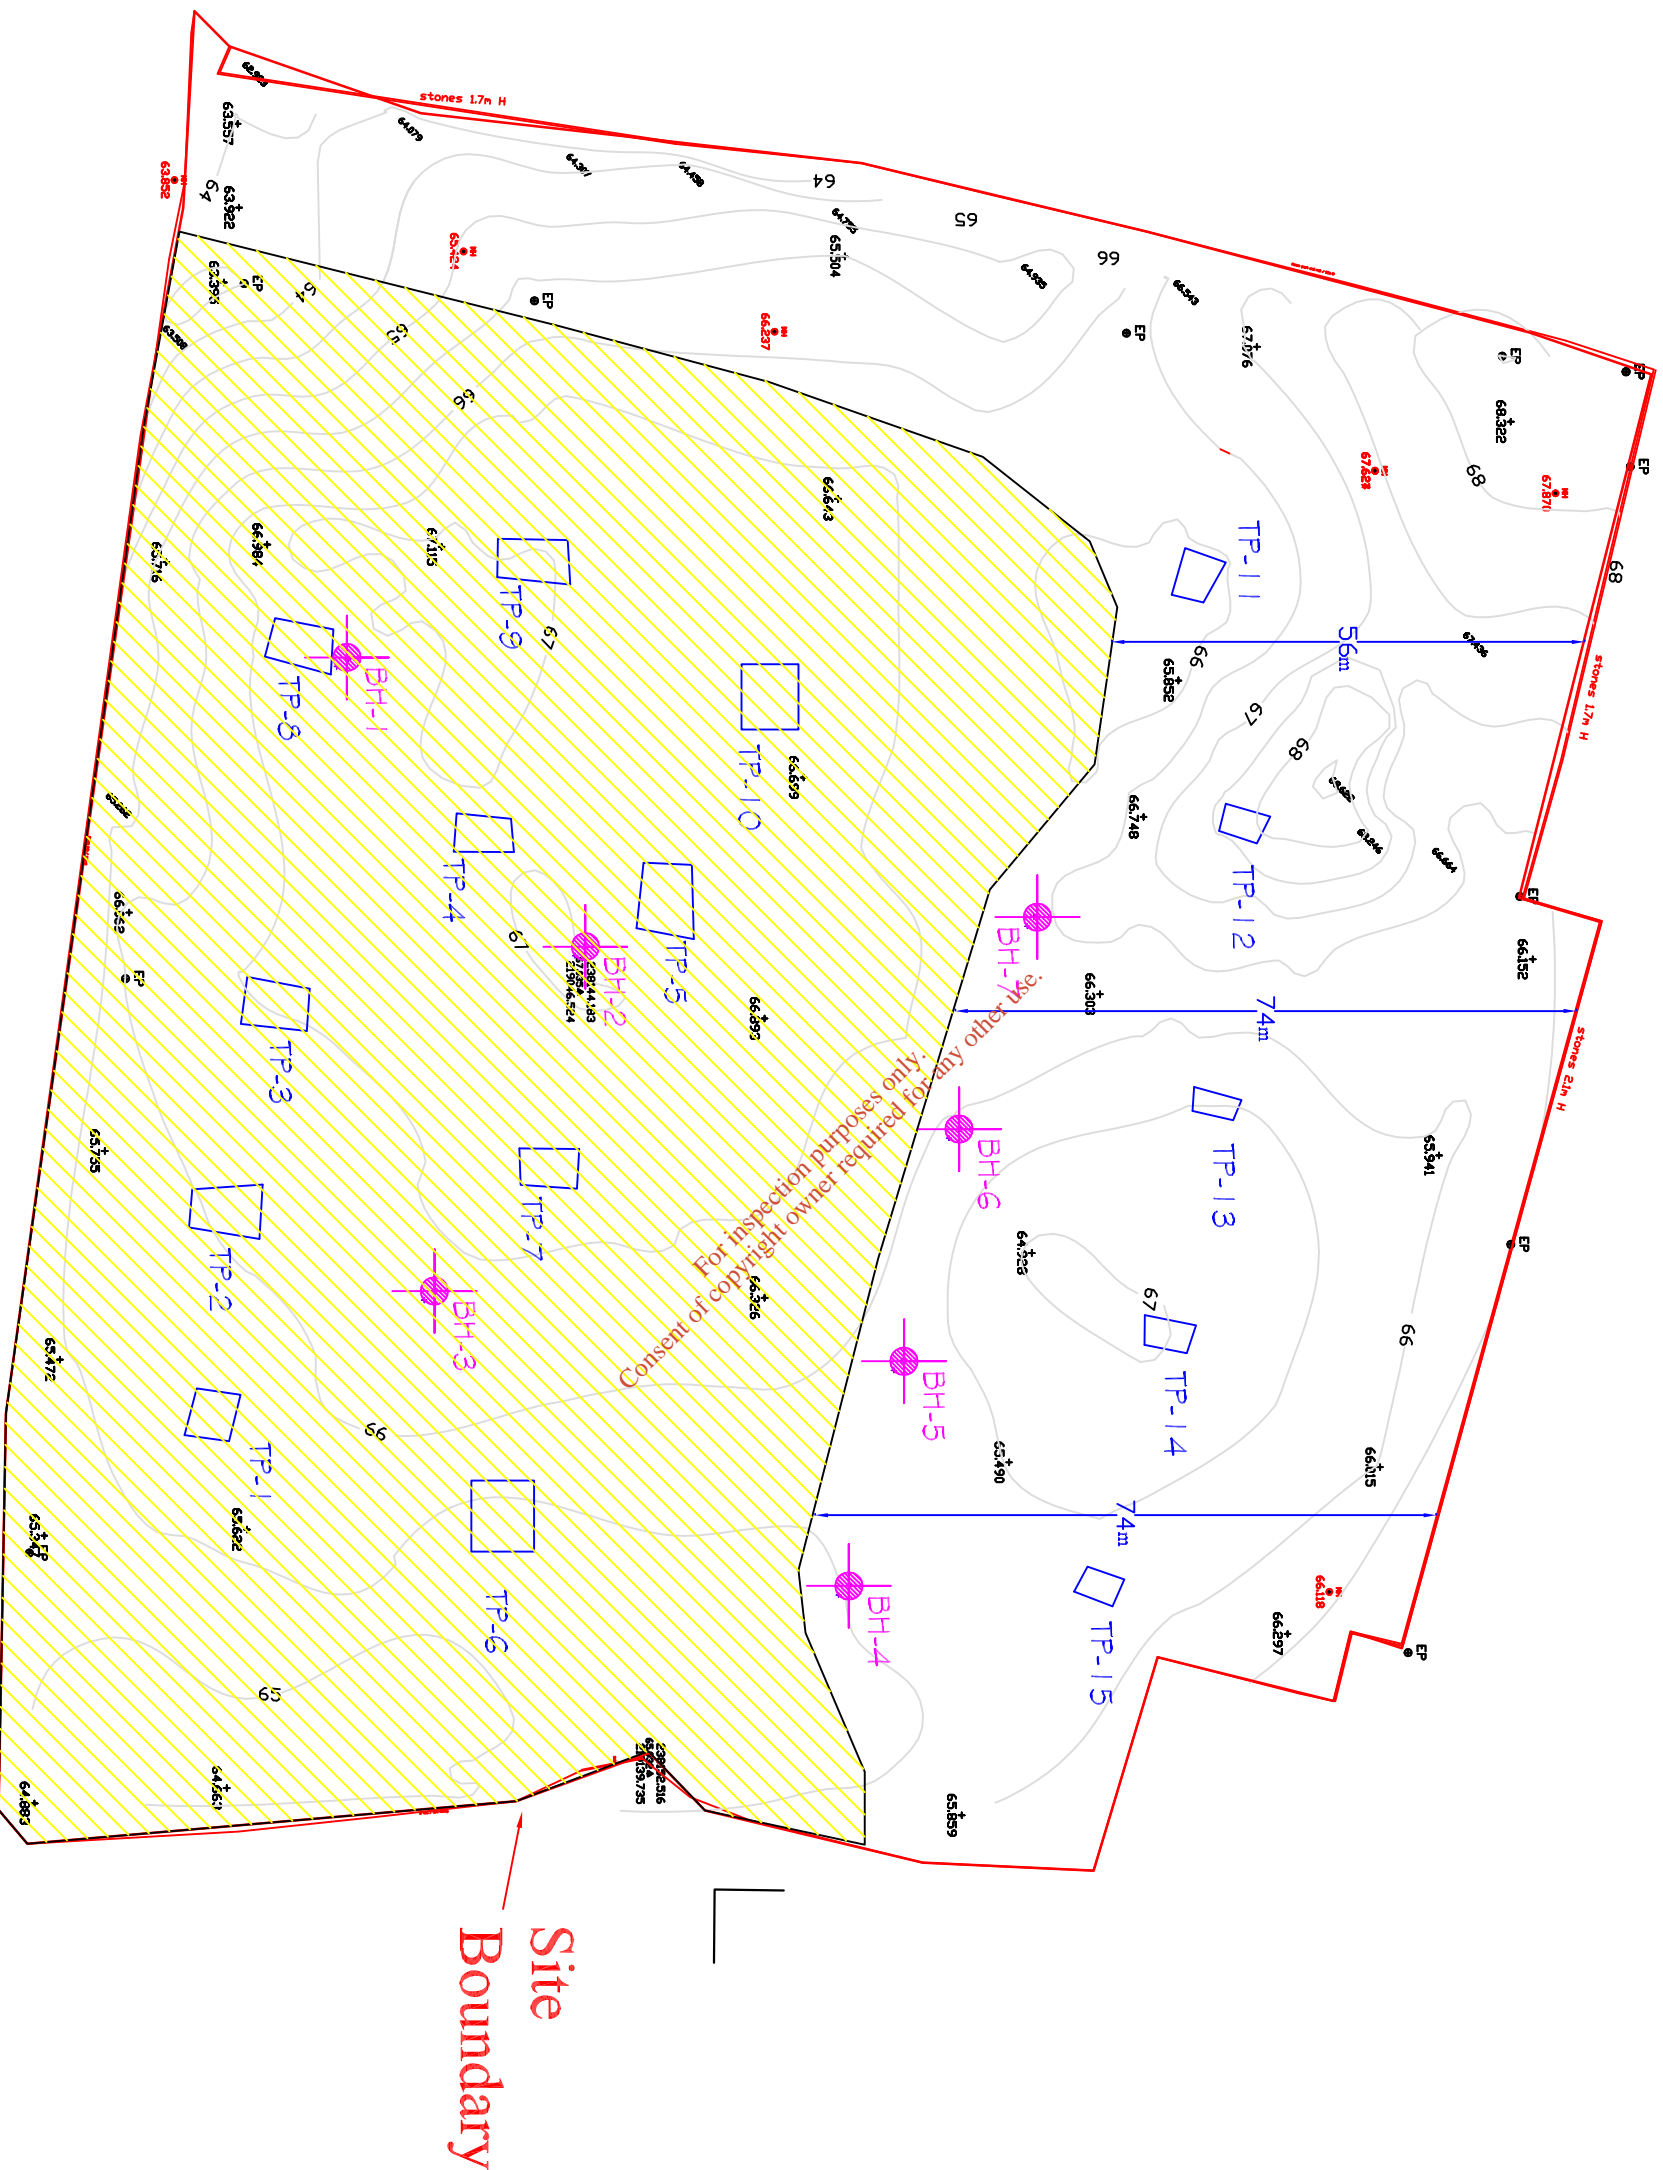
Extent of Waste Body

Initially thirteen (13 No) shallow trial trenches were excavated to delineate the lateral extent of the waste. Following this, ten (10 No) pits were excavated within the waste body to determine the depth of the waste and to collect representative samples for laboratory analyses. Five (5 No) pits were excavated in the undisturbed ground north of the deposition area to establish natural ground conditions.

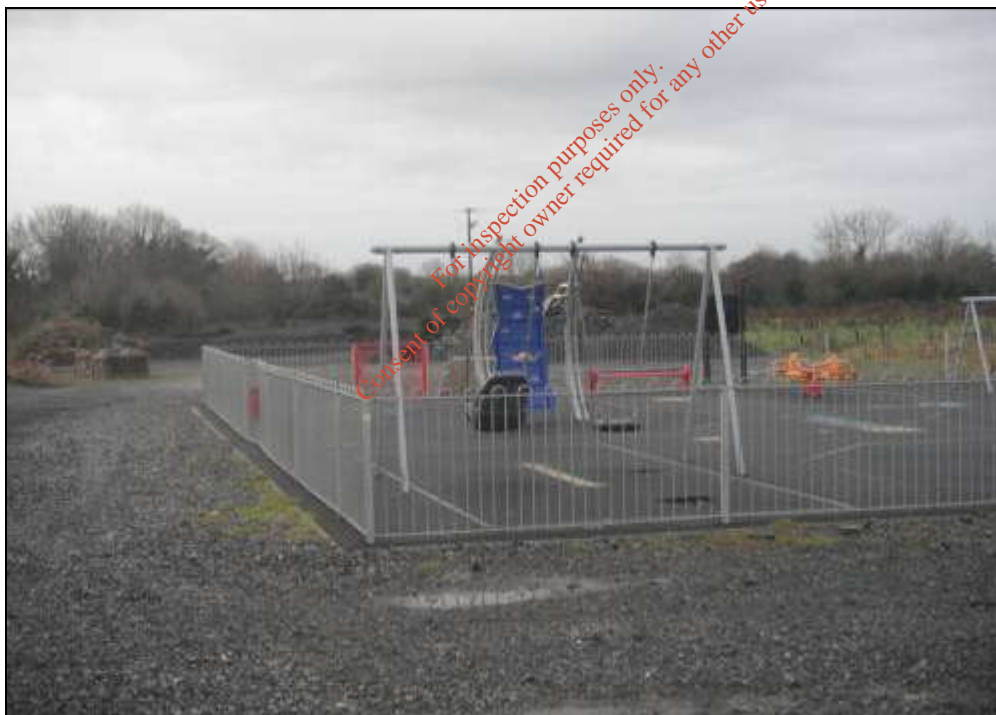
Photograph No 5 Looking South: Playground in eastern part of the site

The construction of the playground involved the placement of 600mm of Clause 804 aggregate on a geotextile layer which was then covered with approximately 324m² of soft asphalt. The hard core extends beyond the asphalted area. The playground is surrounded by a 1.2m high railing. (Photograph No 5). Drainage from the play area is directed to the stream along the southern boundary. .

It is recommended that no buildings or enclosed spaces be either constructed, or provided at the playground or civic amenity area.

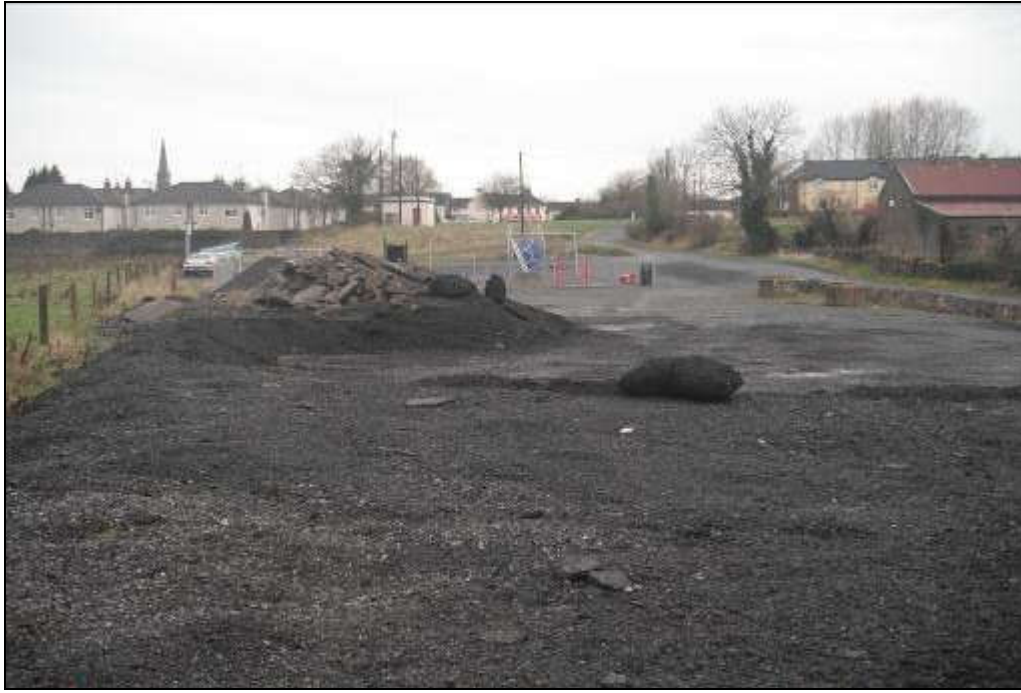
Photograph No 6 Looking North Road Planings

The area to the south of the playground is used to temporarily store road planings (Photograph No 6).

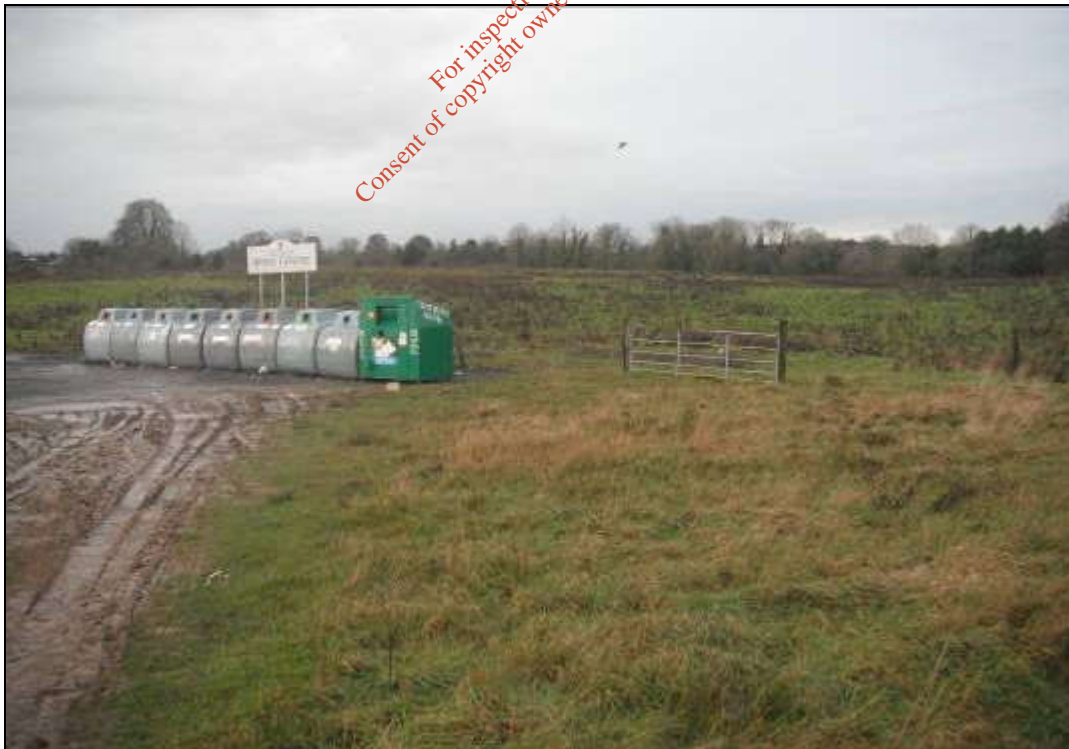
Photograph No 7 Looking South West: Bring Centre & Southern Part of the Site

The civic amenity bring centre is to the north of the playground and contains bottle, aluminium cans and clothes banks (Photograph No 7). The proposed location of the Moate Football Club Dressing Rooms is immediately to the south west of the bring centre, with the pitch further to the south.

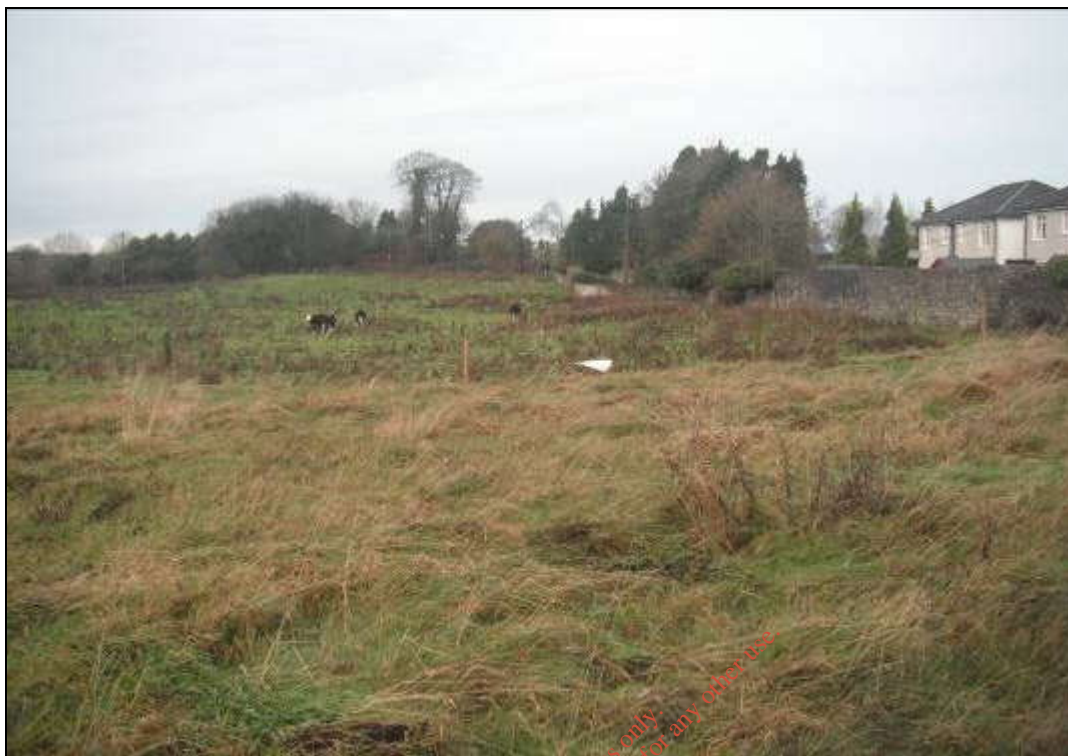
Photograph No 8 Livestock in the Northern Unfilled Area.

The remainder of the site, which is to the west of and fenced from the play ground and civic amenity area, is covered in grass and used for animal grazing (Photograph No 8).
