## TIER 2 ENVIRONMENTAL RISK ASSESSMENT

# Carrigeen Former Landfill Site, Clane, Co. Kildare

**Report Number.** 10507190201.500/A.0

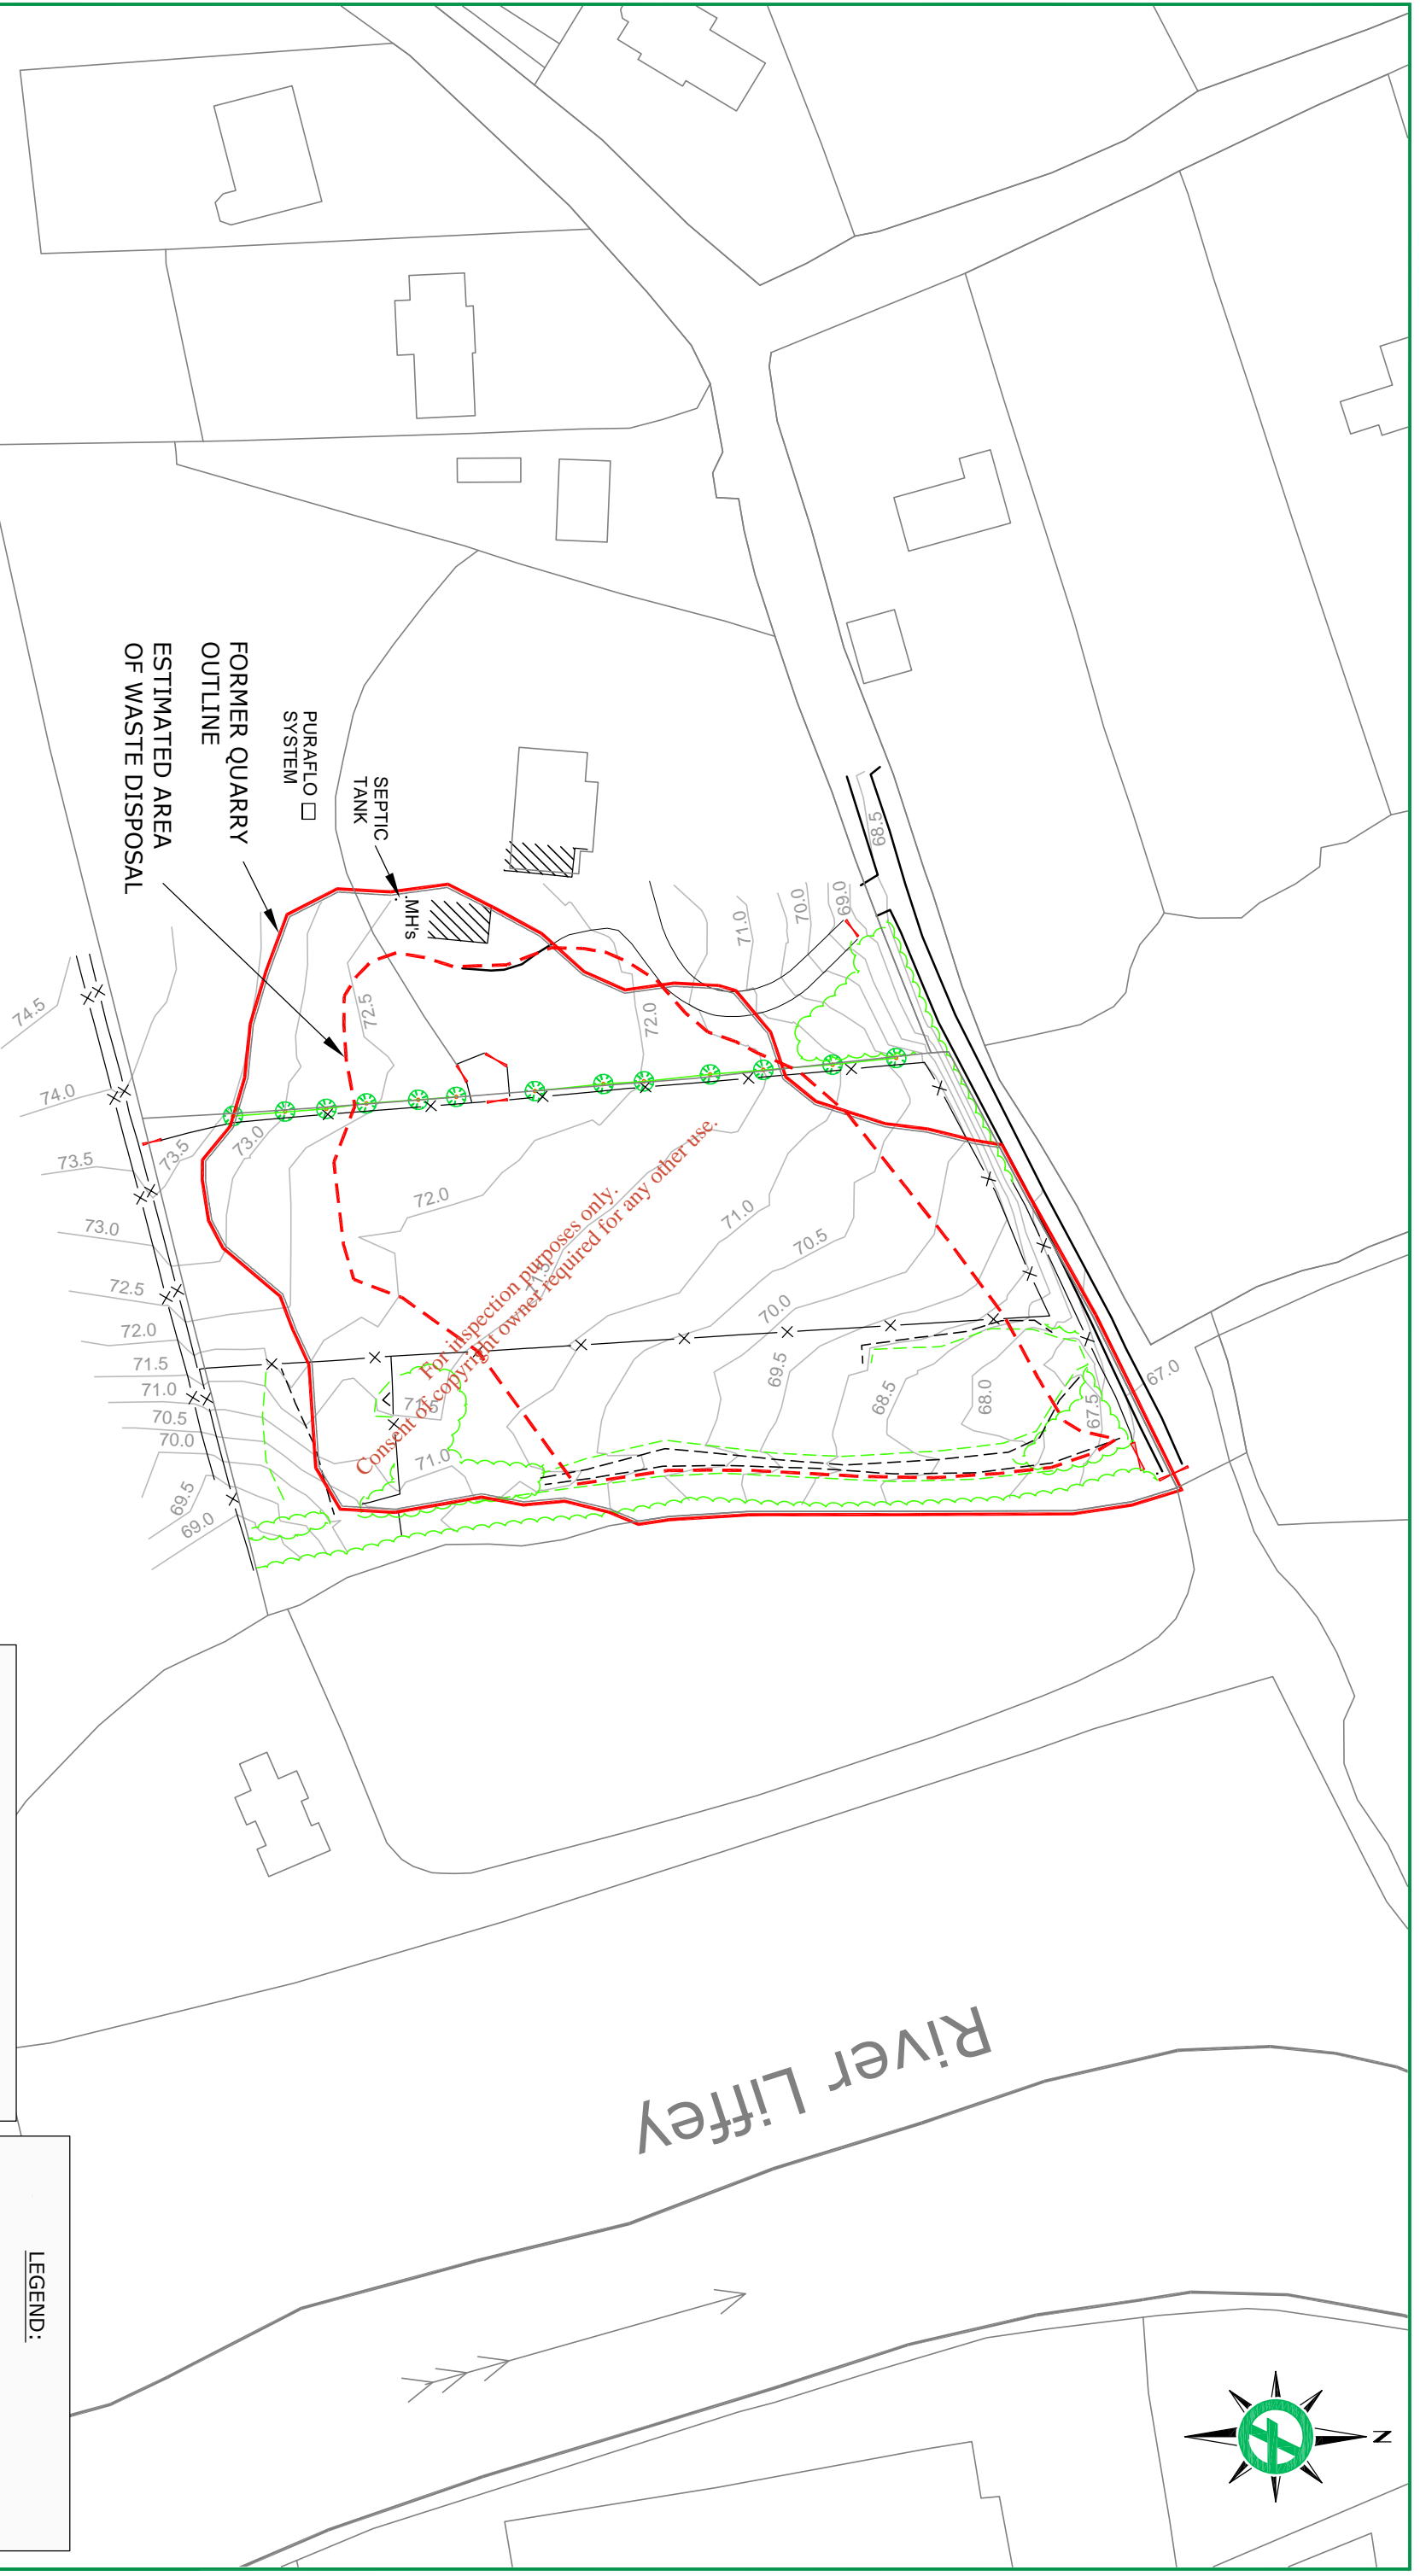
## Figure 1

The Site layout and sampling locations are presented in Figure 01 (Appendix A).

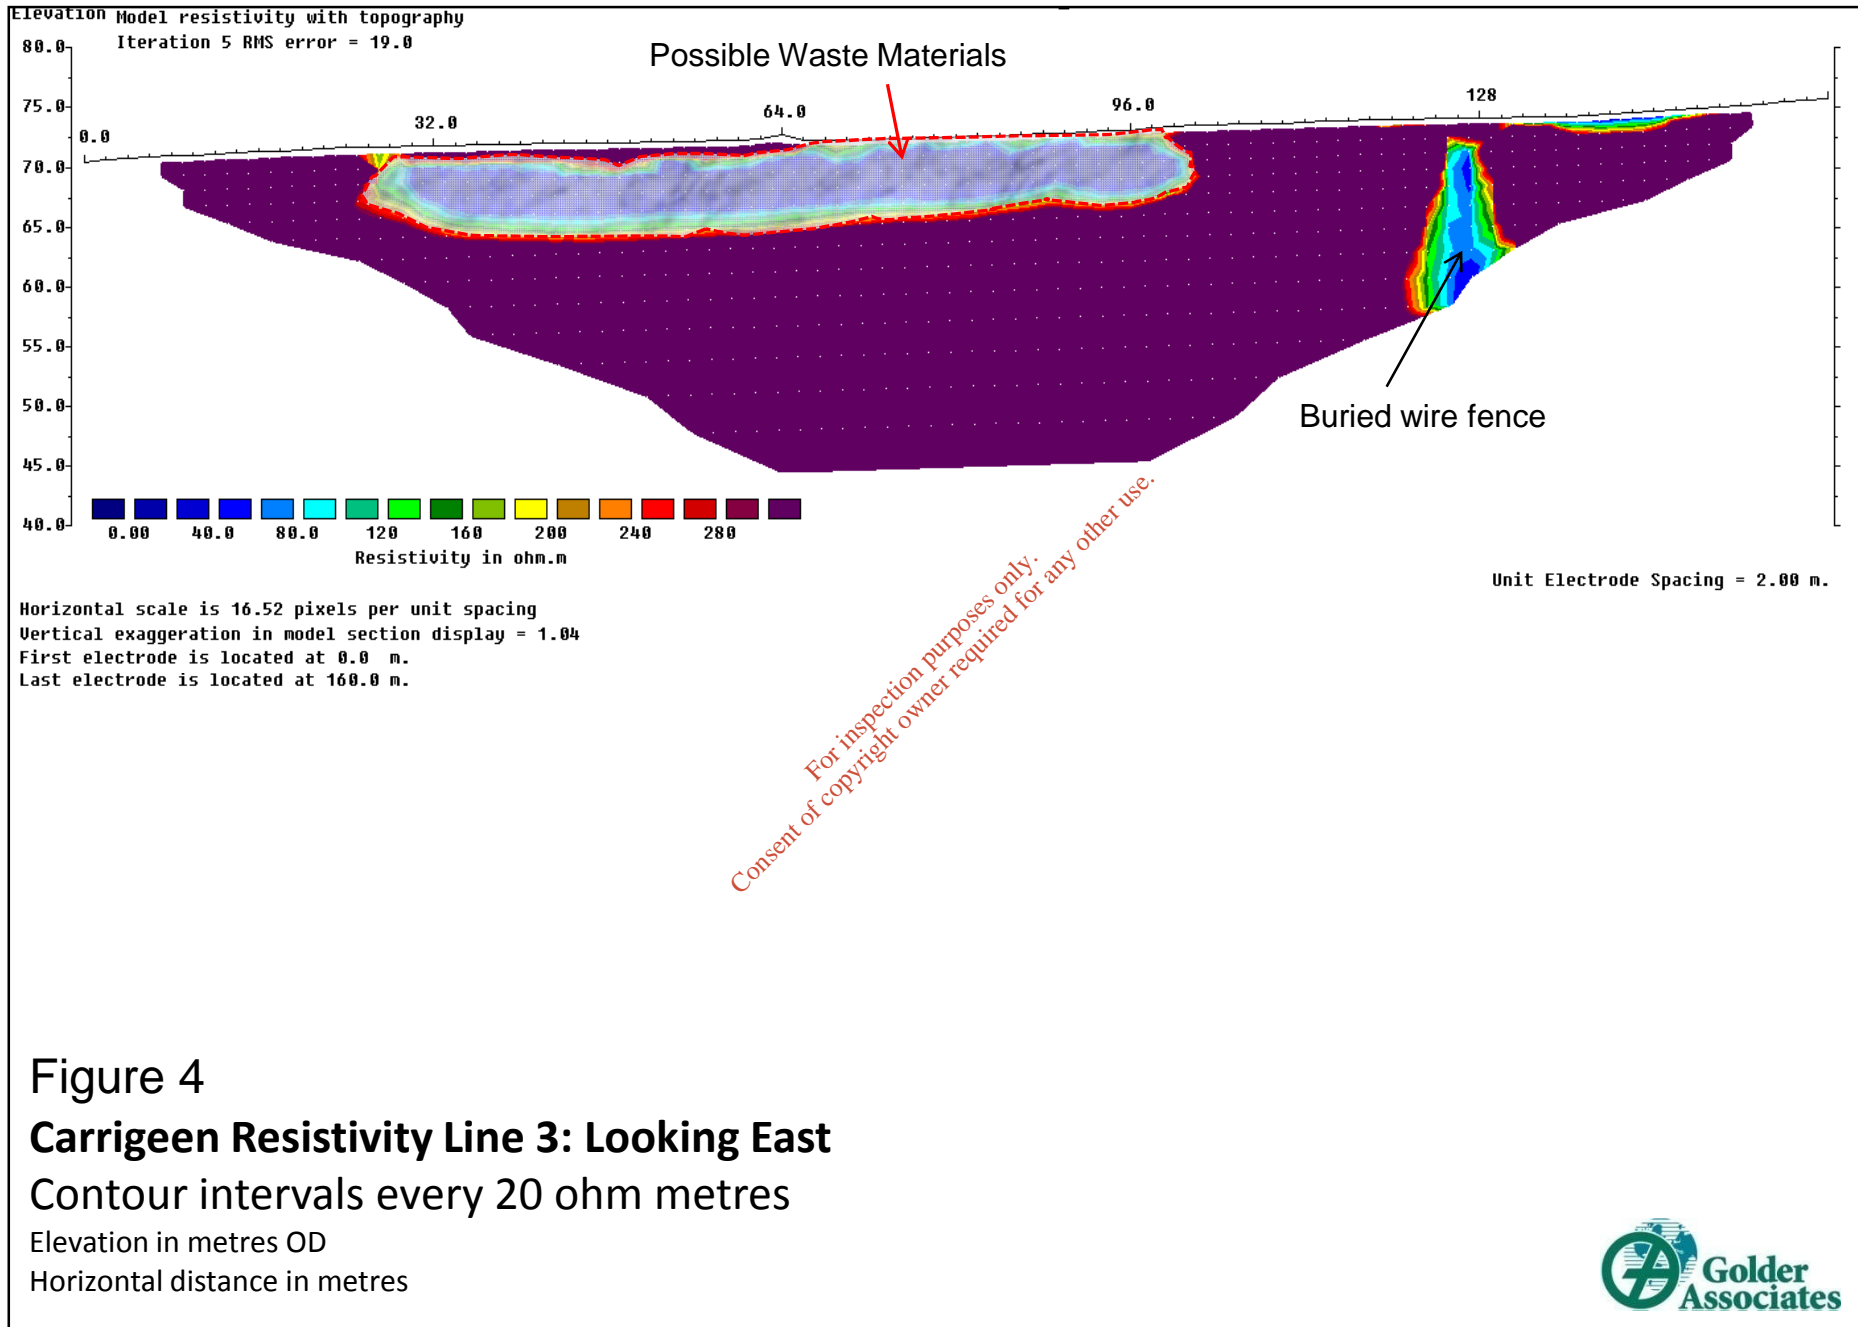
**Figure 4**  
**Carrigeen Resistivity Line 3: Looking East**  
 Contour intervals every 20 ohm metres  
 Elevation in metres OD  
 Horizontal distance in metres

As with both Lines 1 and 2, the very low resistivity values recorded along Line 3, appear to be well constrained by the underlying bedrock topography. It is recommended that a number of trial pits (in excess of at least 3m deep) be excavated to investigate the type of 'waste' materials and depth to bedrock at ca. 36m, 60m and 82m along this line.

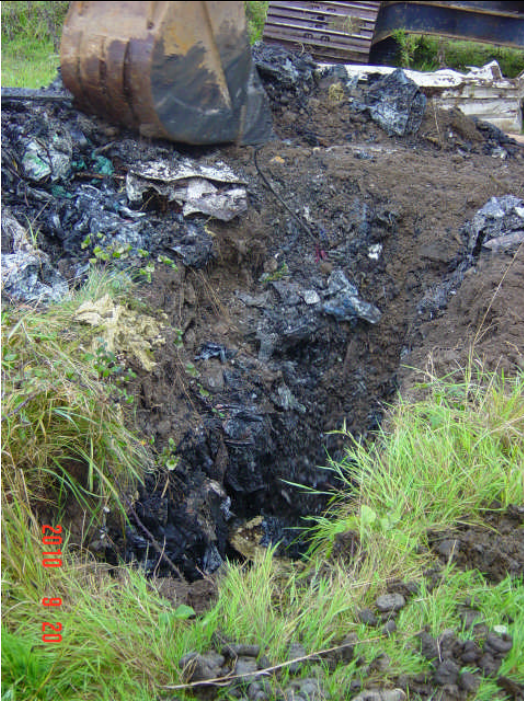
Trial Pit 1

Location	Depth (m)	Thickness of Capping (m)	Bedrock depth (mbgl)	Waste Types	Inert/ biodegradable of waste (%)	Additional Comments
TP01	2.70	0.30	2.70	Black plastic 40-60% Wood 5% Bottles 1% Metal 1% Plastic containers 1-3% Rags and Textiles 1-3%	30/70	Strong leachate and sewer smell during excavation
TP02	2.90	1.60	2.90	C&D waste 30% Black plastic 20% Rags and Textiles 1-3% Plastic containers	50/50	Significant water ingress at 2.90m

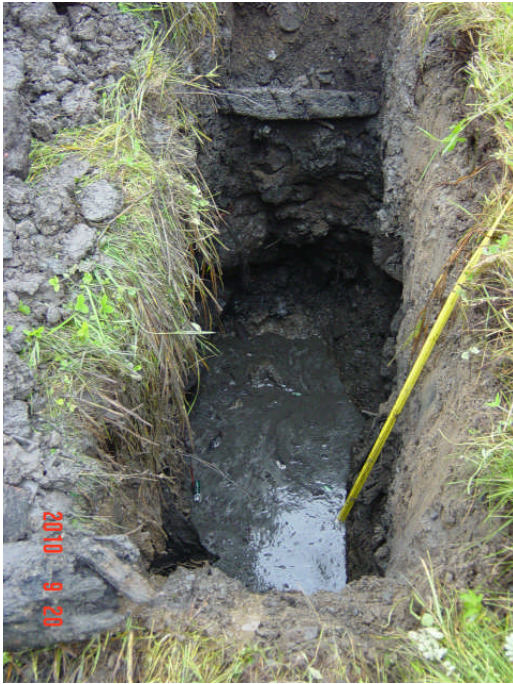
Trial Pit 3

Location	Depth (m)	Thickness of Capping (m)	Bedrock depth (mbgl)	Waste Types	Inert/ biodegradable of waste (%)	Additional Comments
				1-3% Metal 1%		
TP03	2.70	0.40	2.70	C&D 50% Glass, bricks, rock, wood 5% Plastic <1%	60/40	Water at 2.4m
TP04	2.70	0.50	2.70	Plastic 30-60% Wood 5% Pipes 1-5% Paper 20%		Dry
TP05	4.50	0.80	4.50	C&D 40-60% Plastic 20-30% Wood 2.5-7% Stone 10-15% Metal 2-5% Textiles 1-3%	60/40	Dry Layer of dry C&D waste to 2.30mbgl underlain by mixed domestic waste
TP06	4.50	0.70	Not encountered	Black plastic, textiles, paper up to 70% Metal 1-5% Wood 5-10%	50/50	Dry Newspaper dated 1980 still legible Strong waste odour
TP07	4.20	0.70	Not encountered	C&D waste 10% Municipal waste comprising plastic wood and textiles 70-80%	30/70	Dry Moderate waste odour
TP08	1.50	0.50	Not encountered	Boulder clay, possibly fill 90%	100/0	Dry No C&D or municipal waste
TP09	3.00	0.50	Not encountered	Boulder clay possibly C&D fill (all)	100/0	Dry No visible waste or odour

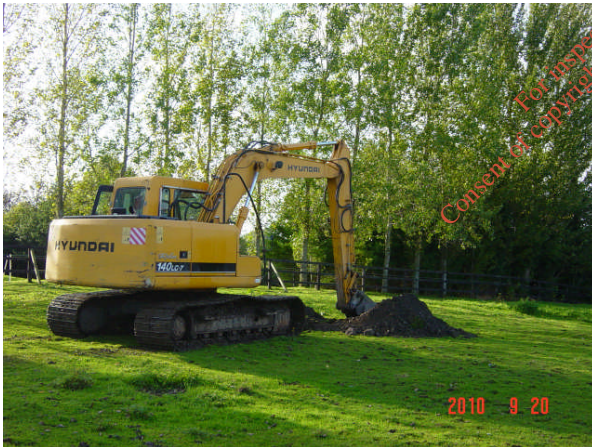
Trial Pit 10

TP10	4.00	0.80	Not encountered	C&D fill and broken rock fragments (all)	100/0	Dry No odour
TP11	1.50	0.50	Not encountered	Mixed domestic and C&D plastic, glass, plastic bottles (30%)	90/10	Dry Moderate odour
TP12	1.20	0.40	Not encountered	Plastic 5% C&D 10%	95/5	Dry Moderate odour

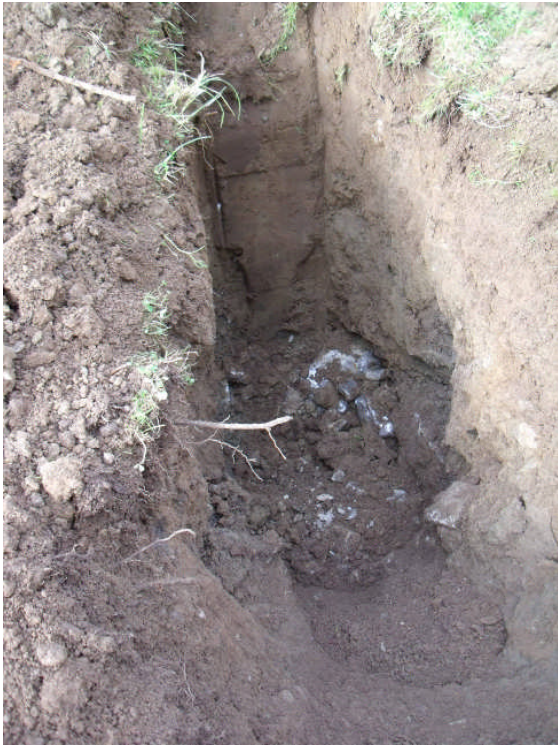
Trial Pit 13

Location	Depth (m)	Thickness of Capping (m)	Bedrock depth (mbgl)	Waste Types	Inert/ biodegradable of waste (%)	Additional Comments
TP13	1.10	0.50	No encountered	Possibly all natural ground, large amount of cobbles and broken rock	100/0	Dry no odour
