2017 ANNUAL ENVIRONMENTAL REPORT

**LENNON QUARRIES LIMITED,
SOIL RECOVERY FACILITY,
TALLAGH HILL, BELMULLET, CO. MAYO**

Waste Licence Reg. No. WO-256-02

(Reporting Period January 2017– December 2017)

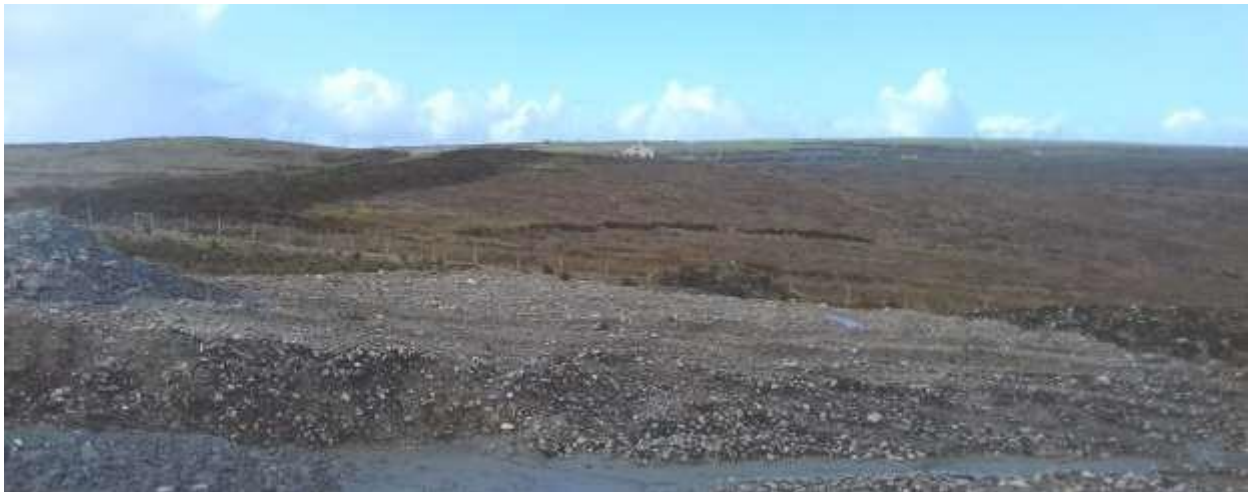
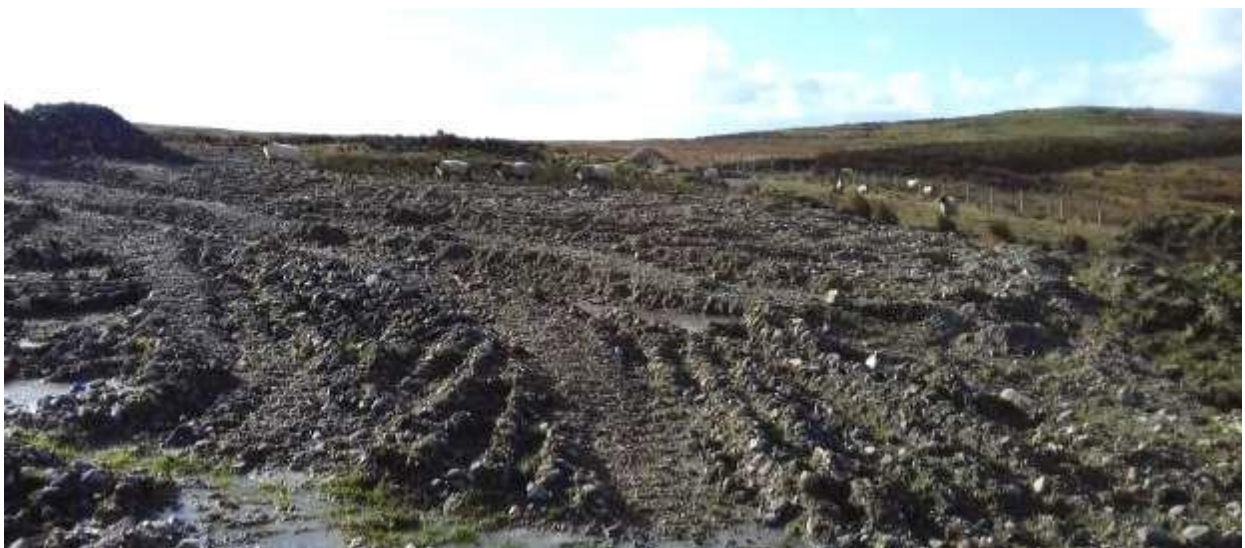
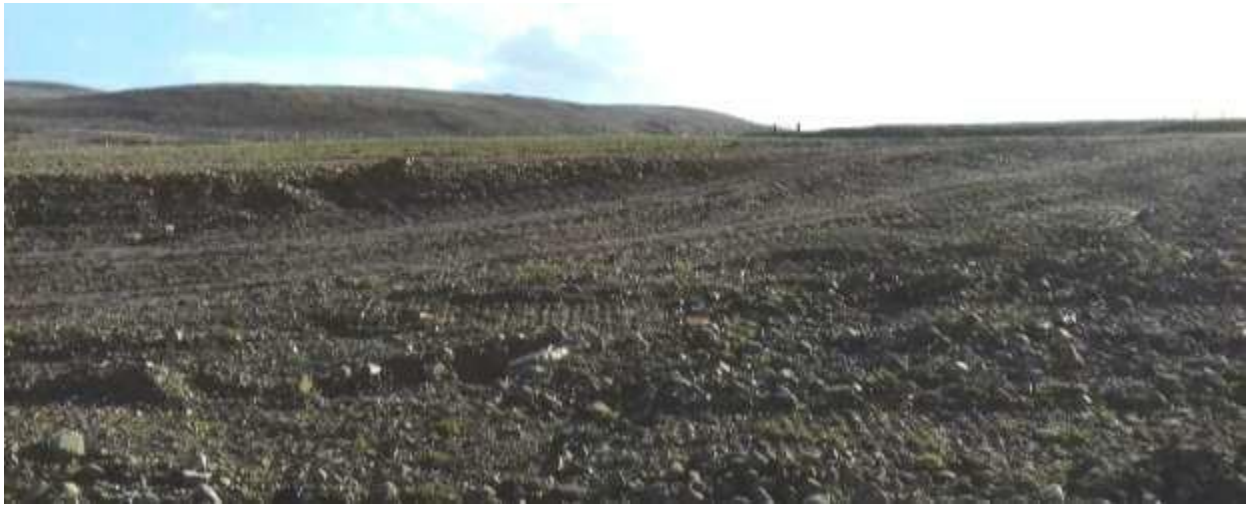
An inspection of the fill site in Tallagh, as demonstrated by the photographs below;

The inspection and photographic evidence shows that the material being deposited is;-

- In a solid state
- The existing ground does not exceed 1 in 12 slope
- The total height of the material does not exceed 2.5 meters at any time
- The material that is unloaded in the designated area is levelled and maintained at a slope of less than 1 in 3 at all times prior to final levelling & final grading.
- The total area being filled at any one time is less than 5,000 square meters.
- There are no structures or objects within the fill area which may be in danger

As can be seen from the above photographs it is evident that the ground conditions does not pose any significant risk from collapse or movement and the hazard is deemed not to be significant or potentially significant it is not necessary to consider any further action.
