## 5 APPENDICES

### 5.1 NEED FOR DEVELOPMENT

A notice issued by the EPA on 18<sup>th</sup> December 2017 under Article 16(1) of the Waste Management (Licencing) Regulations 2004, required an environmental liabilities risk assessment (ELRA) to be prepared in accordance with *Guidance on assessing and costing environmental liabilities* (EPA 2014). This (characterisation) report identifies the environmental risks associated with the Clashford site to allow the ELRA to be undertaken. The ELRA is completed by others on the Project Team. This report is focused on the Phase 2 Restoration Area of the Clashford WRF site. The Phase 2<sup>1</sup> Restoration Area is identified on **Figure B**.

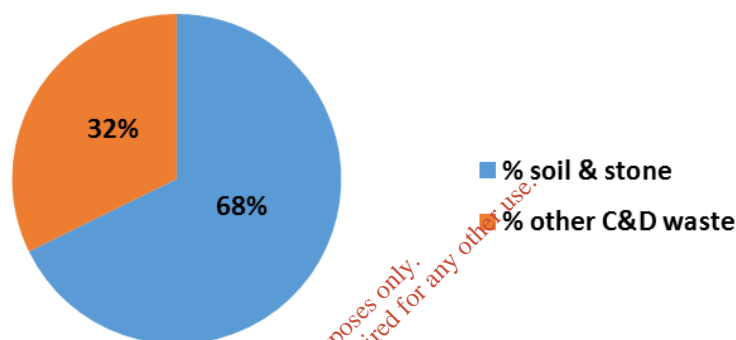
**Figure 5.1-1 C&D Wastes Collected in the Eastern-Midlands Region in 2012**

The soil and stone waste collected within the EMR is primarily managed at local authority permitted infill sites with the other C&D waste types primarily managed at EPA licensed activities.

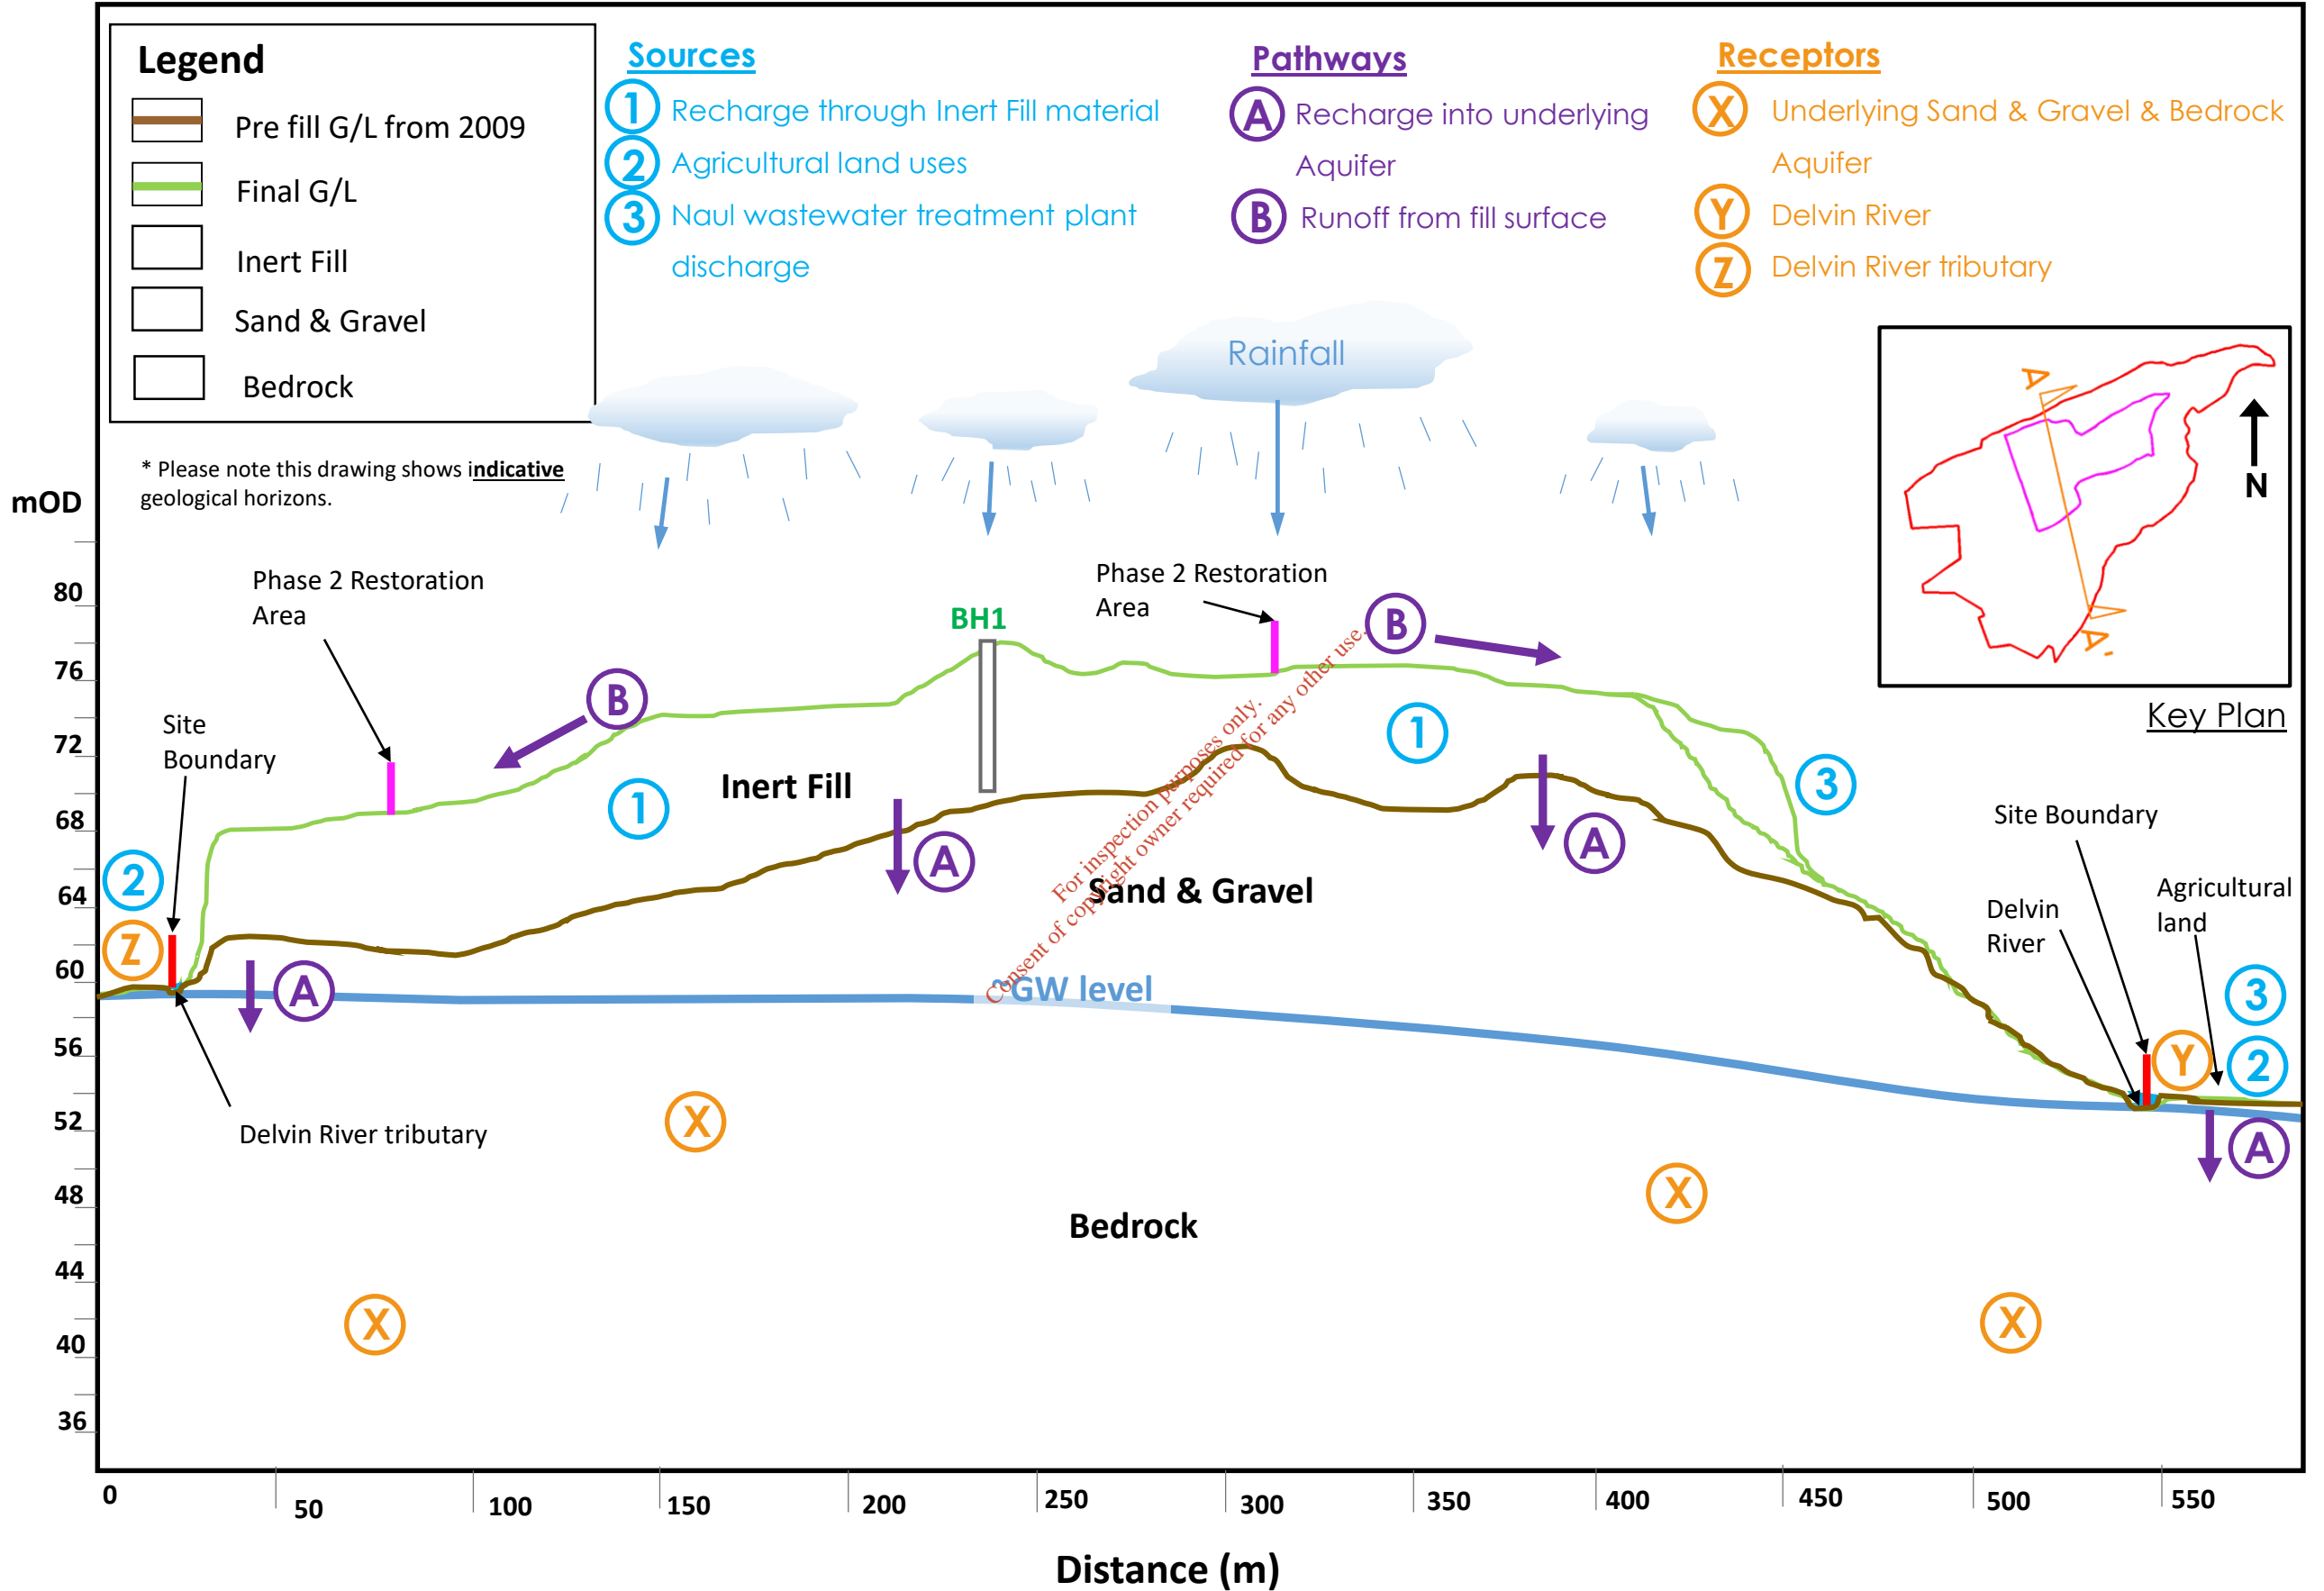
Figure 2 - CSM of Clashford WRF Site

Listed below are all the potential minor sources of contamination that were noted this assessment, along with the main potential pathways and receptors. These notes should be read in conjunction with the CSM diagram presented in **Figure 2**.

- Leakages and spillages of fuels and chemicals stored on the site or used in machinery and trucks during backfill of the site;
- Leaching to groundwater from the infilled deposition areas; and
- Material with pollution potential on site surfaces e.g. sediment, and subsequent entrainment in site runoff during rainfall events.

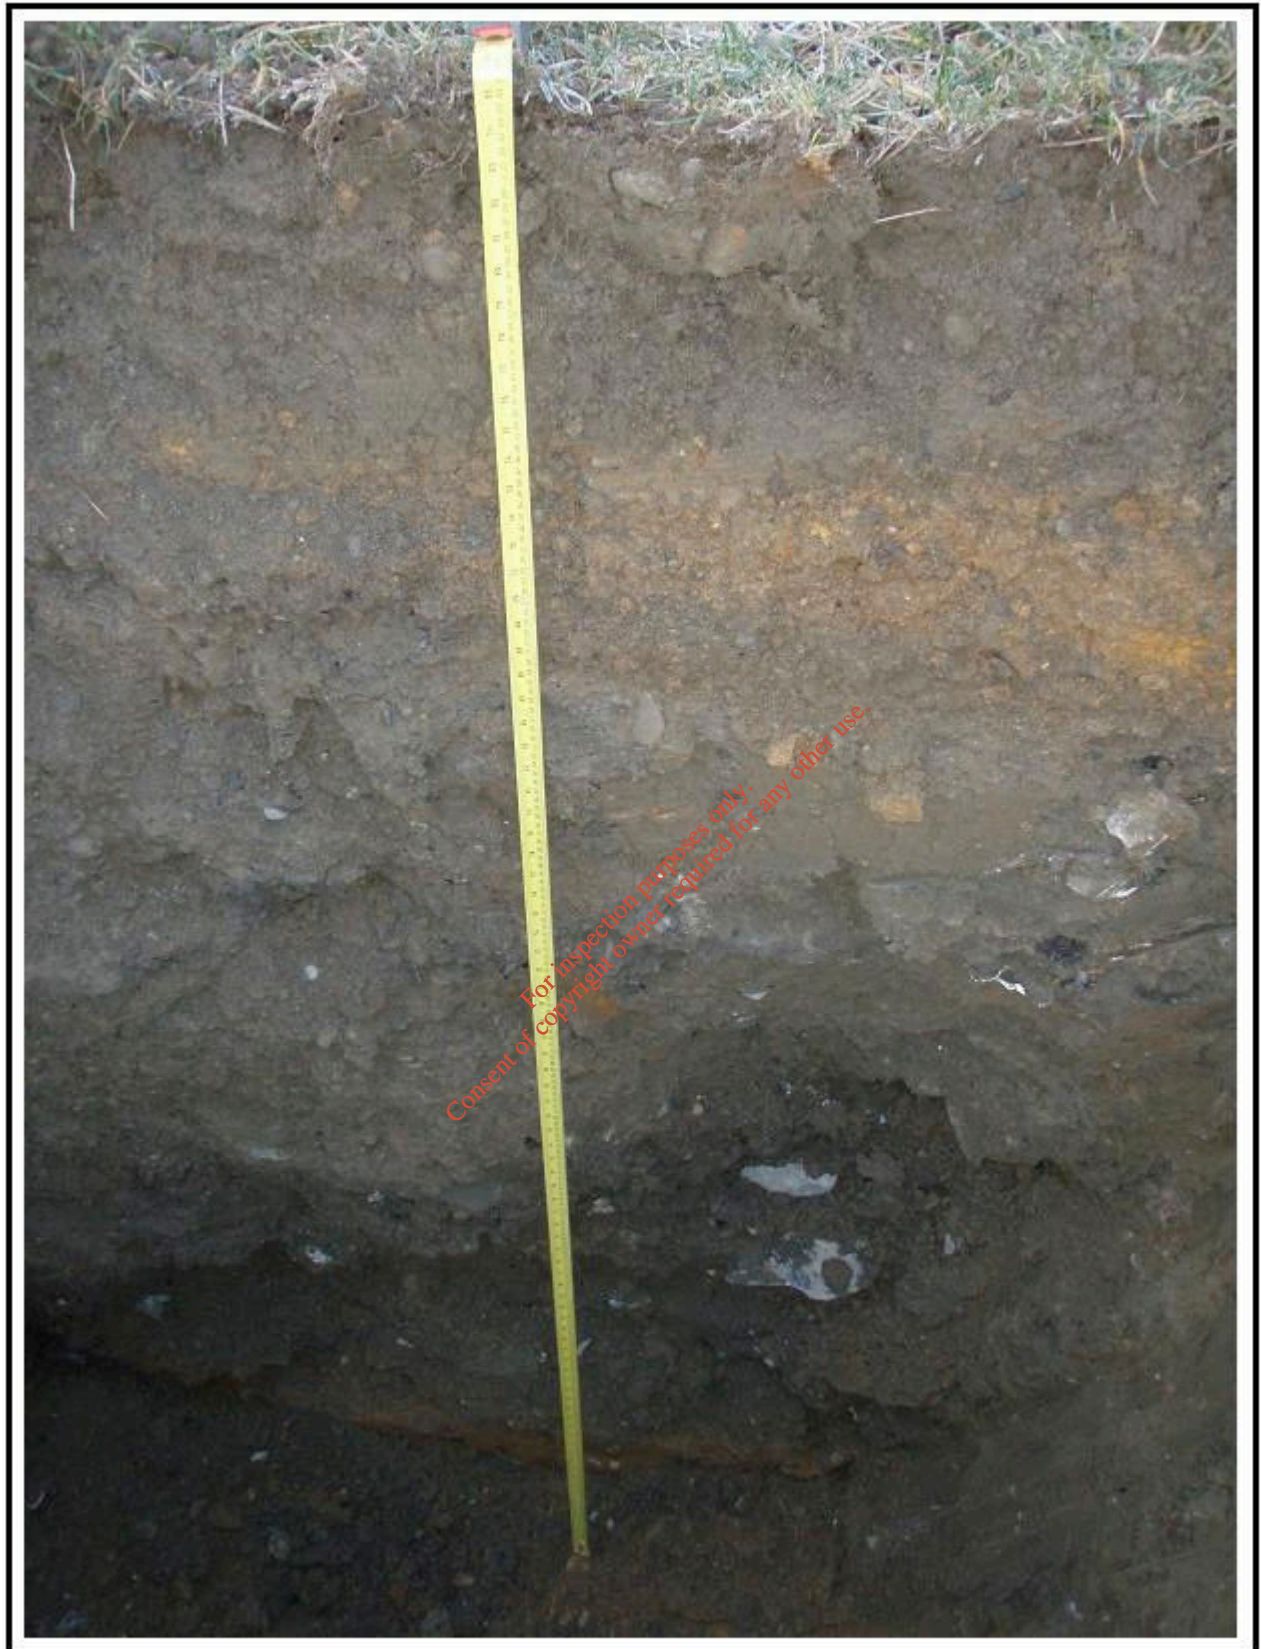
**Stability :**  
 Trial pit walls very consolidated, and material very competent.

**Sequence summary :**  
 Well drained, deep, 'filled' topsoil over filled boulder clay, 'lifted' on-site.

**Plate A1: Profile of deep topsoil overlying subsoil in trial hole no. 1. See the absence of waste material from the profile and the well aerated nature of the material, with no groundwater seepages throughout the profile.**

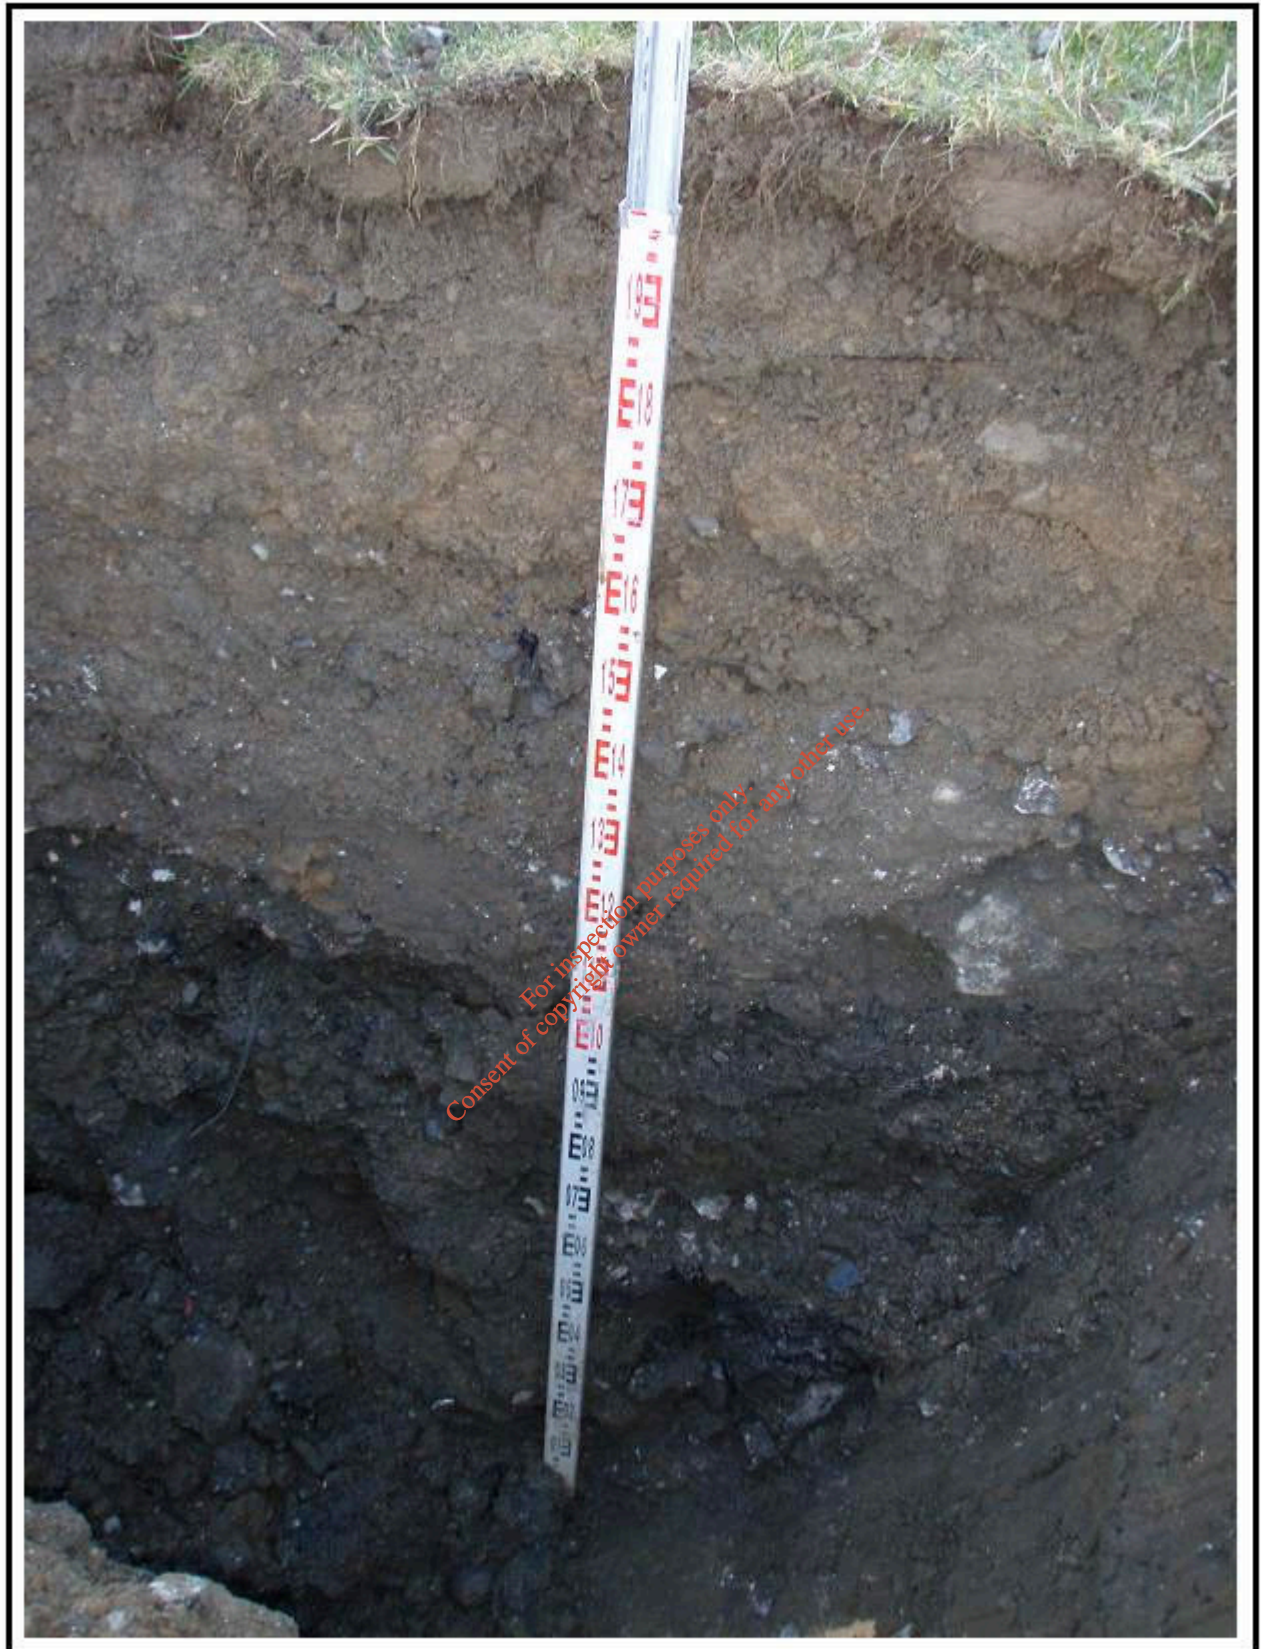
**Stability :**  
 Trial pit walls very consolidated, and material very competent.

**Sequence summary:**  
 Well drained, deep, 'filled' topsoil over filled boulder clay, 'lifted' on-site.

**Plate A2: Profile of topsoil overlying subsoil in trial hole no. 2. See the general absence of waste material from the profile and the well aerated nature of the material, with one slight groundwater seepage at 1.05m depth.**

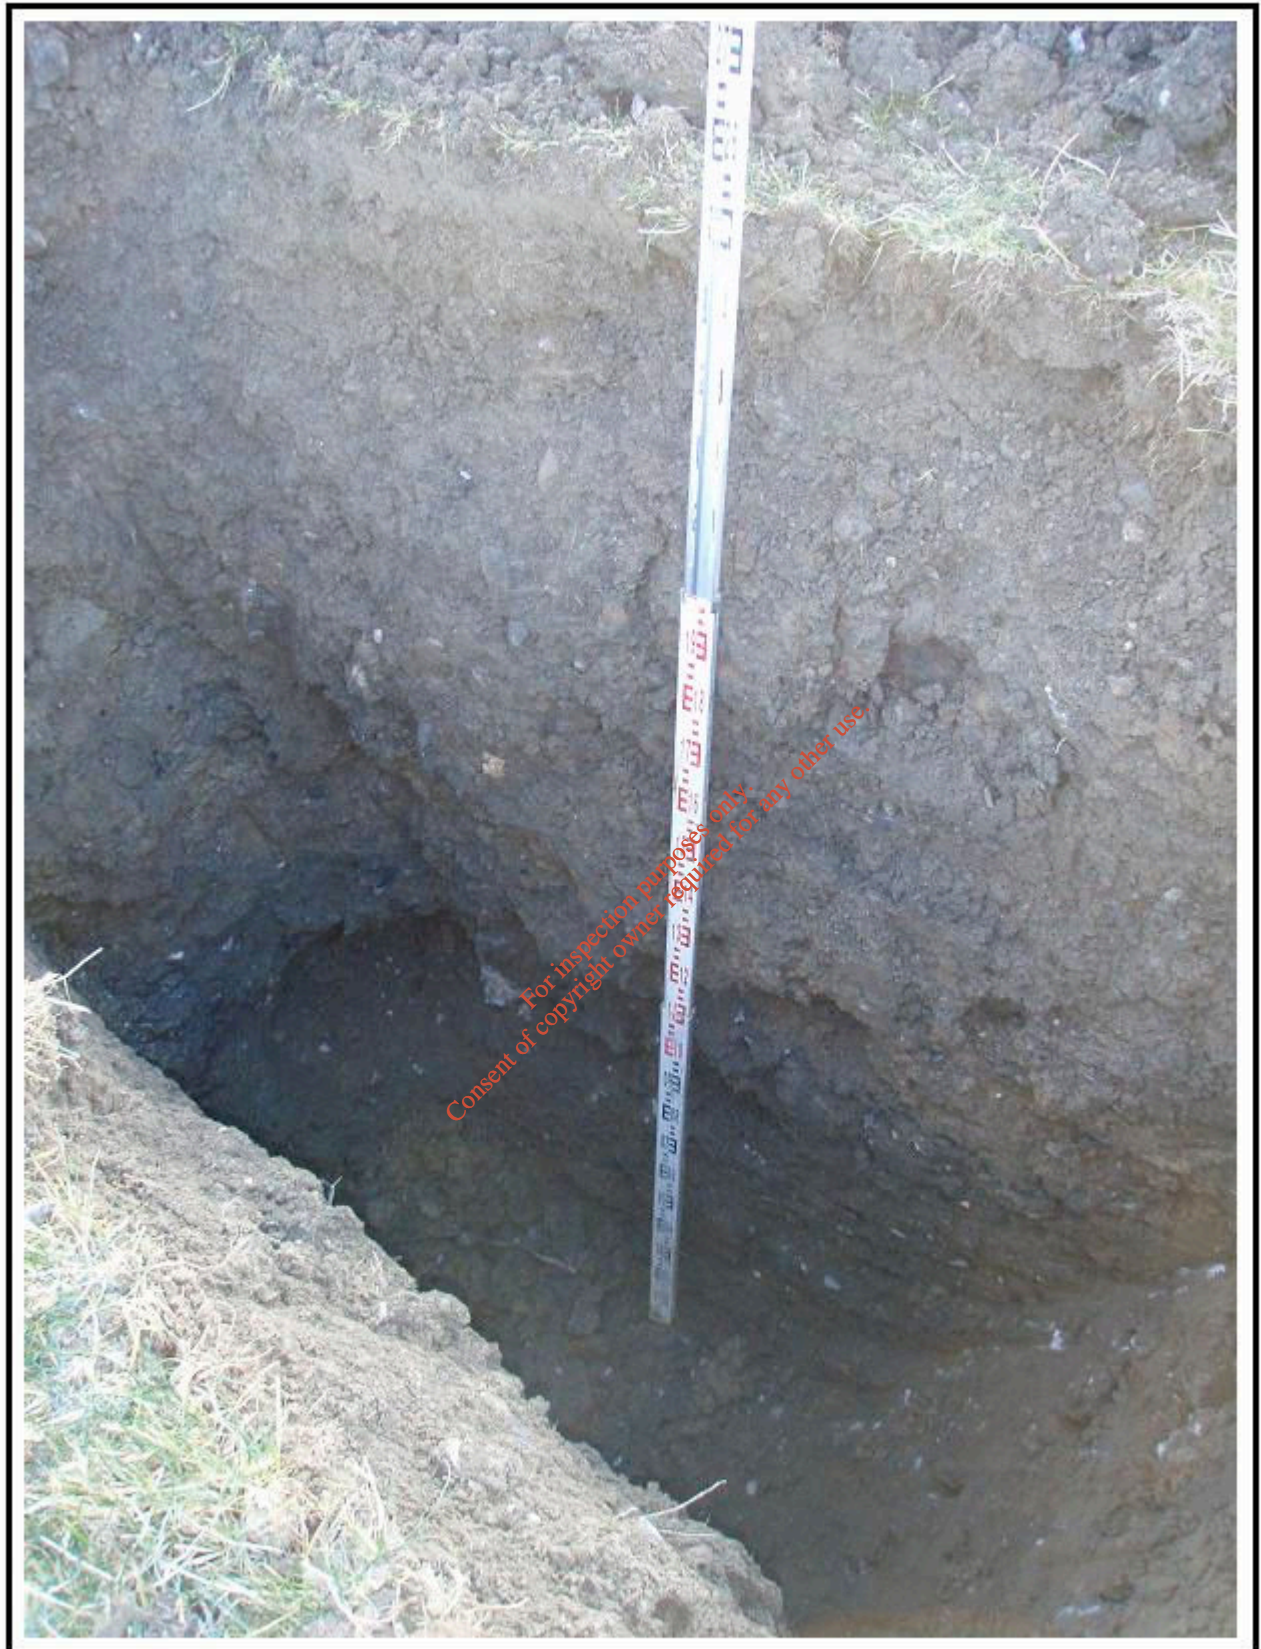
**Stability :**  
 Trial pit walls very consolidated, and material very competent.

**Sequence summary:**  
 Well drained, shallow, 'filled' topsoil over filled boulder clay, 'lifted' on-site.

**Plate A3: Profile of shallow soil overlying subsoil in trial hole no. 3. See the occasional pieces of concrete in the basal area of the profile and the well aerated nature of the material, with no groundwater seepages recorded to 2.5m depth.**

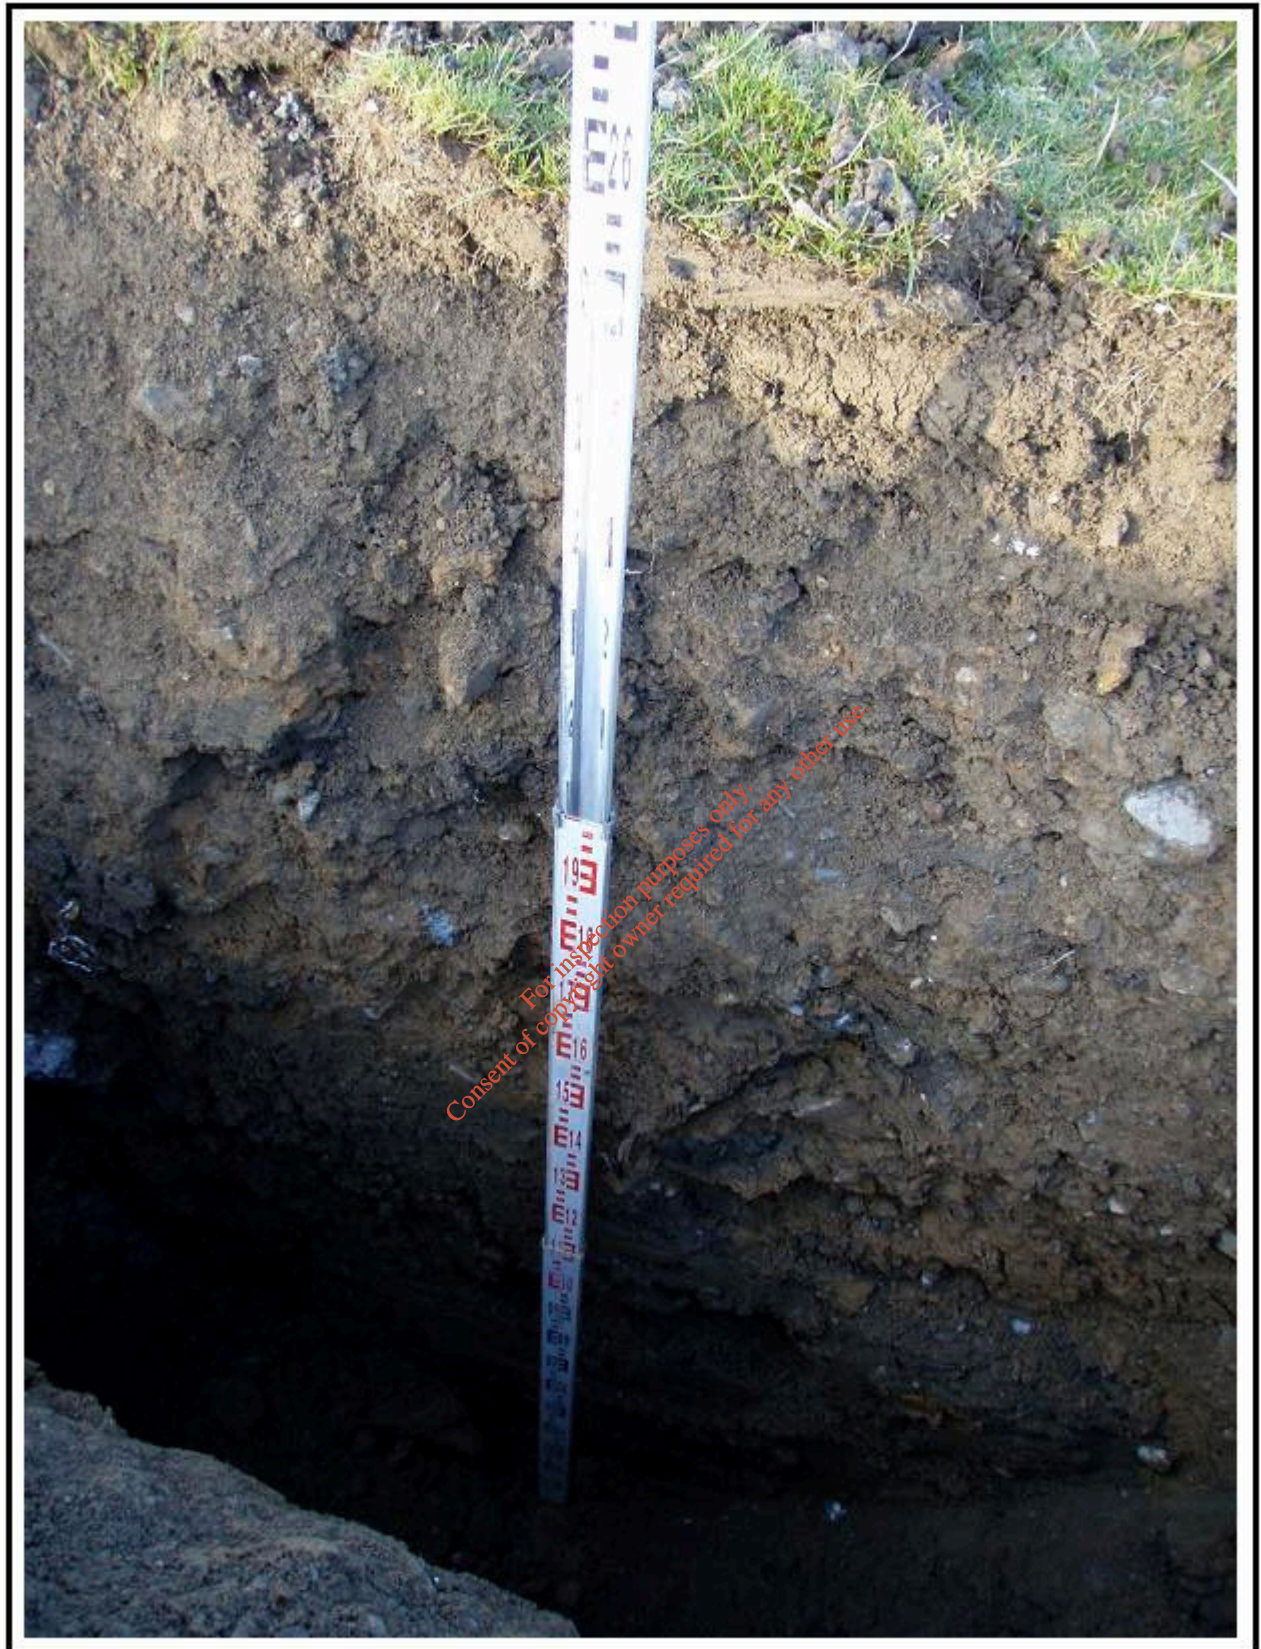
<p><b>Bearing</b> : 30° (SW-NE)</p>	<p><b>Stability :</b></p> <p>Trial pit walls very consolidated, and material very competent.</p>	
	<p><b>General remarks :</b></p> <p>Dug in southwestern portion of the dry, grass-covered 'reclaimed' field. Dug on a 1° slope, falling northwards.</p>	
	<table border="1"> <tr> <td> <p><b>Groundwater :</b></p> <p>Dry.</p> </td> <td> <p><b>Sequence summary:</b></p> <p>Well drained, shallow, 'filled' topsoil over filled boulder clay, 'lifted' on-site.</p> </td> </tr> </table>	<p><b>Groundwater :</b></p> <p>Dry.</p>
<p><b>Groundwater :</b></p> <p>Dry.</p>	<p><b>Sequence summary:</b></p> <p>Well drained, shallow, 'filled' topsoil over filled boulder clay, 'lifted' on-site.</p>

**Plate A5: Profile of shallow topsoil overlying subsoil in trial hole no. 5. See the occasional concrete pieces and fragments of steel within the profile and the well aerated nature of the material, with no groundwater seepages recorded to 2.47m depth.**

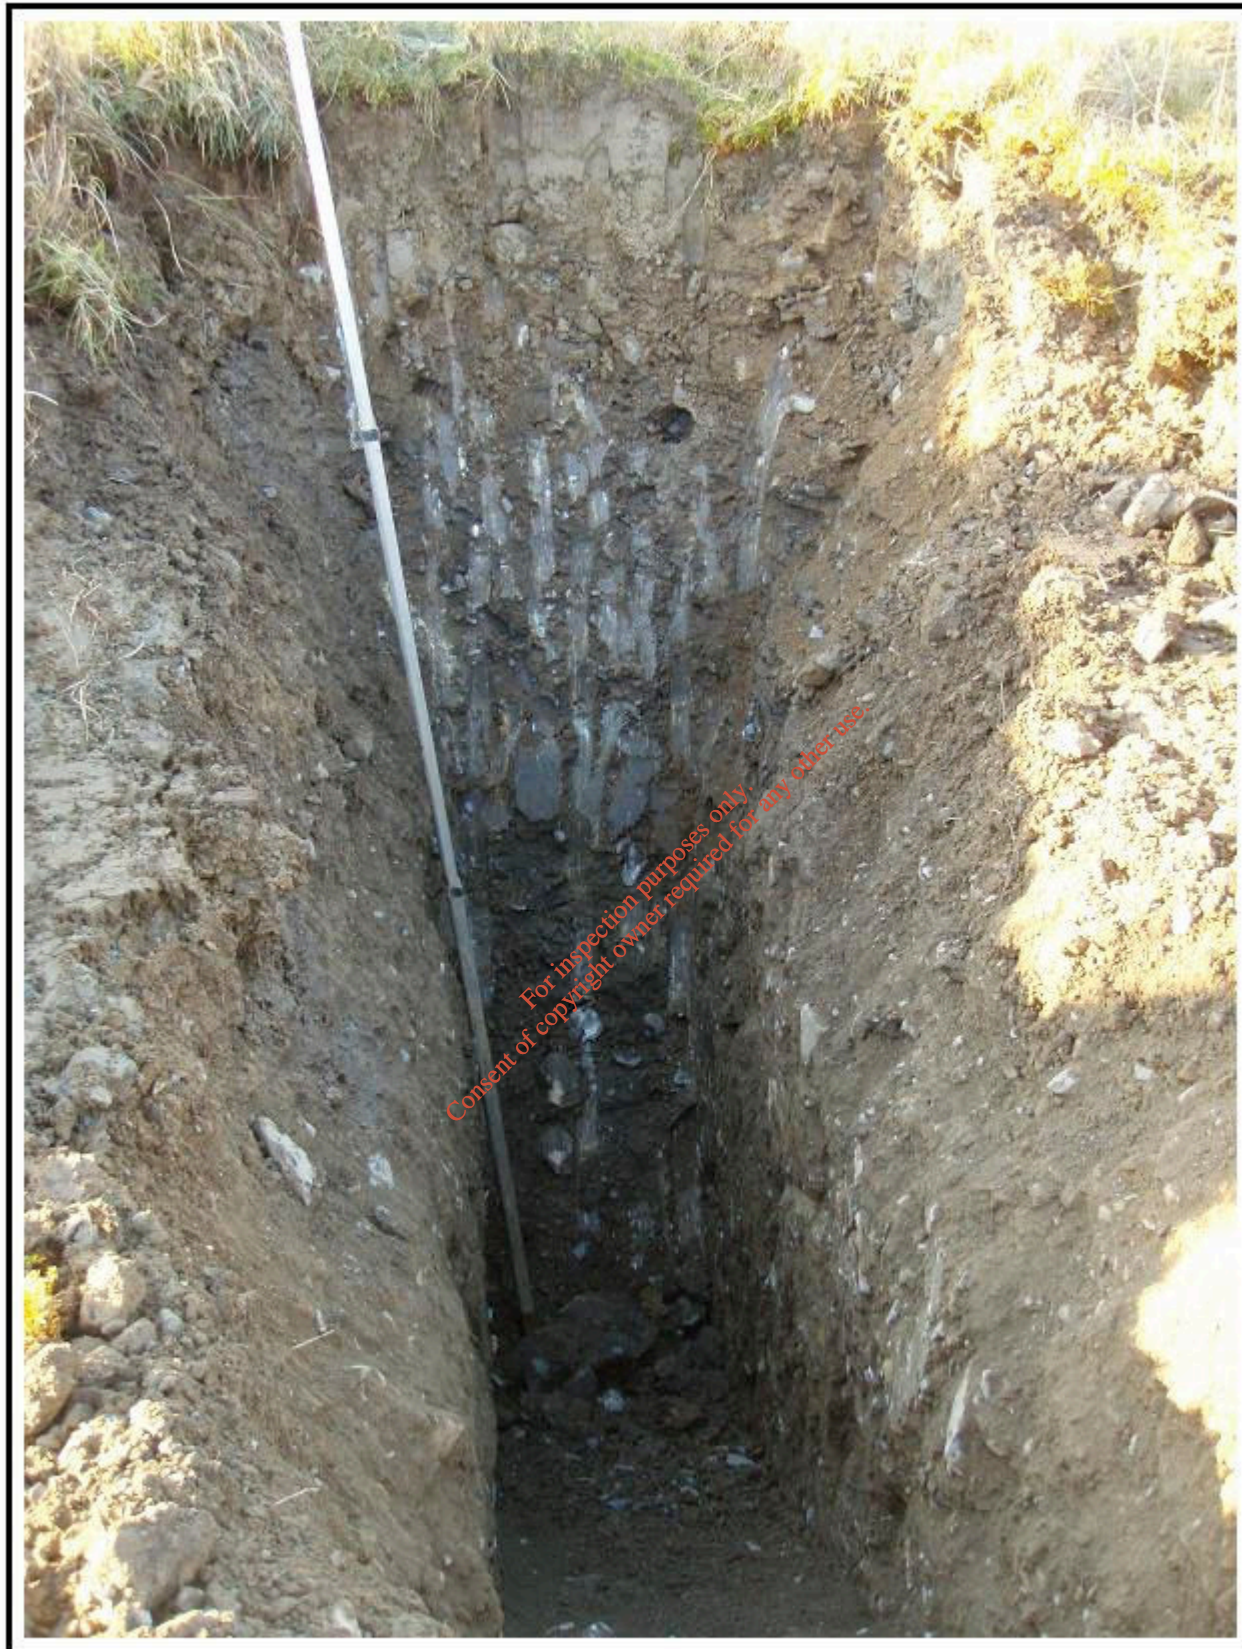
<p>Bearing : 152° (NW-SE)</p>	<p><b>Stability :</b></p> <p>Trial pit walls very consolidated, and material very competent.</p>	
	<p><b>General remarks :</b></p> <p>Dug in northwestern portion of the low, 'failed' forestry area. Dug on a 1° slope, falling northwards.</p>	
	<table border="1"> <tr> <td> <p><b>Groundwater :</b></p> <p>Dry.</p> </td> <td> <p><b>Sequence summary:</b></p> <p>Well drained, shallow, imported topsoil over <i>in situ</i> boulder clay.</p> </td> </tr> </table>	<p><b>Groundwater :</b></p> <p>Dry.</p>
<p><b>Groundwater :</b></p> <p>Dry.</p>	<p><b>Sequence summary:</b></p> <p>Well drained, shallow, imported topsoil over <i>in situ</i> boulder clay.</p>

**Plate A6: Profile of shallow topsoil overlying subsoil in trial hole no. 6. Surprisingly, given the low elevation, this hole was dry. See the complete absence of waste material in the clean *in situ* subsoil, with no groundwater seepages recorded to 2.8m depth.**

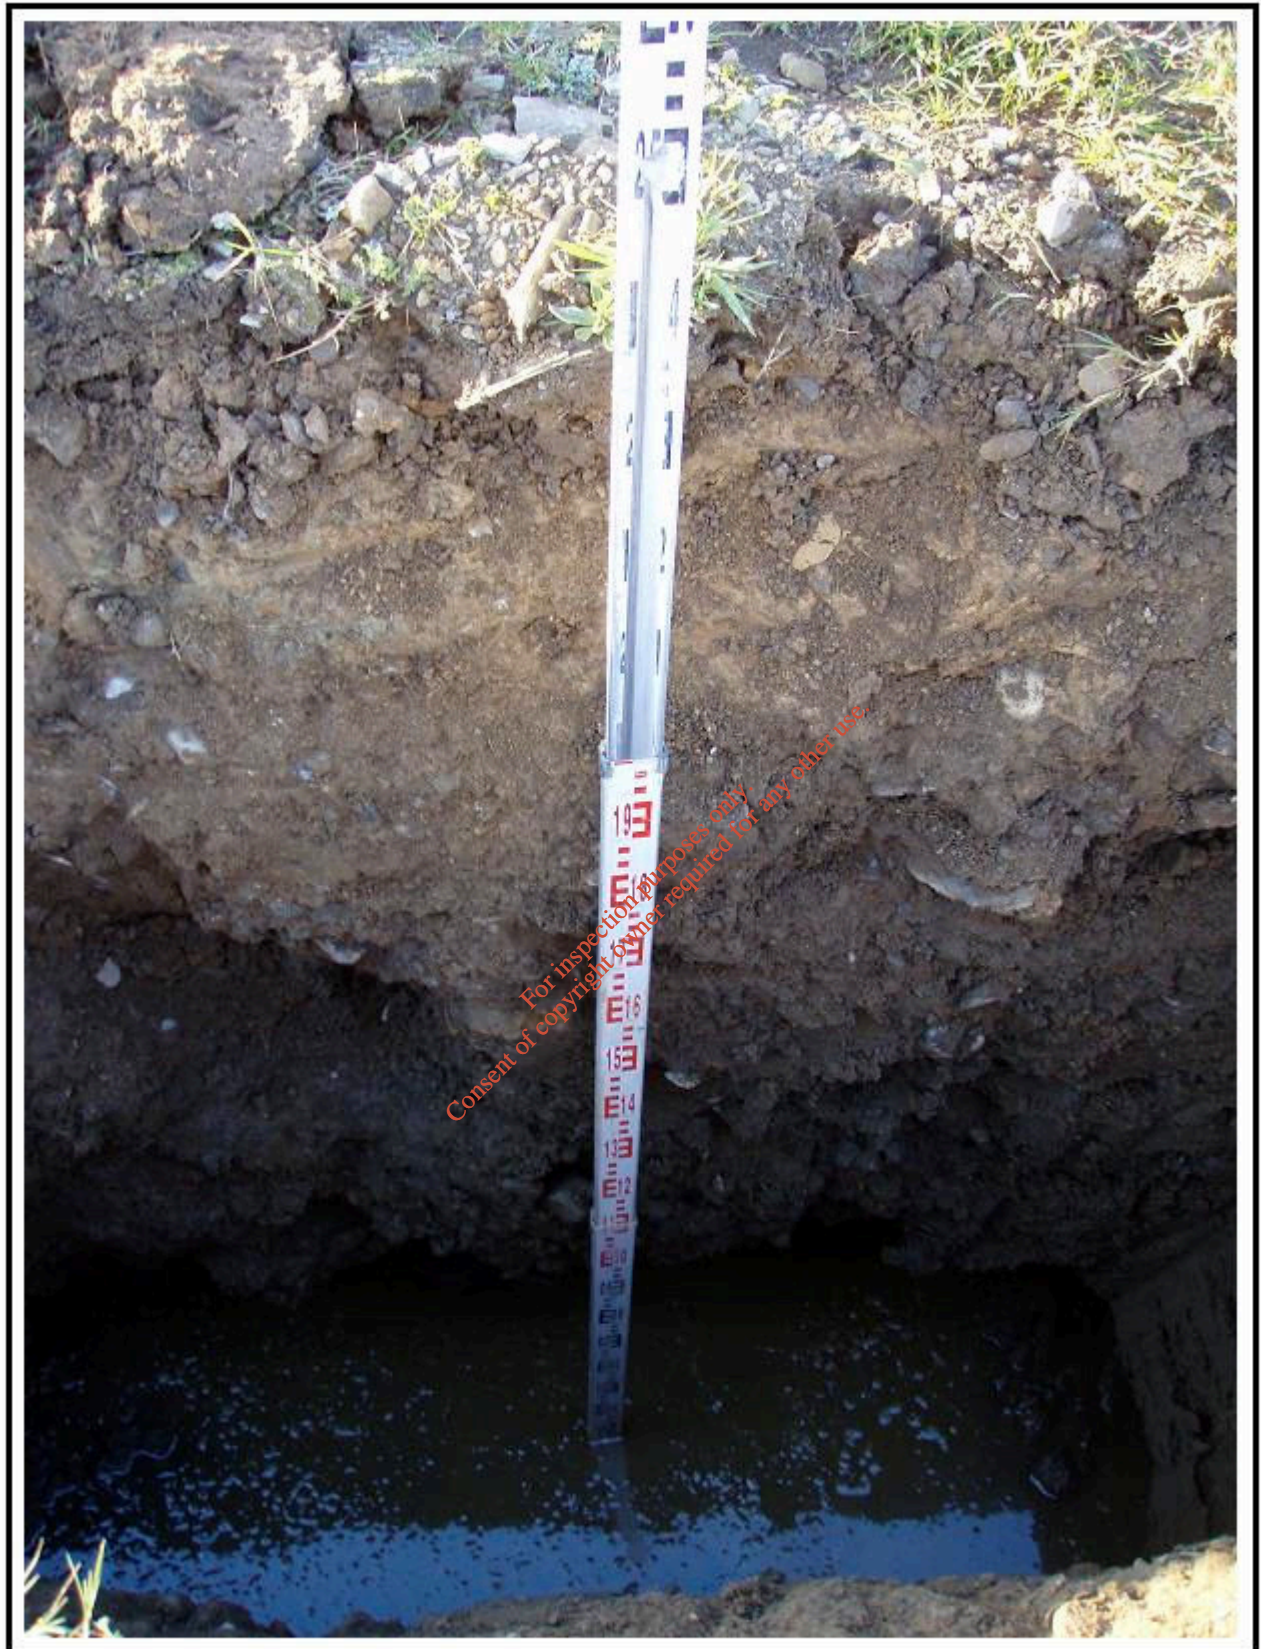
<p style="text-align: center;"><b>Bearing : 152° (NW-SE)</b></p>	<p><b>Stability :</b> Trial pit walls very consolidated, and material very competent.</p> <hr/> <p><b>General remarks :</b> Dug in southwestern portion of the low, 'failed' forestry area. Dug on a 1° slope, falling northwards.</p> <hr/> <table border="1" style="width: 100%;"> <tr> <td style="width: 50%;"><b>Groundwater :</b> Water table rests at 2.04m bgl.</td> <td style="width: 50%;"><b>Sequence summary:</b> Well drained, shallow, 'filled' topsoil over filled boulder clay, 'lifted' on-site.</td> </tr> </table>	<b>Groundwater :</b> Water table rests at 2.04m bgl.	<b>Sequence summary:</b> Well drained, shallow, 'filled' topsoil over filled boulder clay, 'lifted' on-site.
<b>Groundwater :</b> Water table rests at 2.04m bgl.	<b>Sequence summary:</b> Well drained, shallow, 'filled' topsoil over filled boulder clay, 'lifted' on-site.

**Plate A7: Profile of shallow topsoil overlying subsoil in trial hole no. 7. The water table seeps into this hole and rests at 2.04m depth below surface. See the complete absence of waste material and the preponderance of 'clean' imported subsoil here.**

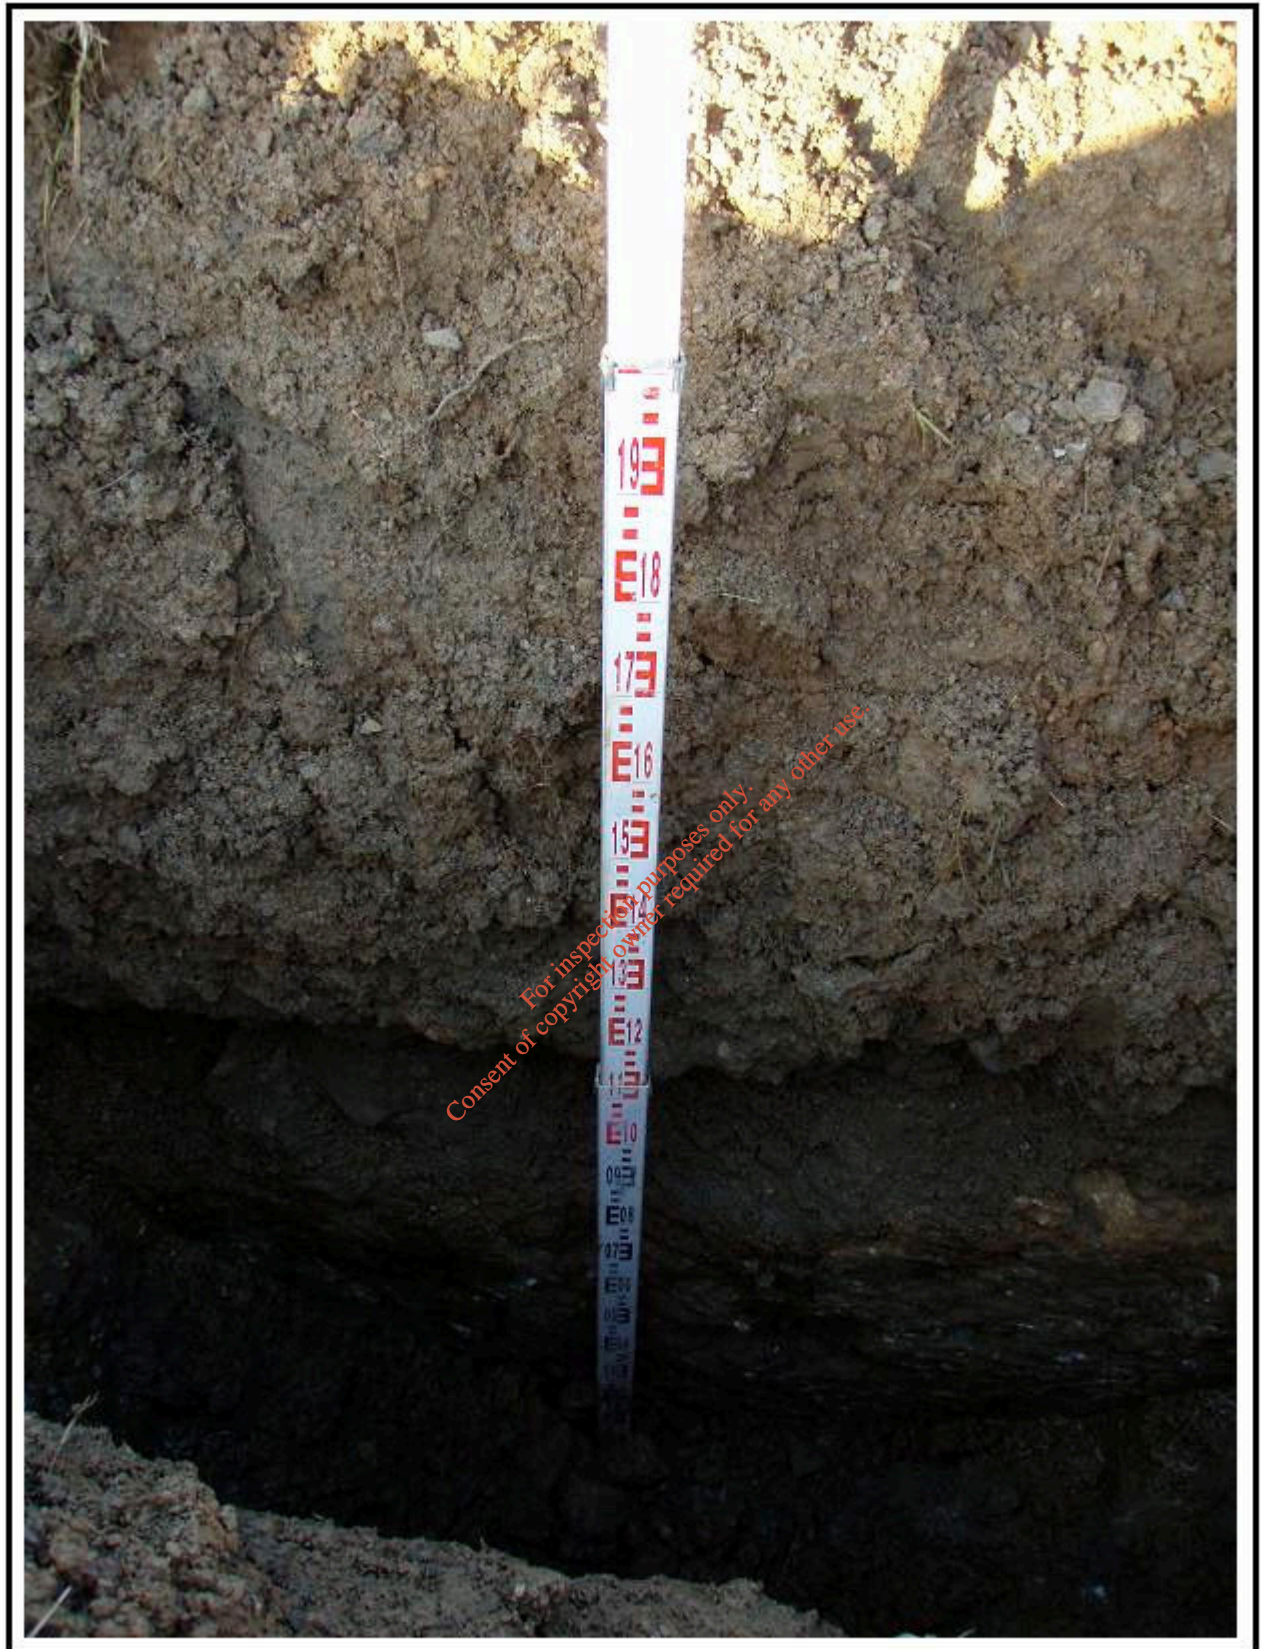
<p style="text-align: center;">3.2m</p> <p style="text-align: center;">1.1m</p> <p style="text-align: center;"><b>Bearing : 52° (SW-NE)</b></p>	<p><b>Stability :</b></p> <p>Trial pit walls very consolidated, and material very competent.</p> <hr/> <p><b>General remarks :</b></p> <p>Dug in northern portion of the low, 'failed' forestry area. Dug on a 1° slope, falling northwards.</p> <hr/> <table border="1" style="width: 100%;"> <tr> <td style="width: 50%; vertical-align: top;"> <p><b>Groundwater :</b></p> <p>Dry initially, but some seeps below 1m depth.</p> </td> <td style="width: 50%; vertical-align: top;"> <p><b>Sequence summary:</b></p> <p>Well drained, deep, 'filled' topsoil and subsoil over <i>in situ</i> boulder clay.</p> </td> </tr> </table>	<p><b>Groundwater :</b></p> <p>Dry initially, but some seeps below 1m depth.</p>	<p><b>Sequence summary:</b></p> <p>Well drained, deep, 'filled' topsoil and subsoil over <i>in situ</i> boulder clay.</p>
<p><b>Groundwater :</b></p> <p>Dry initially, but some seeps below 1m depth.</p>	<p><b>Sequence summary:</b></p> <p>Well drained, deep, 'filled' topsoil and subsoil over <i>in situ</i> boulder clay.</p>

Plate A8: Profile of deep topsoil overlying 2 no. subsoil units in trial hole no. 8. Though initially dry, some groundwater seeps into this hole at depths below 1.0m below surface. See again the complete absence of waste material in the imported, uppermost subsoil units, and the *in situ* subsoil underneath.

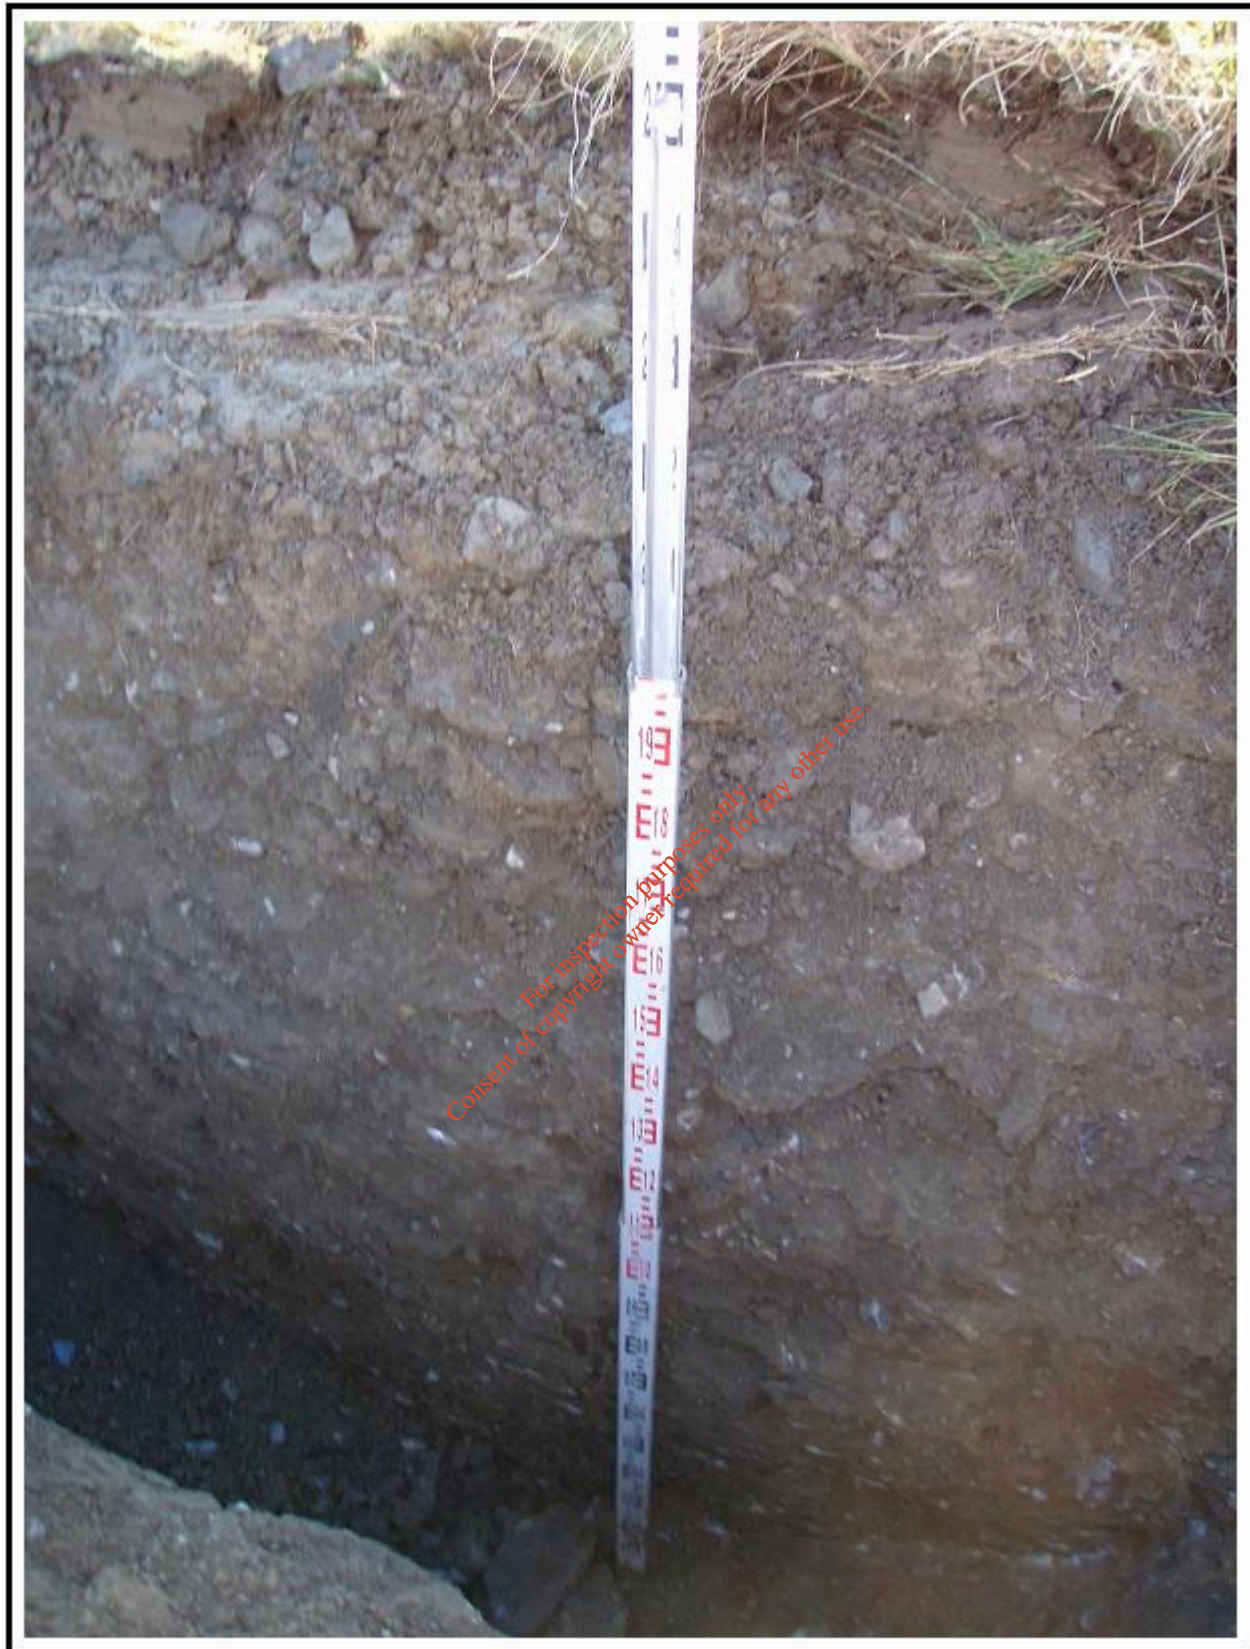
**Stability :**  
 Trial pit walls very consolidated, and material extremely competent.

<b>Groundwater :</b> Dry.	<b>Sequence summary:</b> Well drained, shallow to deep, 'filled' CLAY 'topsoil' over <i>in situ</i> boulder clay.
------------------------------	--

**Plate A9: Profile of relatively shallow topsoil overlying over consolidated, very stiff to hard subsoil in trial hole no. 9. See again the complete absence of waste material in the clean *in situ* subsoil here also. The topsoil is of very poor quality and may actually comprise mostly CLAY subsoil. The hole was dry to 2.2m depth.**
