## 5 APPENDICES

### 5.1 NEED FOR DEVELOPMENT

A notice issued by the EPA on 18<sup>th</sup> December 2017 under Article 16(1) of the Waste Management (Licencing) Regulations 2004, required an environmental liabilities risk assessment (ELRA) to be prepared in accordance with *Guidance on assessing and costing environmental liabilities* (EPA 2014). This (characterisation) report identifies the environmental risks associated with the Clashford site to allow the ELRA to be undertaken. The ELRA is completed by others on the Project Team. This report is focused on the Phase 2 Restoration Area of the Clashford WRF site. The Phase 2<sup>1</sup> Restoration Area is identified on **Figure B**.

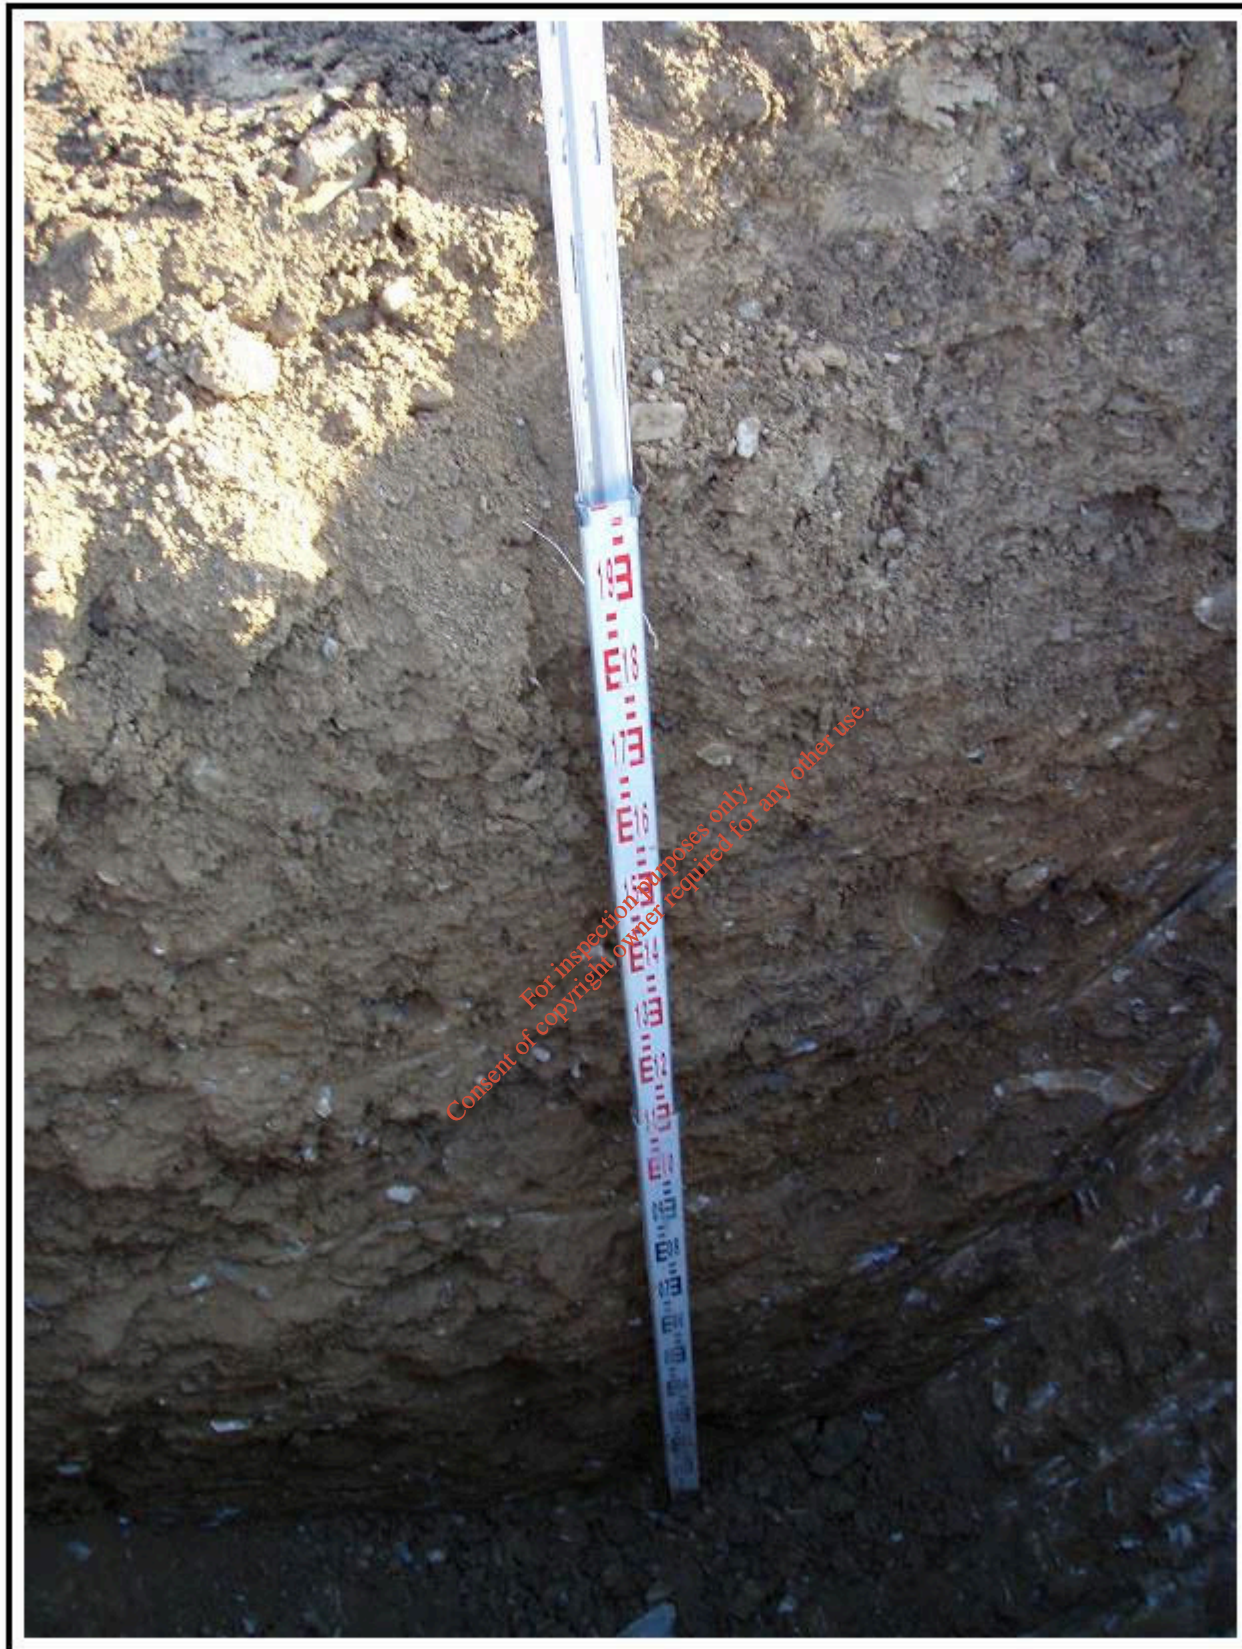
**Stability :**  
 Trial pit walls very consolidated, and material very competent.

**Sequence summary:**  
 Well drained, deep, 'filled' topsoil over *in situ* boulder clay.

**Plate A10: Profile of relatively shallow topsoil overlying overconsolidated, very stiff to hard subsoil in trial hole no. 10. See again the complete absence of waste material in this *in situ* subsoil material. The topsoil is of slightly better quality here and the subsoil is slightly more aerated. The hole was dry to 2.25m depth.**

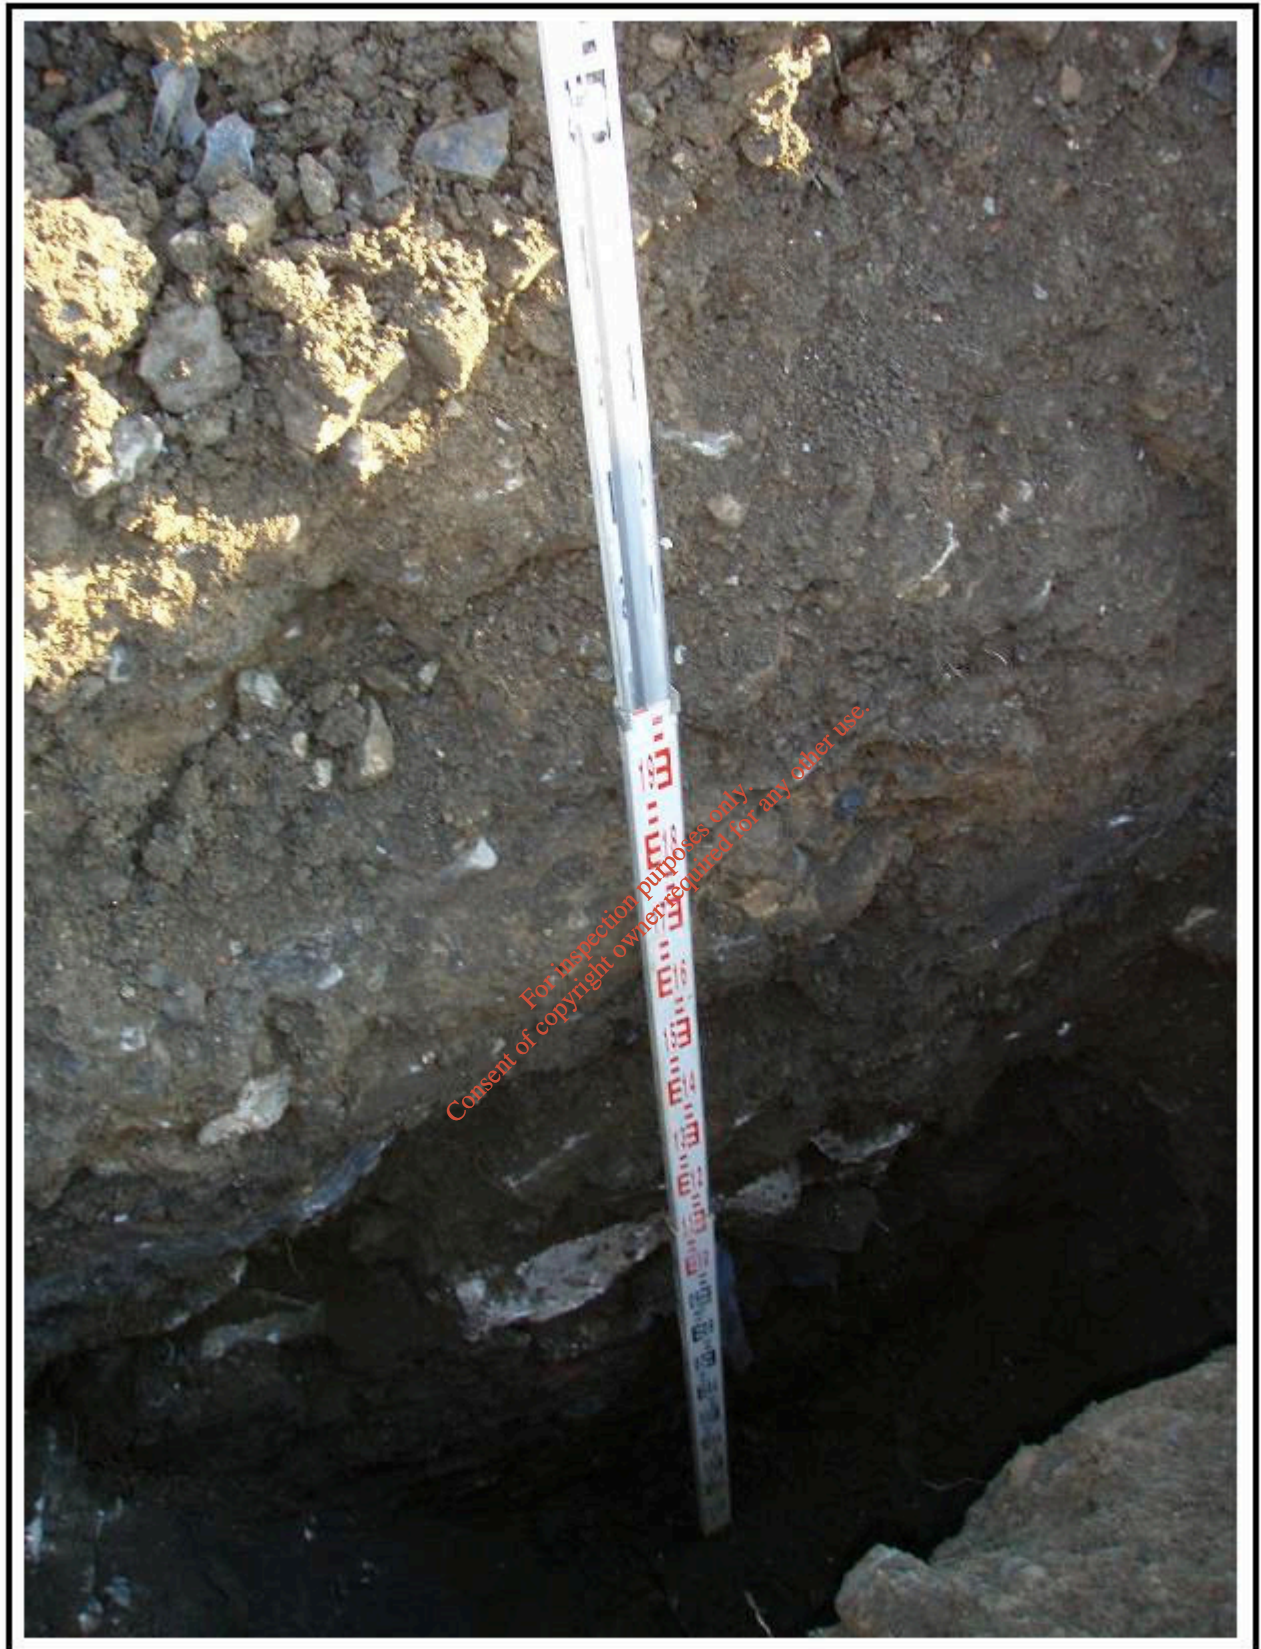
**Stability :**  
 Trial pit walls very consolidated, and material very competent.

**Sequence summary:**  
 Deep, 'filled' boulder clay, 'lifted' on-site. No topsoil.

**Plate A11: Profile of overconsolidated subsoil with alternating layers of very soft to stiff material in trial hole no. 11. Here some buried pieces of concrete are seen at depth. No topsoil has been emplaced above this material as of yet, and the ground is bare.**

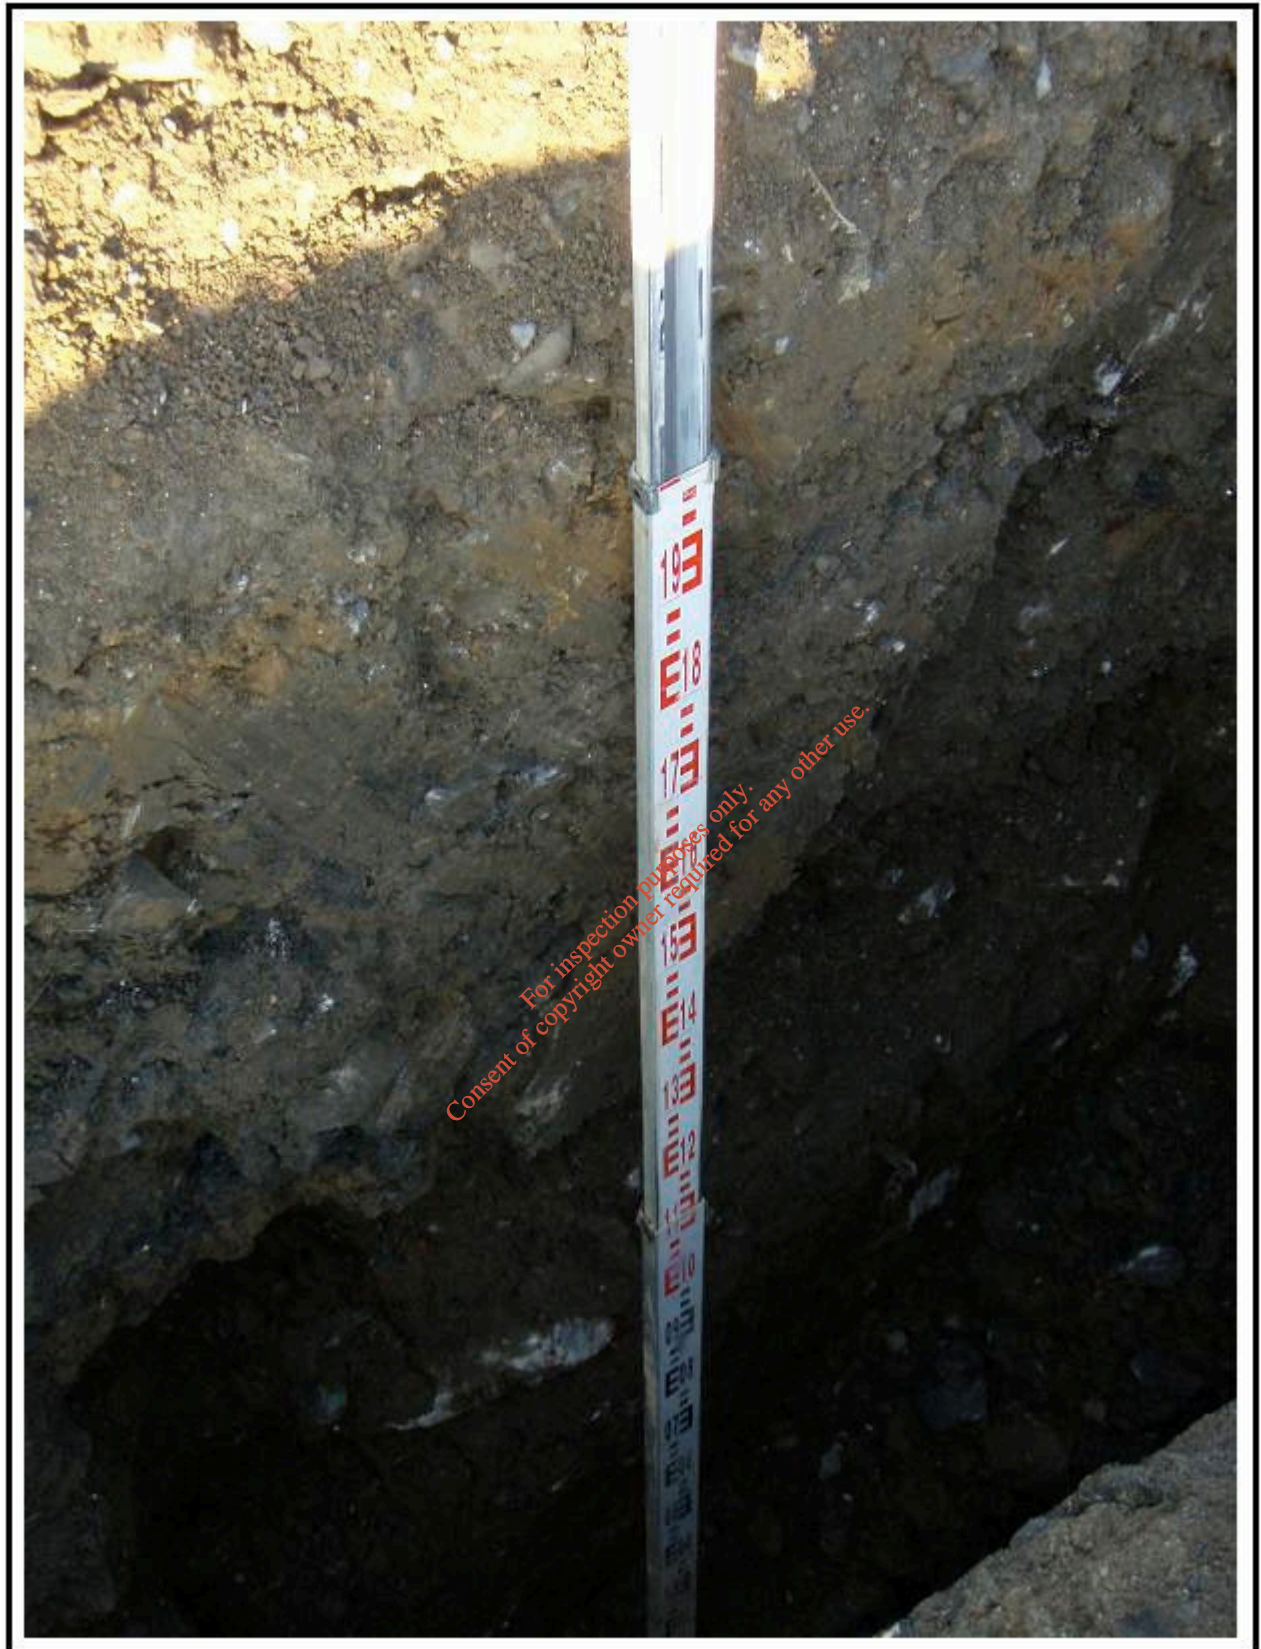
**Plate A12: Profile of overconsolidated subsoil with alternating layers of very soft to stiff material in trial hole no. 12. Here also some buried pieces of concrete are seen at depth. No topsoil has been emplaced above this material as of yet, and the ground is bare.**

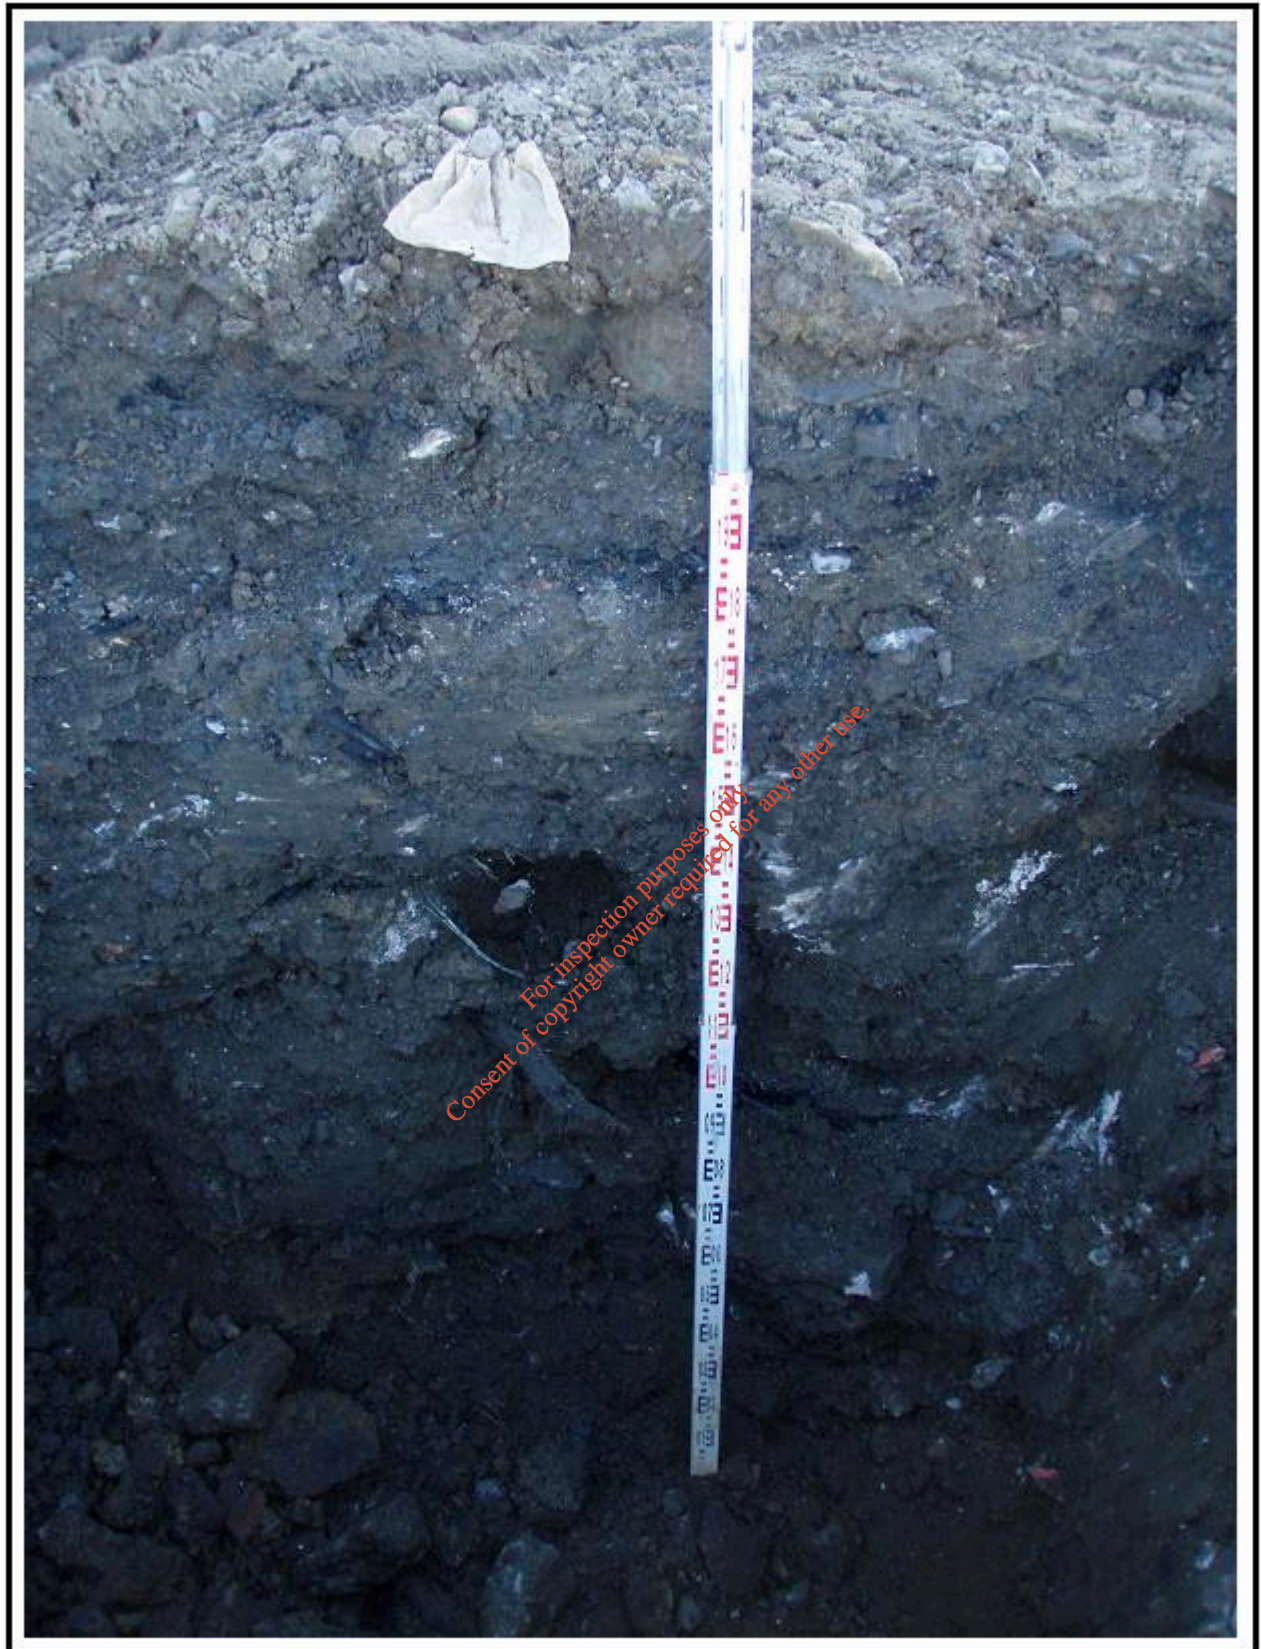
<p style="text-align: center;"><b>Bearing : 108° (N-S)</b></p>	<p><b>Stability :</b></p> <p>Trial pit walls very consolidated, and material very competent.</p> <hr/> <p><b>General remarks :</b></p> <p>Dug in northern portion of recently-filled eastern portion of the site, into an area of bare ground. Dug on a 1° slope, falling northwards.</p> <hr/> <table border="1" style="width: 100%;"> <tr> <td style="width: 50%;"><b>Groundwater :</b></td> <td style="width: 50%;"><b>Sequence summary:</b></td> </tr> <tr> <td>Dry.</td> <td>Deep, 'filled' boulder clay, 'lifted' on-site. No topsoil.</td> </tr> </table>	<b>Groundwater :</b>	<b>Sequence summary:</b>	Dry.	Deep, 'filled' boulder clay, 'lifted' on-site. No topsoil.
<b>Groundwater :</b>	<b>Sequence summary:</b>				
Dry.	Deep, 'filled' boulder clay, 'lifted' on-site. No topsoil.

Plate A13: Profile of overconsolidated subsoil with alternating layers of very soft to stiff material in trial hole no. 13. Buried pieces of concrete, wire, branches and cloth also occur. No topsoil has been emplaced above this material as of yet either, and the ground is bare.

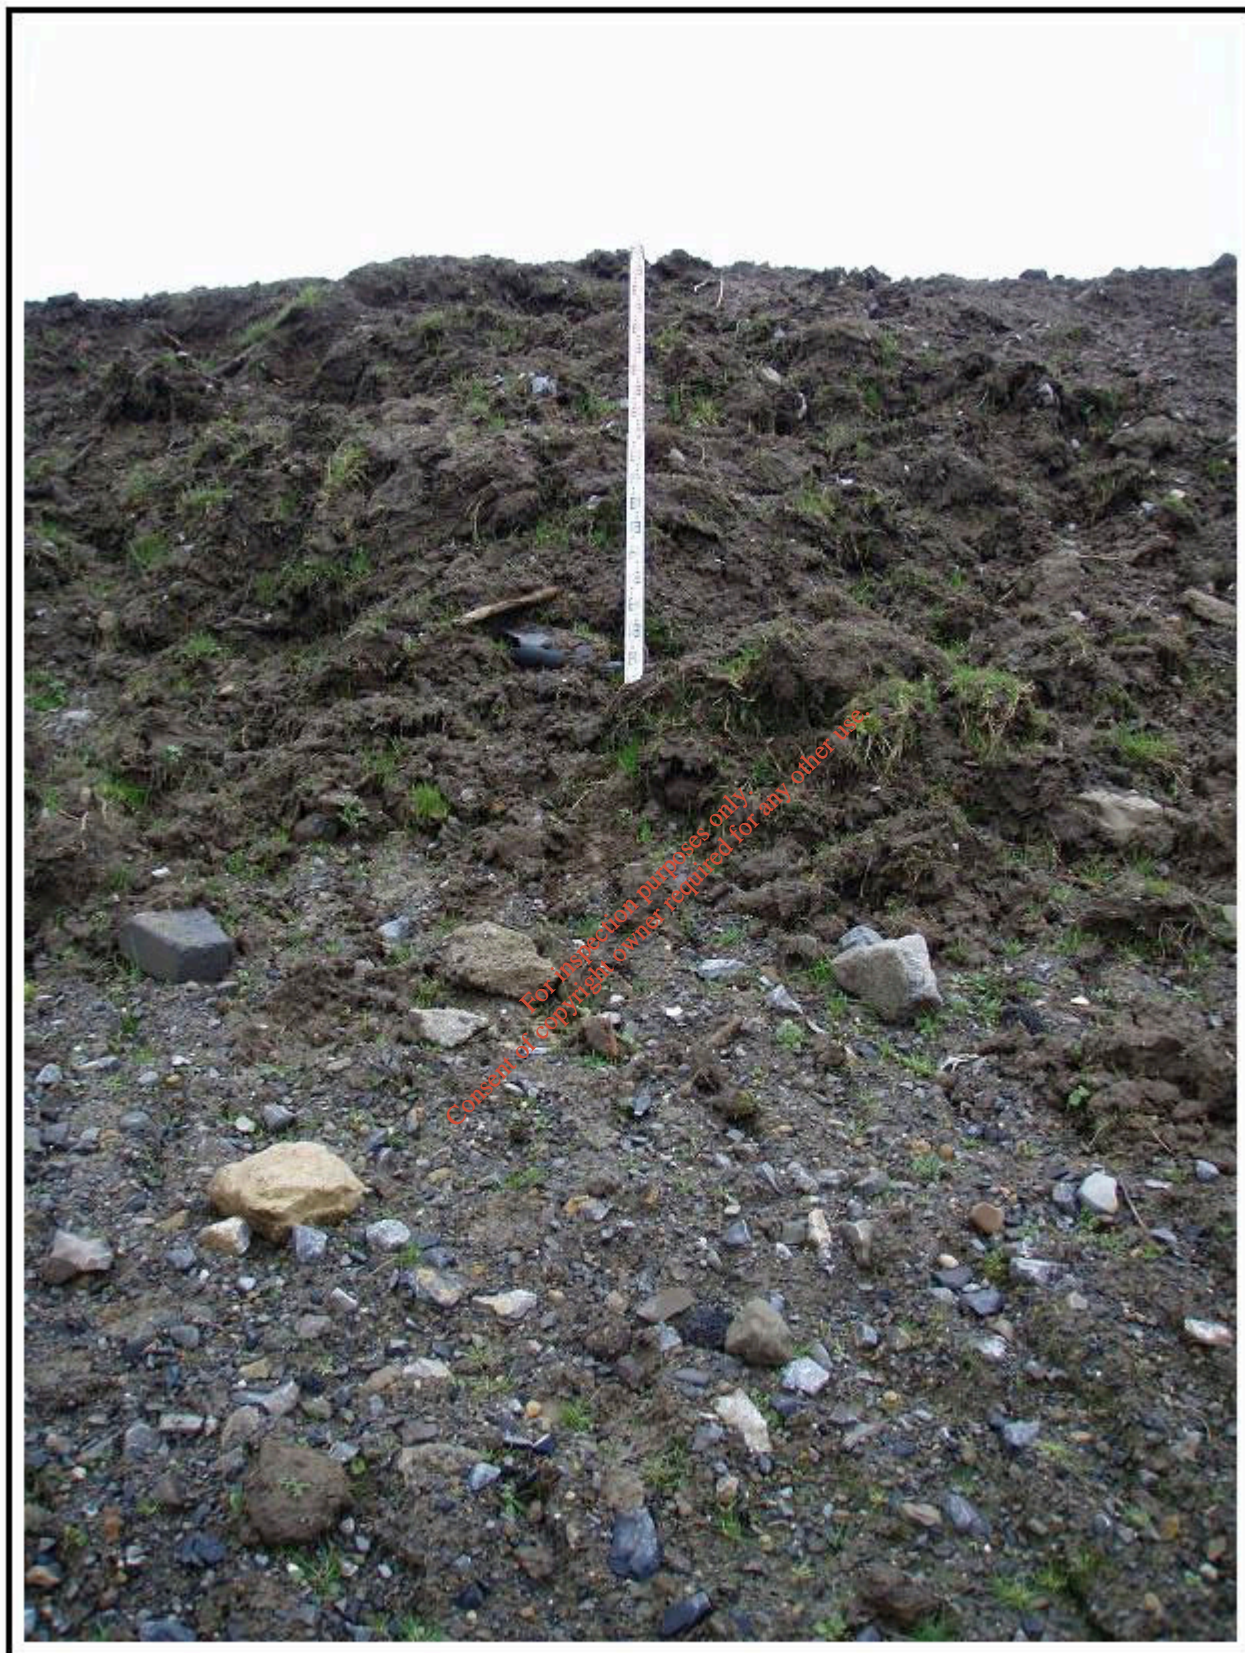
<p><b>Plan</b></p> <p>Face bearing : 10° (N-S)</p>	<p><b>Stability :</b></p> <p>Material very consolidated and competent.</p>	
	<p><b>General remarks :</b></p> <p>Dug in southeastern portion of the site, into the main face of imported fill around the existing pit area.</p>	
	<table border="1"> <tr> <td> <p><b>Groundwater :</b></p> <p>Dry.</p> </td> <td> <p><b>Sequence summary:</b></p> <p>Well drained, deep, 'filled' topsoil over filled boulder clay, 'lifted' on-site.</p> </td> </tr> </table>	<p><b>Groundwater :</b></p> <p>Dry.</p>
<p><b>Groundwater :</b></p> <p>Dry.</p>	<p><b>Sequence summary:</b></p> <p>Well drained, deep, 'filled' topsoil over filled boulder clay, 'lifted' on-site.</p>

**Plate A14: Profile of recently-lain topsoil overlying overconsolidated subsoil at the side of the main eastern fill area. This material is very clean with only one small portion of waste material (plastic pipe) seen.**

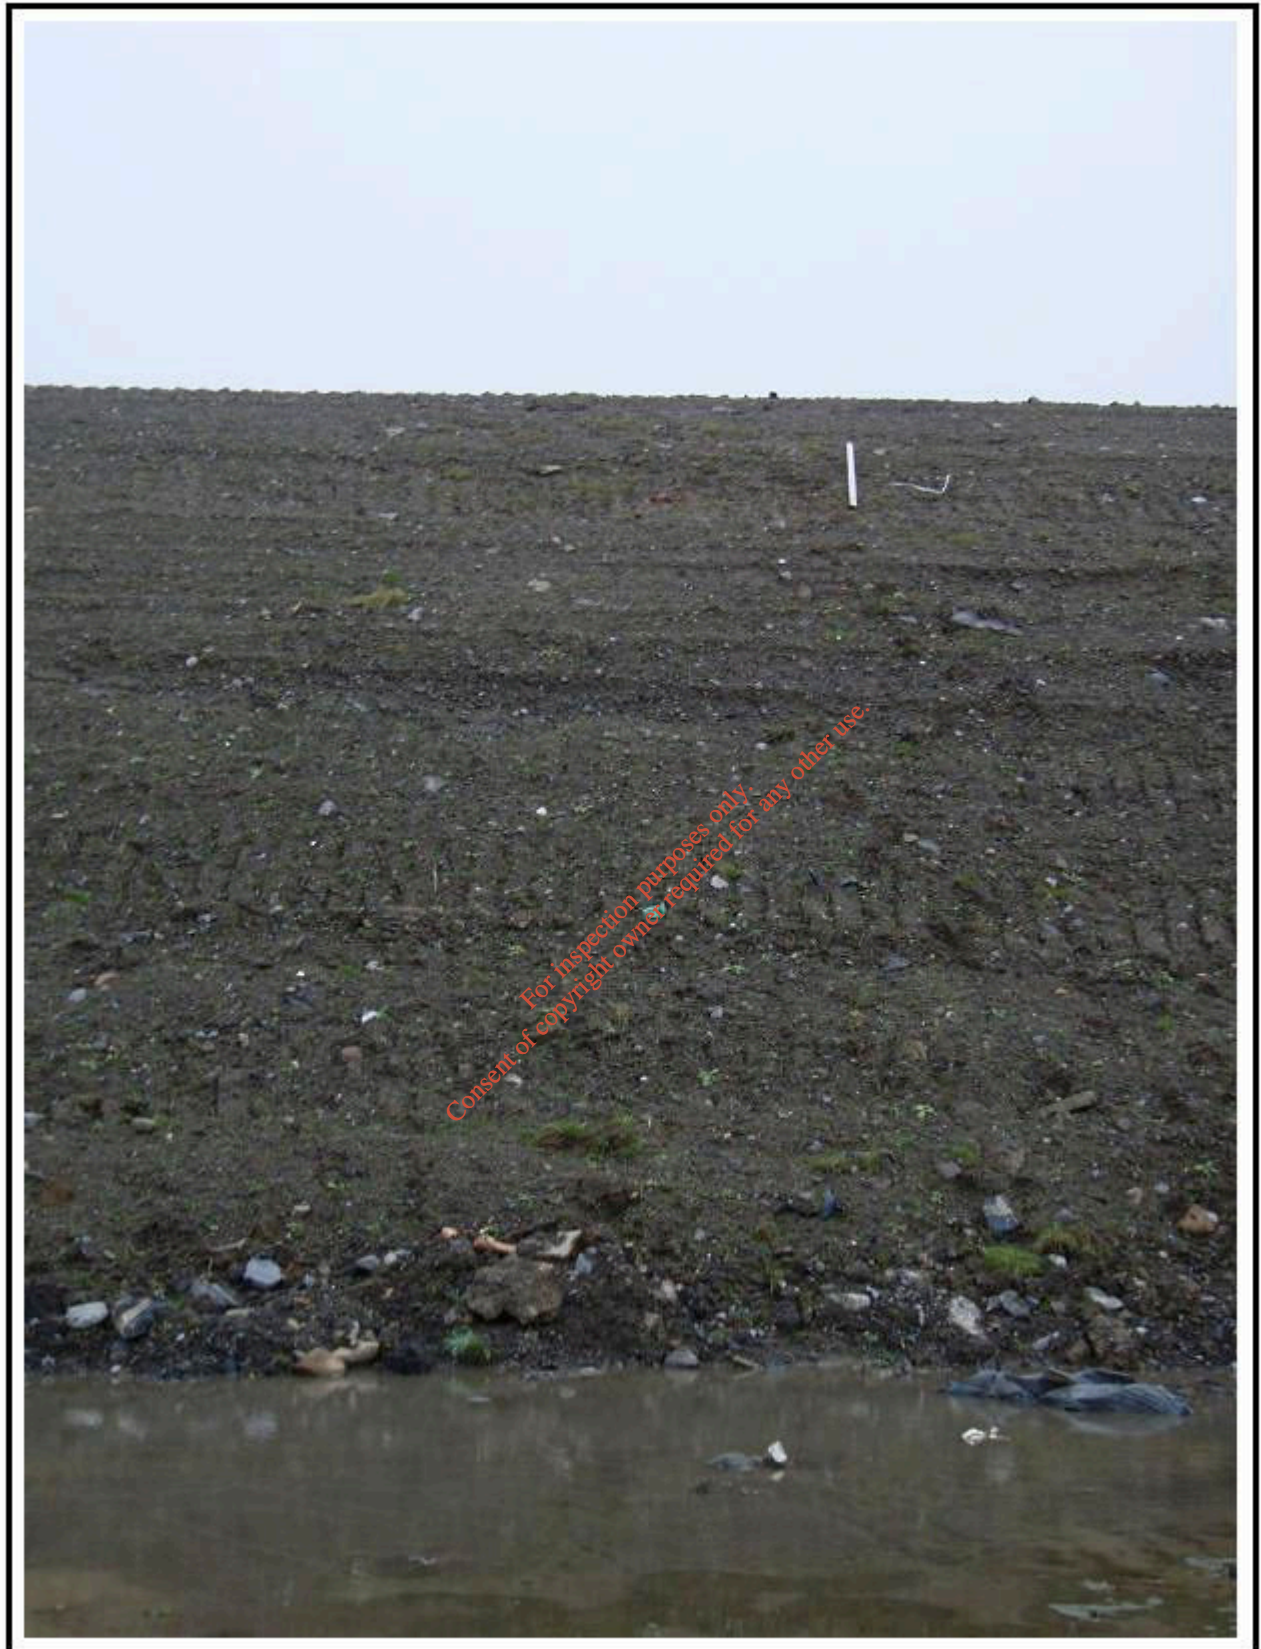
<b>Plan</b>           <b>Face bearing</b> : 170° (N-S)	<b>Stability :</b>  Material very consolidated and competent.	
	<b>General remarks :</b>  Dug in northeastern portion of the site, into the main face of imported fill around the existing pit area.	
	<table border="0"> <tr> <td> <b>Groundwater :</b>                               Dry. Some surface water at base in main pit floor.                         </td> <td> <b>Sequence summary:</b>                               Well drained, deep, 'filled' topsoil over filled boulder clay, 'lifted' on-site.                         </td> </tr> </table>	<b>Groundwater :</b>  Dry. Some surface water at base in main pit floor.
<b>Groundwater :</b>  Dry. Some surface water at base in main pit floor.	<b>Sequence summary:</b>  Well drained, deep, 'filled' topsoil over filled boulder clay, 'lifted' on-site.

**Plate A15: Profile of relatively shallow, recently-lain topsoil overlying overconsolidated subsoil at the northern side of the main eastern fill area. This material is very clean also.**

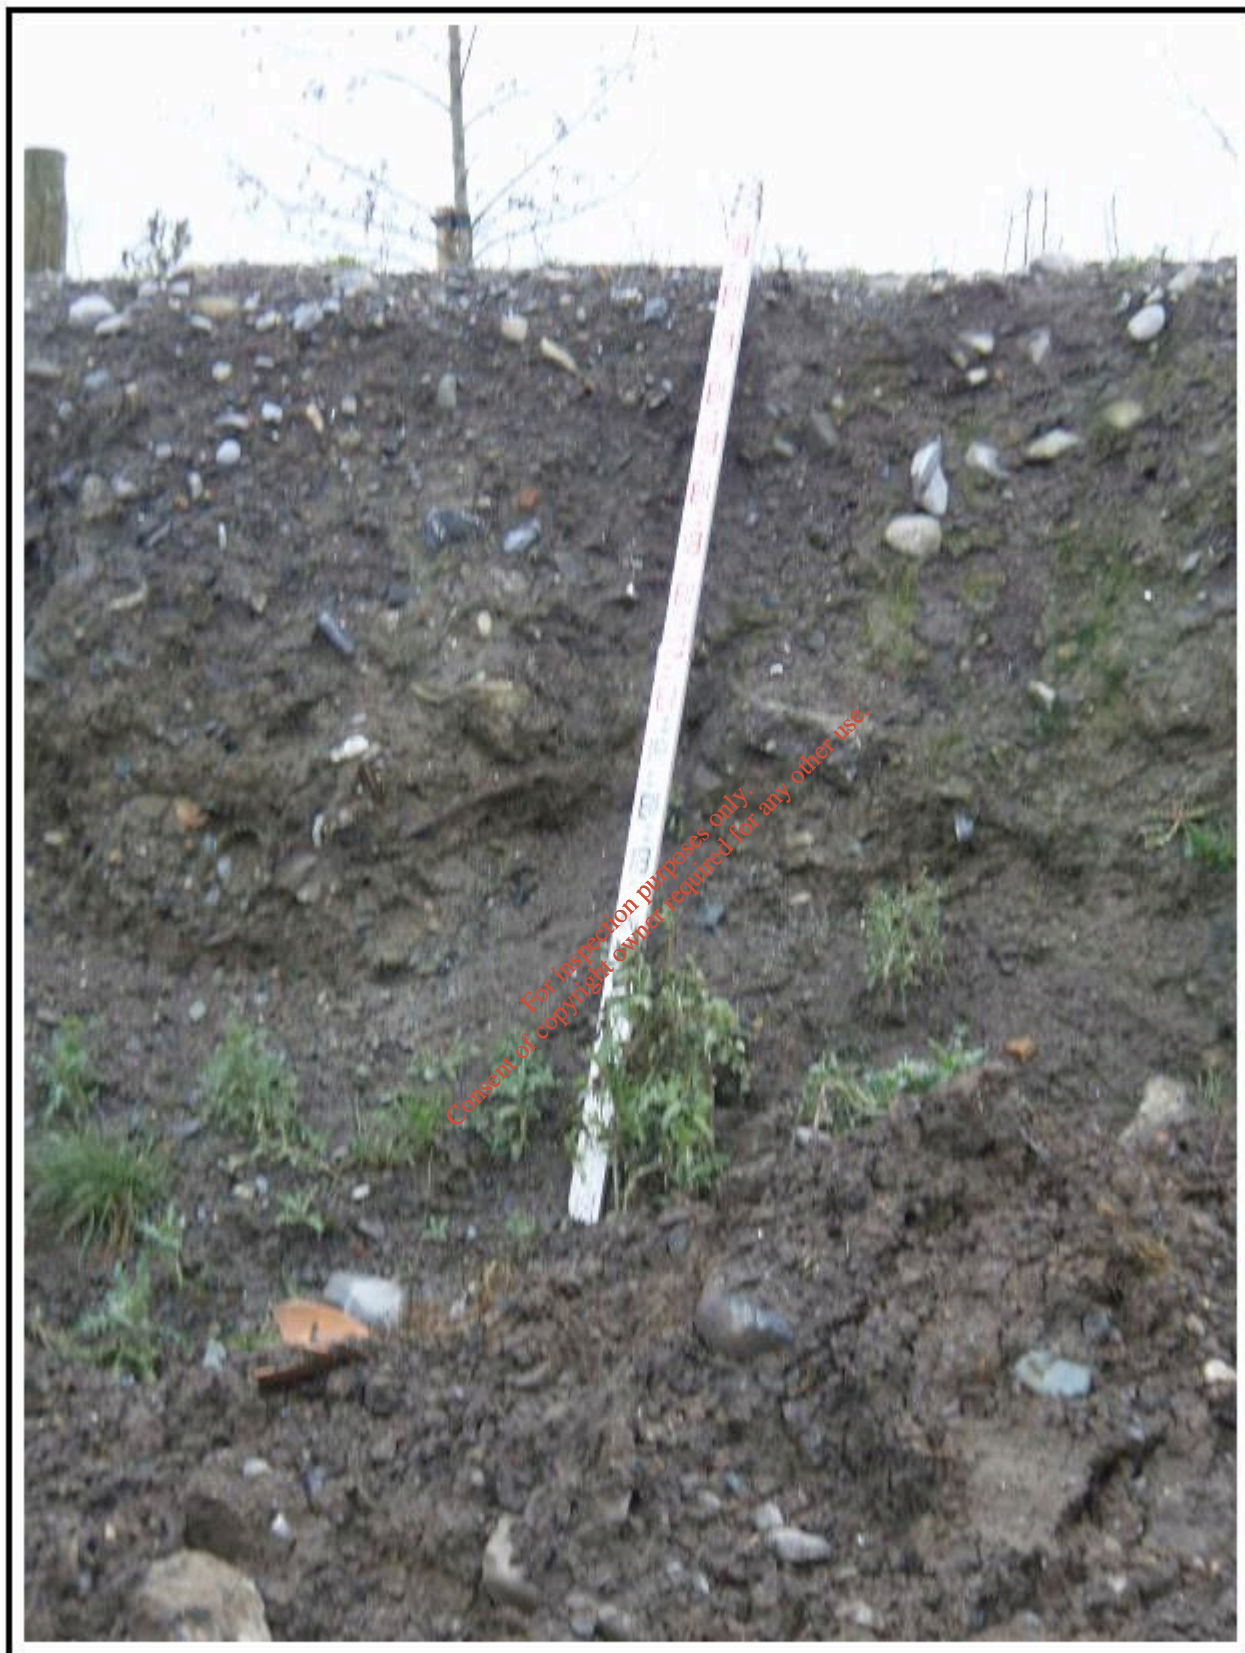
<p><b>Plan</b></p> <p style="text-align: center;">Face bearing : 40° (SW-NE)</p>	<p><b>Stability :</b></p> <p>Material very consolidated and competent.</p>	
	<p><b>General remarks :</b></p> <p>Dug in eastern extreme of the site, into a low face at the edge of the southeastern circling trackway.</p>	
	<table border="1" style="width: 100%;"> <tr> <td style="width: 50%;"> <p><b>Groundwater :</b></p> <p>Dry.</p> </td> <td style="width: 50%;"> <p><b>Sequence summary:</b></p> <p>Well drained, deep, 'filled' boulder clay, 'lifted' on-site.</p> </td> </tr> </table>	<p><b>Groundwater :</b></p> <p>Dry.</p>
<p><b>Groundwater :</b></p> <p>Dry.</p>	<p><b>Sequence summary:</b></p> <p>Well drained, deep, 'filled' boulder clay, 'lifted' on-site.</p>

**Plate A16: Profile of relatively shallow exposure into subsoil at the eastern extreme of the fill area. This material is also very clean.**

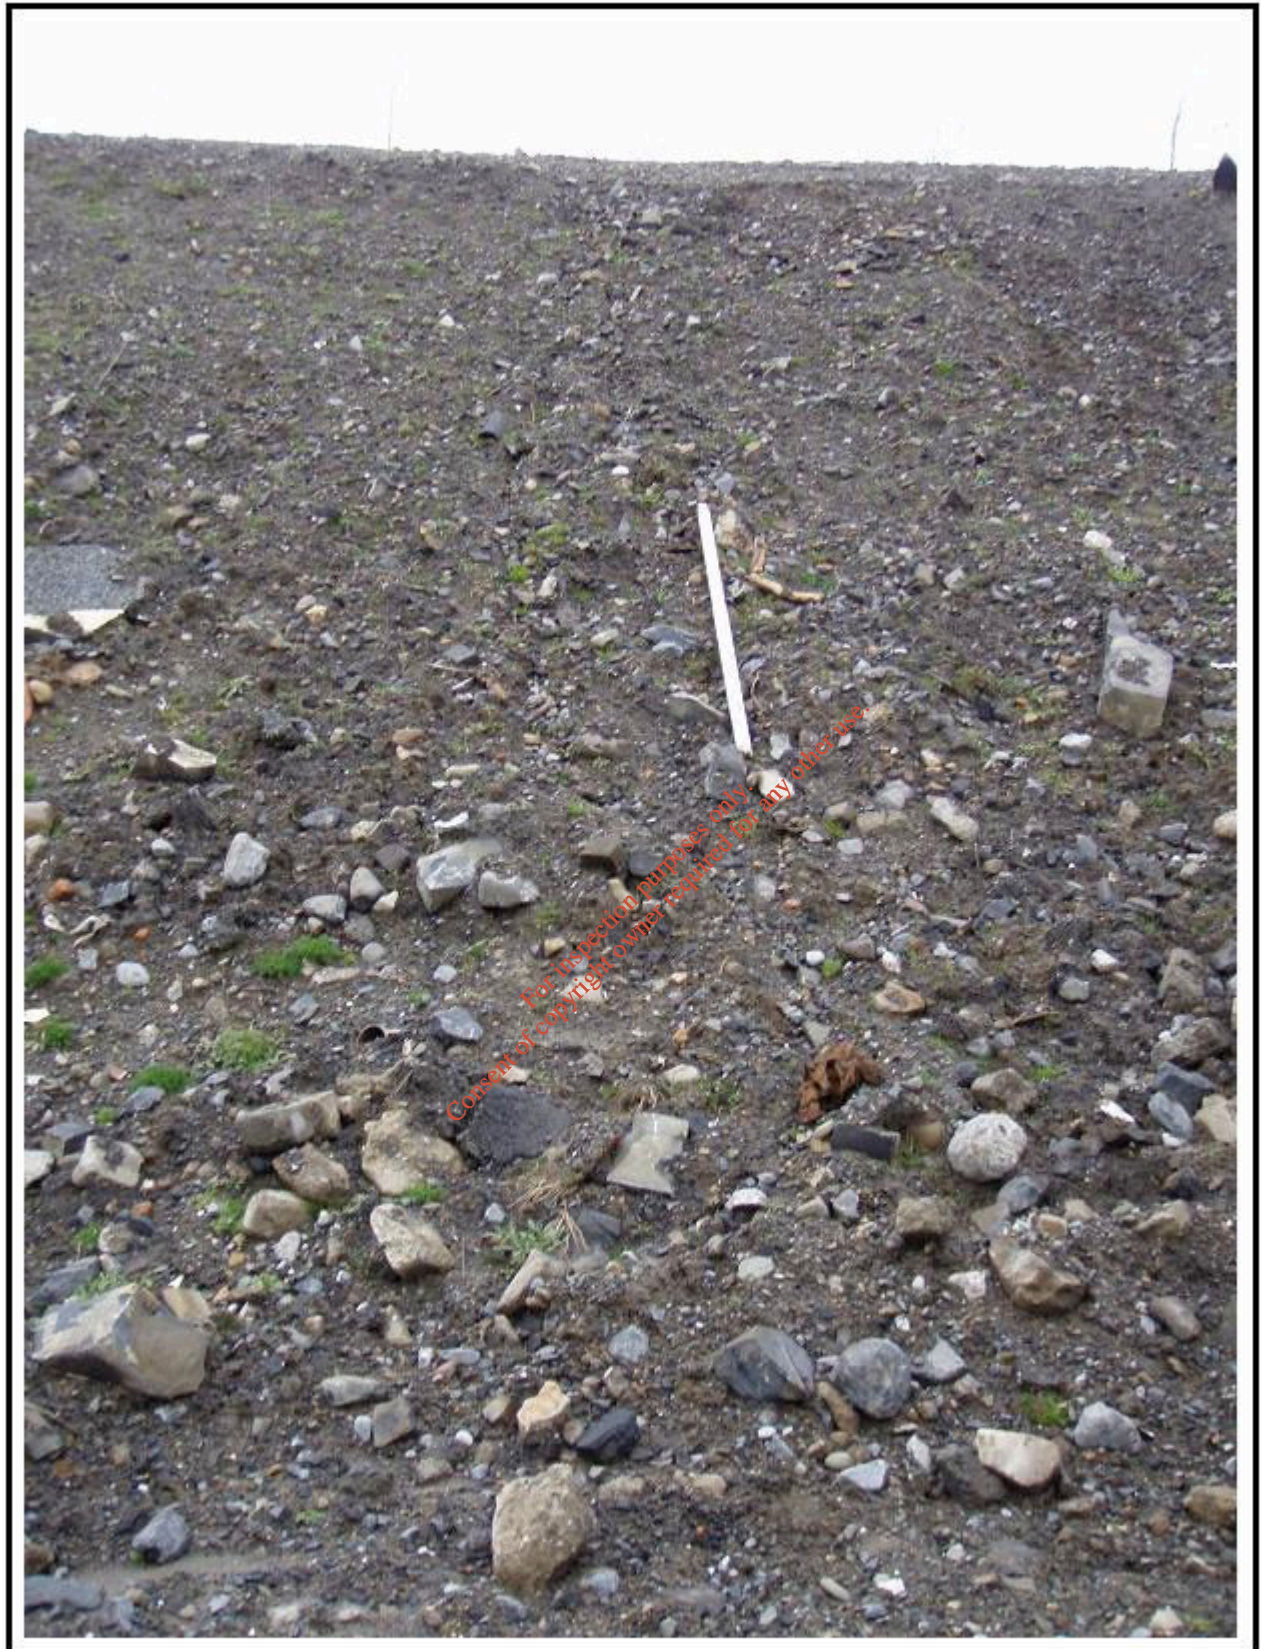
<p><b>Plan</b></p> <p>Face bearing : 80° (W-E)</p>	<p><b>Stability :</b></p> <p>Material very consolidated and competent.</p>	
	<p><b>General remarks :</b></p> <p>Dug in northeastern portion of the site, into the main face of imported fill around the northern edge of the existing pit area.</p>	
	<table border="1"> <tr> <td> <p><b>Groundwater :</b></p> <p>Dry. Some surface water at base in main pit floor.</p> </td> <td> <p><b>Sequence summary:</b></p> <p>Well drained, deep, 'filled' boulder clay, 'lifted' on-site.</p> </td> </tr> </table>	<p><b>Groundwater :</b></p> <p>Dry. Some surface water at base in main pit floor.</p>
<p><b>Groundwater :</b></p> <p>Dry. Some surface water at base in main pit floor.</p>	<p><b>Sequence summary:</b></p> <p>Well drained, deep, 'filled' boulder clay, 'lifted' on-site.</p>

**Plate A17: Profile of exposure into subsoil at the northeastern extreme of the main pit area. This material is clean, and gets more gravelly and 'bouldery' at the base.**

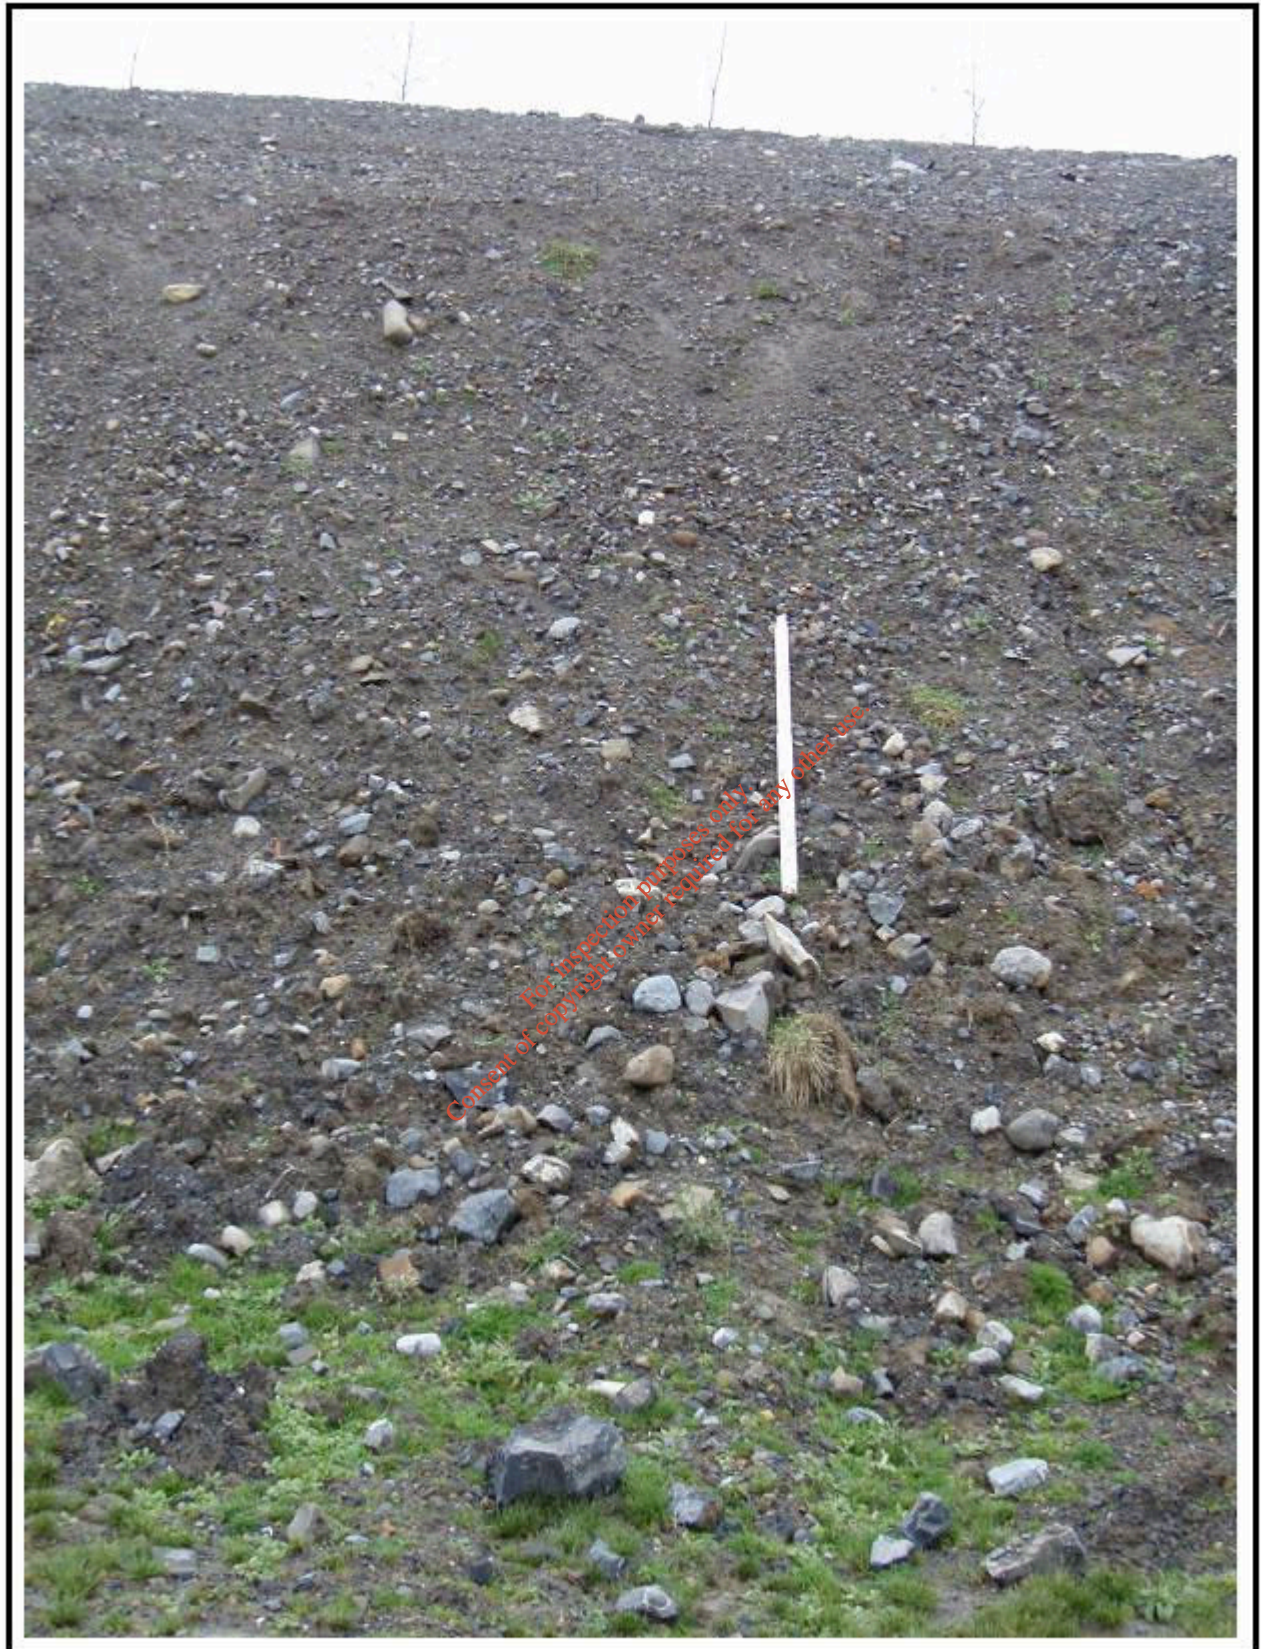
<p><b>Plan</b></p> <p>Face bearing : 80° (W-E)</p>	<p><b>Stability :</b></p> <p>Material very consolidated and competent.</p>	
	<p><b>General remarks :</b></p> <p>Dug in northwestern portion of the site, into the main face of imported fill around the northern edge of the existing pit area.</p>	
	<table border="1"> <tr> <td> <p><b>Groundwater :</b></p> <p>Dry. Some surface water at base in main pit floor.</p> </td> <td> <p><b>Sequence summary:</b></p> <p>Well drained, deep, 'filled' boulder clay, 'lifted' on-site.</p> </td> </tr> </table>	<p><b>Groundwater :</b></p> <p>Dry. Some surface water at base in main pit floor.</p>
<p><b>Groundwater :</b></p> <p>Dry. Some surface water at base in main pit floor.</p>	<p><b>Sequence summary:</b></p> <p>Well drained, deep, 'filled' boulder clay, 'lifted' on-site.</p>

**Plate A18: Profile of exposure into subsoil at the northwestern extreme of the main pit area. This material is clean, and again gets more gravelly and 'bouldery' at the base.**
