Subject: FW: Tier 3 Report
Attachments: Tier 3 final.pdf

**REPORT
ON THE
GEOPHYSICAL SURVEY
AT A
LANDFILL
AT
CARLINGFORD, Co. LOUTH
FOR
SITE INVESTIGATIONS LTD.**

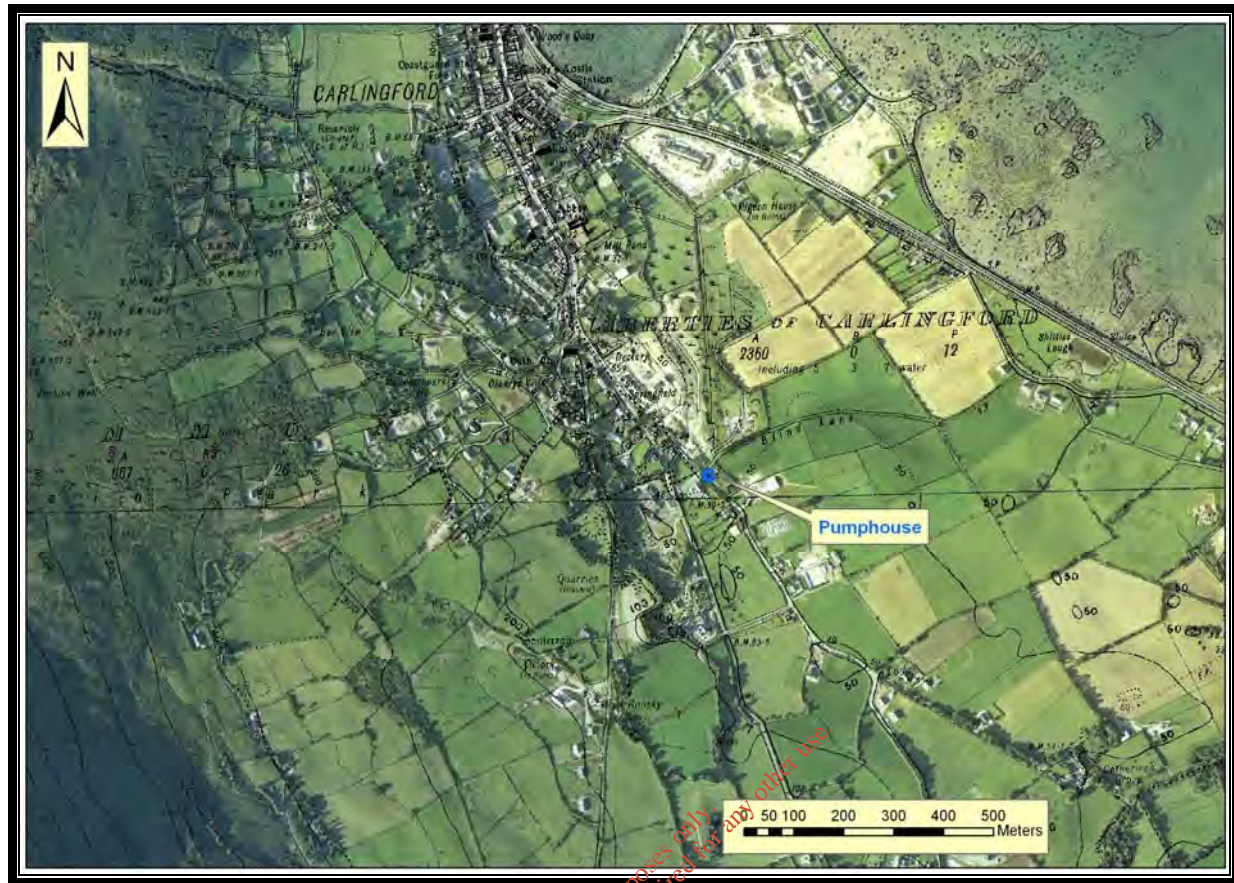
Figure 3: Land use around the source. The sewerage works comprise the bouldings immediately northeast of the pumphouse. The dominance of well drained pasture land to the south and southwest is seen, as are the arable fields to the east and the built area of Carlingford to the north. Montane heath and scrub is also seen to the west on the high mountains slopes.

The area immediately adjacent to the source includes a number of new housing estates to the north and northwest, as well many older residences to the west. These connect to the Carlingford mains sewer but some of the individual houses to the southwest are served by septic tanks, particularly those higher up the hillslopes. The sewerage works themselves are situated 85m northeast of the source. A nursing home lies 100m to the west-southwest of the source, and a farmyard 75m to the east. There also occurs a cemetery 135m to the southeast of the source, and disused quarries 250m to the southwest.

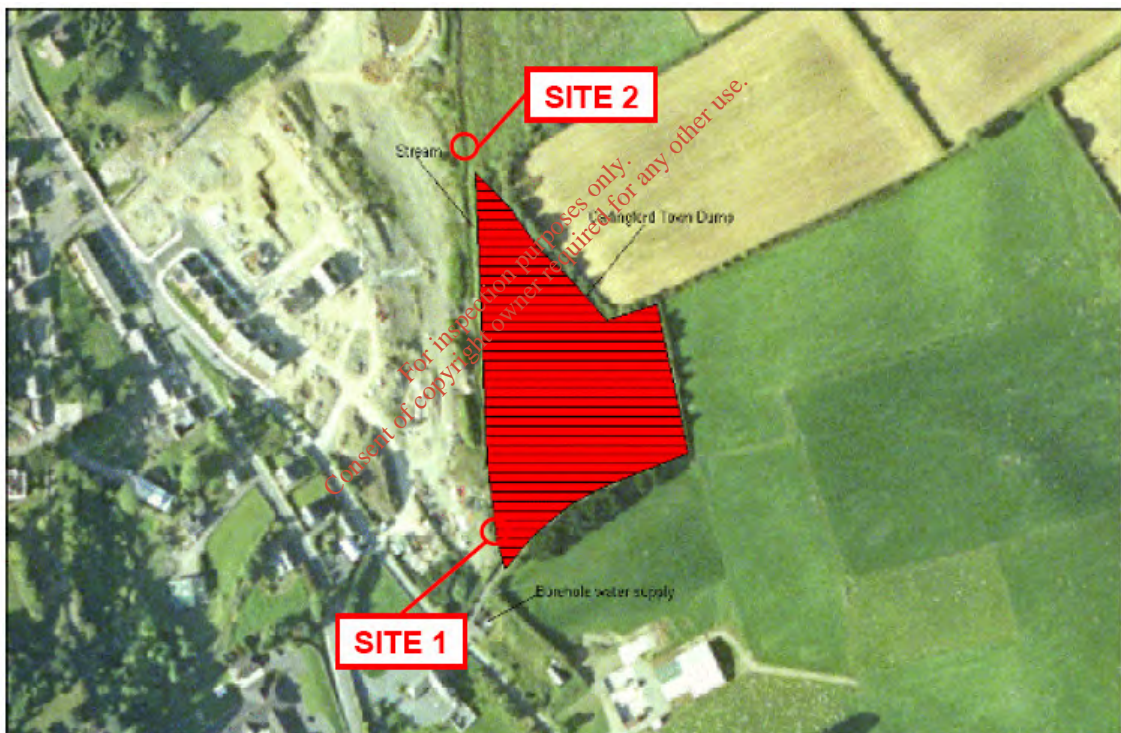
Fig. 2 Locations of sampling sites

Site 1 is located a short distance downstream of the upstream limit of the former landfill. A site immediately upstream of the landfill was not possible as the stream is culverted upstream of the former landfill. Site 2 is located immediately downstream of the former landfill. Grid references were recorded at all sites using a GPS.

Biological sampling and water quality assessment was carried out at the following sites specified by Louth County Council. The locations of the sites are shown on Figs. 1 & 2.

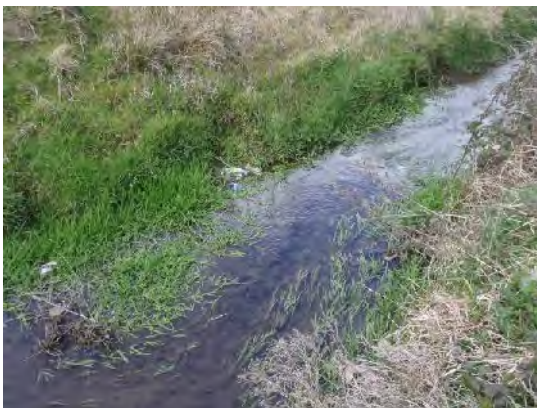
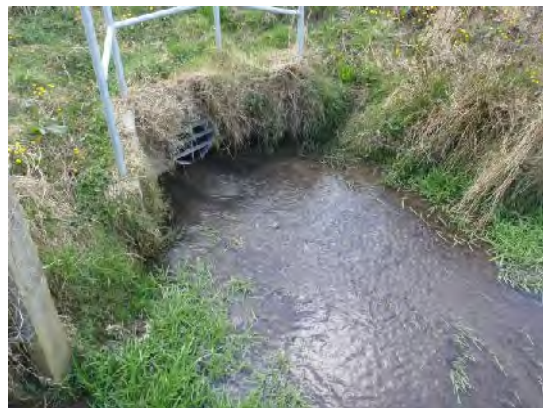
Site Code (Grid Reference)	J 1927 1099
Site Location	Just d/s culvert
Channel Width (m)	6-8
Depth (cm)	5-15
Substrate (in order of dominance)	Mud, Gravel (small amount)
Flow Type	Riffle 10% Glide 90%
Instream Vegetation	<i>Glyceria</i> sp. 20% <i>Rorippa nasturtium-aquaticum</i> agg. <5%
Dominant Bankside Vegetation	Grass, Nettle
Summer Shade of Stream by Bankside Vegetation	<5%
Trout Adult Habitat	None
Trout Nursery Habitat	Poor-None
Trout Spawning Habitat	None

At Site 1 the macroinvertebrate fauna recorded at the site merit a Q-rating of Q3 indicating poor ecological status and moderately polluted conditions.

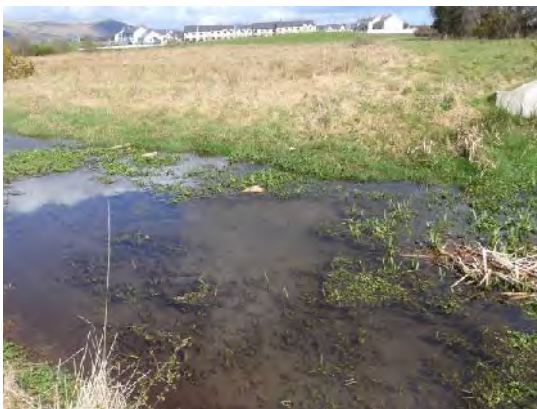
Site 2

Site Code (Grid Reference)	J 1924 1116
Site Location	d/s tributary on RHS
Channel Width (m)	c. 8
Depth (cm)	5 - 15
Substrate (in order of dominance)	Mud
Flow Type	Glide 100%
Instream Vegetation	<i>Apium nodiflorum</i> 15% <i>Sparganium erectum</i> <5% <i>Rorippa nasturtium-aquaticum</i> agg. <5%
Dominant Bankside Vegetation	Grass
Summer Shade of Stream by Bankside Vegetation	<5%
Trout Adult Habitat	None
Trout Nursery Habitat	None
Trout Spawning Habitat	None
Lamprey Nursery	Good
Lamprey Spawning	None
